**CEDD CONTRACT NO. CV/2012/05  
DEVELOPMENT OF A BATHING BEACH AT LUNG MEI,  
TAI PO**

**MONTHLY ENVIRONMENTAL MONITORING AND AUDIT  
REPORT (JULY 2018)**

**PREPARED FOR  
WELCOME CONSTRUCTION CO., LTD**

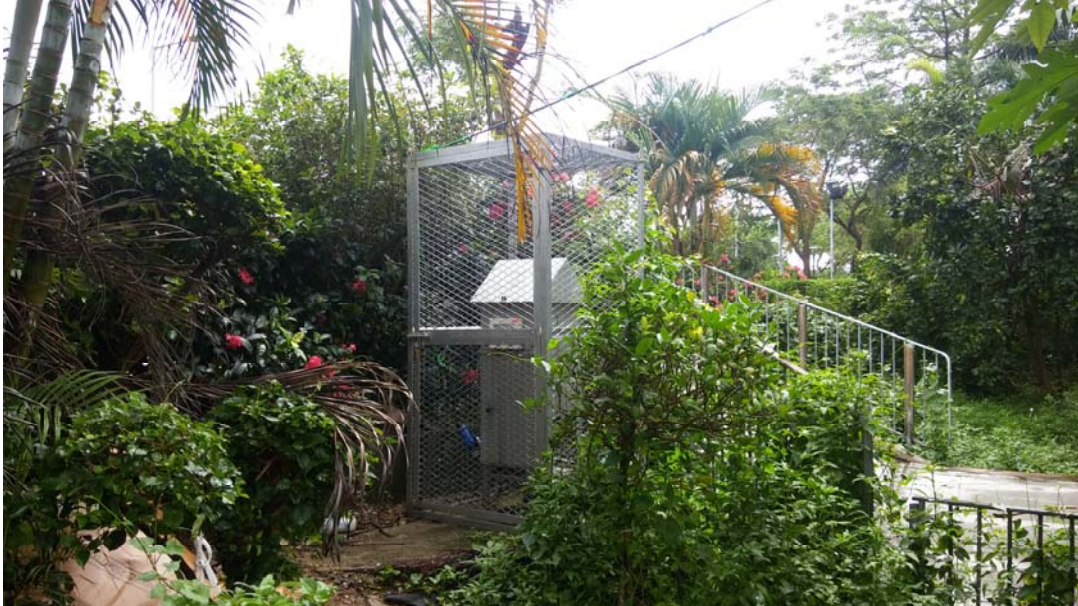
4.2.2 On 4 July 2018, the power supply for HVS at Station A4 was disconnected by the landlord as the tenant removal from the village house. As confirmed by the landlord, the village house will undergo renovation and unable to provision power supply for other use. The Contractor was therefore seeking for power supply from other village houses nearby but failed. Finally, the Contractor decided to set up permanent power supply by connecting power cable from Lung Mei Site to Station A4, which expected to be completed in early August 2018.

**Air Quality Monitoring (24-Hour TSP & 1-Hour TSP)**

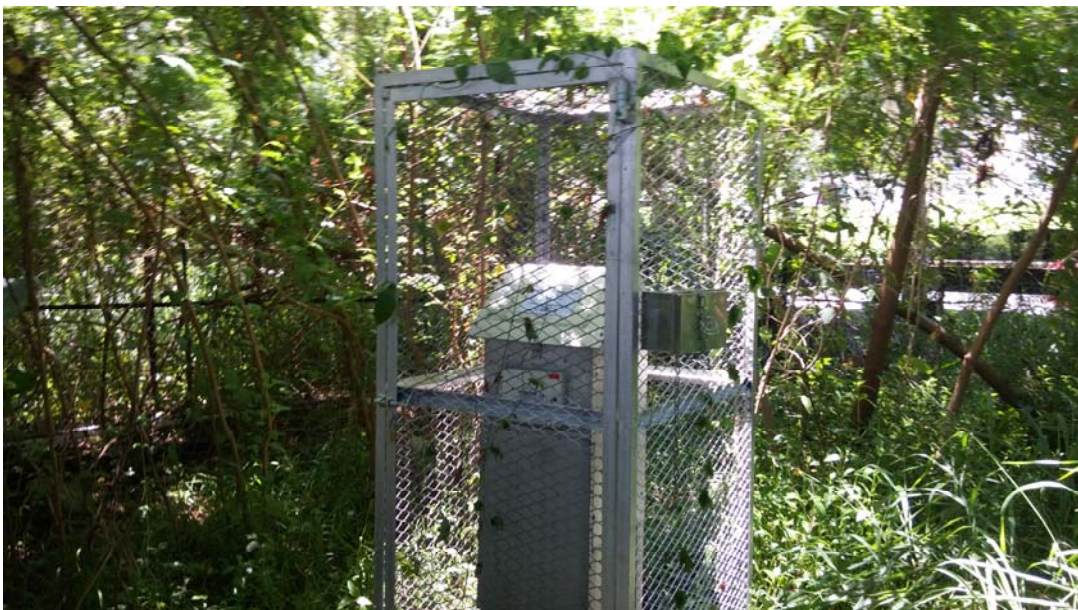
4.2.4 The 24-hour TSP monitoring at Station A7 on 21 July 2018 was failure due to power shortage after successive rainstorm. The power supply was rectified on 27 July 2018 and make-up of lost sample was scheduled on 30 July 2018.

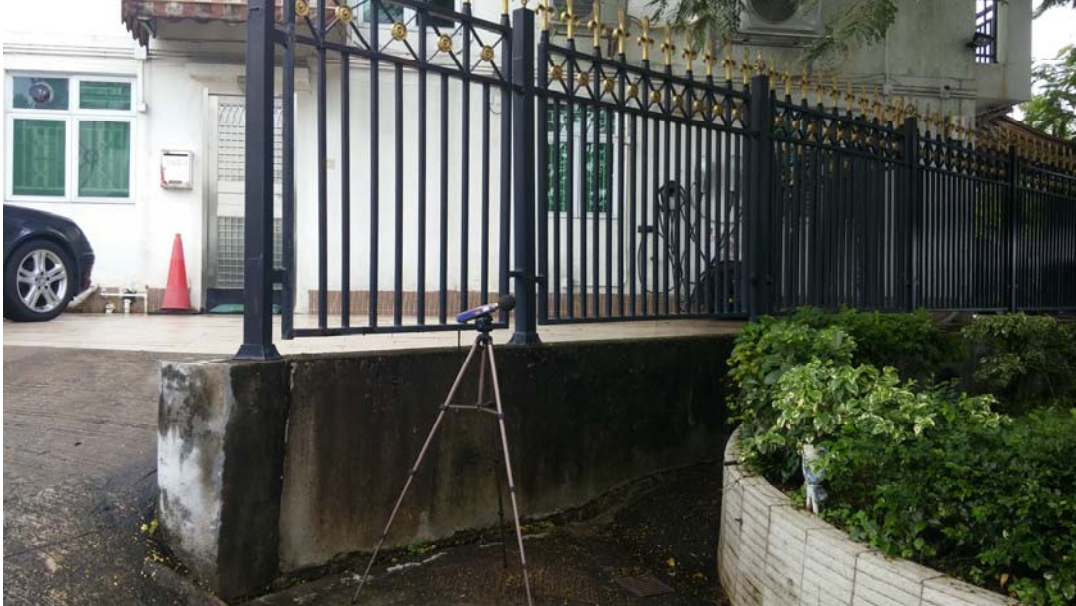
N1

Noise Monitoring

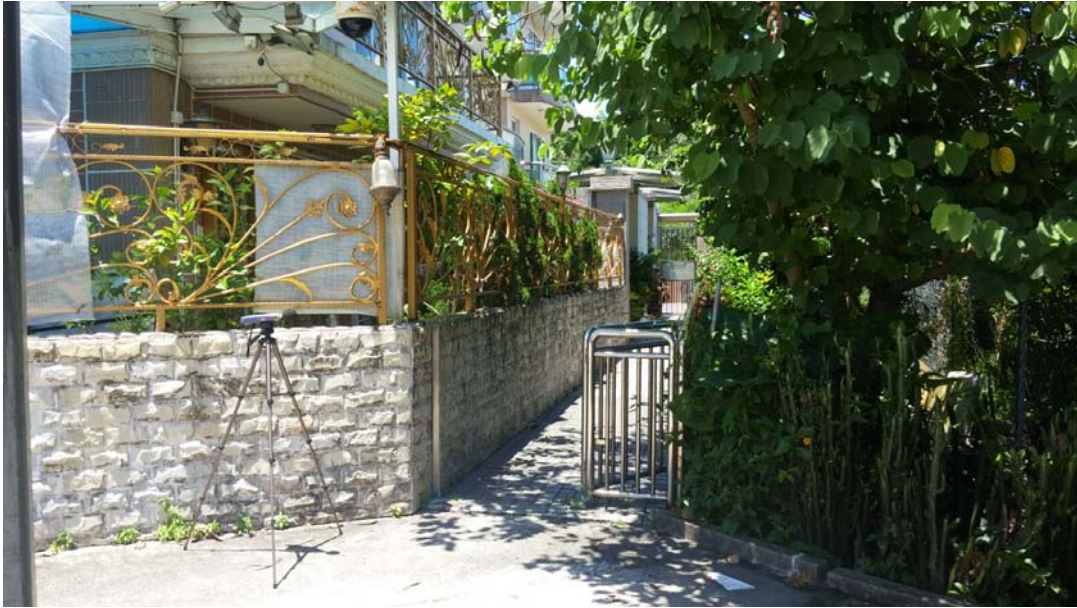
- 1) The distance between N3 and N3a is about 18 meter apart and N3a locates at close proximity of the project site and major site activities which are likely to have noise impacts;
- 2) N3a is a village type residential house and it is a noise sensitive receiver (NSR);
- 3) Accessibility for noise monitoring work at N3a is available; and
- 4) Minimal disturbance would be only caused to the proposed monitoring location N3a.

## Noise Monitoring
