CEDD CONTRACT NO. CV/2012/05
DEVELOPMENT OF A BATHING BEACH AT LUNG MEI,
TAI PO

MONTHLY ENVIRONMENTAL MONITORING AND AUDIT
REPORT (AUGUST 2019)

PREPARED FOR
WELCOME CONSTRUCTION CO., LTD

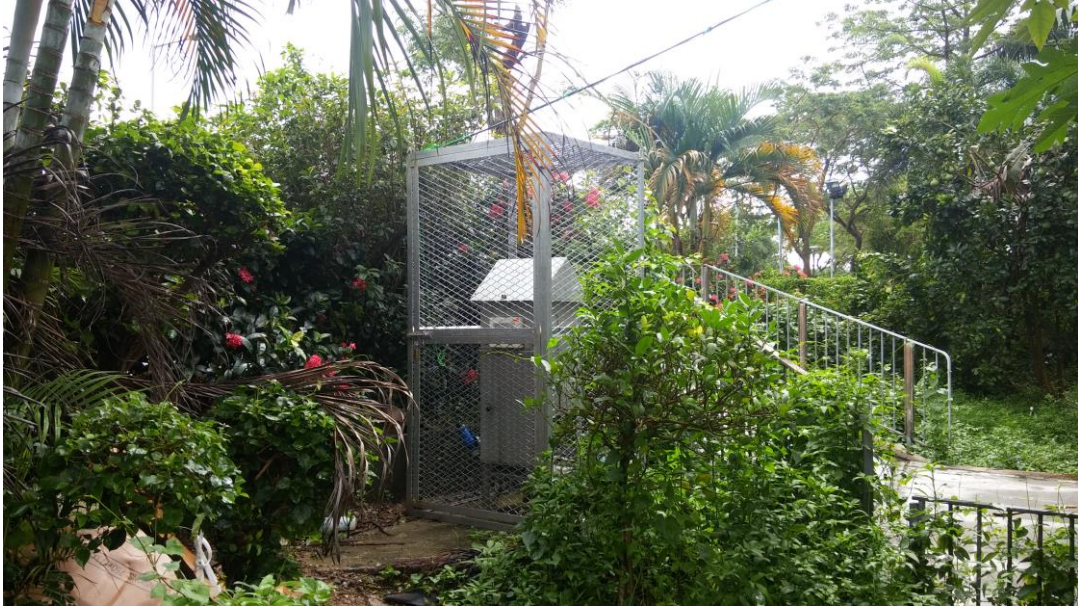
A4

Air Quality Monitoring (24-Hour TSP & 1-Hour TSP)

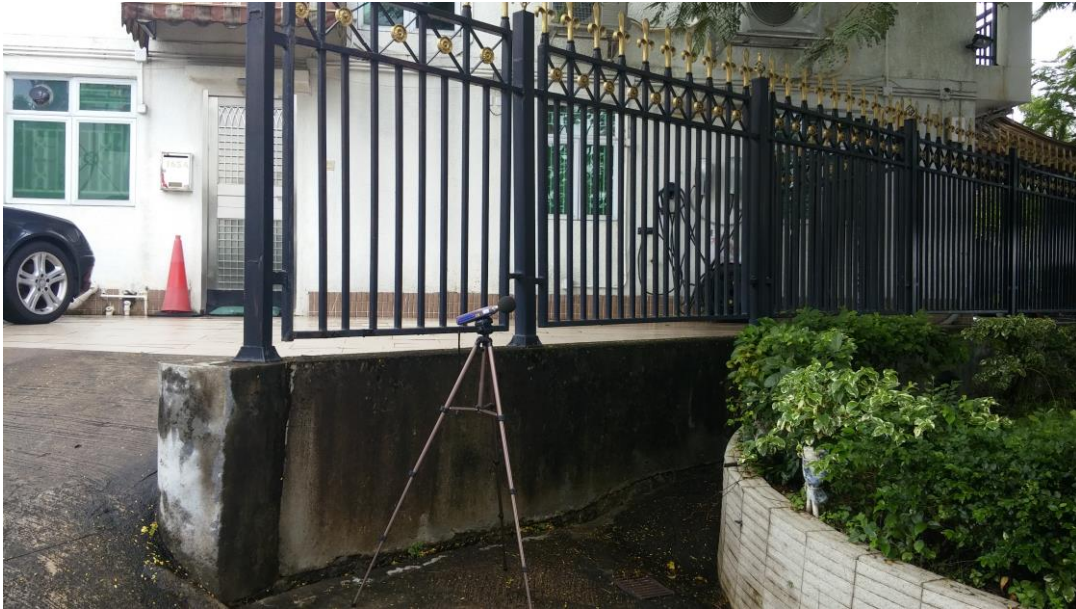
N1

Noise Monitoring

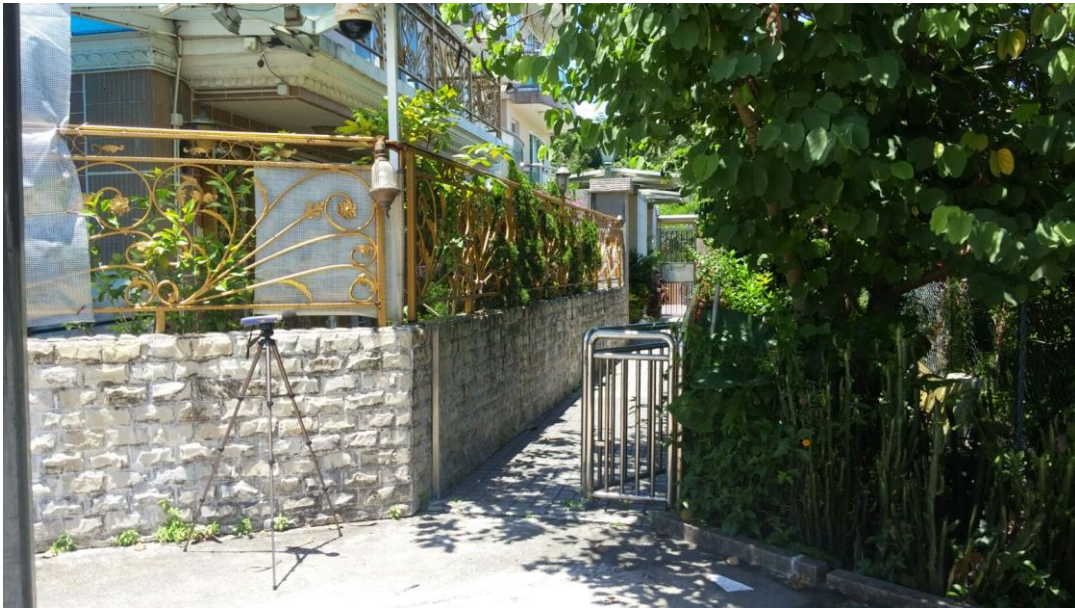
N3a

Noise Monitoring

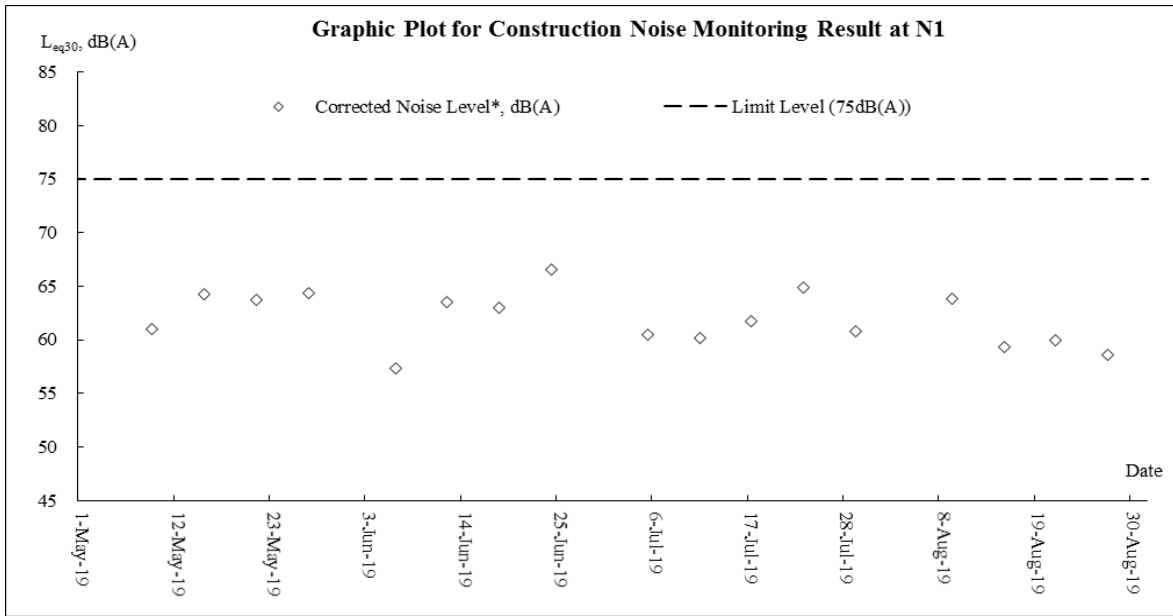
Construction Noise

5.2.2 As shown in [Table 5-1 to Table 5-4](#), all the designated locations measured results were below 75dB(A) of the acceptance criteria. Furthermore, no complaint on construction noise was registered, indicating no exceedance of Action Level. No non-compliance was therefore found during the Reporting Period.
