JOB No.: TCS00874/16

**CEDD CONTRACT NO. CV/2012/05
DEVELOPMENT OF A BATHING BEACH AT LUNG MEI,
TAI PO**

**MONTHLY ENVIRONMENTAL MONITORING AND AUDIT
REPORT (SEPTEMBER 2019)**

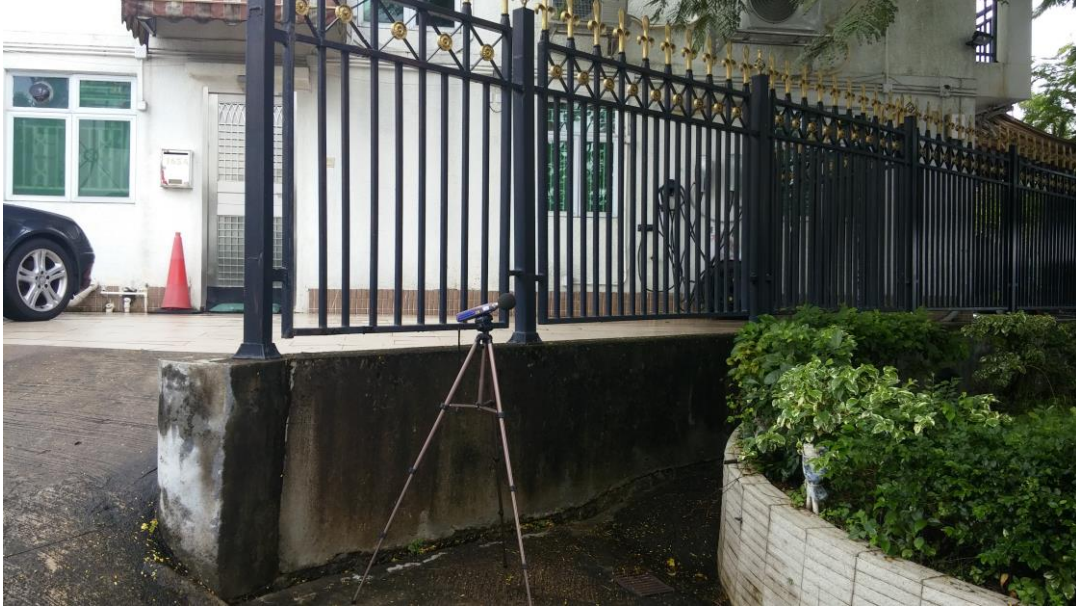
N1

Noise Monitoring

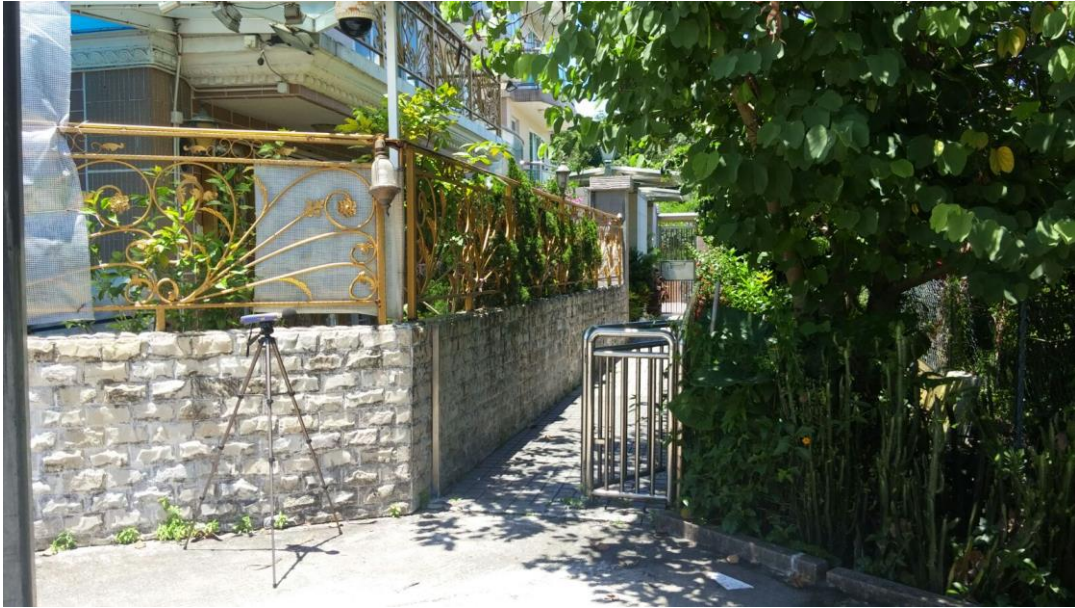
- 1) The distance between N3 and N3a is about 18 meter apart and N3a locates at close proximity of the project site and major site activities which are likely to have noise impacts;
- 2) N3a is a village type residential house and it is a noise sensitive receiver (NSR);
- 3) Accessibility for noise monitoring work at N3a is available; and
- 4) Minimal disturbance would be only caused to the proposed monitoring location N3a.

Noise Monitoring

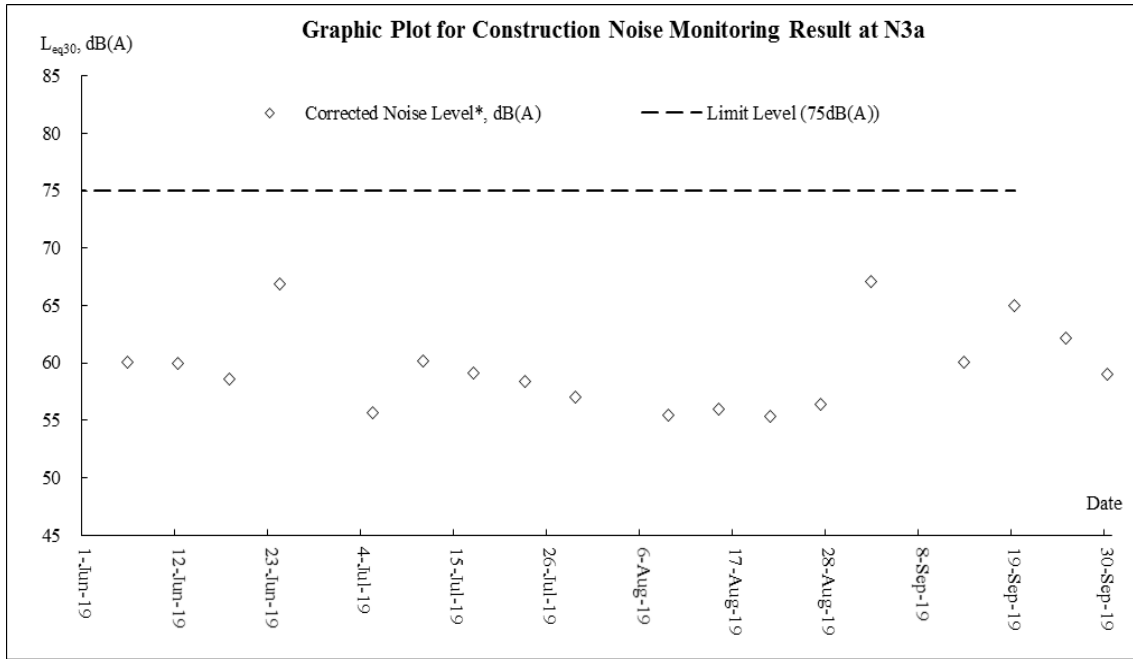
Construction Noise

5.2.2 As shown in [Table 5-1 to Table 5-4](#), all the designated locations measured results were below 75dB(A) of the acceptance criteria. Furthermore, no complaint on construction noise was registered, indicating no exceedance of Action Level. No non-compliance was therefore found during the Reporting Period.

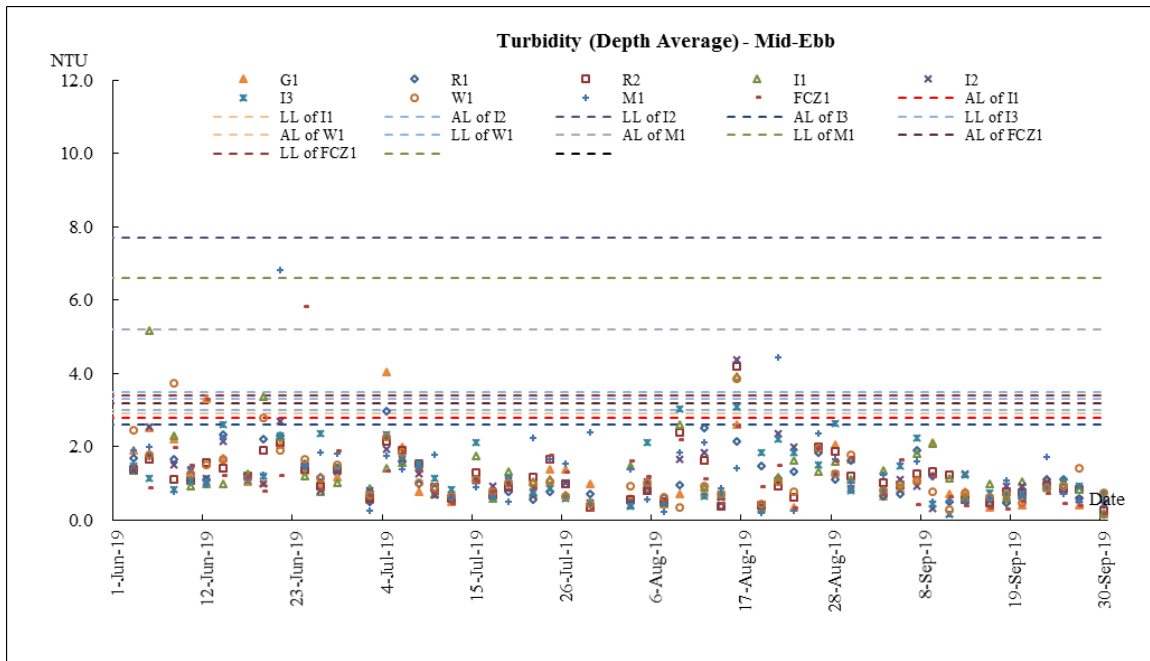
Water Quality

- 12.1.4 In this Reporting Period, there were total of 182 exceedances recorded, included 56 AL/LL exceedance of Dissolved Oxygen, 65 AL/LL exceedances of Turbidity and 61 AL/LL exceedances of Suspended Solids. As water quality mitigation measures, silt curtains were properly in place at locations in accordance with EP. During the course of marine water quality monitoring, no abnormal and turbid discharge made from the construction site was observed. With the implementation of silt curtain, no abnormal / elevated reading of suspended solids and turbidity were recorded, it is considered that the exceedances were unlikely caused by the works under the project. For the DO exceedances, since the baseline was obtained during dry season, it is consideration that the DO exceedances were related to the seasonal change.

- 12.2.2 During the marine works, special attention should be paid on water quality mitigation measures such as silt curtain should be properly implemented and maintained as per the EP condition.
