**Installation of Submarine Gas  
Pipelines and Associated Facilities  
from To Kwa Wan to North Point for  
Former Kai Tak Airport Development**

*Fourth Quarterly Environmental Monitoring &  
Audit (EM&A) Report*

29 July 2013

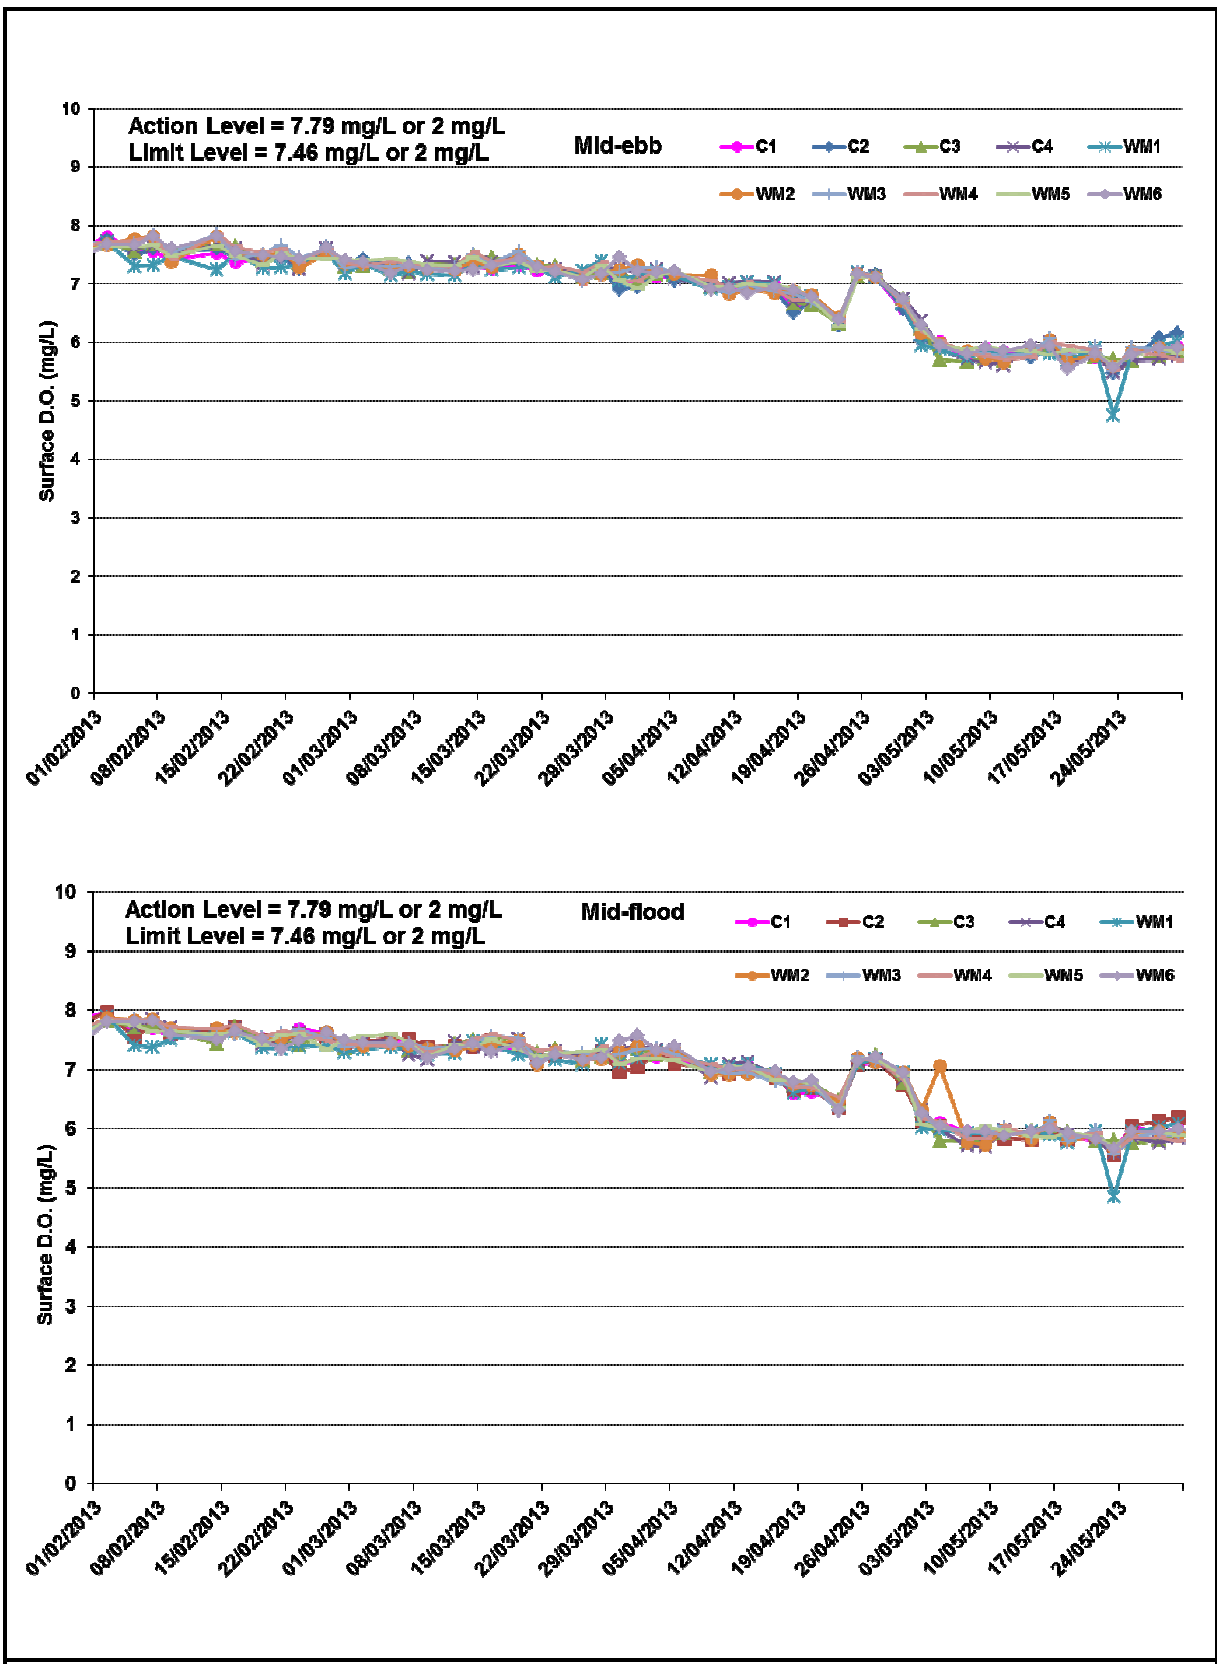
Figure D2 Impact Monitoring – Mean Level of Dissolved Oxygen (mg/L) in surface waters between 1 February 2013 and 31 May 2013 at Monitoring Stations for Marine Works.

Quarterly mean DO levels from surface, mid-depth and bottom waters of Impact Stations were significantly lower than those recorded in Baseline Water Quality Monitoring in March 2012 ( $p < 0.001$ ). Quarterly mean DO levels from surface, mid-depth and bottom waters of Control Stations were also significantly lower than those recorded in Baseline Water Quality Monitoring in March 2012 ( $p < 0.001$ ). When comparing quarterly mean DO levels from surface, mid-depth and bottom waters between Impact Stations and Control Stations, no significant difference was found ( $p > 0.05$ ). Therefore, it is considered that the significantly lower DO levels recorded in this quarterly period (ie compared to the baseline levels) are more likely to be representing natural background fluctuation in water quality rather than indicating any adverse water quality impacts from the Project since the lower DO levels were recorded at the Impact Stations as well as the Control Stations, which are far away from the marine works locations that should not be affected by the marine works.

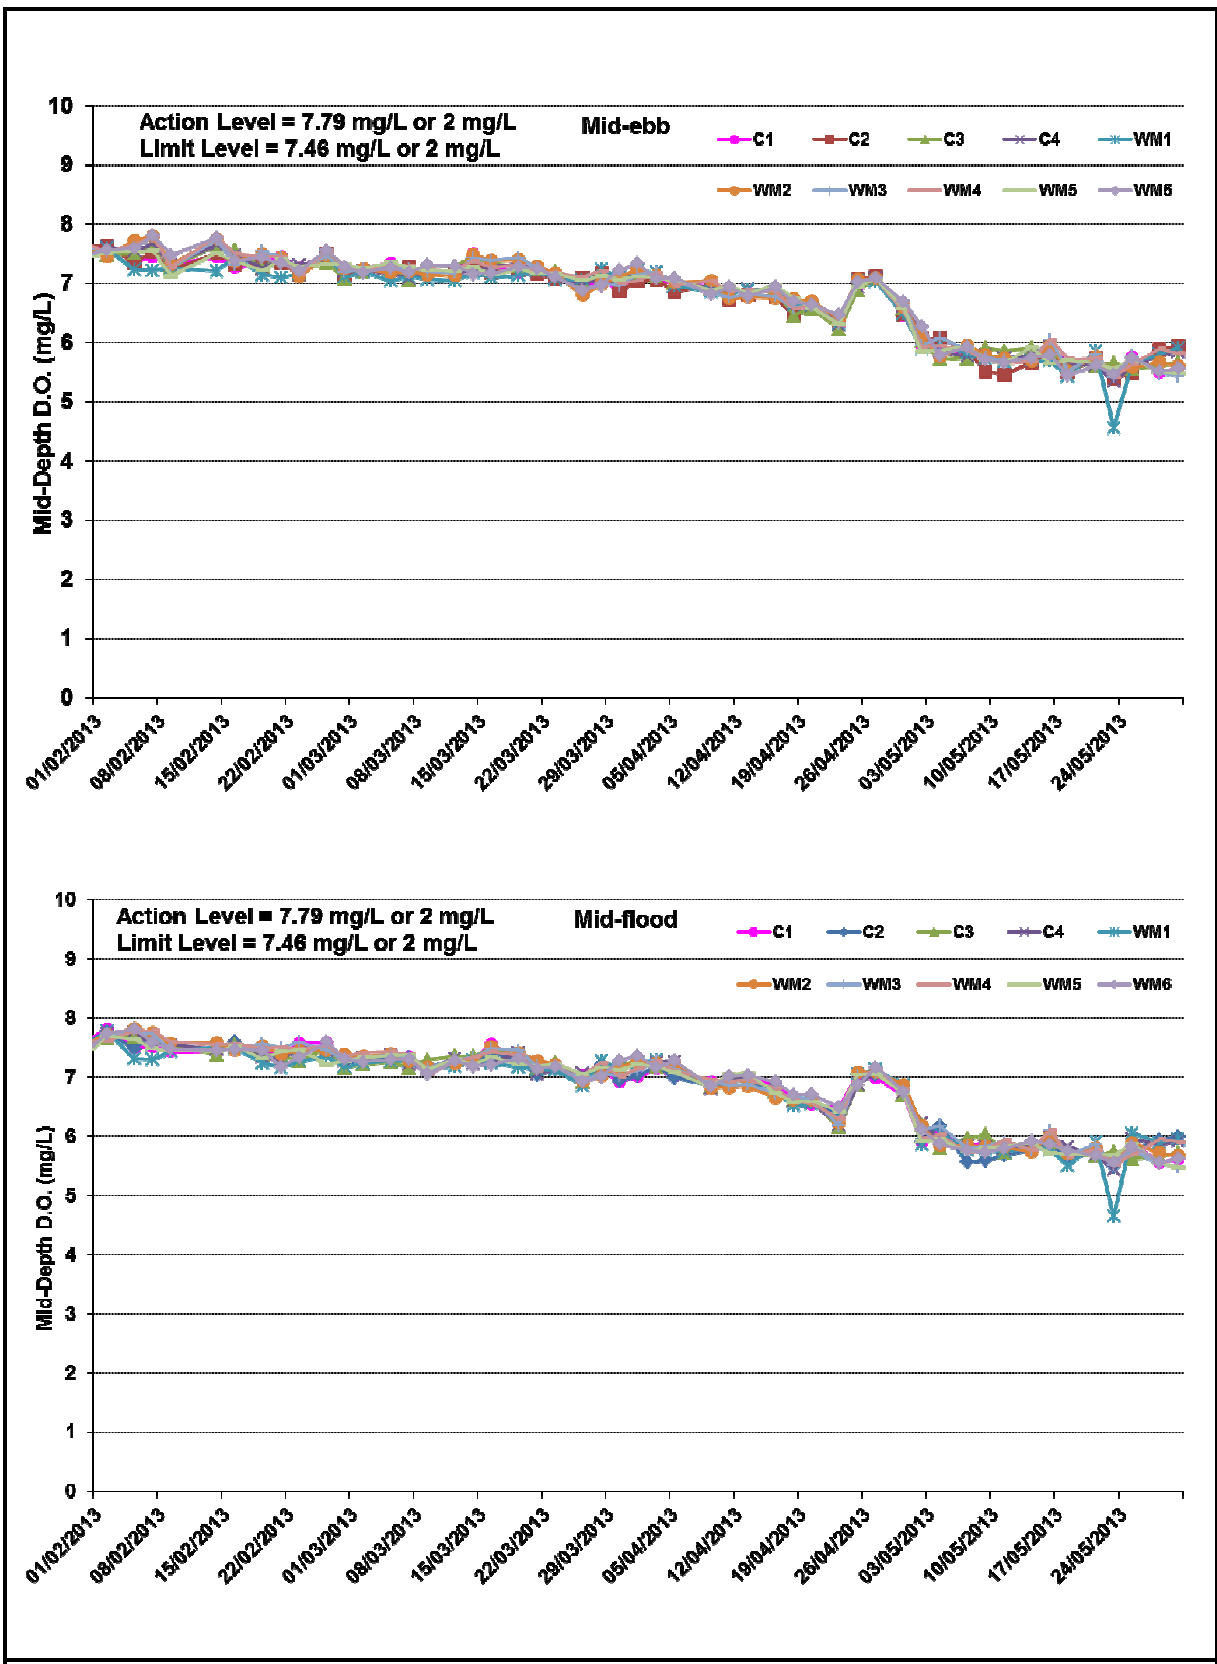
Figure D3 Impact Monitoring – Mean Level of Dissolved Oxygen (mg/L) in mid-depth waters between 1 February 2013 and 31 May 2013 at Monitoring Stations for Marine Works.

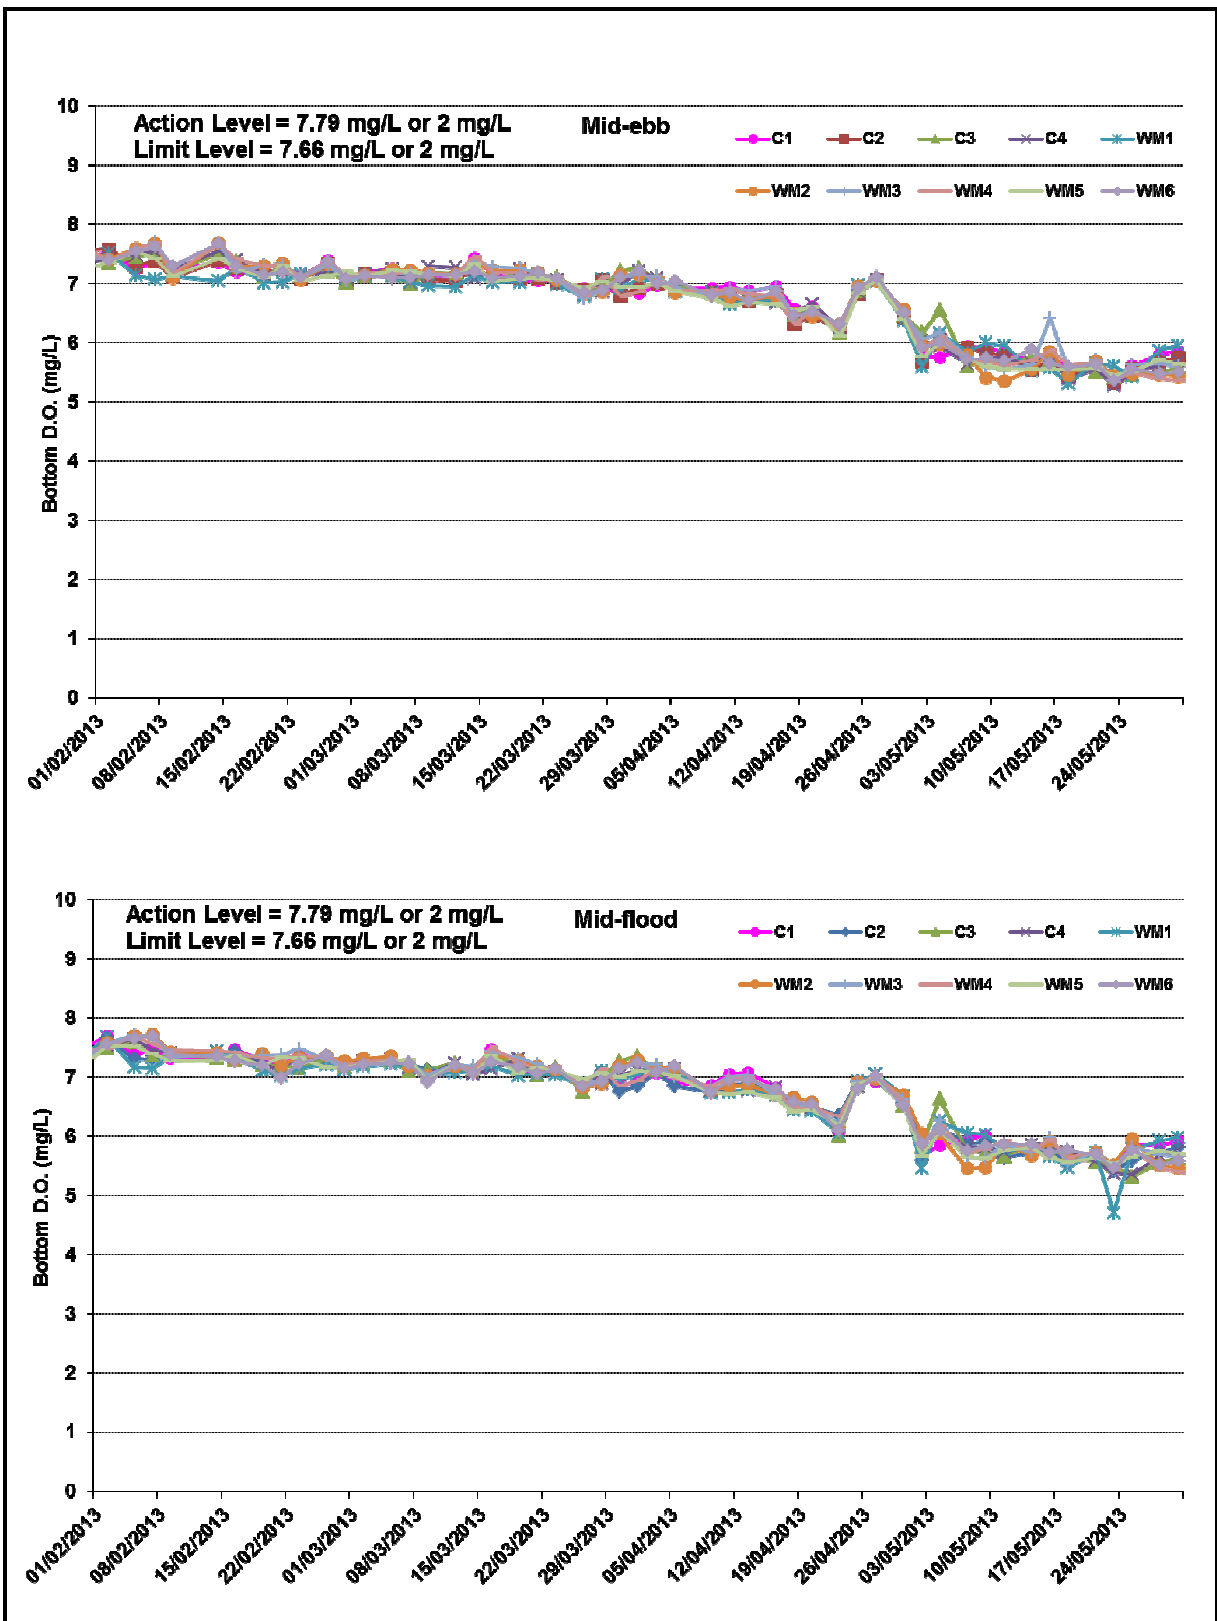
Figure D4 Impact Monitoring – Mean Level of Dissolved Oxygen (mg/L) in bottom waters between 1 February 2013 and 31 May 2013 at Monitoring Stations for Marine Works.

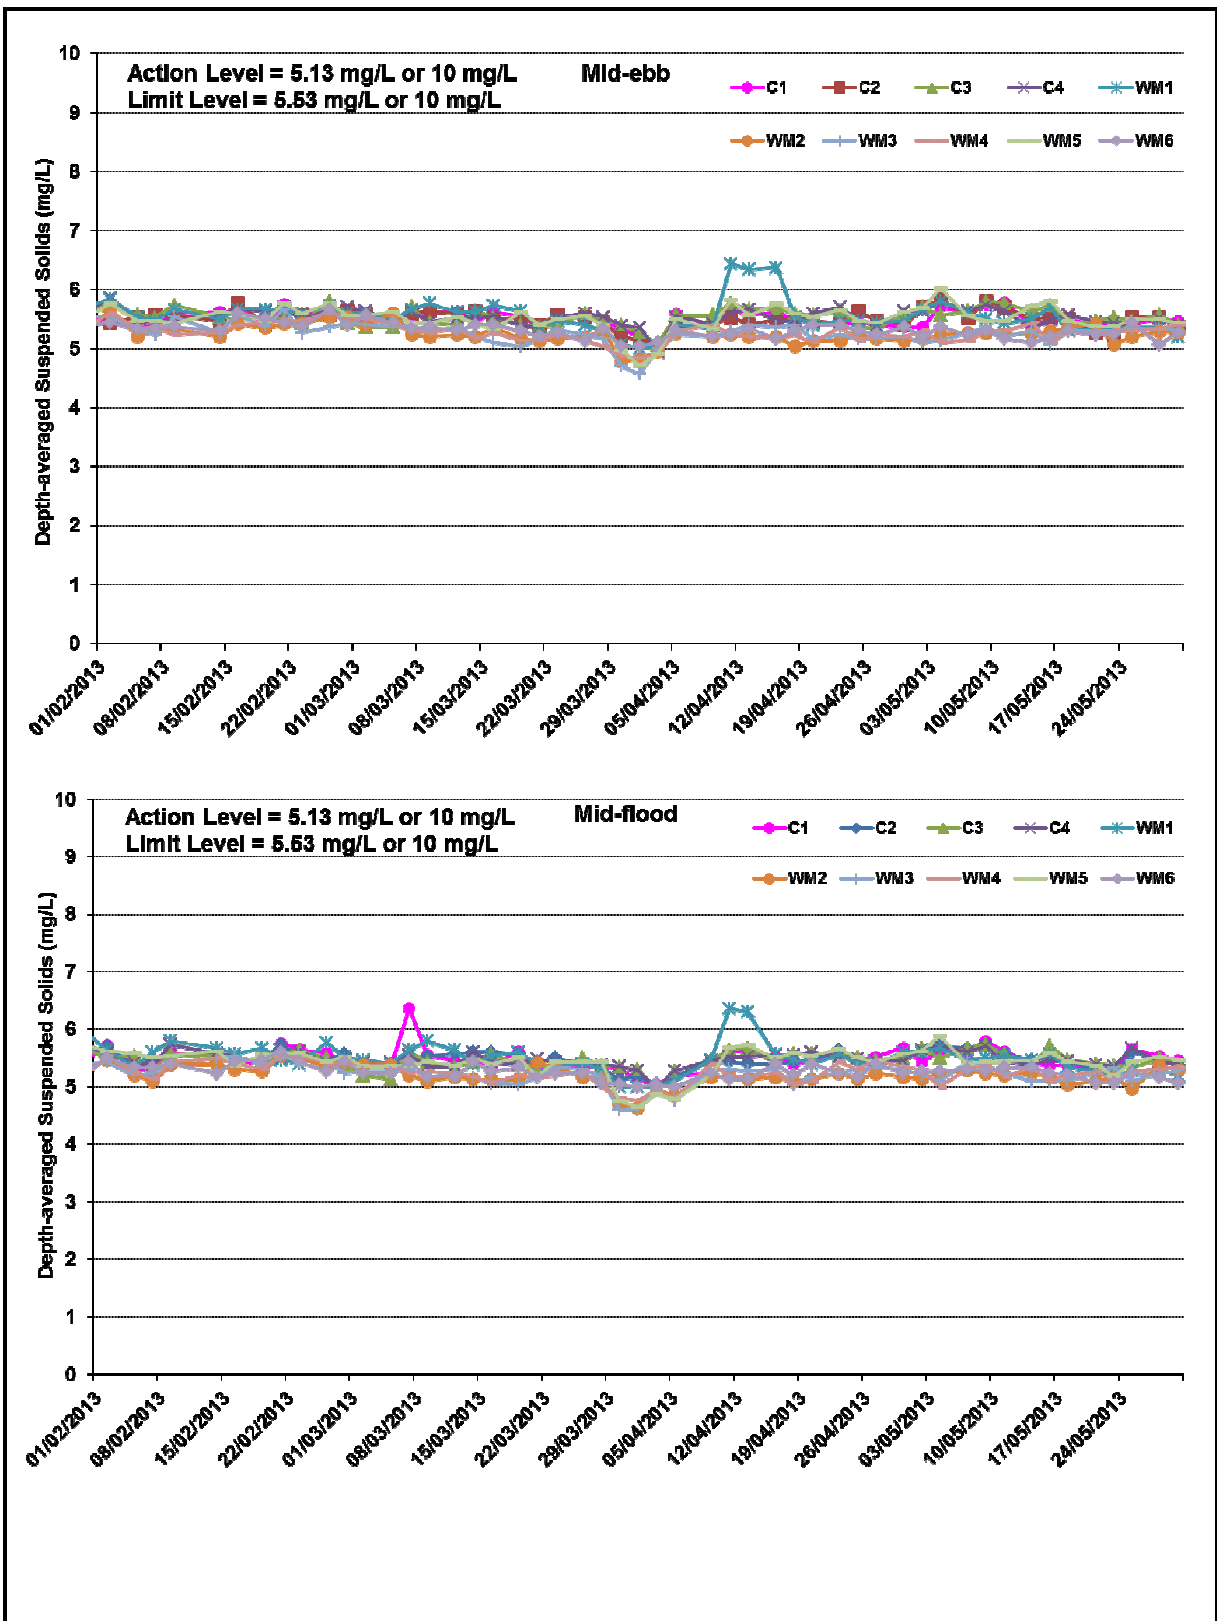
Figure D5 Impact Monitoring – Mean Depth-averaged Level of Suspended Solids (mg/L) between 1 February 2013 and 31 May 2013 at Monitoring Stations for Marine Works.

Similar to DO levels, turbidity and SS levels were generally similar amongst all stations and variable throughout the monitoring period. High levels of turbidity and SS were occasionally recorded during both mid-ebb and mid-flood tides. Such fluctuations were also observed during baseline monitoring and are considered to be sporadic events and characteristic of water quality in this area of Hong Kong.

Exceedances in the Action and Limit Levels of depth-averaged turbidity and SS levels were also recorded. As explained above, high level of turbidity and SS in this area are considered to be sporadic and characteristic of water quality in this area of Hong Kong. The observed exceedances were thus not considered to be of environmental concern.

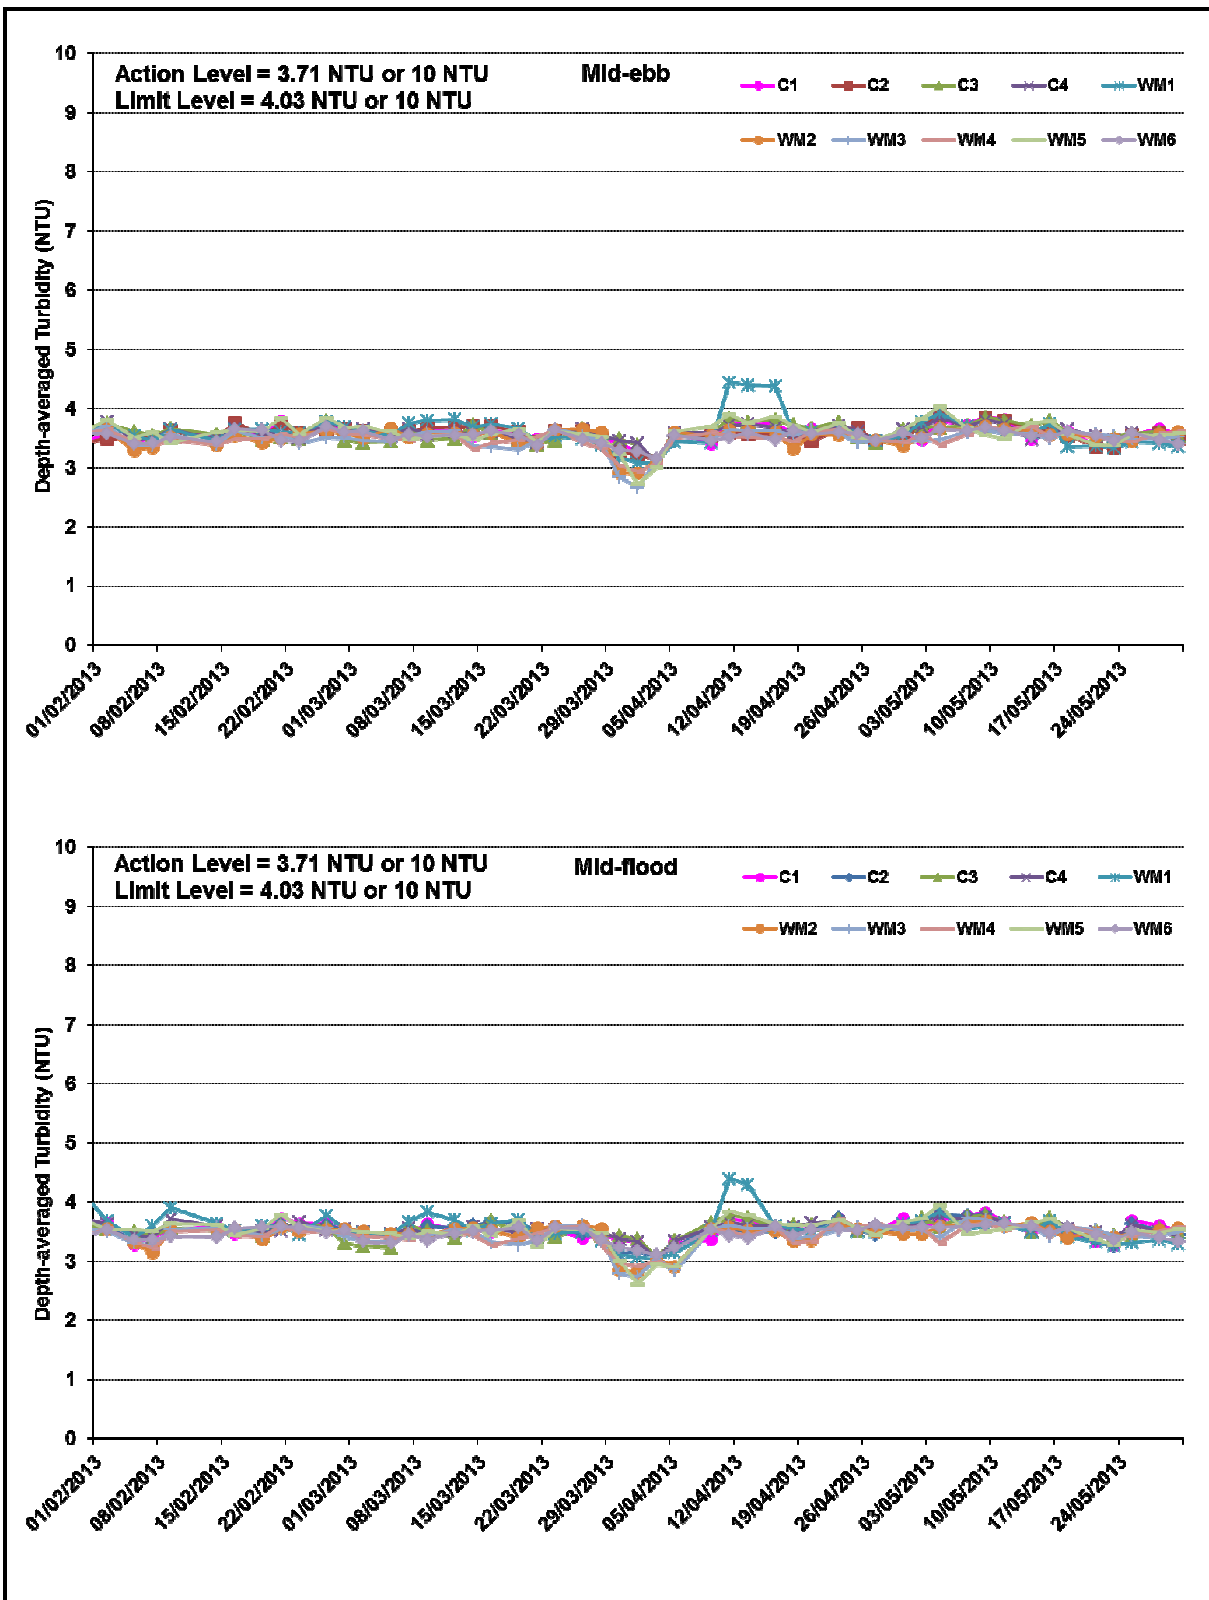
Figure D6 Impact Monitoring – Mean Depth-averaged Level of Turbidity (NTU) between 1 February 2013 and 31 May 2013 at Monitoring Stations for Marine Works.

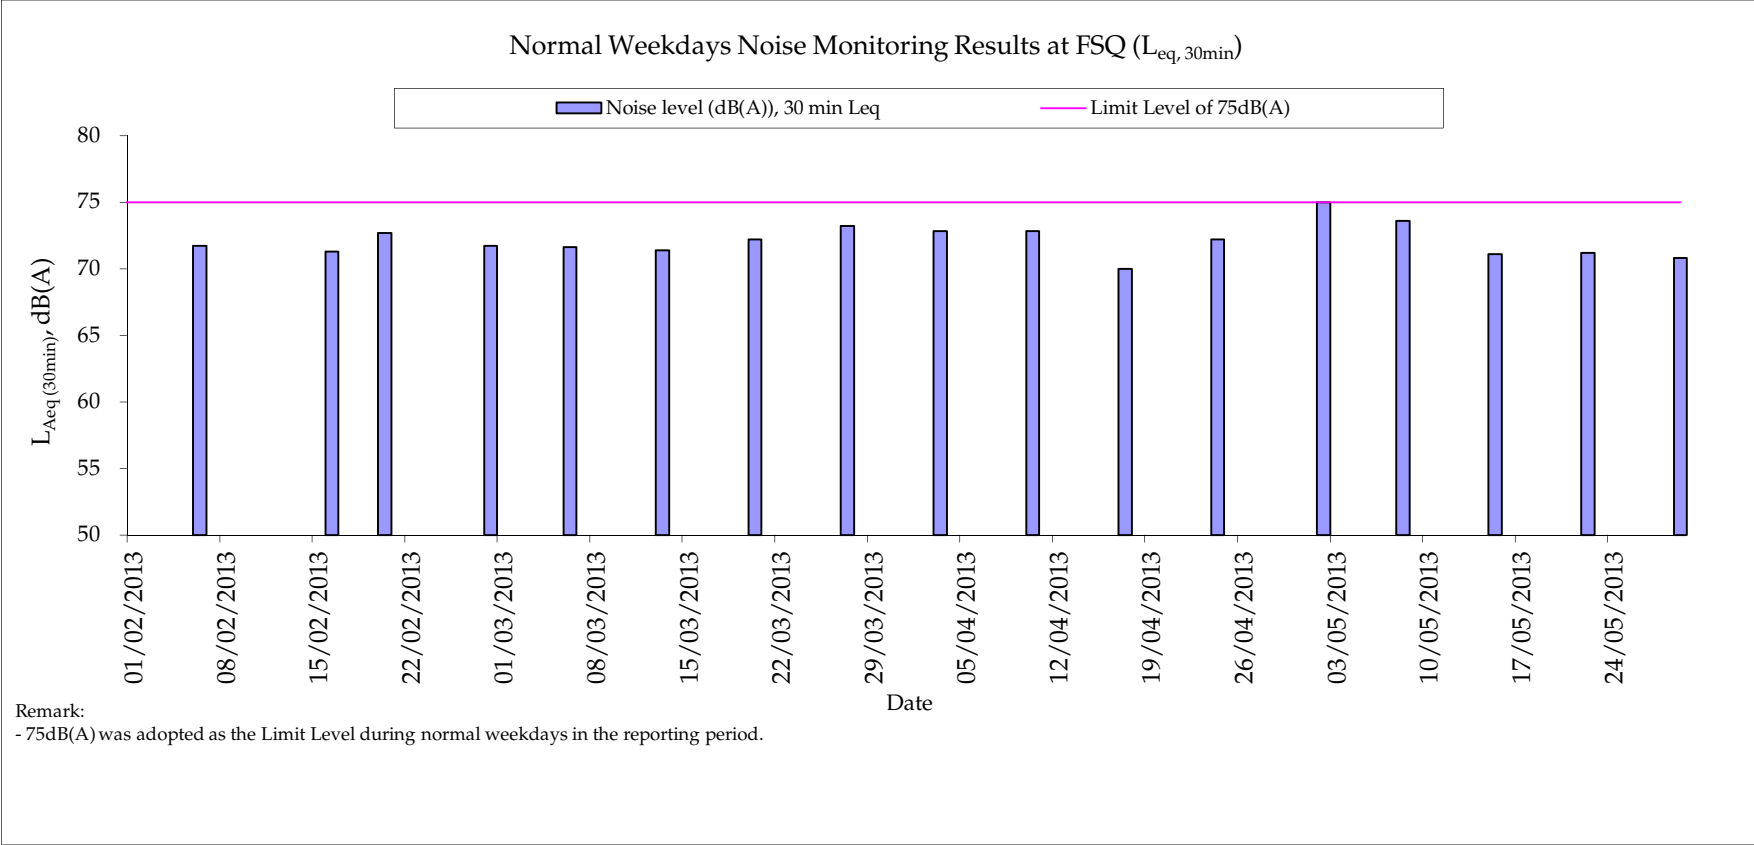
**Annex E7 - Noise Monitoring Result**

The monitoring results together with graphical presentations are presented in *Annex E3 – E8*. The local impacts observed near the monitoring stations of SCH02 and FSQ were due to traffic noise from Sung On Street and Island Eastern Corridor, respectively.
