**Installation of Submarine Gas
Pipelines and Associated Facilities
from To Kwa Wan to North Point for
Former Kai Tak Airport Development**

Ninth Coral Impact Report

31 October 2012

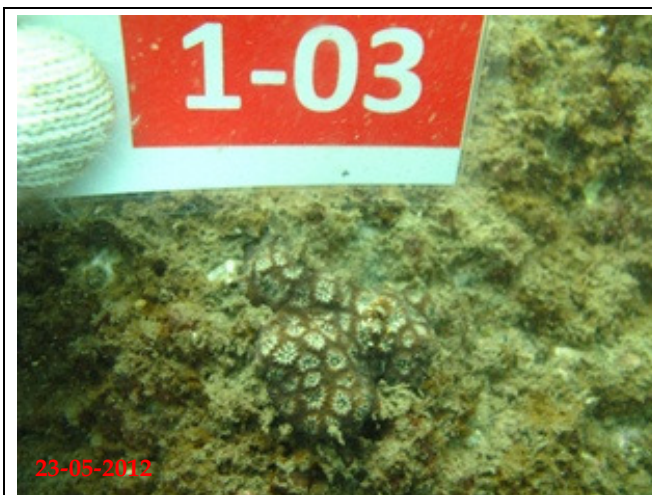
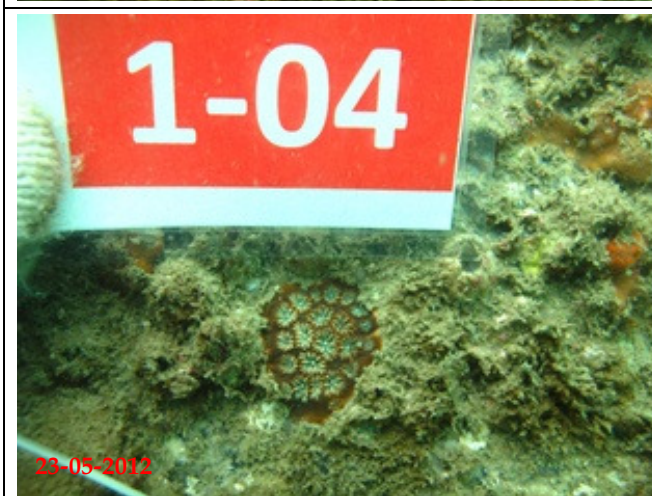
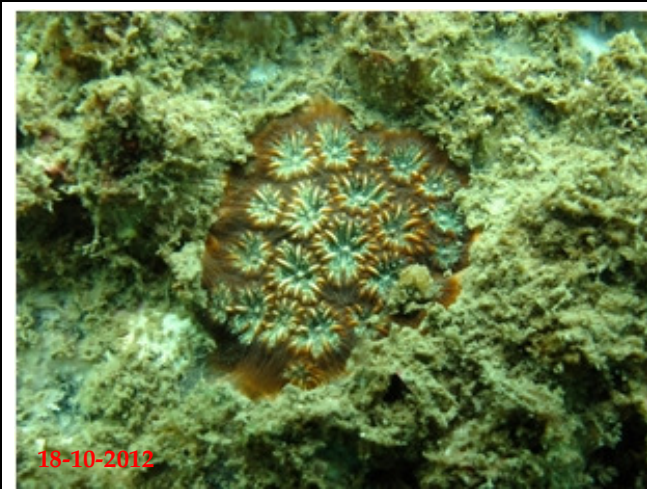
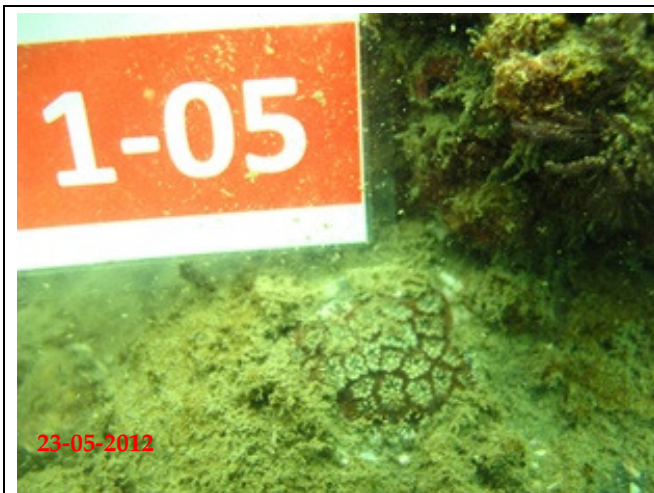
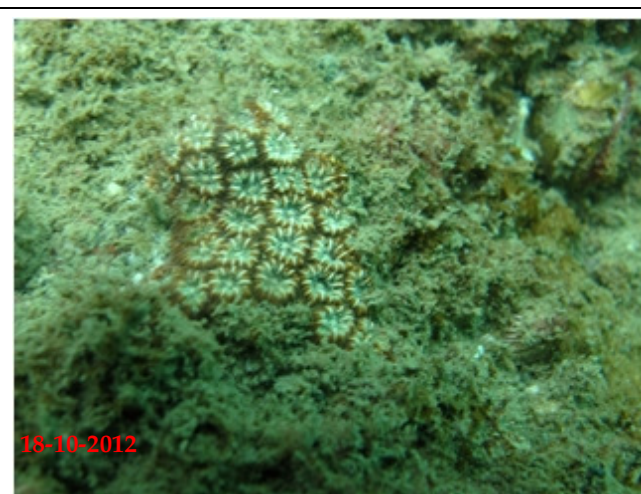
Annex A1 Photographic Records of Tagged Coral Colonies at Impact Monitoring Site (Area 1) during the Baseline and Impact Monitoring Surveys

Findings of the 9th Impact Coral Monitoring Surveys indicated that the Action Levels or Limit Levels for coral monitoring were not exceeded (*Tables 2.2-2.5*). There did not appear to be any deterioration in the general health and

condition of the tagged coral colonies as a result of the dredging activities within 250 m from the To Kwa Wan breakwaters.

Coral No.	Species	Size (cm ²)	Growth Form	Partial Mortality (%)	Percentage Increase in Partial Mortality (%) ⁽²⁾	Sediment Thickness (mm)	Sediment Type (Mud/Sand)	Sediment Color	General Health of Tagged Coral ⁽¹⁾
Baseline Survey on 23 May 2012									
1	<i>Oulastrea crispata</i>	12	Encrusting	0	N/A	0	N/A	N/A	4.5
2	<i>Oulastrea crispata</i>	9.2	Encrusting	0	N/A	0	N/A	N/A	4.5
3	<i>Oulastrea crispata</i>	12.2	Encrusting	0	N/A	0	N/A	N/A	4.5
4	<i>Oulastrea crispata</i>	4.8	Encrusting	0	N/A	0	N/A	N/A	5
5	<i>Oulastrea crispata</i>	6.2	Encrusting	0	N/A	0	N/A	N/A	4.5
6	<i>Oulastrea crispata</i>	4.4	Encrusting	0	N/A	0	N/A	N/A	5
7	<i>Oulastrea crispata</i>	12.1	Encrusting	0	N/A	0	N/A	N/A	4.5
8	<i>Oulastrea crispata</i>	3.6	Encrusting	0	N/A	0	N/A	N/A	5.5
9	<i>Oulastrea crispate</i>	34.6	Encrusting	<1	N/A	0	N/A	N/A	5
10	<i>Oulastrea crispata</i>	3.2	Encrusting	0	N/A	0	N/A	N/A	4.5
Updated Baseline Survey on 6 August 2012

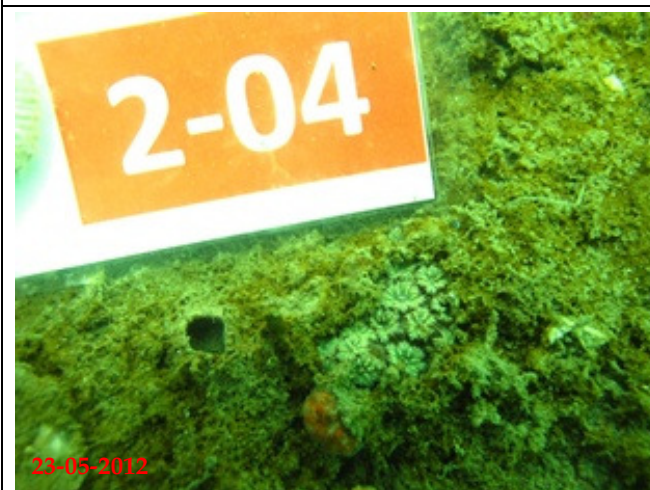
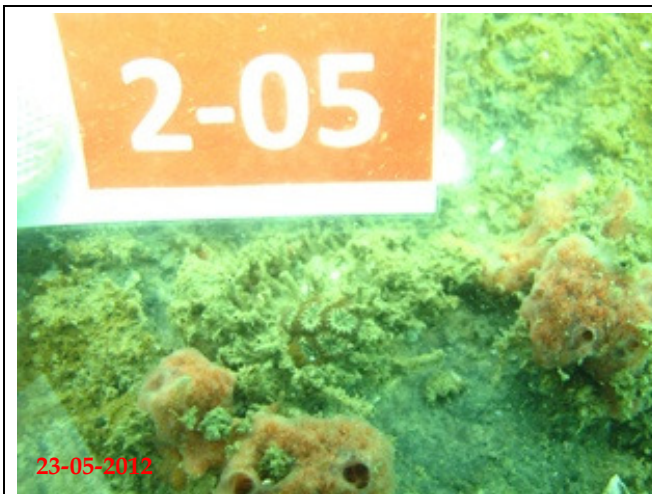
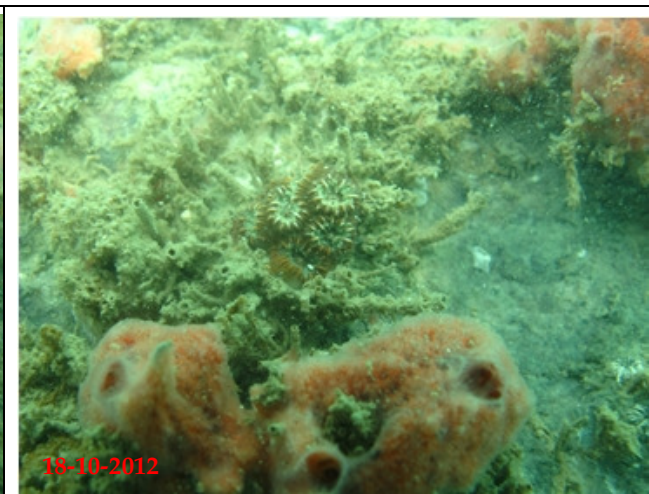
Annex A2 Photographic Records of Tagged Coral Colonies at Impact Monitoring Site (Area 2) during Baseline and Impact Monitoring Surveys

Coral No.	Species	Size (cm ²)	Growth Form	Partial Mortality (%)	Percentage Increase in Partial Mortality (%) ⁽²⁾	Sediment Thickness (mm)	Sediment Type (Mud/Sand)	Sediment Color	General Health of Tagged Coral ⁽¹⁾
Baseline Survey on 23 May 2012									
1	<i>Oulastrea crispata</i>	6.8	Encrusting	0	N/A	0	N/A	N/A	4.5
2	<i>Oulastrea crispata</i>	1.7	Encrusting	0	N/A	0	N/A	N/A	4
3	<i>Oulastrea crispata</i>	1.3	Encrusting	0	N/A	0	N/A	N/A	5
4	<i>Oulastrea crispata</i>	2.6	Encrusting	0	N/A	0	N/A	N/A	5
5	<i>Oulastrea crispata</i>	14.6	Encrusting	0	N/A	0	N/A	N/A	4.5
6	<i>Oulastrea crispata</i>	4.6	Encrusting	0	N/A	0	N/A	N/A	4.5
7	<i>Oulastrea crispata</i>	8.1	Encrusting	0	N/A	0	N/A	N/A	5
8	<i>Oulastrea crispata</i>	13.1	Encrusting	0	N/A	0	N/A	N/A	4.5
9	<i>Oulastrea crispata</i>	5.7	Encrusting	0	N/A	0	N/A	N/A	5
10	<i>Oulastrea crispata</i>	6.9	Encrusting	0	N/A	0	N/A	N/A	5
Updated Baseline Survey on 6 August 2012

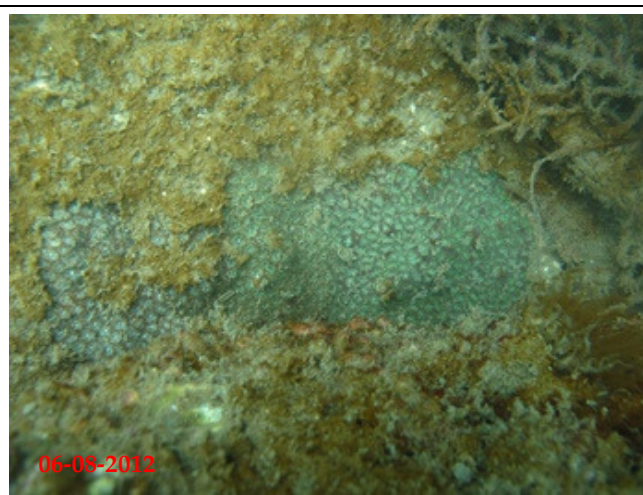
Annex A3 Photographic Records of Tagged Coral Colonies at Impact Monitoring Site (Area 3) during Baseline and Impact Monitoring Surveys

Coral No.	Species	Size (cm ²)	Growth Form	Partial Mortality (%)	Percentage Increase in Partial Mortality (%) ⁽²⁾	Sediment Thickness (mm)	Sediment Type (Mud/Sand)	Sediment Color	General Health of Tagged Coral ⁽¹⁾
Baseline Survey on 23 May 2012									
1	<i>Oulastrea crispata</i>	7.2	Encrusting	0	N/A	0	N/A	N/A	4.5
2	<i>Oulastrea crispata</i>	0.9	Encrusting	0	N/A	0	N/A	N/A	4
3	<i>Oulastrea crispata</i>	3.4	Encrusting	0	N/A	0	N/A	N/A	4
4	<i>Oulastrea crispata</i>	106.8	Encrusting	0	N/A	1	Mud	Light brown	4.5
5	<i>Oulastrea crispata</i>	7.3	Encrusting	0	N/A	1	Mud	Light brown	4.5
6	<i>Oulastrea crispata</i>	32.4	Encrusting	0	N/A	0	N/A	N/A	5
7	<i>Oulastrea crispata</i>	3.6	Encrusting	0	N/A	0	N/A	N/A	5
8	<i>Oulastrea crispata</i>	5.3	Encrusting	0	N/A	1	Mud	Light brown	4.5
9	<i>Oulastrea crispata</i>	20.5	Encrusting	0	N/A	0	N/A	N/A	4
10	<i>Oulastrea crispata</i>	11.6	Encrusting	0	N/A	0	N/A	N/A	5
Updated Baseline Survey on 6 August 2012

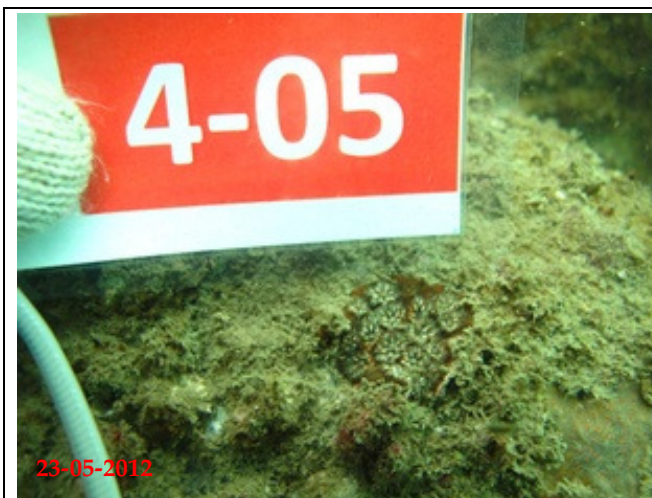
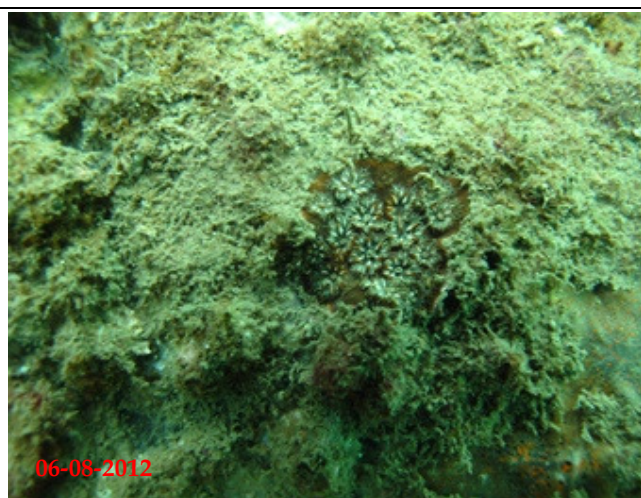
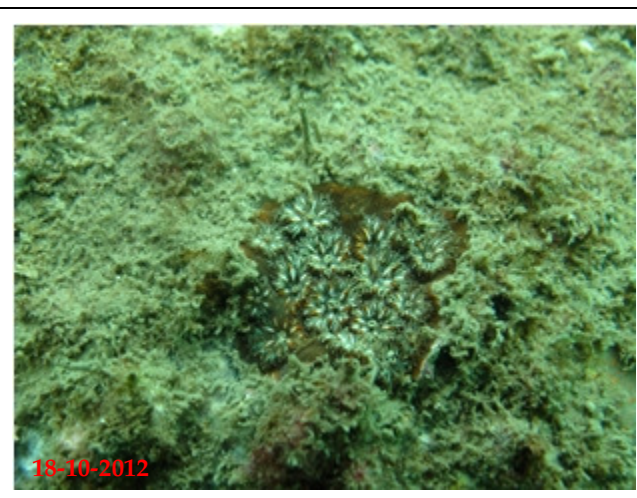
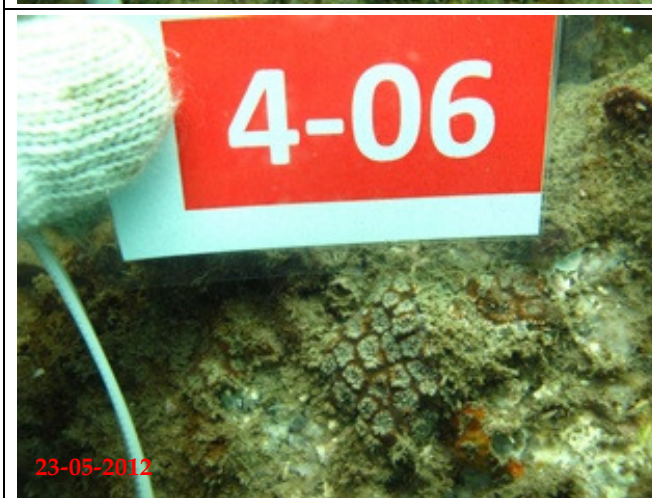
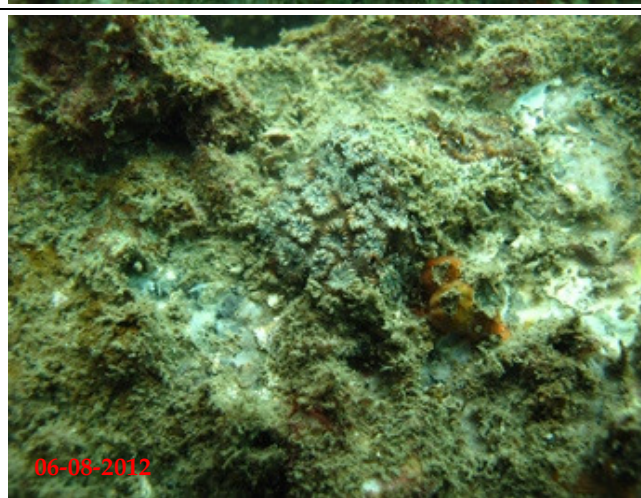
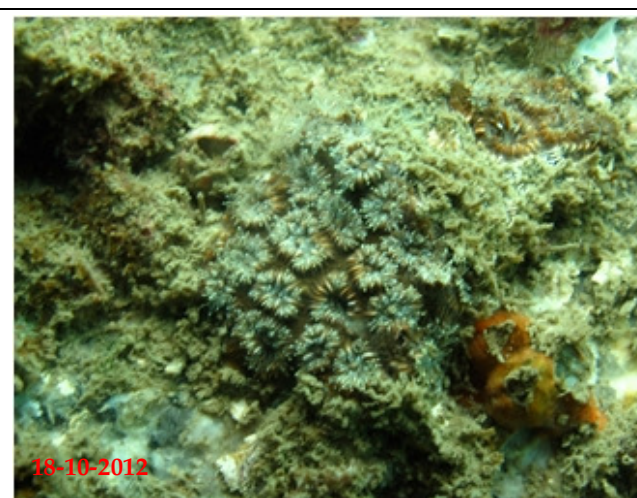
Annex A4 Photographic Records of Tagged Coral Colonies at Control Site (Area 4) during Baseline and Impact Monitoring Surveys

Coral No.	Species	Size (cm ²)	Growth Form	Partial Mortality	Percentage Increase in Partial Mortality (%) ⁽²⁾	Sediment Thickness	Sediment Type	Sediment Color	General Health of Tagged Coral ⁽¹⁾
Baseline Survey on 23 May 2012									
1	<i>Oulastrea crispata</i>	7.8	Encrusting	0	N/A	0	N/A	N/A	5
2	<i>Oulastrea crispata</i>	3.9	Encrusting	0	N/A	0	N/A	N/A	5
3	<i>Oulastrea crispata</i>	15.2	Encrusting	0	N/A	0	N/A	N/A	5
4	<i>Oulastrea crispata</i>	6.2	Encrusting	0	N/A	0	N/A	N/A	5
5	<i>Oulastrea crispata</i>	8.2	Encrusting	0	N/A	0	N/A	N/A	4.5
6	<i>Oulastrea crispata</i>	7.3	Encrusting	0	N/A	0	N/A	N/A	4.5
7	<i>Oulastrea crispata</i>	12.2	Encrusting	0	N/A	0	N/A	N/A	5
8	<i>Oulastrea crispata</i>	14.4	Encrusting	0	N/A	0	N/A	N/A	5
9	<i>Oulastrea crispata</i>	5.2	Encrusting	0	N/A	0	N/A	N/A	4
10	<i>Oulastrea crispata</i>	13.5	Encrusting	0	N/A	0	N/A	N/A	5
Updated Baseline Survey on 6 August 2012									
1	<i>Oulastrea crispata</i>	7.8	Encrusting	0	N/A	0	N/A	N/A	4.5
