Installation of Submarine Gas Pipelines and Associated Facilities from To Kwa Wan to North Point for Former Kai Tak Airport Development

16 August 2012

First Coral Impact Report

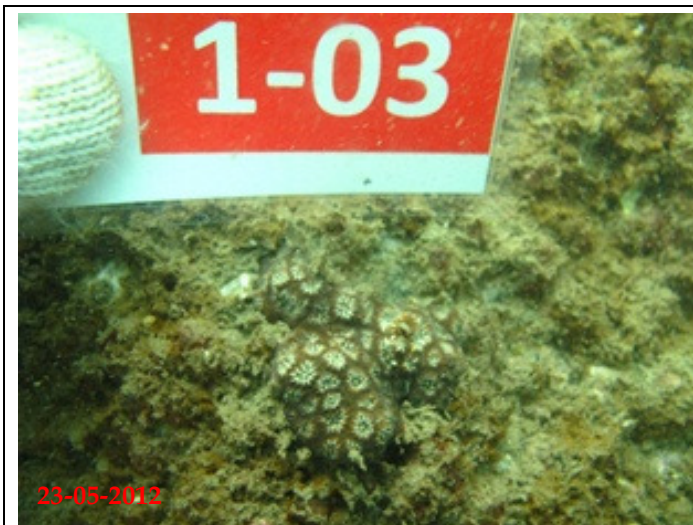
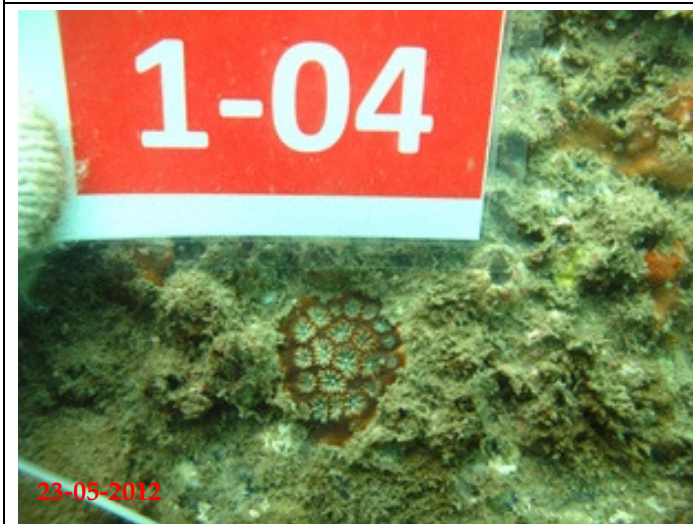
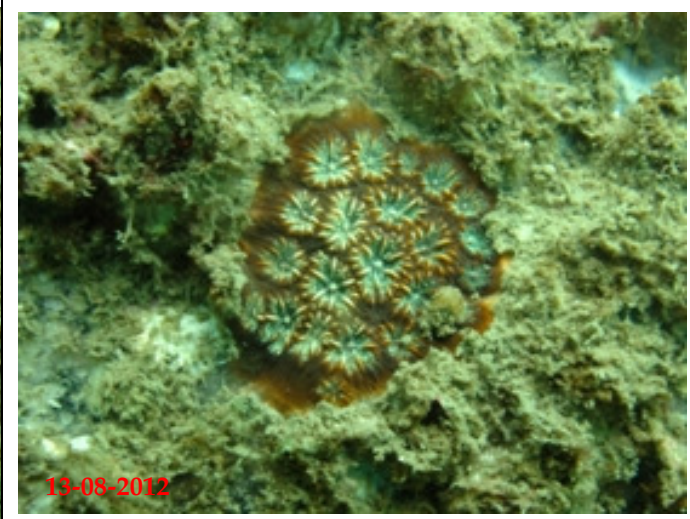
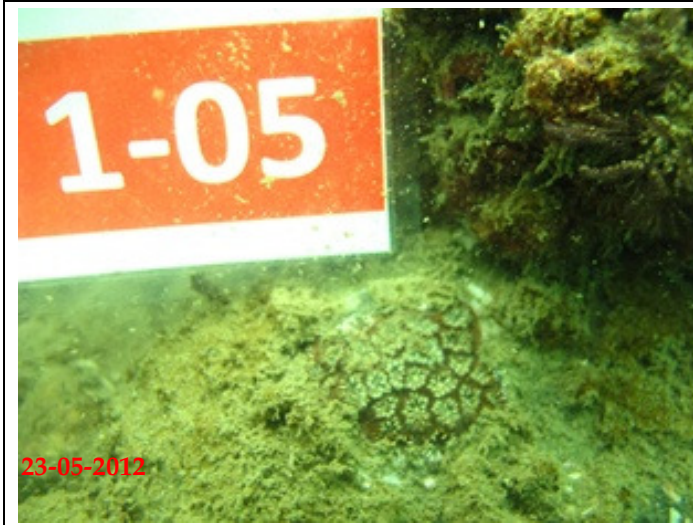
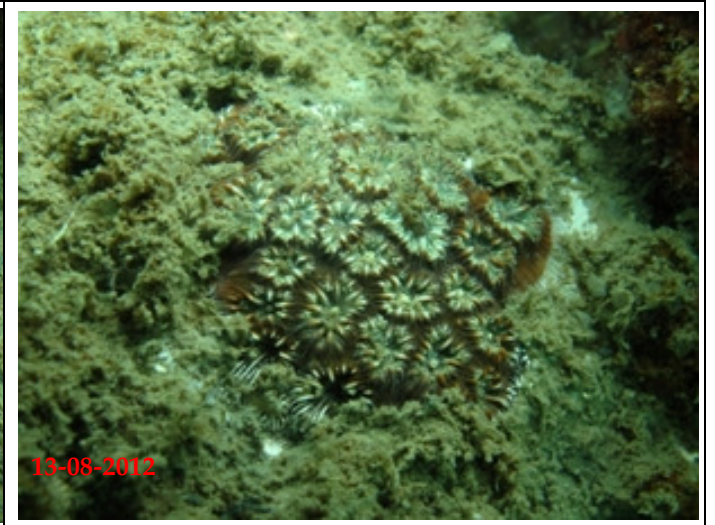
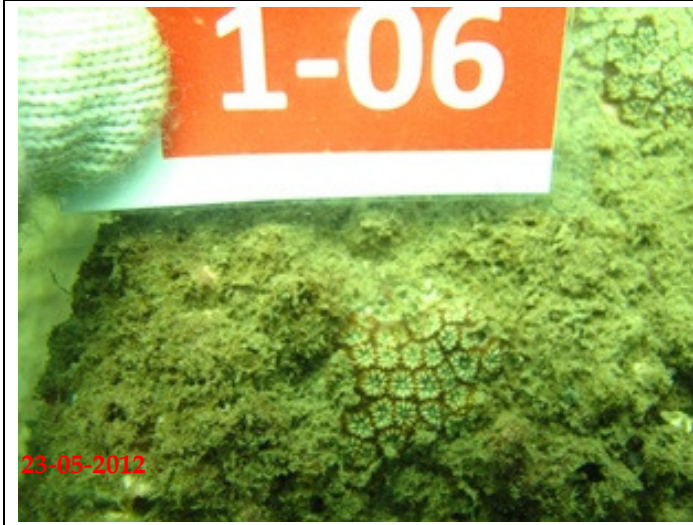
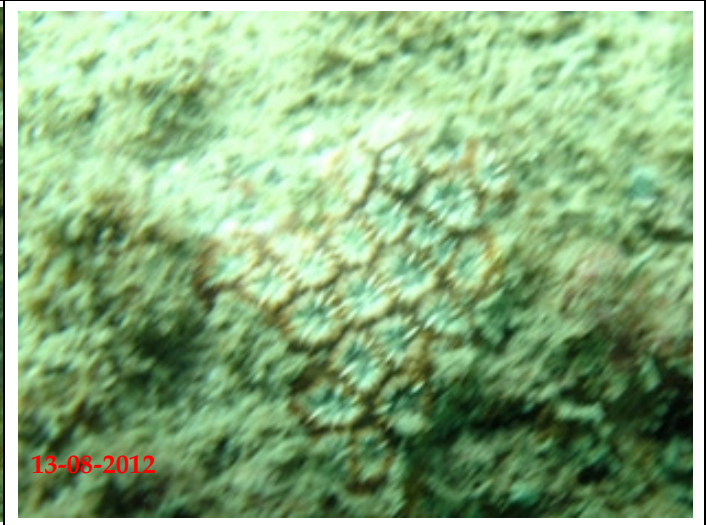
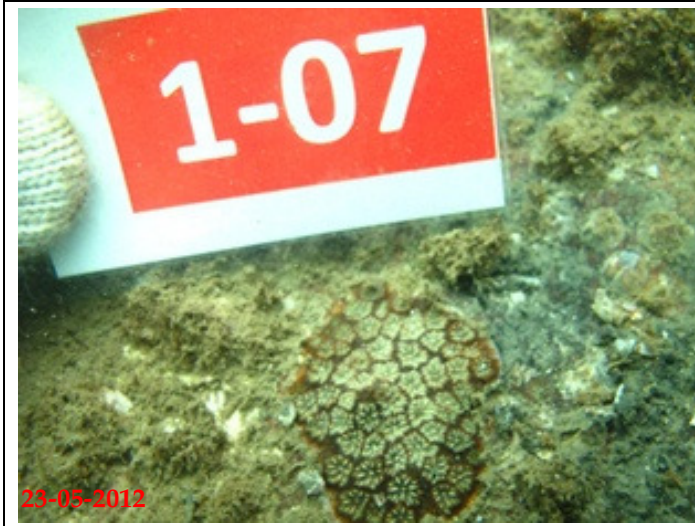
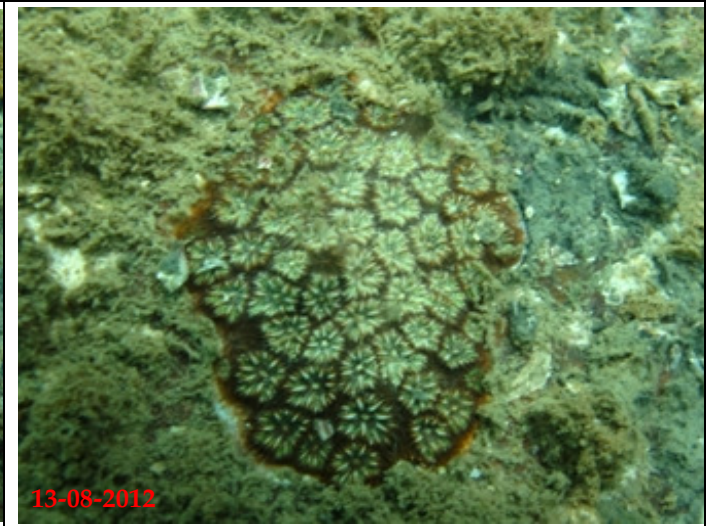
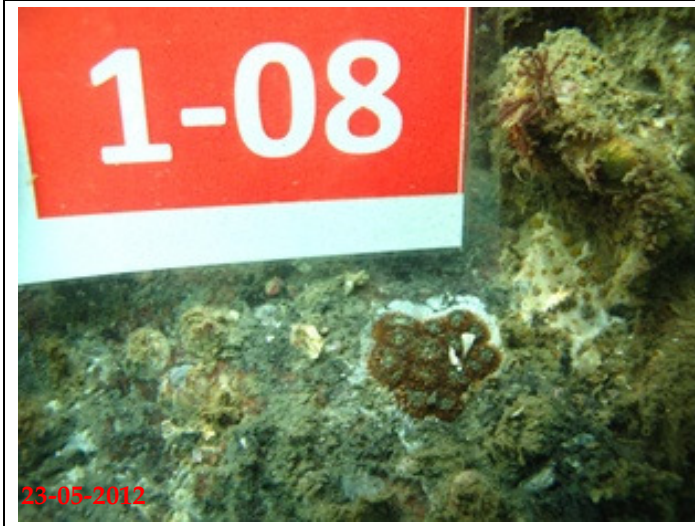
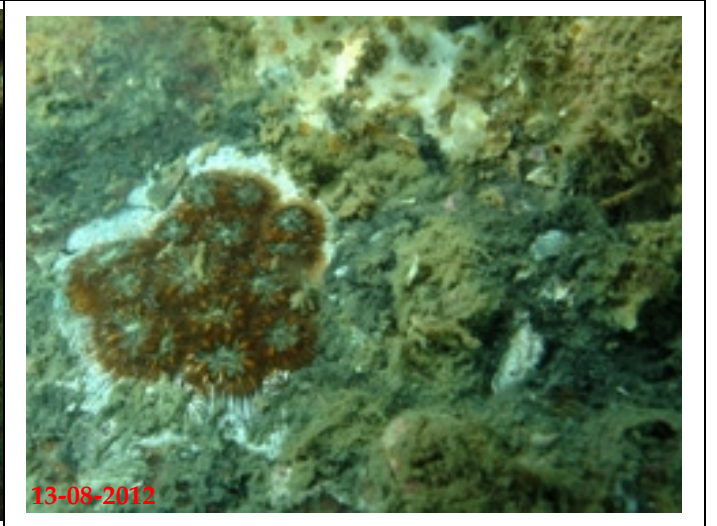
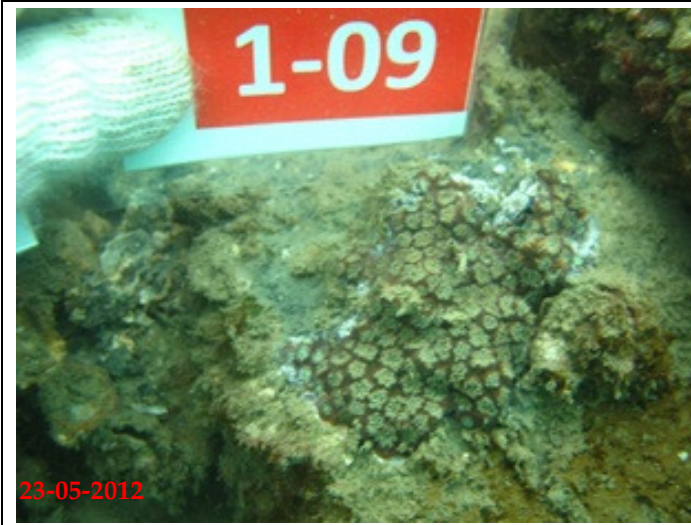
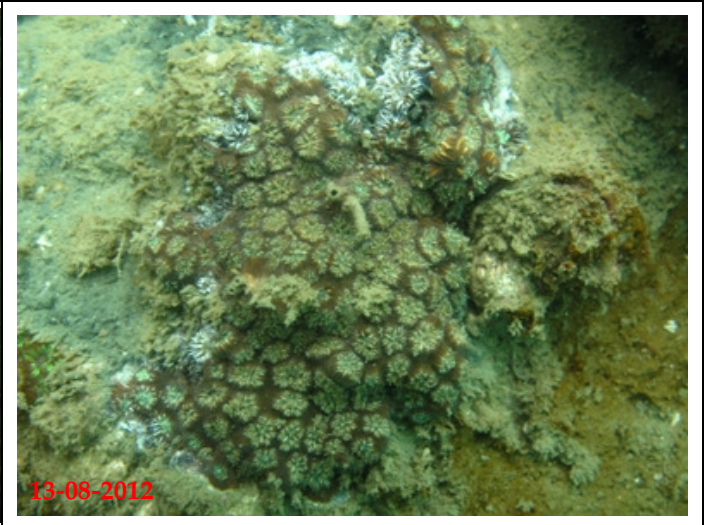
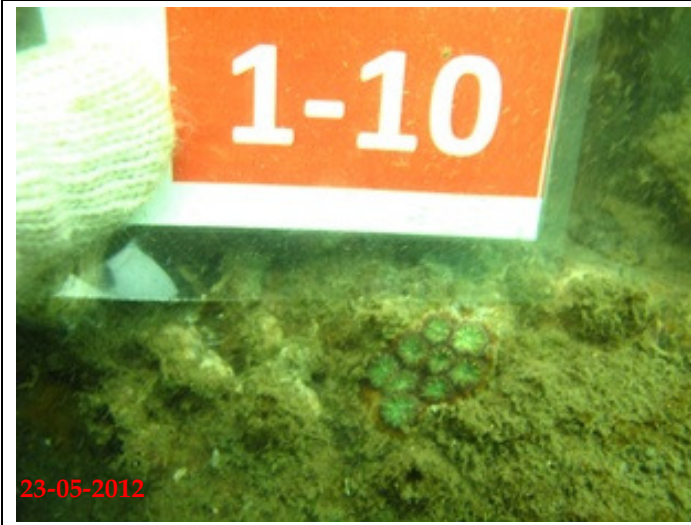
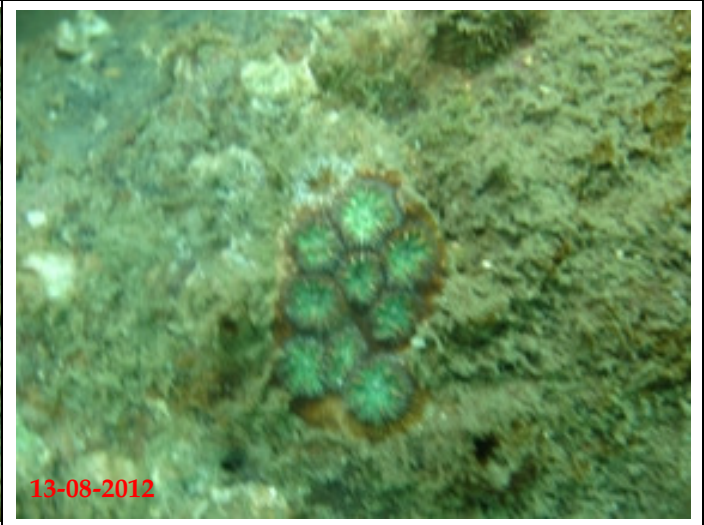
Annex A1 Photographic Records of Tagged Coral Colonies at Impact Monitoring Site (Area 1) during the Baseline and Impact Monitoring Surveys

Table 2.2 Species, Size, Growth Form, Partial Mortality, Sediment Cover and General Health of Tagged Coral Colonies at Area 1 (Impact Site)

Coral No.	Species	Size (cm ²)	Growth Form	Partial Mortality (%)	Percentage Increase in Partial Mortality (%) ⁽²⁾	Sediment Thickness (mm)	Sediment Type (Mud/Sand)	Sediment Color	General Health of Tagged Coral ⁽¹⁾
4	<i>Oulastrea crispata</i>	4.8	Encrusting	0	0	0	N/A	N/A	4.5
5	<i>Oulastrea crispata</i>	6.2	Encrusting	0	0	0	N/A	N/A	5
6	<i>Oulastrea crispata</i>	4.4	Encrusting	0	0	0	N/A	N/A	4
7	<i>Oulastrea crispata</i>	12.1	Encrusting	0	0	0	N/A	N/A	5
8	<i>Oulastrea crispata</i>	3.6	Encrusting	0	0	0	N/A	N/A	5
9	<i>Oulastrea crispata</i>	34.6	Encrusting	<1	0	0	N/A	N/A	4.5
10	<i>Oulastrea crispata</i>	3.2	Encrusting	0	0	0	N/A	N/A	5

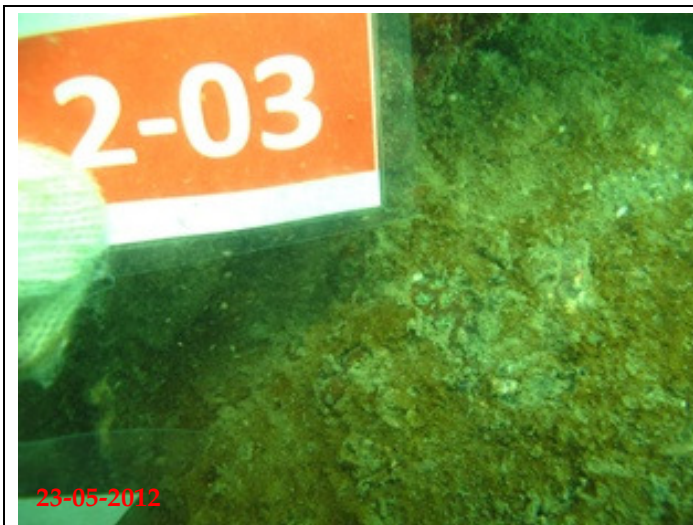
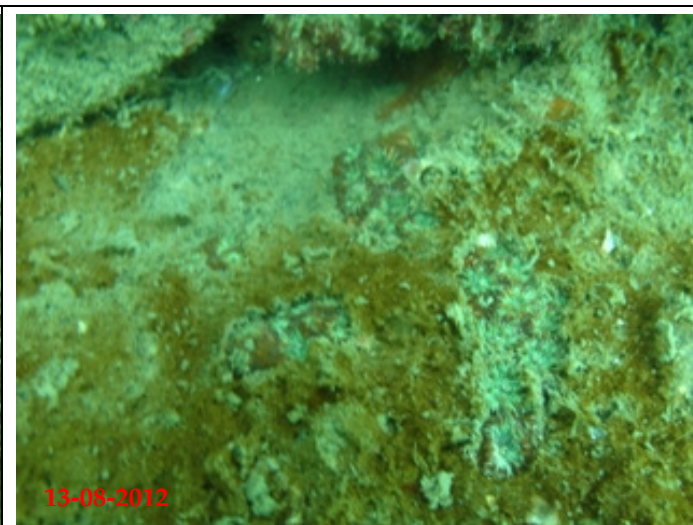
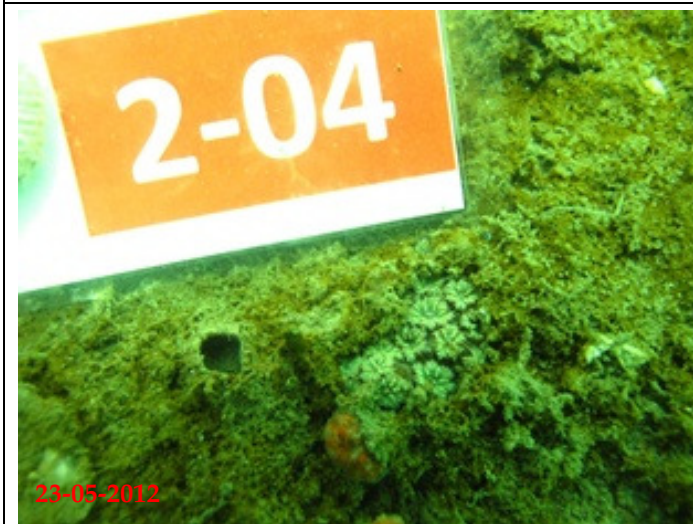
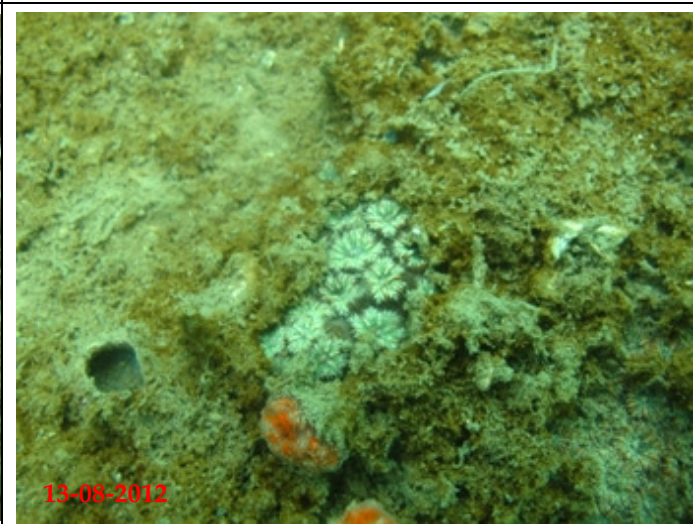
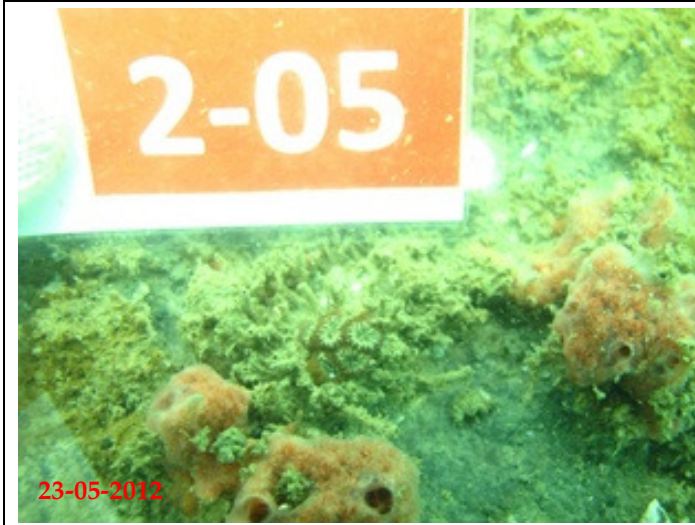
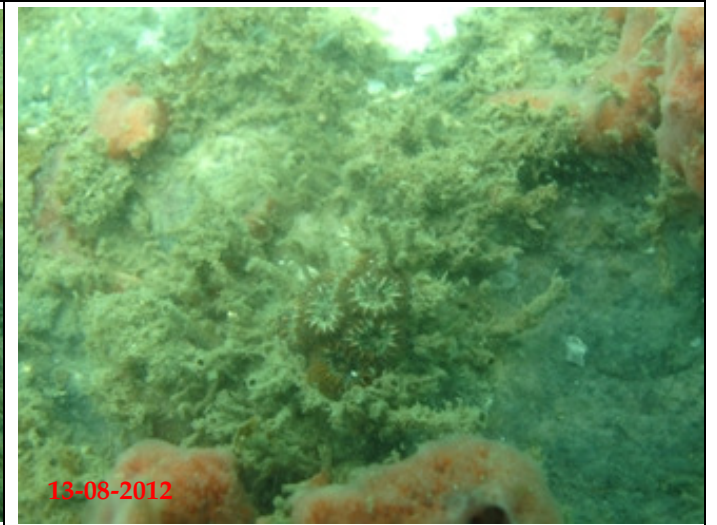
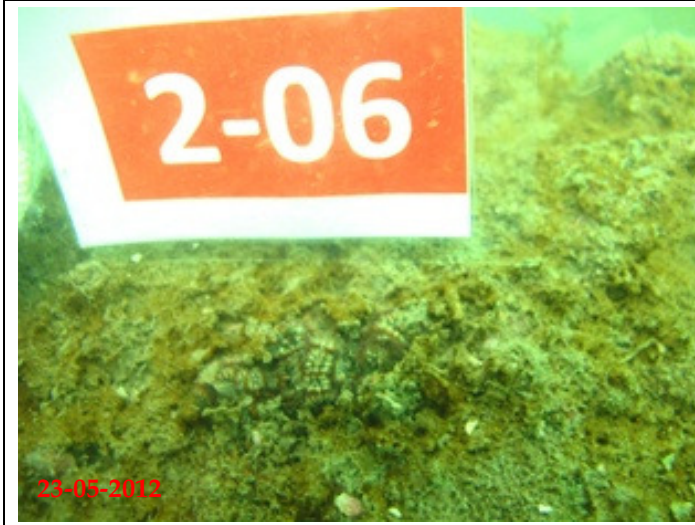
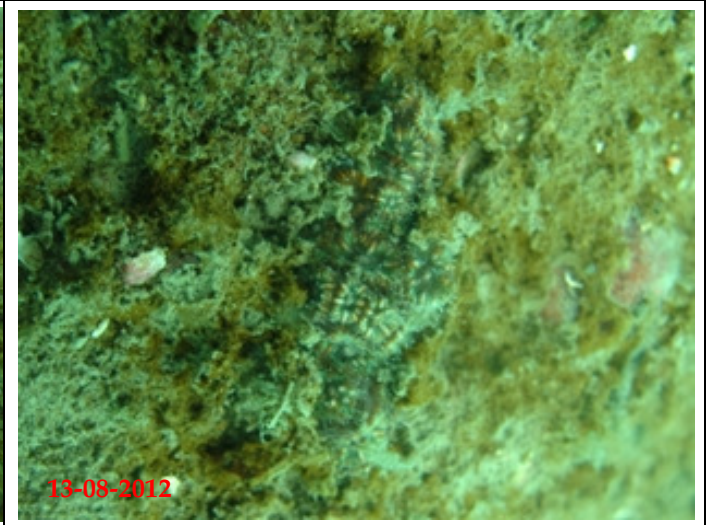
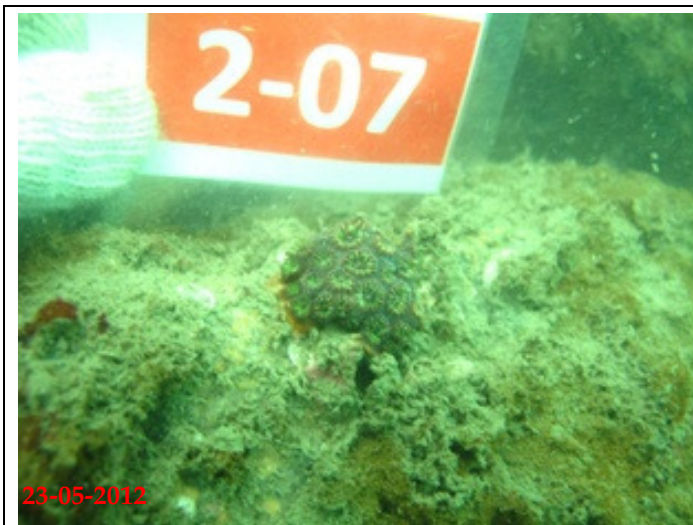
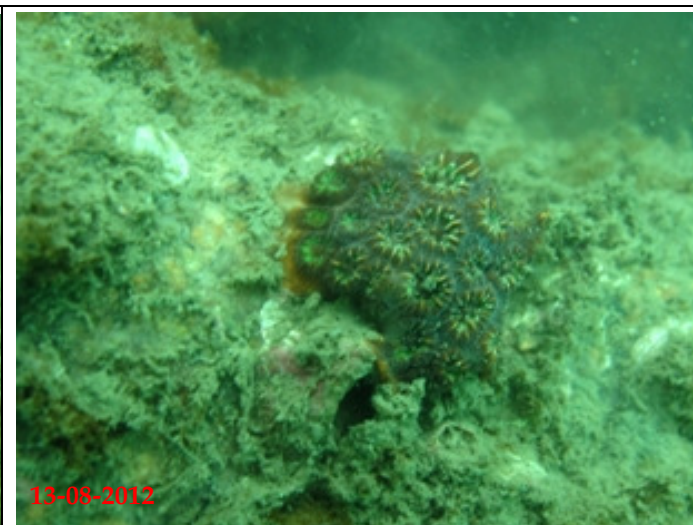
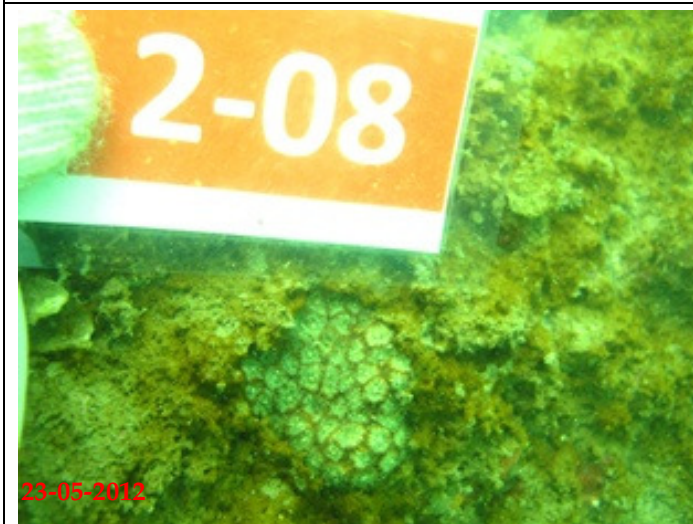
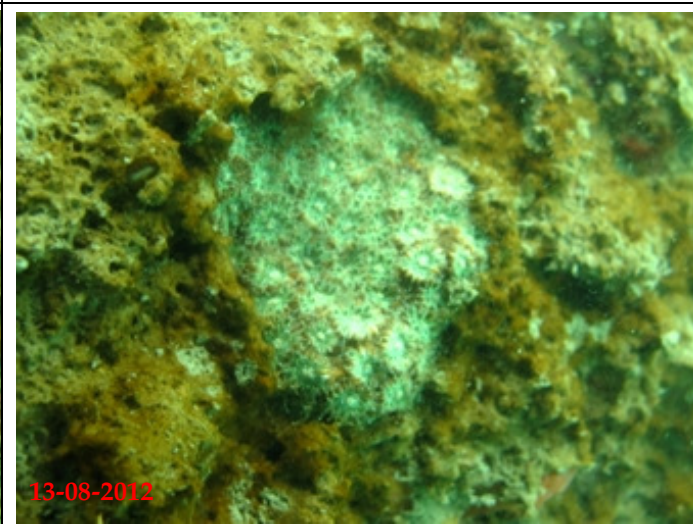
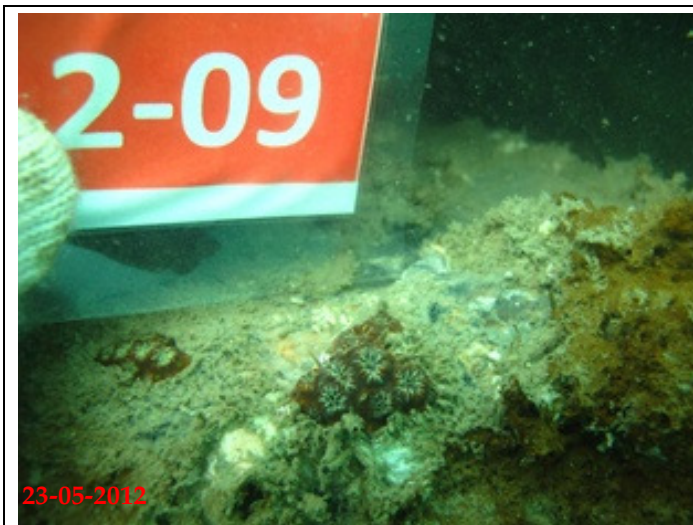
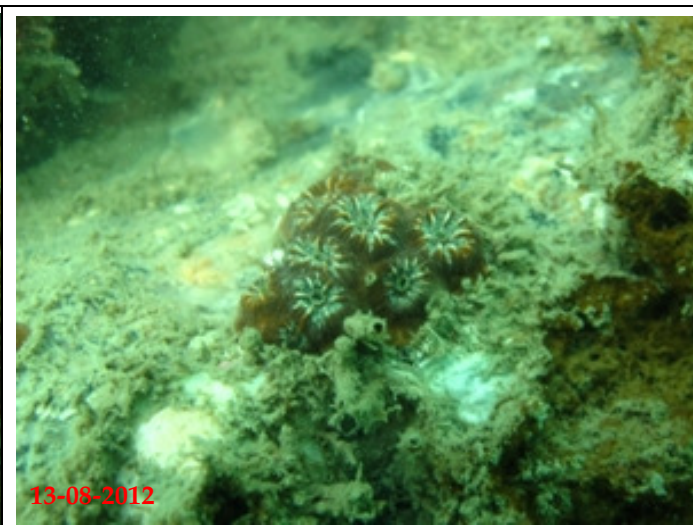
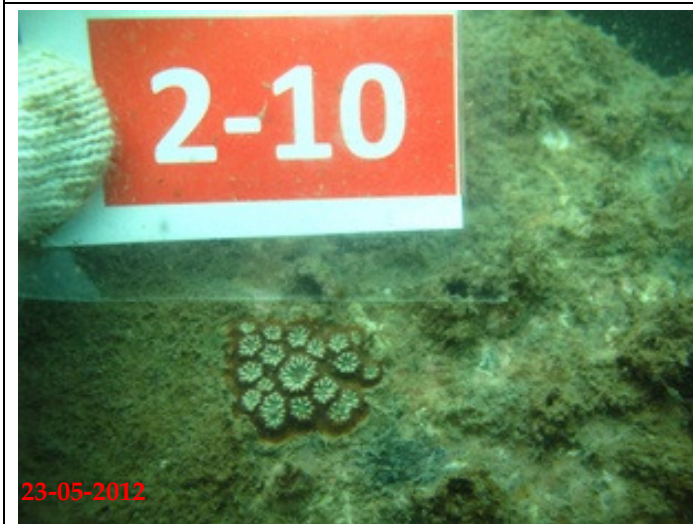
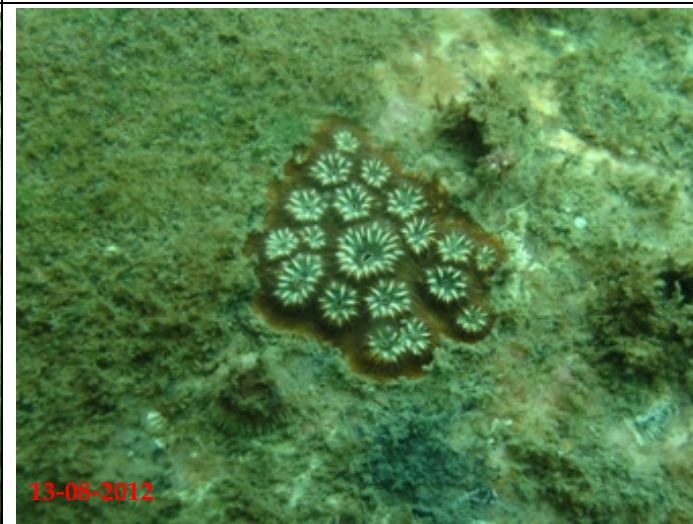
Annex A2 Photographic Records of Tagged Coral Colonies at Impact Monitoring Site (Area 2) during Baseline and Impact Monitoring Surveys

Table 2.3 Species, Size, Growth Form, Partial Mortality, Sediment Cover and General Health of Tagged Coral Colonies at Area 2 (Impact Site)

Coral No.	Species	Size (cm ²)	Growth Form	Partial Mortality (%)	Percentage Increase in Partial Mortality (%) ⁽²⁾	Sediment Thickness (mm)	Sediment Type (Mud/Sand)	Sediment Color	General Health of Tagged Coral ⁽¹⁾
4	<i>Oulastrea crispata</i>	2.6	Encrusting	0	0	0	N/A	N/A	4.5
5	<i>Oulastrea crispata</i>	14.6	Encrusting	0	0	0	N/A	N/A	5
6	<i>Oulastrea crispata</i>	4.6	Encrusting	0	0	0	N/A	N/A	4
7	<i>Oulastrea crispata</i>	8.1	Encrusting	0	0	0	N/A	N/A	5
8	<i>Oulastrea crispata</i>	13.1	Encrusting	0	0	0	N/A	N/A	4
9	<i>Oulastrea crispata</i>	5.7	Encrusting	0	0	0	N/A	N/A	4.5
10	<i>Oulastrea crispata</i>	6.9	Encrusting	0	0	0	N/A	N/A	5

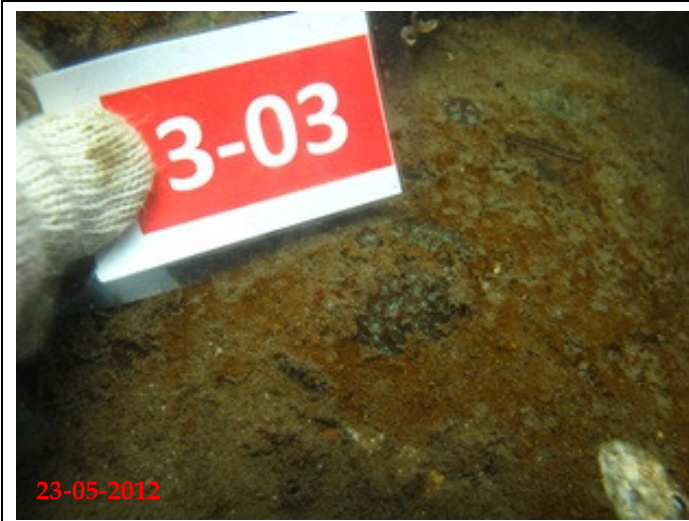
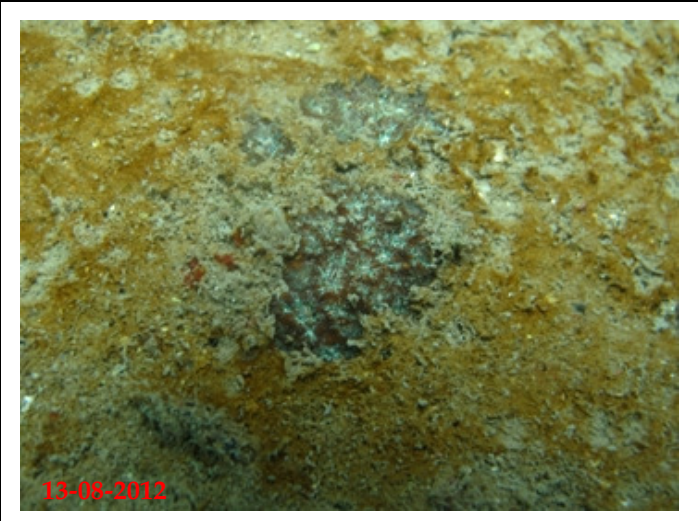
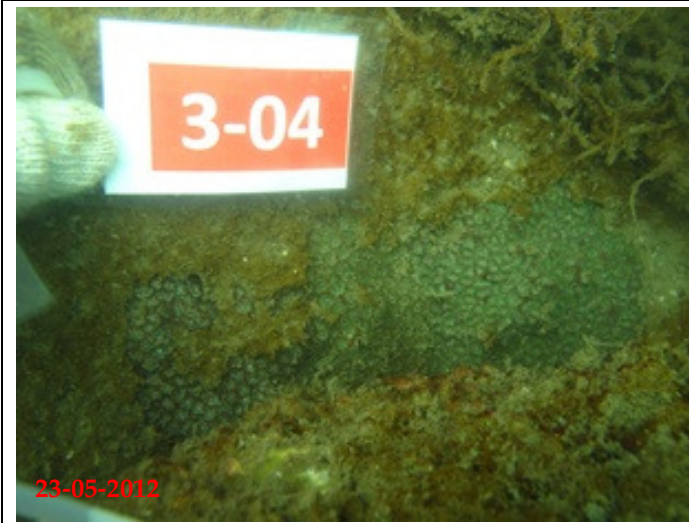
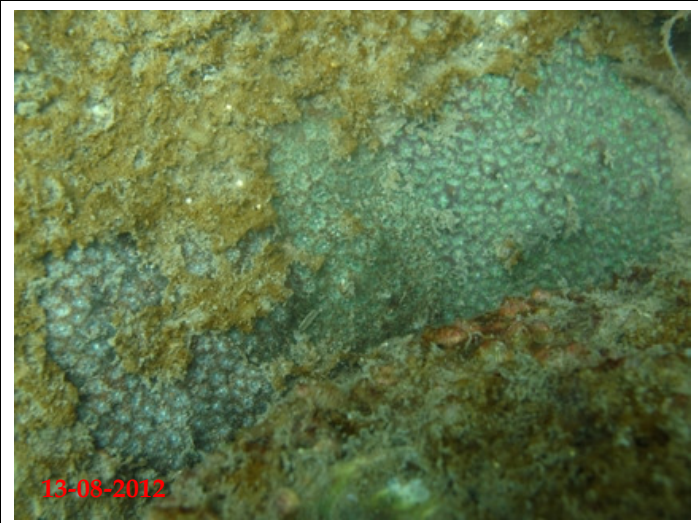
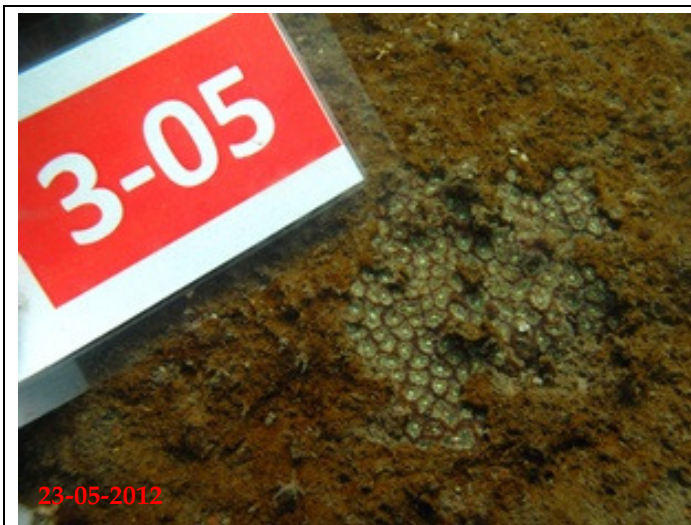
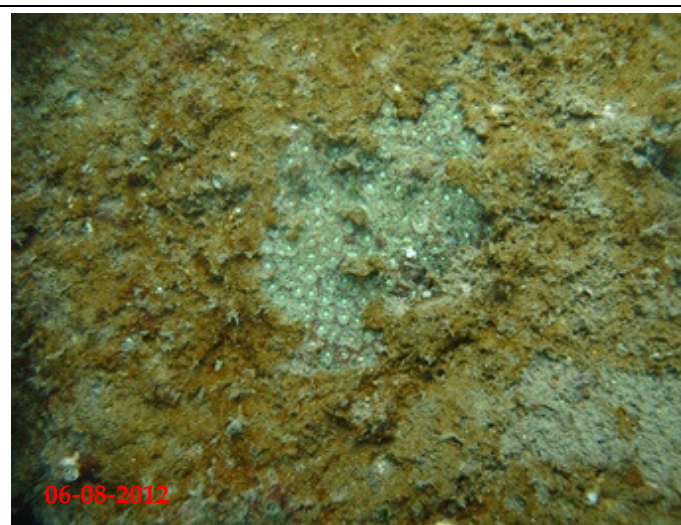
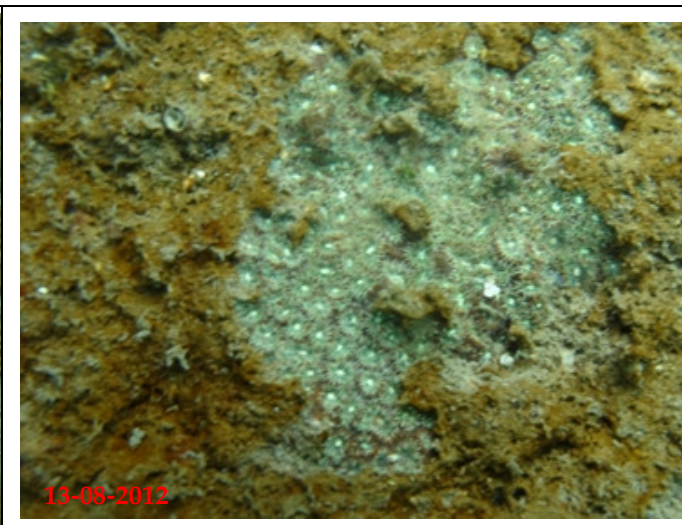
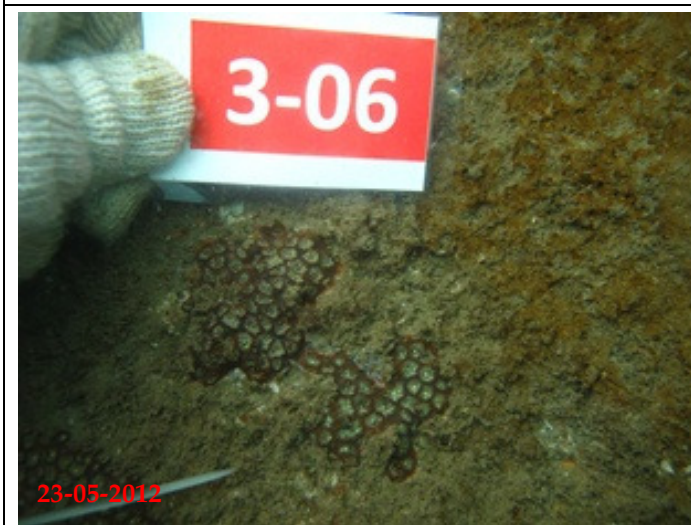
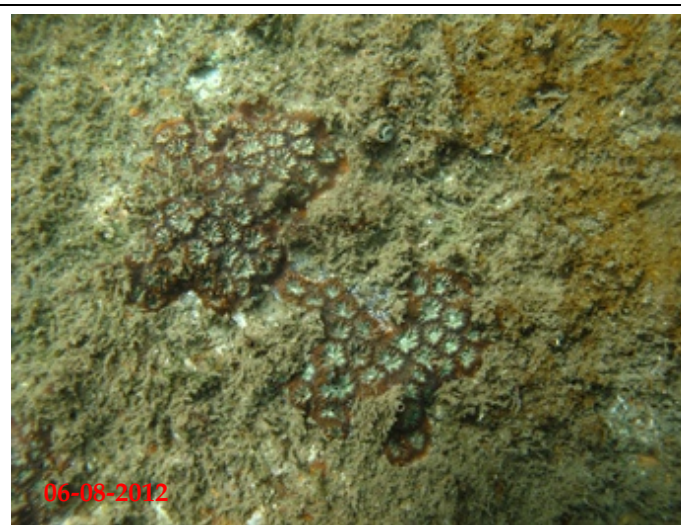
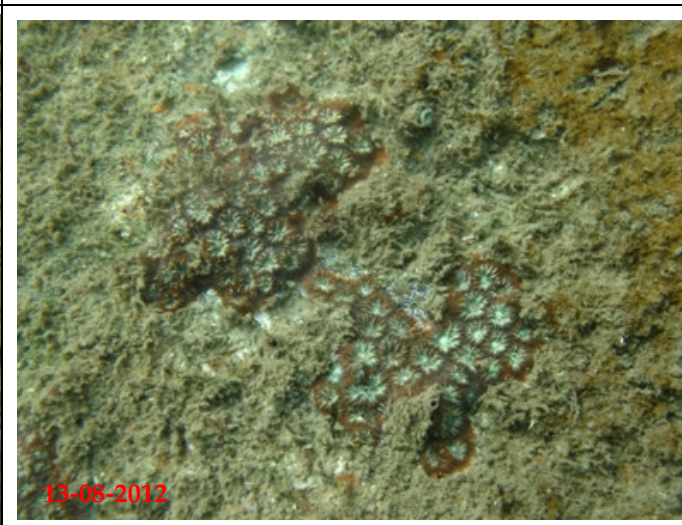
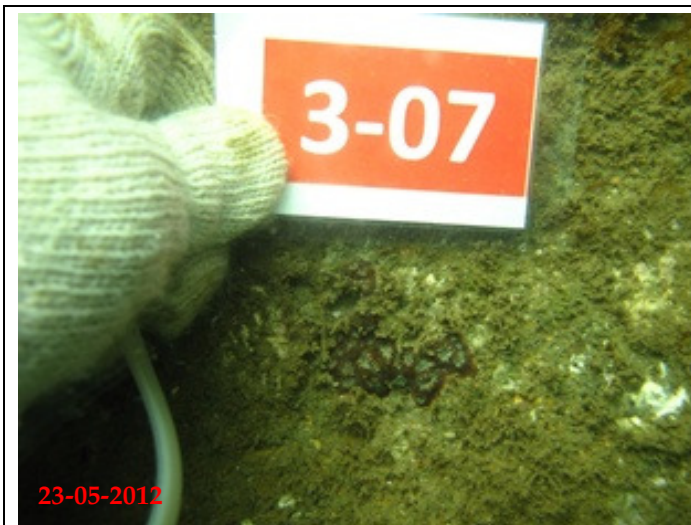
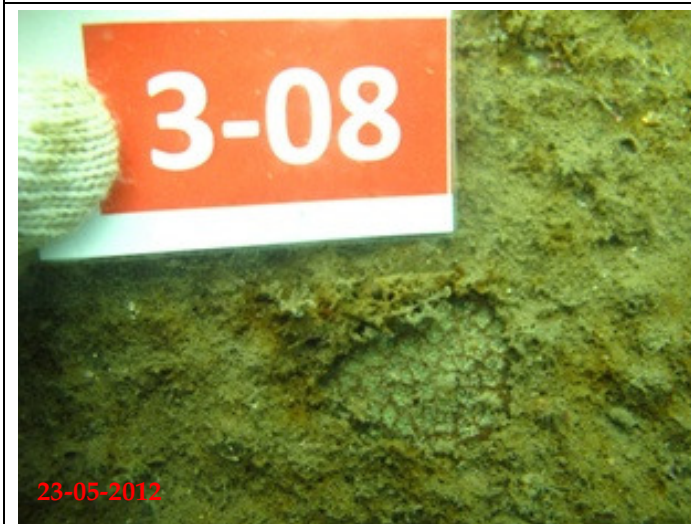
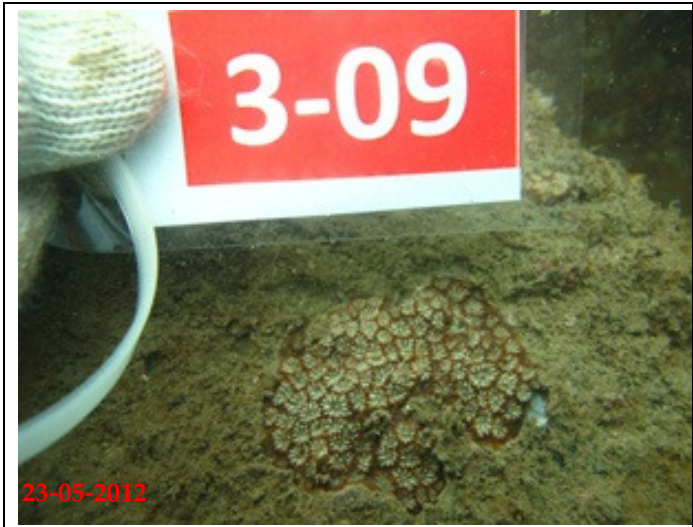
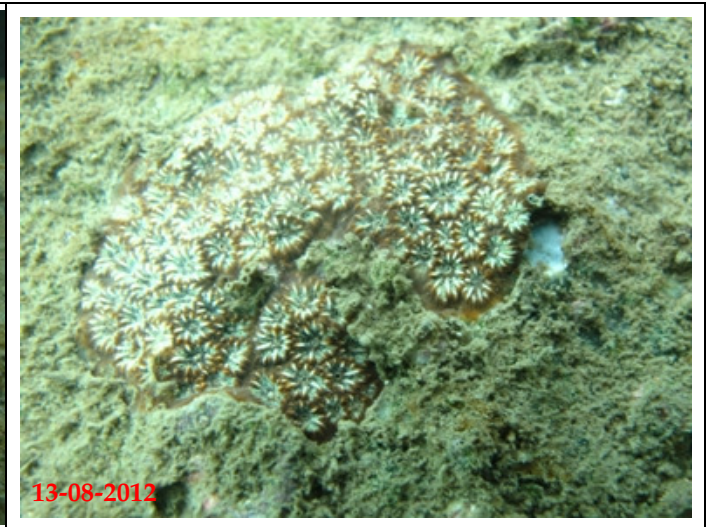
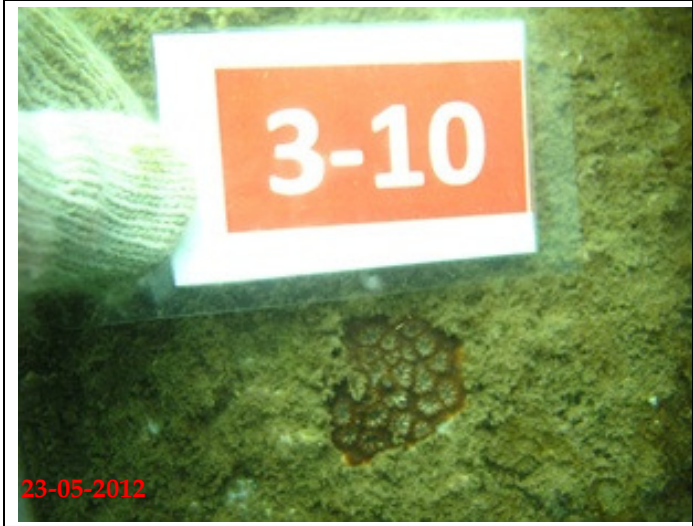
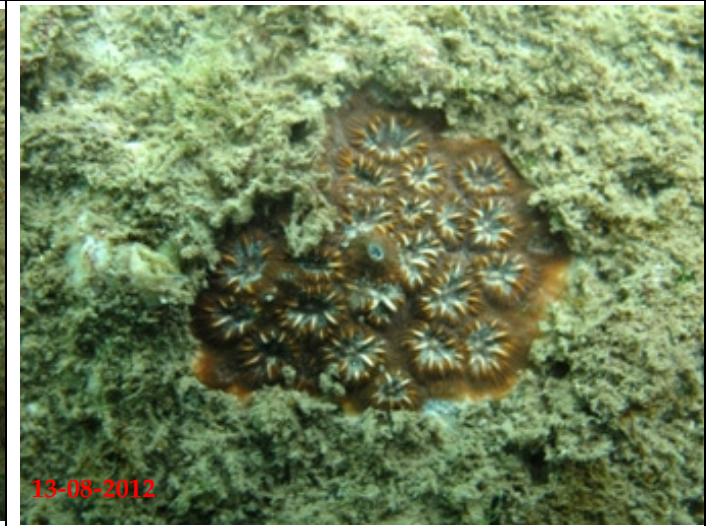
Annex A3 Photographic Records of Tagged Coral Colonies at Impact Monitoring Site (Area 3) during Baseline and Impact Monitoring Surveys

Table 2.4 Species, Size, Growth Form, Partial Mortality, Sediment Cover and General Health of Tagged Coral Colonies at Area 3 (Impact Site)

Coral No.	Species	Size (cm ²)	Growth Form	Partial Mortality (%)	Percentage Increase in Partial Mortality (%) ⁽²⁾	Sediment Thickness (mm)	Sediment Type (Mud/Sand)	Sediment Color	General Health of Tagged Coral ⁽¹⁾
4	<i>Oulastrea crispata</i>	106.8	Encrusting	0	0	1	Mud	Light brown	4
5	<i>Oulastrea crispata</i>	7.3	Encrusting	0	0	1	Mud	Light brown	5
6	<i>Oulastrea crispata</i>	32.4	Encrusting	0	0	0	N/A	N/A	4.5
7	<i>Oulastrea crispata</i>	23.6	Encrusting	0	0	0	N/A	N/A	5
8	<i>Oulastrea crispata</i>	5.3	Encrusting	0	0	0	N/A	N/A	4.5
9	<i>Oulastrea crispata</i>	20.5	Encrusting	0	0	0	N/A	N/A	5
10	<i>Oulastrea crispata</i>	11.6	Encrusting	0	0	0	N/A	N/A	5
