Installation of Submarine Gas Pipelines and Associated Facilities from To Kwa Wan to North Point for Former Kai Tak Airport Development

16 August 2012

First Coral Impact Report

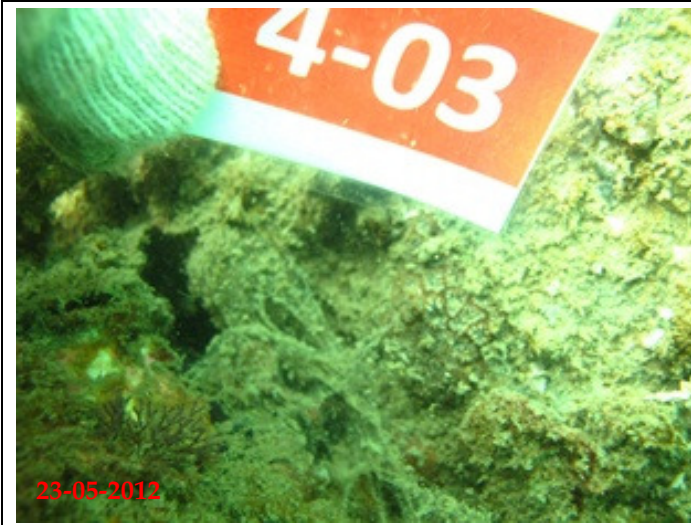
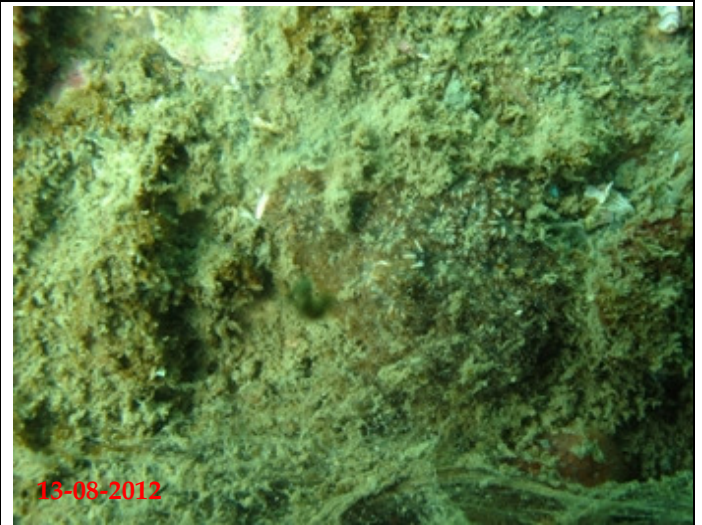
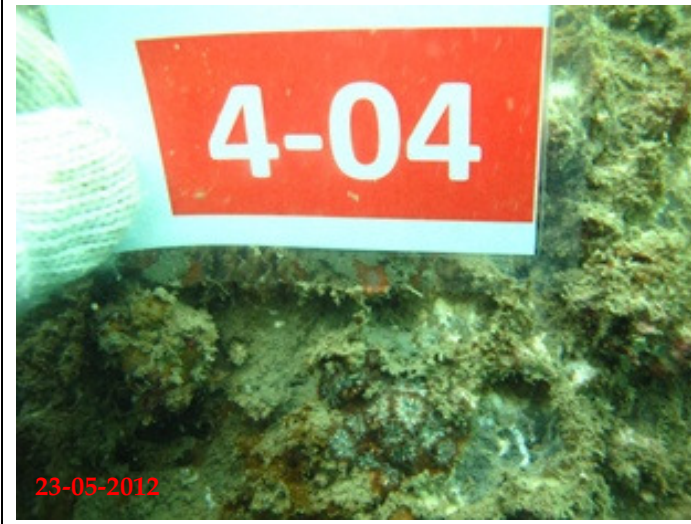
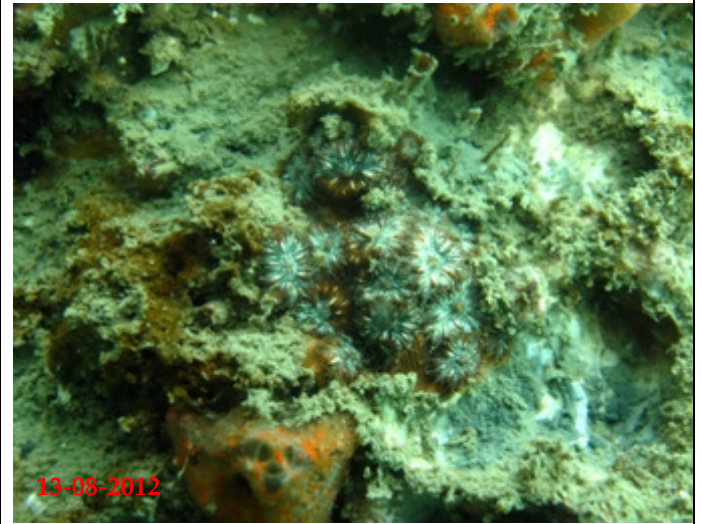
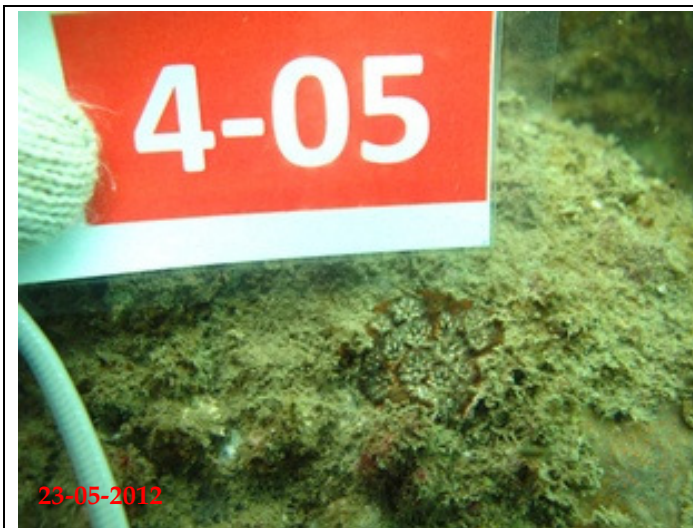
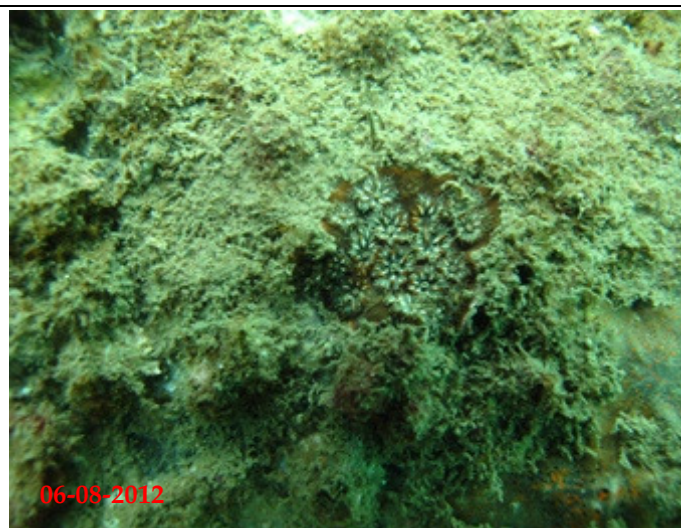
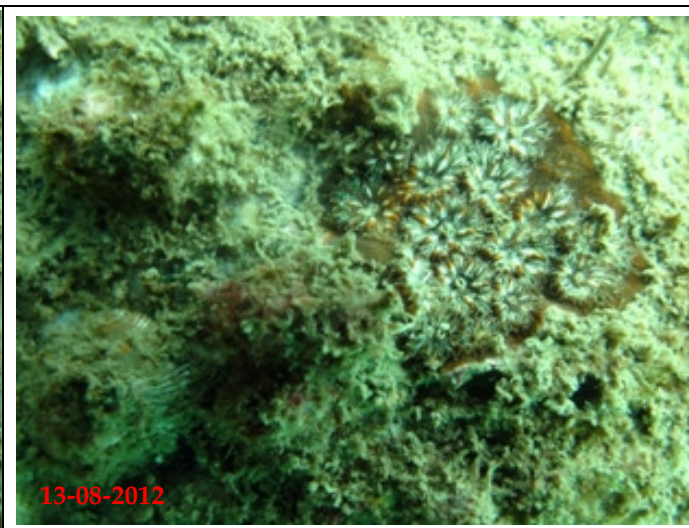
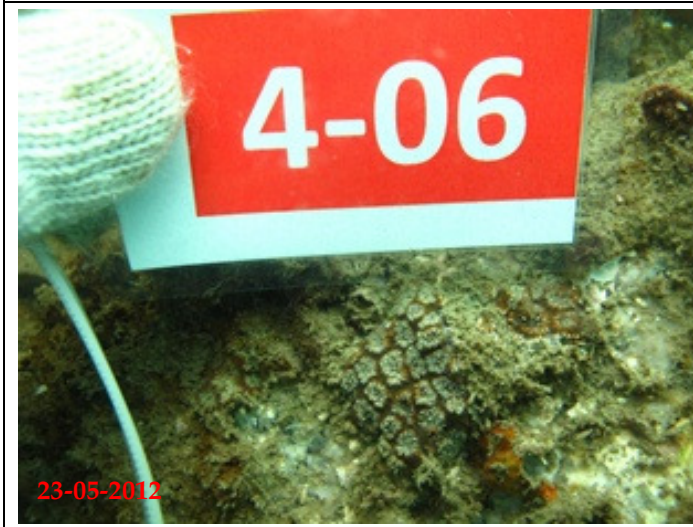
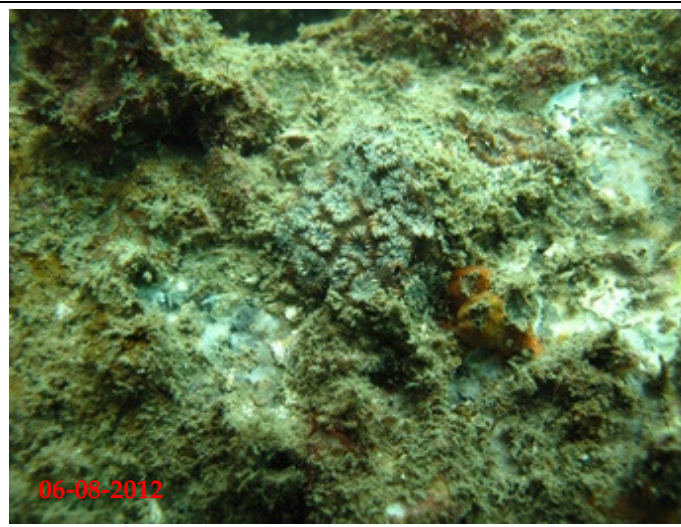
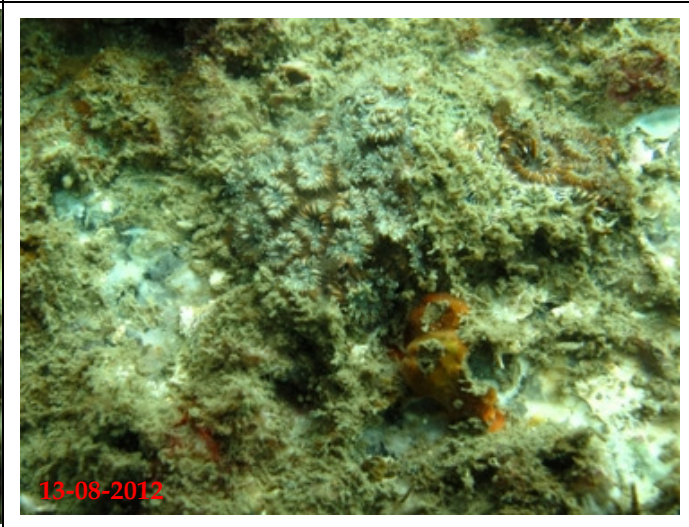
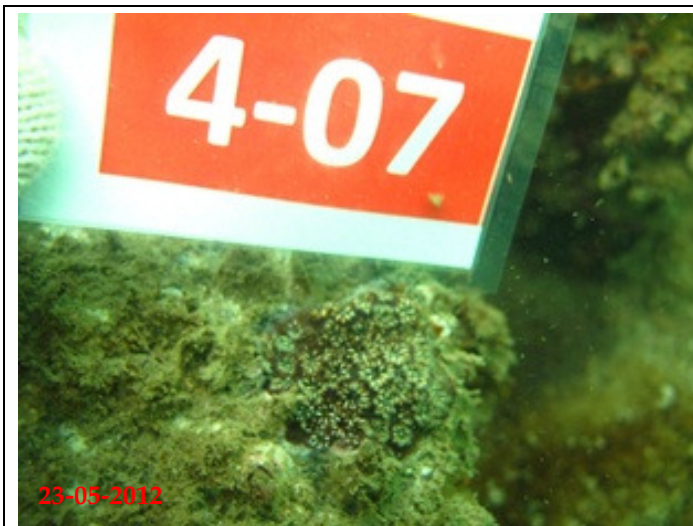
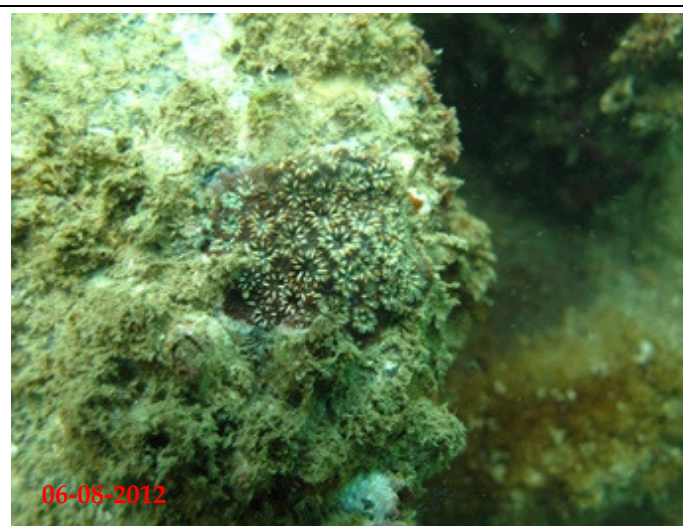
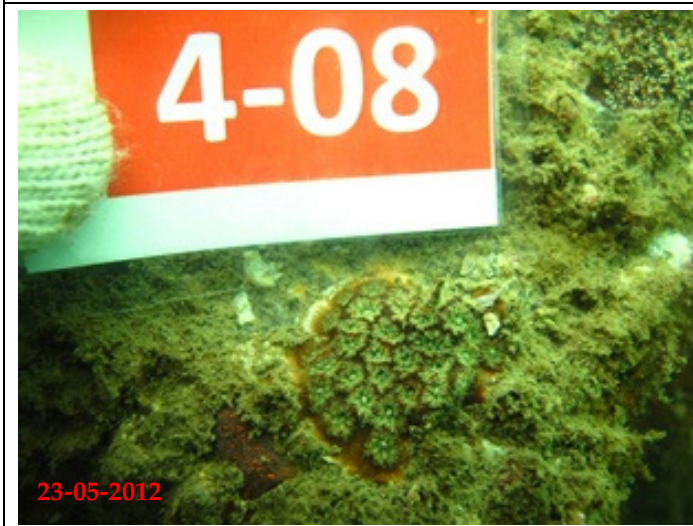
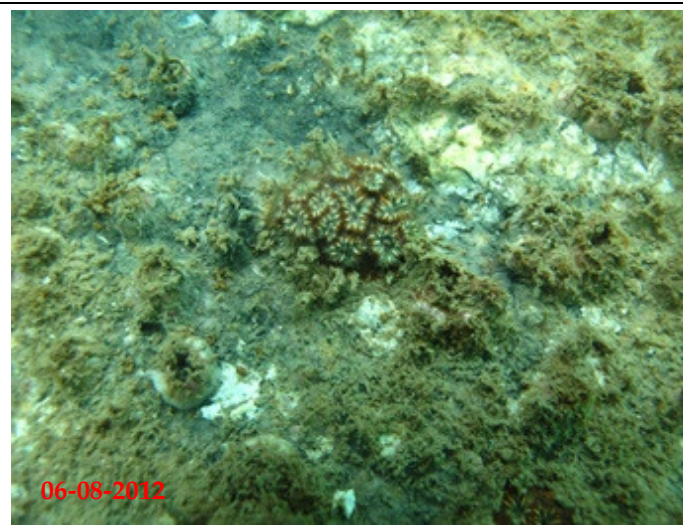
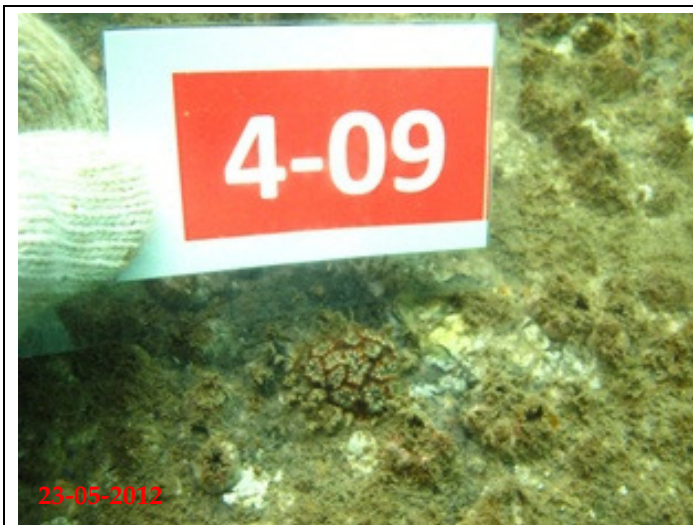
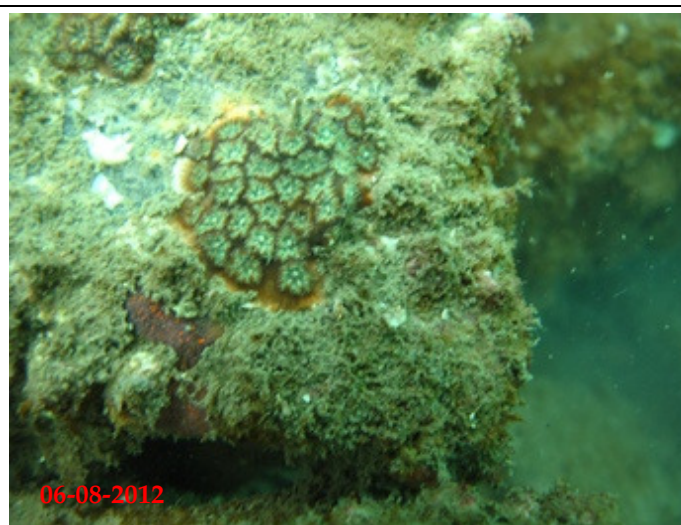
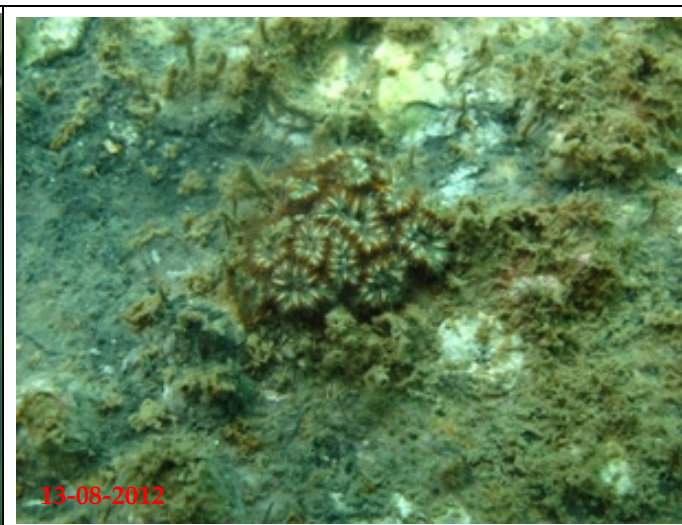
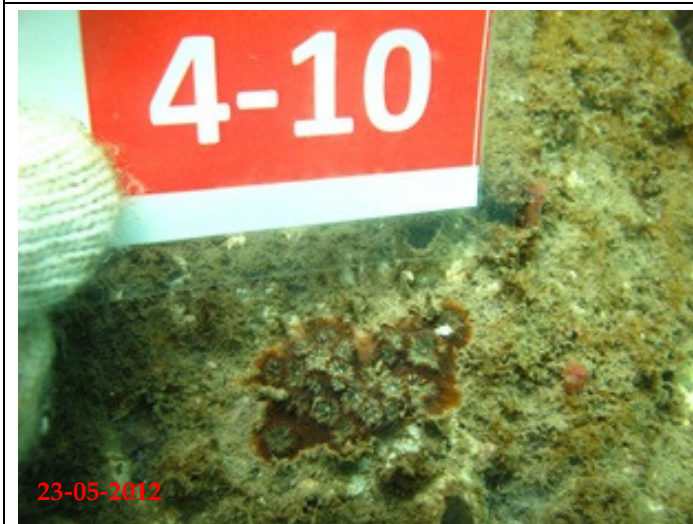
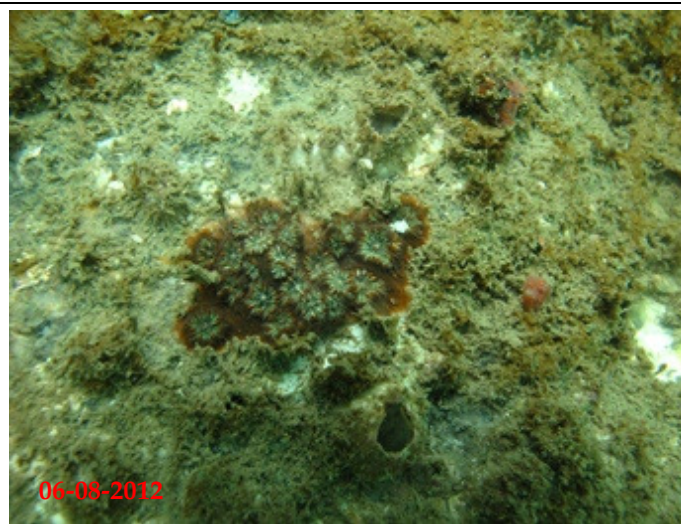
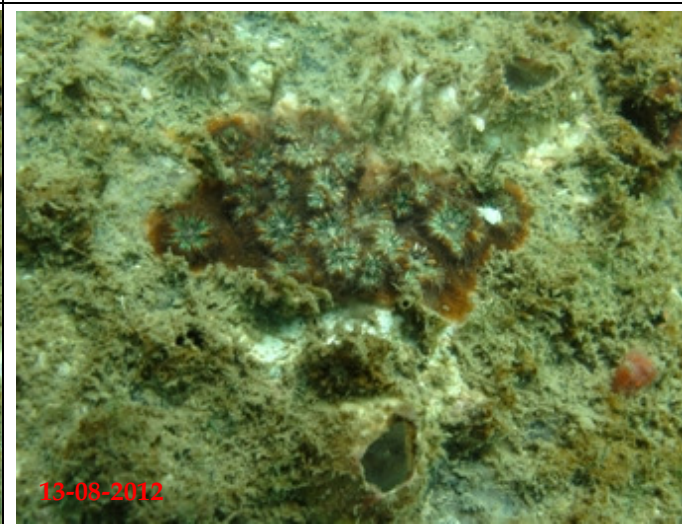
Annex A4 Photographic Records of Tagged Coral Colonies at Control Site (Area 4) during Baseline and Impact Monitoring Surveys

Table 2.5 Species, Size, Growth Form, Partial Mortality, Sediment Cover and General Health of Tagged Coral Colonies at Area 4 (Control Site)

Coral No.	Species	Size (cm ²)	Growth Form	Partial Mortality	Percentage Increase in Partial Mortality (%) ⁽²⁾	Sediment Thickness	Sediment Type	Sediment Color	General Health of Tagged Coral ⁽¹⁾
5	<i>Oulastrea crispata</i>	8.2	Encrusting	0	0	0	N/A	N/A	5
6	<i>Oulastrea crispata</i>	7.3	Encrusting	0	0	0	N/A	N/A	5
7	<i>Oulastrea crispata</i>	12.2	Encrusting	0	0	0	N/A	N/A	4.5
8	<i>Oulastrea crispata</i>	14.4	Encrusting	0	0	0	N/A	N/A	4
9	<i>Oulastrea crispata</i>	5.2	Encrusting	0	0	0	N/A	N/A	4.5
10	<i>Oulastrea crispata</i>	13.5	Encrusting	0	0	0	N/A	N/A	4.5
