Installation of Submarine Gas
Pipelines and Associated Facilities
from To Kwa Wan to North Point for
Former Kai Tak Airport Development

Second Coral Impact Report

Client: MKJV		Project No: 0158059			
Summary: This document presents the 2 nd Coral Impact Report for the Installation of Submarine Gas Pipelines and Associated Facilities from To Kwa Wan to North Point for Former Kai Tak Airport Development.		Date: 24 August 2012			
		Approved by:

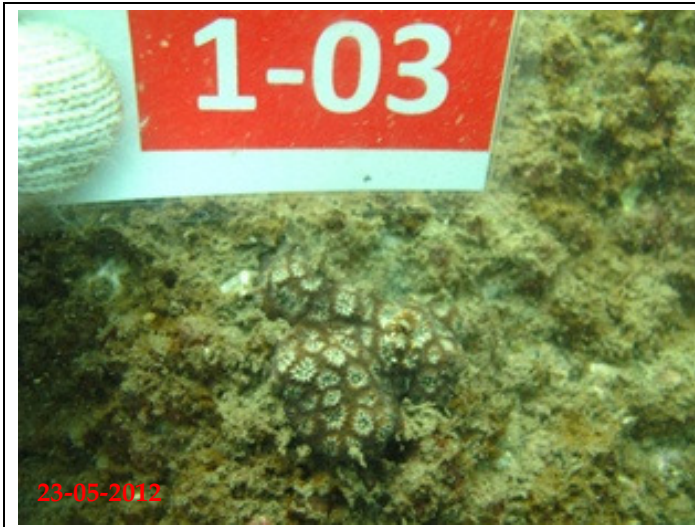
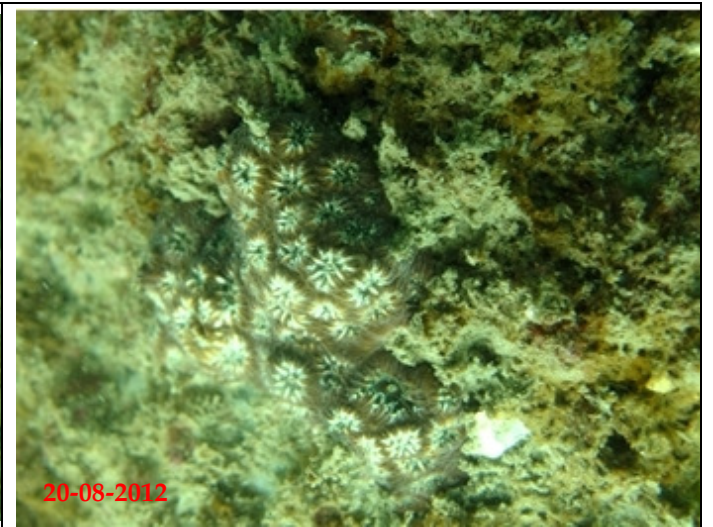
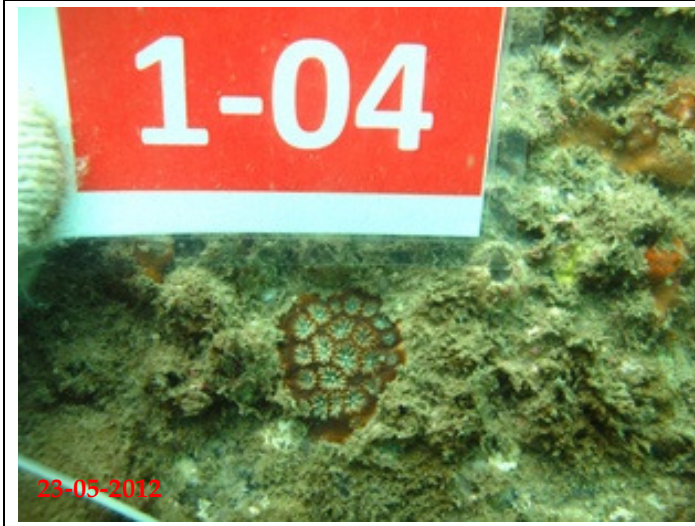
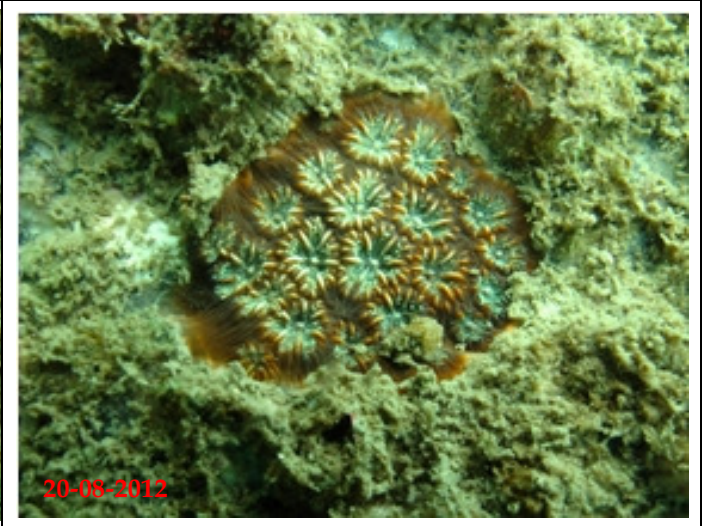
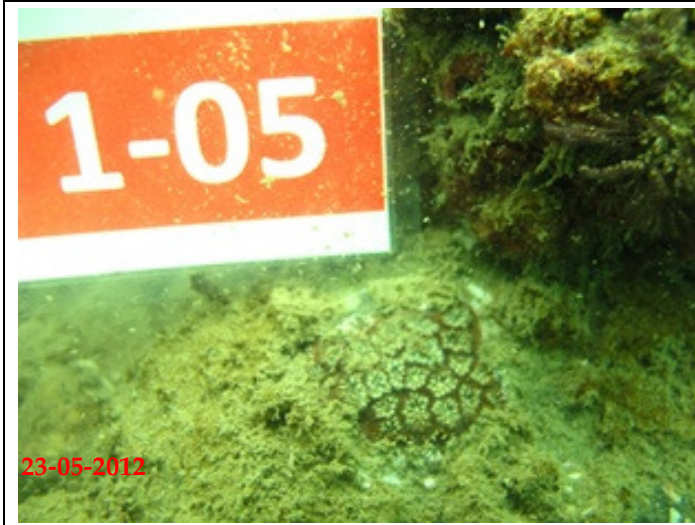
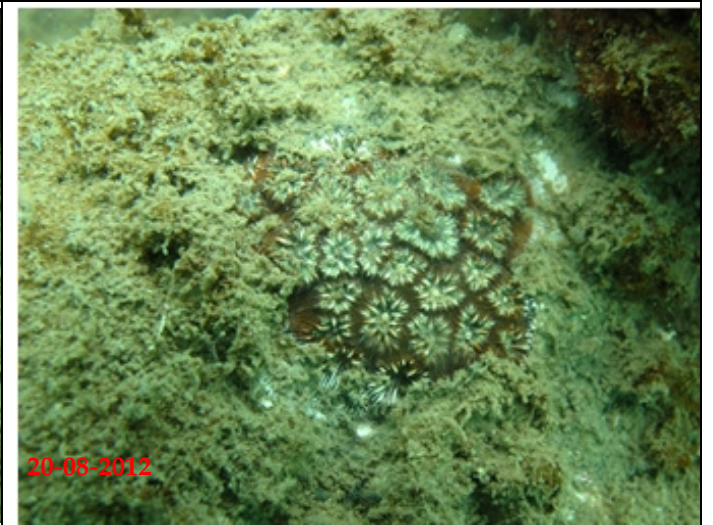
Annex A1 Photographic Records of Tagged Coral Colonies at Impact Monitoring Site (Area 1) during the Baseline and Impact Monitoring Surveys

Findings of the 2nd Impact Coral Monitoring Surveys indicated that the Action Levels or Limit Levels for coral monitoring were not exceeded (*Tables 2.2-5*). There did not appear to be any deterioration in the general health and condition of the tagged coral colonies as a result of the dredging activities within 250 m from the To Kwa Wan breakwaters.
