**Proposed 11kV Submarine Cables
Replacement Connecting Liu Ko
Ngam and Pak Sha Tau Tsui at Kat O**

*4th Weekly Coral Impact Monitoring Survey
Report*

25 January 2016

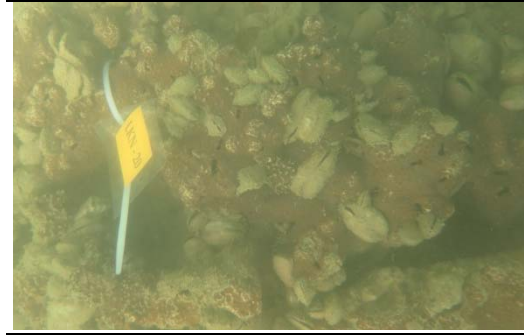
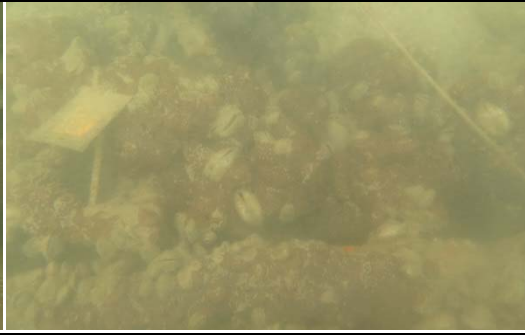
<p>Tag No.: LKN-20 (<i>Leptastrea pruinosa</i>)</p>

LKN20	<i>Leptastrea pruinosa</i>	10-50	<1	<1	5	5	<1	Mud	light Brown
LKN21	<i>Leptastrea purpurea</i>	10-50	<1	<1	<1	0	<1	N/A	N/A
LKN22	<i>Leptastrea purpurea</i>	10-50	<1	<1	<1	0	<1	N/A	N/A
LKN23	<i>Leptastrea purpurea</i>	>50	<1	<1	<1	0	<1	N/A	N/A
LKN24	<i>Porites sp.</i>	10-50	<1	<1	<1	0	<1	N/A	N/A
LKN25	<i>Leptastrea pruinosa</i>	10-50	<1	<1	<1	0	<1	N/A	N/A
LKN26	<i>Leptastrea pruinosa</i>	10-50	<1	<1	<1	0	<1	N/A	N/A
LKN27	<i>Leptastrea pruinosa</i>	10-50	<1	<1	<1	0	<1	N/A	N/A
LKN28	<i>Leptastrea pruinosa</i>	10-50	<1	<1	<1	0	<1	N/A	N/A
LKN29	<i>Leptastrea pruinosa</i>	10-50	<1	<1	<1	0	<1	N/A	N/A
LKN30	<i>Dipsastraea rotumana</i>	<10	<1	<1	5	5	<1	Mud	Light Brown
Impact Monitoring on 14 January 2016									
LKN1	<i>Dipsastraea rotumana</i>	<10	<1	<1	<1	0	<1	N/A	N/A
LKN2	<i>Leptastrea pruinosa</i>	10-50	<1	<1	<1	0	<1	N/A	N/A
LKN3	<i>Cyphastrea japonica</i>	10-50	<1	<1	<1	0	<1	N/A	N/A
LKN4	<i>Favites pentagona</i>	10-50	<1	<1	<1	0	<1	N/A	N/A

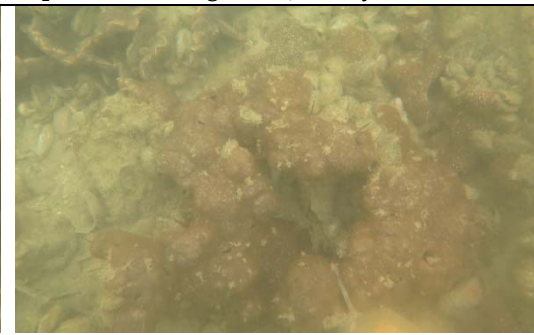
<p>Underwater photograph showing a rocky substrate covered with green and brown algae. A yellow tag labeled 'LKN-27' is visible on the left side, and a blue string is tied around a rock.</p>

<p>Underwater photograph showing the same rocky substrate as the baseline. The algae cover is significantly reduced, and the rocks appear more exposed and darker.</p>

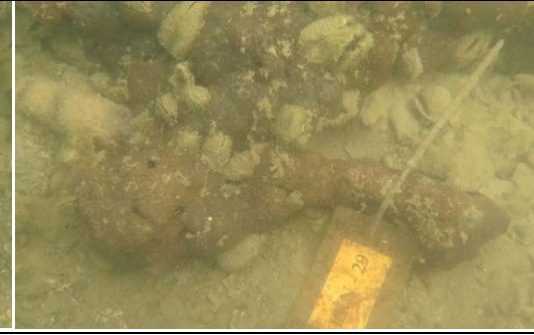
<p>Underwater photograph showing a rocky substrate with green and brown algae. A yellow tag labeled 'LKN-29' is visible at the bottom, and a blue string is tied around a rock.</p>

<p>Underwater photograph showing the same rocky substrate. The algae cover is significantly reduced, and the rocks appear more exposed and darker.</p>
