**Proposed 11kV Submarine Cables  
Replacement Connecting Liu Ko Ngam  
and Pak Sha Tau Tsui at Kat O**

*8<sup>th</sup> Weekly Coral Impact Monitoring Survey  
Report*

8 March 2016

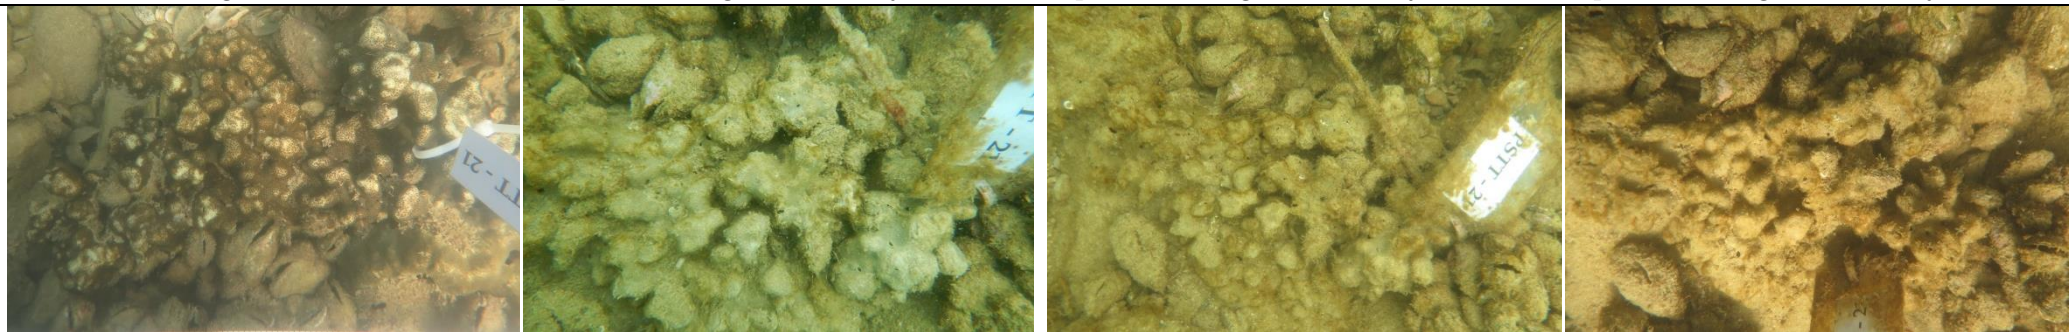
Tag No.: PSTT-21 (*Porites* sp.)

Tag no.	Species	Size range (<10, 10-50; >50cm)	Partial Mortality (%)	Bleaching (%)	Sediment cover (%)	Percentage increase in sediment cover (%)	Sediment Thickness (<1mm; 1mm; >1mm)	Sediment Type (Mud/Sand)	Sediment Color
PSIT9	<i>Cyphastrea serailia</i>	10-50	<1	<1	<1	0	<1	N/A	N/A
PSIT10	<i>Leptastrea pruinosa</i>	>50	<1	<1	<1	0	<1	N/A	N/A
PSIT11	<i>Leptastrea purpurea</i>	10-50	<1	<1	<1	0	<1	N/A	N/A
PSIT12	<i>Goniastrea aspera</i>	10-50	<1	<1	<1	0	<1	N/A	N/A
PSIT13	<i>Leptastrea pruinosa</i>	<10	<1	<1	<1	0	<1	N/A	N/A
PSIT14	<i>Dipsastraea rotumana</i>	<10	<1	<1	<1	0	<1	N/A	N/A
PSIT15	<i>Leptastrea purpurea</i>	10-50	<1	<1	<1	0	<1	N/A	N/A
PSIT16	<i>Leptastrea purpurea</i>	>50	<1	<1	<1	0	<1	N/A	N/A
PSIT18	<i>Leptastrea pruinosa</i>	10-50	<1	<1	<1	0	<1	N/A	N/A
PSST19	<i>Leptastrea pruinosa</i>	<10	<1	<1	<1	0	<1	N/A	N/A
PSIT20	<i>Leptastrea pruinosa</i>	10-50	<1	<1	<1	0	<1	N/A	N/A
PSIT21	<i>Porites</i> sp.	10-50	5	50	<1	0	<1	N/A	N/A
