**Proposed 11kV Submarine Cables
Replacement Connecting Liu Ko
Ngam and Pak Sha Tau Tsui at Kat O**

Tree Protection Plan

November 2015

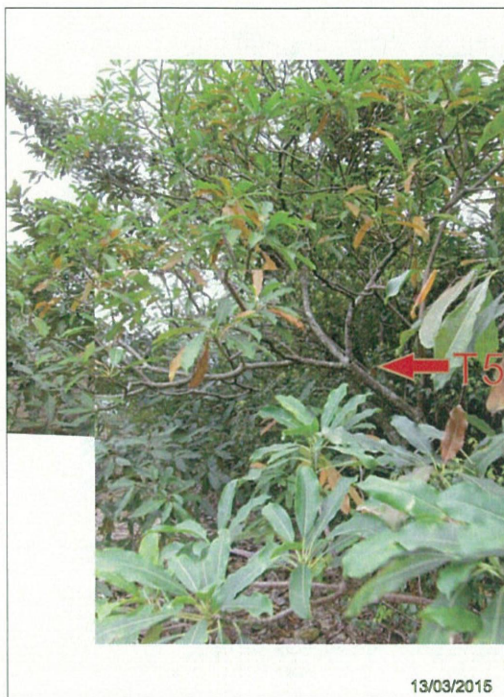
Tree No. T5: *Cerbera manghas* 海芒果
 Retain Transplant Fell Dead

T5	<i>Cerbera manghas</i>	海芒果	4.0	4.0	130	P	F	F	1, 2	Retain	Heavily leaning and unbalanced canopy.
T6	<i>Cerbera manghas</i>	海芒果	6.0	4.0	150	P	F	F	1, 2	Retain	Leaning, curving branch with self rectification and unbalanced canopy intersects with T6a.
T6a	<i>Hibiscus tiliaceus</i>	黃槿	7.0	7.0	194	P	F	F	1, 2	Retain	Heavily leaning, codominant V-shape branches with self rectification and unbalanced canopy intersects with T6a.
T6b	<i>Rhus succedanea</i>	野漆樹	6.0	4.0	147	F	F	F	1, 2	Retain	Low foliage density, heavily covered by shrub and climbers and broken branches.

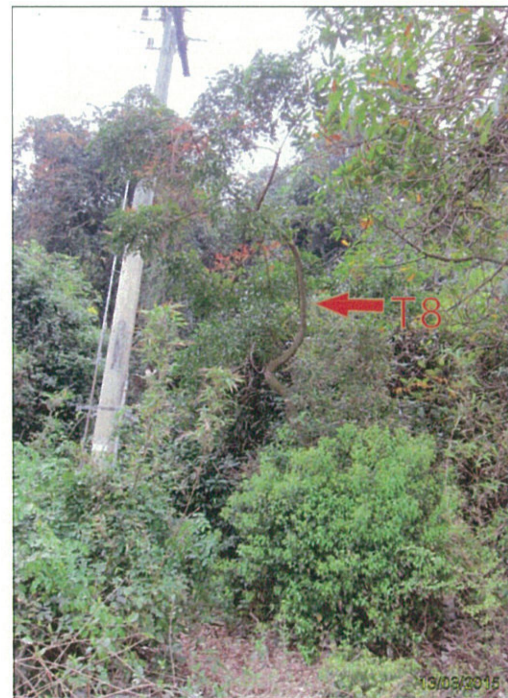
Tree No. T8: *Rhus succedanea* 野漆樹
 Retain Transplant Fell Dead

T8	<i>Rhus succedanea</i>	野漆樹	5.0	2.0	95	P	F	F	1, 2	Retain	S-shape trunk with self rectification, low foliage density and slightly unbalanced canopy.	
T9	<i>Cerbera manghas</i>	海芒果	4.0	1.0	165	F	F	F	1, 2	Retain	Y-shape trunk with one of the branch wilted and broken and canopy intersects with T10.	
T10	<i>Cerbera manghas</i>	海芒果	7.0	4.0	319	F	G	F	1, 2	Retain	Codominant V-shape trunk, leaning in one of the trunk with self rectification, normal foliage density and fruiting.	
T11	<i>Rhus succedanea</i>	野漆樹	6.0	1.5	157	F	F	F	1, 2	Retain	Codominant Y-shape branches, unbalanced canopy and low foliage density.	
T12	<i>Cerbera manghas</i>	海芒果	4.0	2.0	195	P	P	L	1, 2	Retain	Main trunk broken, sprouts, low foliage density and canopy covered by climbers.	
T13	<i>Hibiscus tiliaceus</i>	黃槿	4.0	8.0	307	P	P	L	1, 2	Retain	Unbalanced canopy, heavily leaning, multi-trunk found toppled and growing horizontally with 90 degree self rectification.

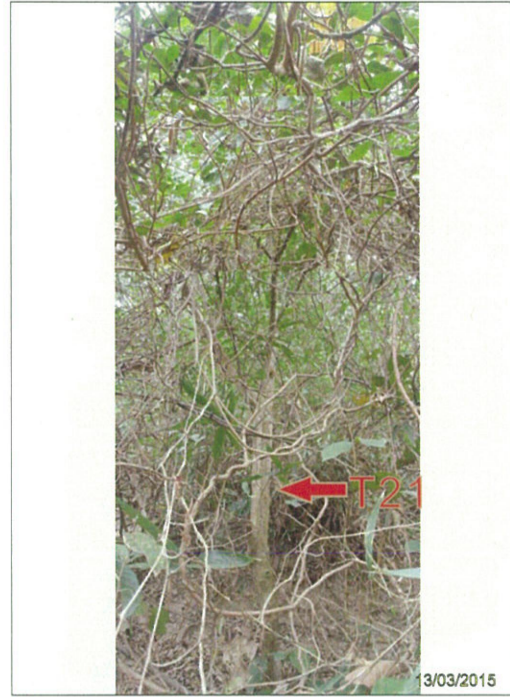
Tree No. T21: *Acronychia pedunculata* 山油柑
 Retain Transplant Fell Dead

T21	<i>Acronychia pedunculata</i>	山油柑	7.0	5.0	180	F	P	L	1, 2	Retain	Y-shape trunk and branches, heavily covered by climbers with an emerging canopy.	
T22 (Tree Group 1)	<i>Schefflera heptaphylla</i>	鴨腳木	12.0	7.0	250	F	F	F	1, 2	Retain	Not accessible due to dense understory vegetation, slightly unbalanced canopy, broken branch, normal foliage density and colour.

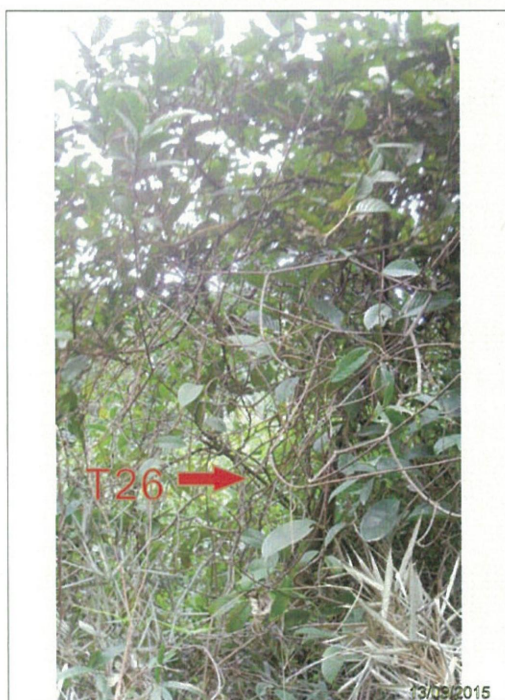
Tree No. T26: *Aporosa dioica* 銀柴 (Tree Group 2)
 Retain Transplant Fell Dead

T26 (Tree Group 2)	<i>Aporosa dioica</i>	銀柴	5.0	2	80	F	F	F	1, 2	Retain	Not accessible due to dense understory vegetation, slightly unbalanced canopy, some broken branches and covered with climbers.
T27 (Tree Group 2)	<i>Schefflera heptaphylla</i>	鴨腳木	12.0	10.0	400	F	F	F	1, 2	Retain	Not accessible due to dense understory vegetation, slightly unbalanced canopy, normal foliage density and colour.
T28	<i>Microcos nervosa</i>	布渣葉	5.0	5.0	100	P	P	L	1, 2	Retain	Not accessible due to dense understory vegetation, slightly unbalanced canopy, small amount of yellow and bitten leaves and covered by climbers.
T29	<i>Rhus succedanea</i>	野漆樹	3.5	3.0	130	F	F	F	1, 2	Retain	Not accessible due to dense understory vegetation, slightly unbalanced canopy and low foliage density.

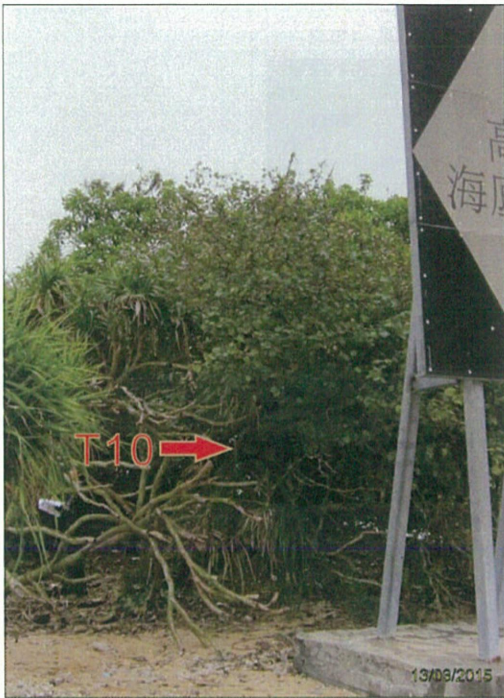
Tree No. T10: *Hibiscus tiliaceus* 黃槿
 Retain Transplant Fell Dead

T10	<i>Hibiscus tiliaceus</i>	黃槿	4.0	8.0	340	F	F	M	1, 2	Retain	Balanced canopy, normal foliage density and colour.
T11	<i>Pandanus tectorius</i>	露兜樹	4.0	2.0	100	P	F	L	1, 2	Retain	Heavily leaning with broken branches.
T12	<i>Pandanus tectorius</i>	露兜樹	4.0	2.0	130	P	P	L	1, 2	Retain	Heavily leaning, broken branches and diebacks.
T14	<i>Pandanus tectorius</i>	露兜樹	4.0	3.0	175	P	F	L	1, 2	Retain	Leaning with broken branches.

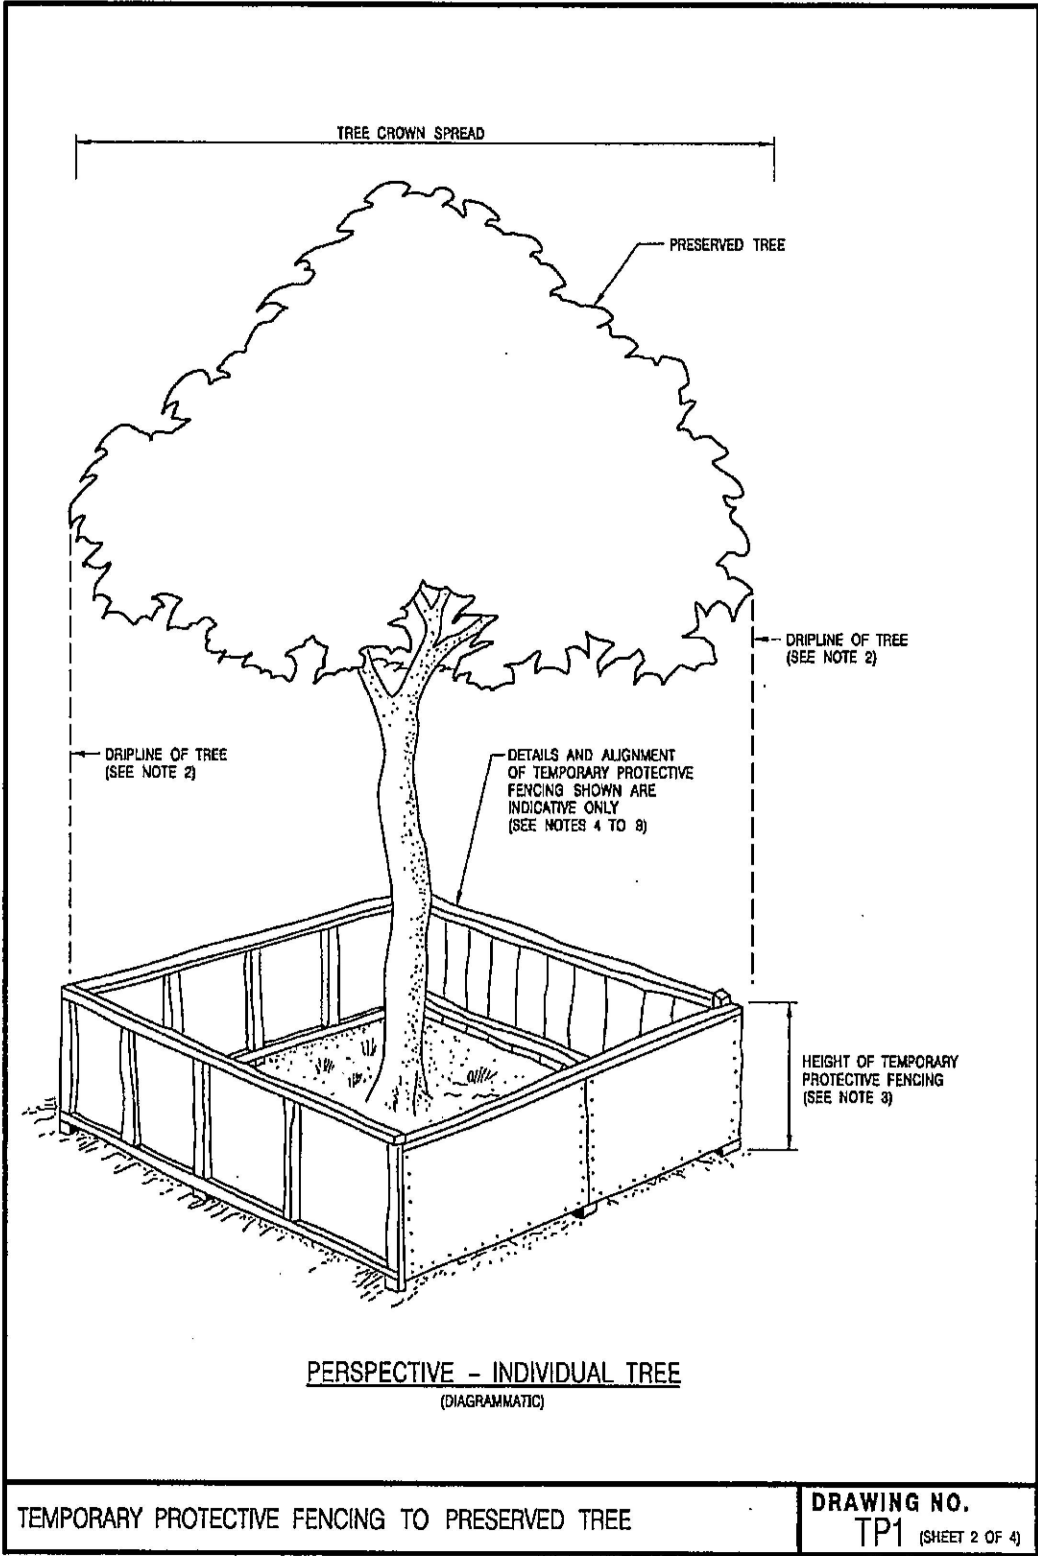
DRAWING NO.
TP1 (SHEET 2 OF 4)

TEMPORARY PROTECTIVE FENCING TO PRESERVED TREE

Protective fencing, or similar protection subject to the actual site conditions, will be erected before the works commence. Protective fence should be erected beyond the crown spread or the designed protection zone (within dripline) of all retained trees (typical fencing is shown in Drawing No. TP1. This restricted area is known as the Tree Protection Zone (TPZ). Access into the TPZ will be restricted only to workers directly involved in tree work. No construction machinery, tools, equipment or materials will breach the TPZ. No heat or fume will drift into the TPZ.
