Expansion of Hong Kong International Airport into a Three-Runway System

Contamination Assessment Report for Terminal 2 Emergency Power Supply Systems No.2, Emergency Power Supply Systems No.3 and Emergency Power Supply Systems No. 5

October 2020

Airport Authority Hong Kong

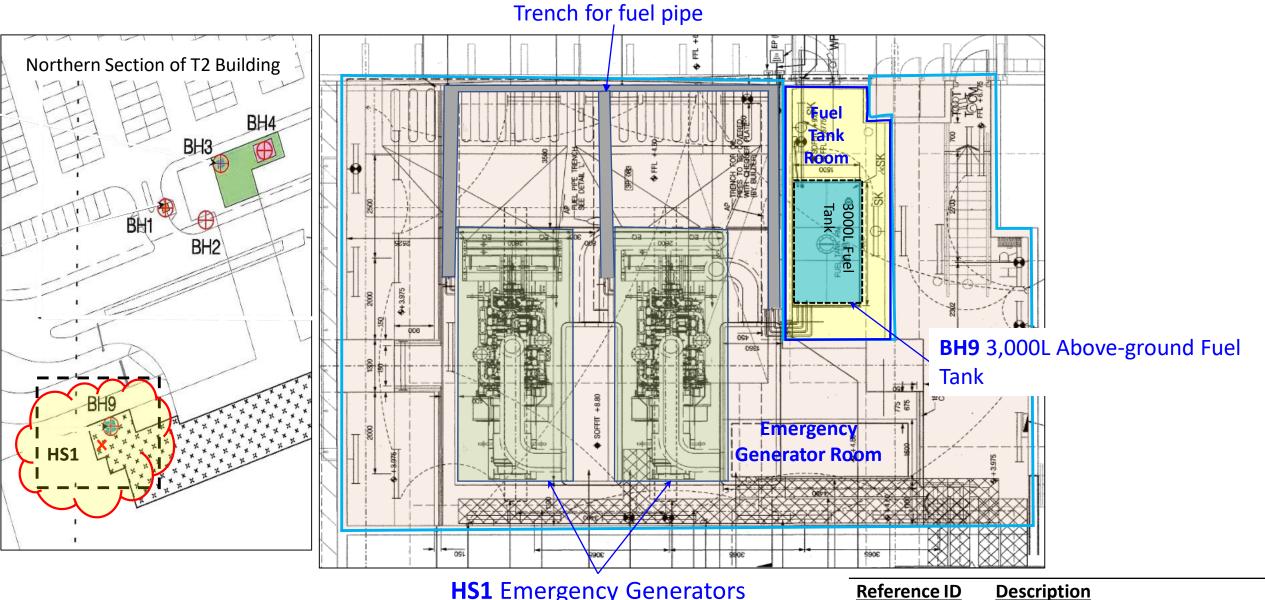
HS1 Emergency Generators (Stand on **200mm-thick concrete plinth**)

BH9 A 3,000 L above-ground fuel tank at Fuel Tank Room

Two above-ground emergency generators at Emergency Generator Room, connected to 3,000 L above-ground fuel tank (i.e. BH9)

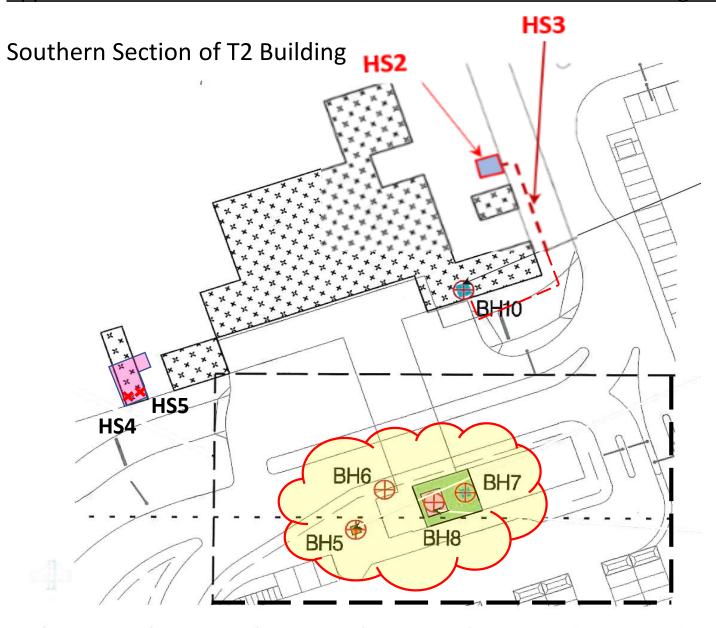
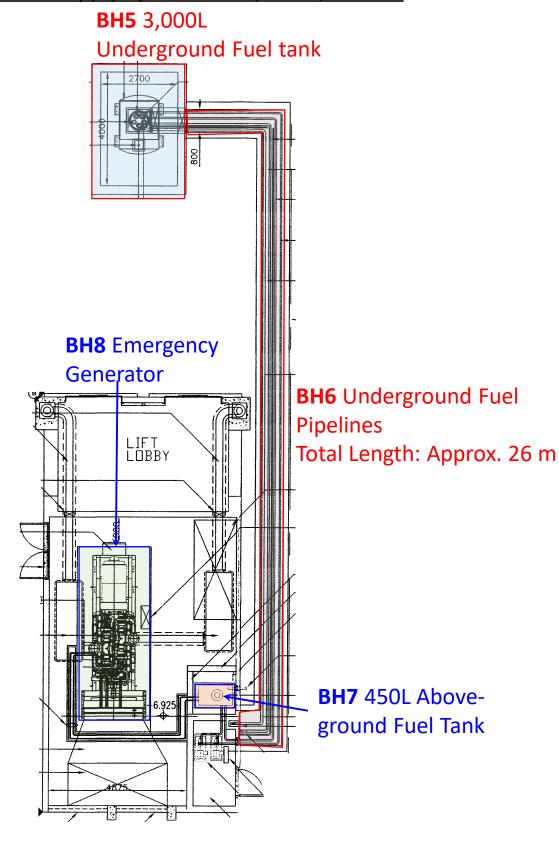
Appendix C.2 Identified Potential Land Contaminated Source of Emergency Power Supply System No.3 (EPSS3) in SCAP

Reference ID	<u>Description</u>
ВН5	A 3,000 L underground fuel tank
ВН7	A 450 L above-ground fuel tank at Emergency Generator Room
вн6	26 m-in-length underground fuel pipelines connecting the 3,000 L underground fuel tank (i.e. BH5) and the 450 L above-ground fuel tank (i.e. BH7)
ВН8	An emergency generator at Emergency Generator Room (above-ground)

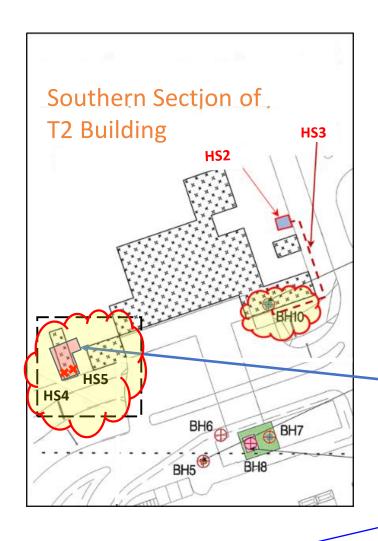
Reference ID Description HS4 A 1,500 L above-ground fuel tank at **Fuel Tank Room** HS₅ An emergency generator at Emergency 1,500L Above-ground Generator Room (above-ground)

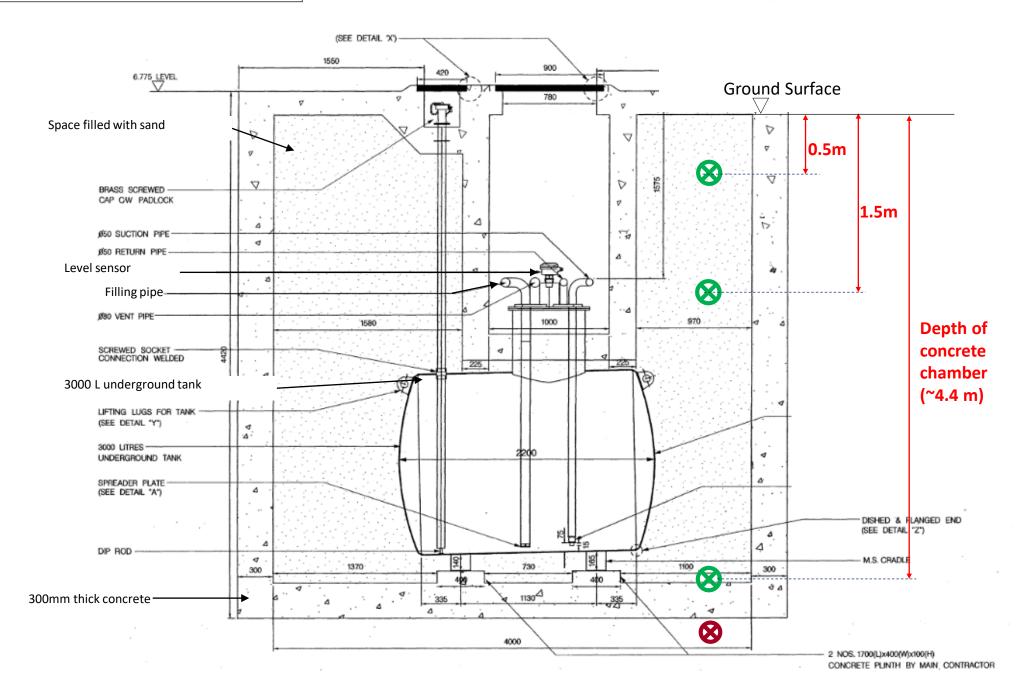
Appendix D Indicative Sampling Point Selection of 3,000 L Underground Fuel Tank of EPSS3 in SCAP (i.e. BH5)

With the sampling experience of BH1 (for Emergency Power Supply System No.1), deviation between as-built drawing and the actual concrete chamber is expected. It is expected that the fuel tank is fully encased in the concrete chamber. However, the top concrete slab would be located at an uncertain level which would be beneath the surface ground and above the fuel tank. In consideration of the actual site condition and safety reasons, borehole sampling for BH5 was proposed by the Contractor, instead of grab sampling as proposed in the SCAP. Discussion was held between amongst the Contractor, AAHK and the land contamination specialist. It was agreed with the land contamination specialist that the borehole would be undertaken by means of rotary drilling method.

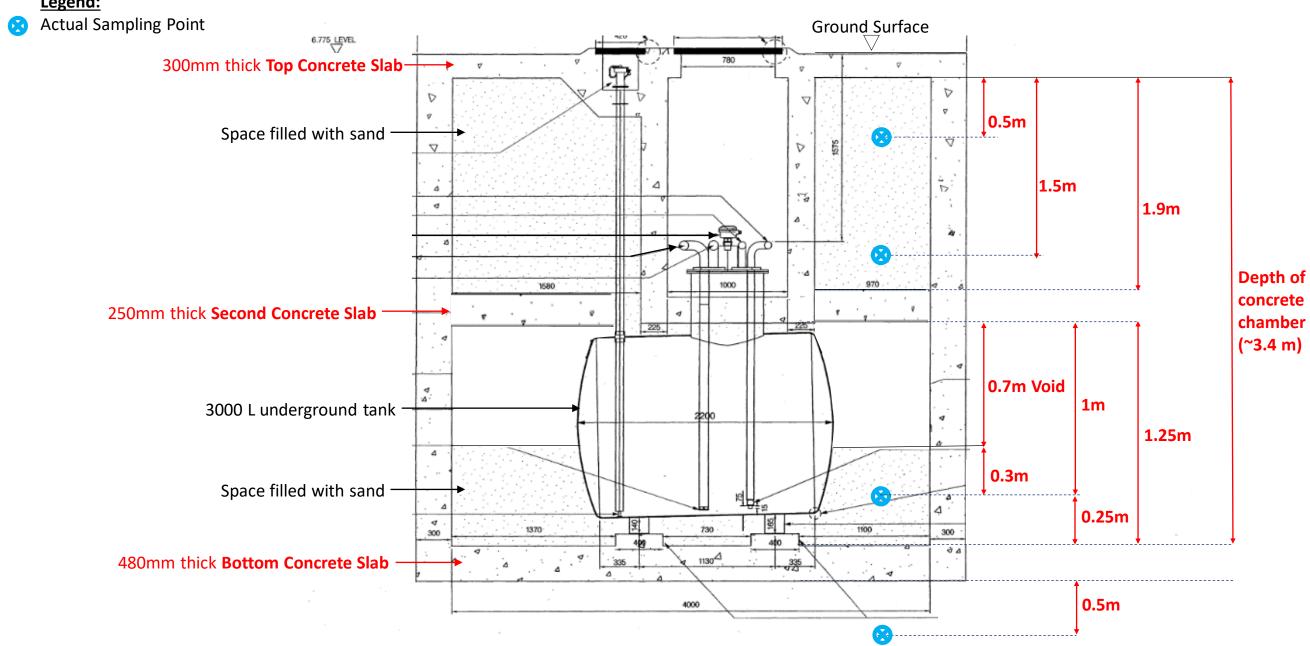
Appendix F Structure and Actual Sampling Depth of 3,000 L Underground Fuel Tank of EPSS3 (i.e. BH5)

To confirm with the structure encountered at 1.9m below the top concrete slab, an inspection pit was excavated down to 1.9m below ground surface. An inspection was conducted by the land contamination specialist on 24 July 2020. It was found that there was a second concrete slab inside the concrete chamber and the fuel tank was still fully encased in a at least 300 mm thick concrete chamber, with the top concrete slab right beneath the surface ground level and the second concrete slab located at around 1.9 m below the top concrete slab. The structure is illustrated in **Appendix F**.

Another site investigation was conducted by land contamination specialist on 20 August 2020. It was found that the lower concrete chamber encasing the fuel tank with an inner depth of 1.25m, with 0.7m void right underneath the second concrete slab. A depth of 0.55m sand was filled from the bottom of the second concrete chamber. Since the actual inner depth of concrete chamber is smaller than those shown in the as-built drawing, as decided by the land contamination specialist, it was considered that 1 undisturbed sand samples collected at 1.0m below the second concrete slab of the concrete chamber was adequate and representative to confirm whether there was land contamination impact caused by the underground fuel tank.

<u>Sample</u>	Sampling Point Selection Strategy
Sand	0.5 m, 1.5 m below top concrete slab, 1.0m below second concrete slab
Soil	0.5m below base concrete slab

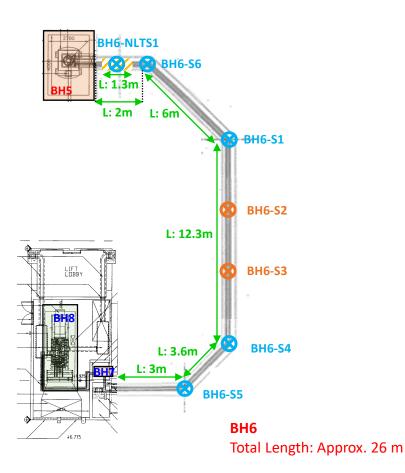
Actual Sampling Point of Underground Pipeline Trench of Emergency Power Supply System No.3 (i.e. BH6)

Based on-site observation, it was found that the concrete trench was filled with concrete rather than sand and no sand samples could be collected inside the concrete trench. Therefore, soil samples were collected at the following sampling points at the depth right underneath the concrete trench, where the curvature of the pipelines located,

- BH6-S1 (Same sampling point proposed in SCAP);
- BH6-S4 (Same sampling point proposed in SCAP);
- BH6-S5 (Newly added according to on-site condition); and
- BH6-S6 (Newly added according to on-site condition).

To confirm no diesel leakage from underground fuel pipelines from the 1.3m in length no-concrete-trench segment, 1 soil sample was taken right underneath the particular segment (i.e. BH6-NLTS1). Having considered that the sampling point selection strategy in the SCAP (i.e. If pipeline segment is ≤10 m, an additional sample is considered not required), the site observations where no oil stains being found in the vicinity of BH6-NLTS1, and the laboratory testing result for BH6-S6 (no contamination was found) which is near to the location of BH6-NLTS1, 1 sample collected at the depth right underneath the pipeline was deemed to be sufficient to represent and confirm if any diesel leakage from the 1.3m long (as revealed on-site) of no-concrete-trench segment.

Segment of underground pipeline not laid in concrete trench

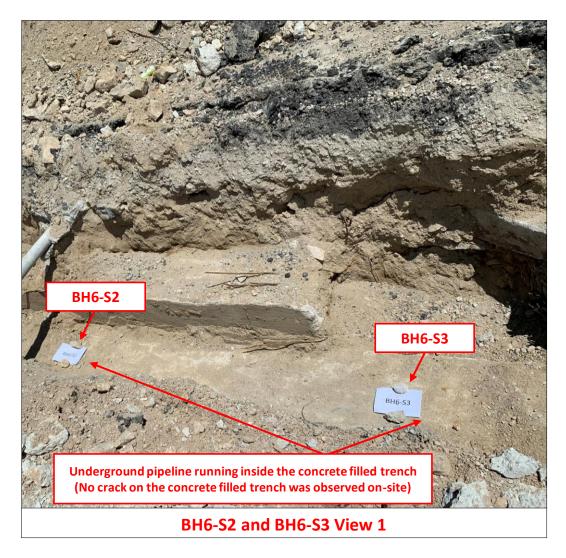
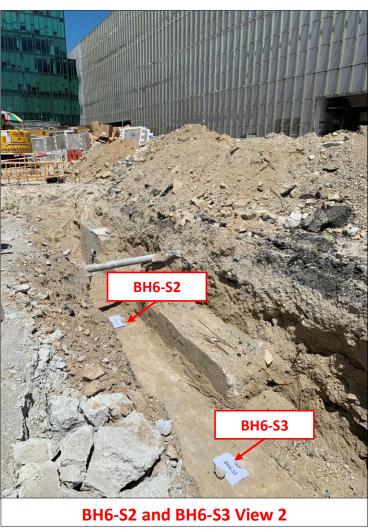
Appendix G.2 Site Photo Record of Underground Pipeline Trench of EPSS3 at BH6-S2 and BH6-S3 (Photo Record)

For indicative sampling points, BH6-S2 and BH6-S3, as no sand samples could be collected at the level of fuel pipelines, the site condition of the concrete trench was examined on-site and the observations are presented in **Appendix G.** No cracks on the concrete-trench nor oil stains were found in the vicinity of these 2 sampling points. However, due to the safety concerns of excavation at the time of on-site inspection, site photos at the sides and bottom of BH6-S2 and BH6-S3 could not be taken on 24 July 2020. However, with consideration of the site observations as presented in **Appendix G** and the laboratory testing results of BH6-S1 and BH6-S4, which are at the same segment and near in location, it is confirmed that no diesel leakage from the underground fuel pipelines laid in concrete trench.

To err on a conservative side, additional site photo records at the sides and bottom of BH6-S2 and BH6-S3 will be submitted to EPD upon the demolition work at these locations to reaffirm the conclusion drawn in **Section 3.1.2** that there was no diesel leakage from the underground fuel pipe.

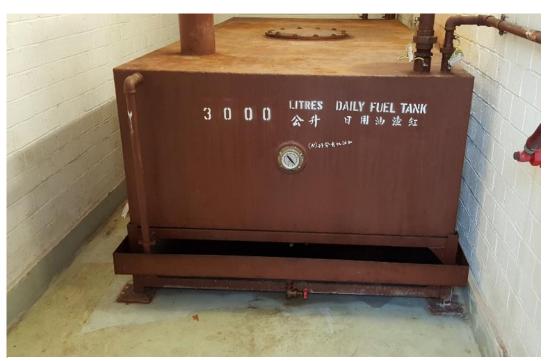
BH9 View 1 - 3000L Above-ground Fuel Tank (BH9)

The above-ground fuel tank (i.e. BH9) and emergency generator (i.e. HS1) of EPSS2 were disconnected in late-May 2020. As advised by the contractor, the fuel inside EPSS2 was removed in late-June 2020. Hence the final inspection of the BH9 and HS1 was conducted on 8 July 2020. During our final inspection, BH9 and HS1 were at the same locations as for the time of preparation of SCAP in 2018. Both facilities were mounted on intact concrete floor with no oil stain observed, and no oil stain was observed inside the drip tray of the above-ground fuel tank (BH9). In addition, bund wall was provided in the access of the fuel tank room.

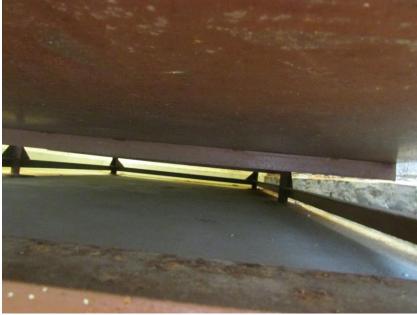
BH9 View 2 - concrete floor condition underneath 3000L Aboveground Fuel Tank

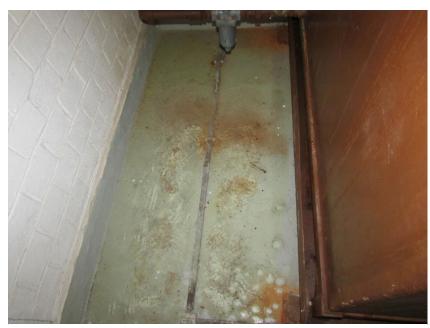
BH9 View 3 - concrete floor condition of fuel tank room with 3000L Above-ground Fuel Tank

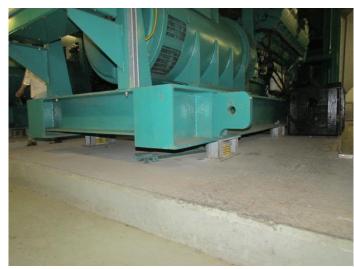
HS1 View 1 - concrete floor condition underneath emergency generators

The fuel pipelines running through BH9 and HS1 were buried by sand inside a concrete and brick trench at floor level. Two sections of the pipelines were checked by removing the chequer plate cover and no sign of leakage was observed. Photo records of final inspections are presented in Appendix J1 and Appendix J2.

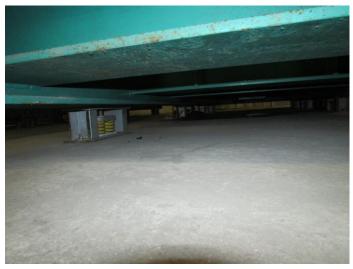
HS1 View 2 - concrete floor condition underneath emergency generators

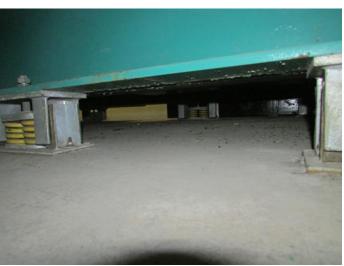
HS1 View 3 - concrete floor condition underneath emergency generators

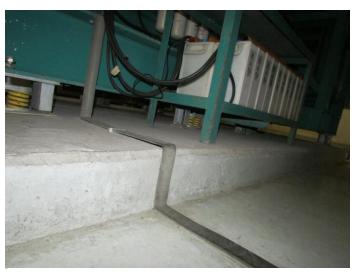
HS1 View 4 - concrete floor condition underneath emergency generators

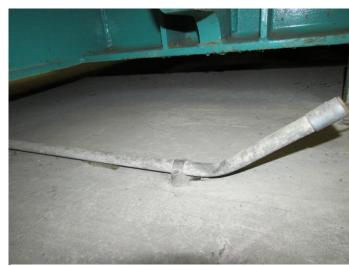
HS1 View 5 - concrete floor condition underneath emergency generators

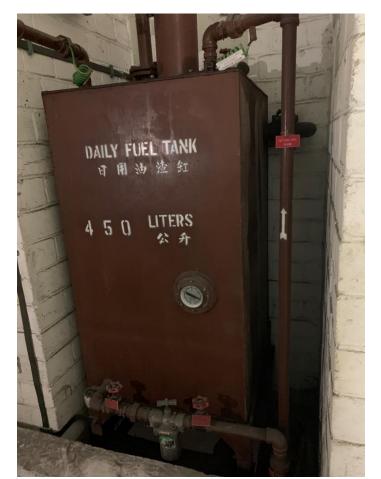
BH7 View 1 - 450 L Above-ground Fuel Tank

The above-ground fuel tank (i.e. BH7) and emergency generator (i.e. BH8) of EPSS3 were decommissioned in early-April 2020. Final inspection of the BH7 and BH8 was conducted on 1 April 2020. During our final inspection, BH7 and BH8 were at the same locations as for the time of preparation of SCAP in 2018. The above-ground fuel tank (BH7) was surrounded by concrete curb and no oil stain was observed inside its drip tray, and the emergency generator (BH8) was mounted on intact concrete floor with no oil stain observed.

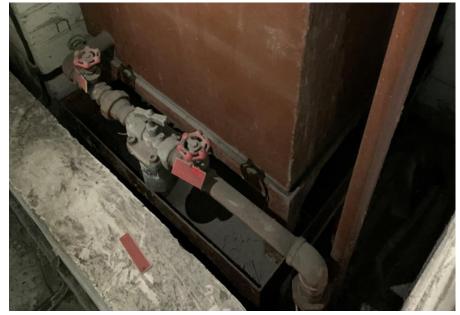
BH7 View 2 – Drip tray condition underneath 450 L Above-ground Fuel Tank

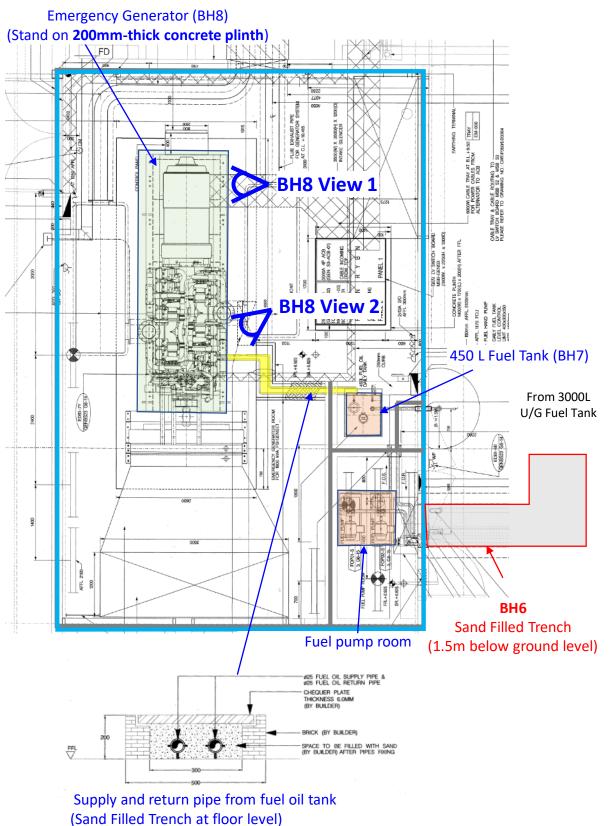
BH8 View 1 - concrete floor condition underneath emergency generator

BH8 View 2 - concrete floor condition underneath emergency generator

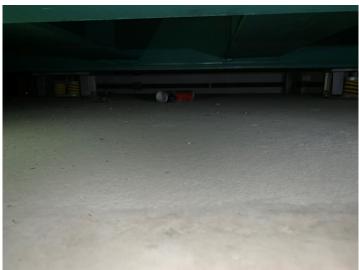
HS5 View 1 - concrete floor condition underneath emergency generator

The above-ground fuel tank (i.e. HS4) and emergency generator (i.e. HS5) of EPSS5 were decommissioned in late-May 2020. Final inspection of the HS4 and HS5 was conducted on 25 May 2020. During our final inspection, HS4 and HS5 were at the same locations as for the time of preparation of SCAP in 2018. Both facilities are mounted on intact concrete floor with no oil stain observed, and no oil stain was observed inside the drip tray of the above-ground fuel tank (HS4). In addition, curb wall was provided in the access of the fuel tank room.

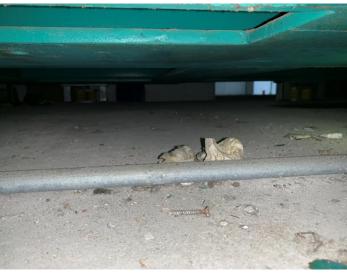
HS5 View 2 - concrete floor condition underneath emergency generator

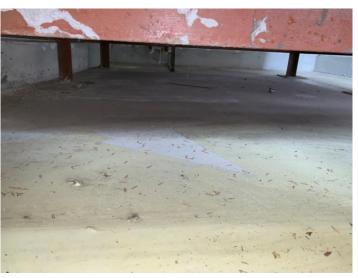
HS4 View 1 - concrete floor condition underneath 1,500L Above-ground Fuel Tank

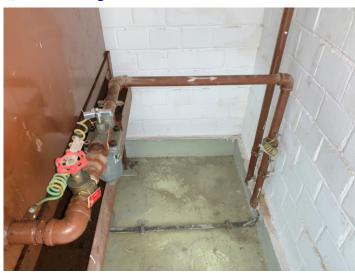
HS4 View 2 - concrete floor condition of fuel tank room with 1,500 L above-ground fuel tank
