Expansion of Hong Kong International Airport into a Three-Runway System

Construction Phase Quarterly EM&A Report
No.11 (1 July to 30 September 2018)

November 2018

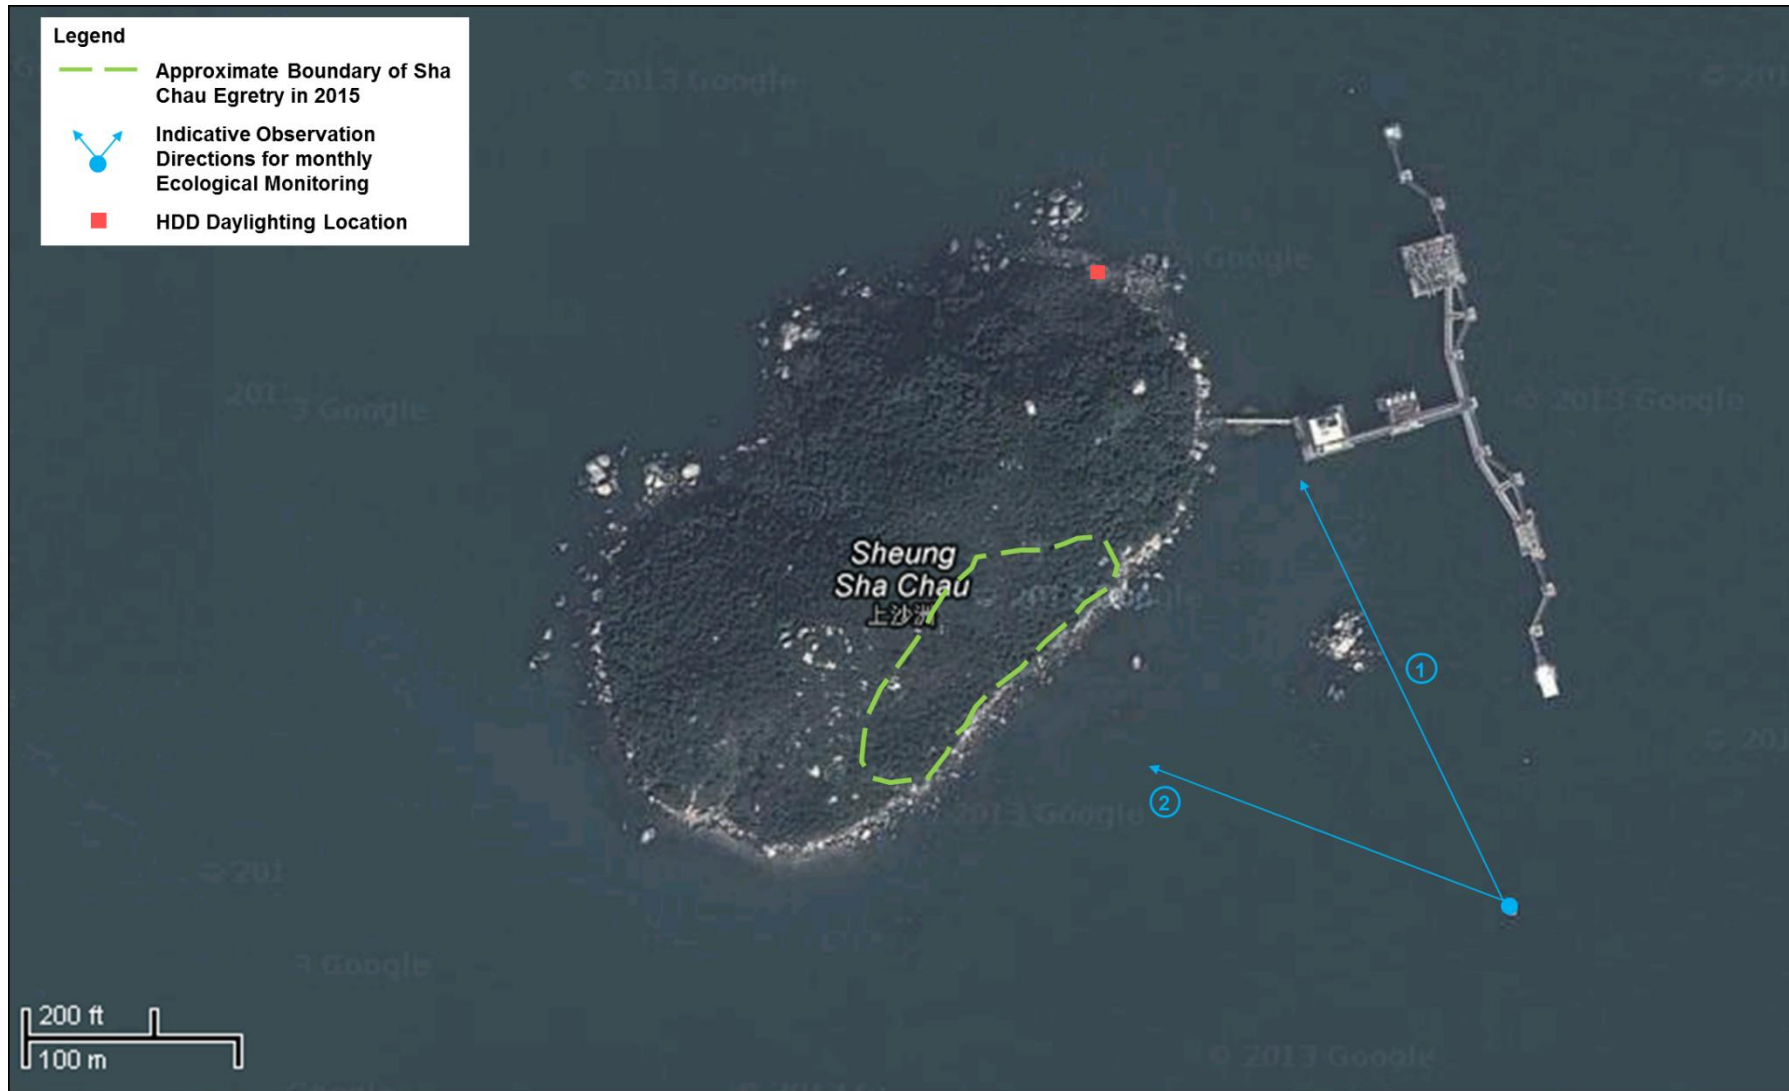
No construction works were conducted on Sheung Sha Chau Island in July 2018 (i.e. during the ardeid's breeding season) in accordance with the Manual. Monthly ecological monitoring was carried out in August and September 2018 on Sheung Sha Chau Island. No encroachment of any works upon the egret area nor any significant disturbance to the ardeids on the island by the works was recorded during ecological monitoring. Sign of a few nursery activities by Little Egret was observed in August on trees located at the previously identified egret area where it is at the southern side of Sheung Sha Chau Island. At the HDD daylighting location, neither nest nor breeding activity of ardeids were found during the monthly ecological monitoring and weekly site inspections in August and September 2018. The site photos and location map regarding the ecological monitoring for HDD daylighting location and egret area are provided in **Appendix C** for reference.

Terrestrial Ecological Monitoring – site photos and location map regarding the monthly ecological monitoring for the egret area on Sheung Sha Chau and the HDD daylighting location

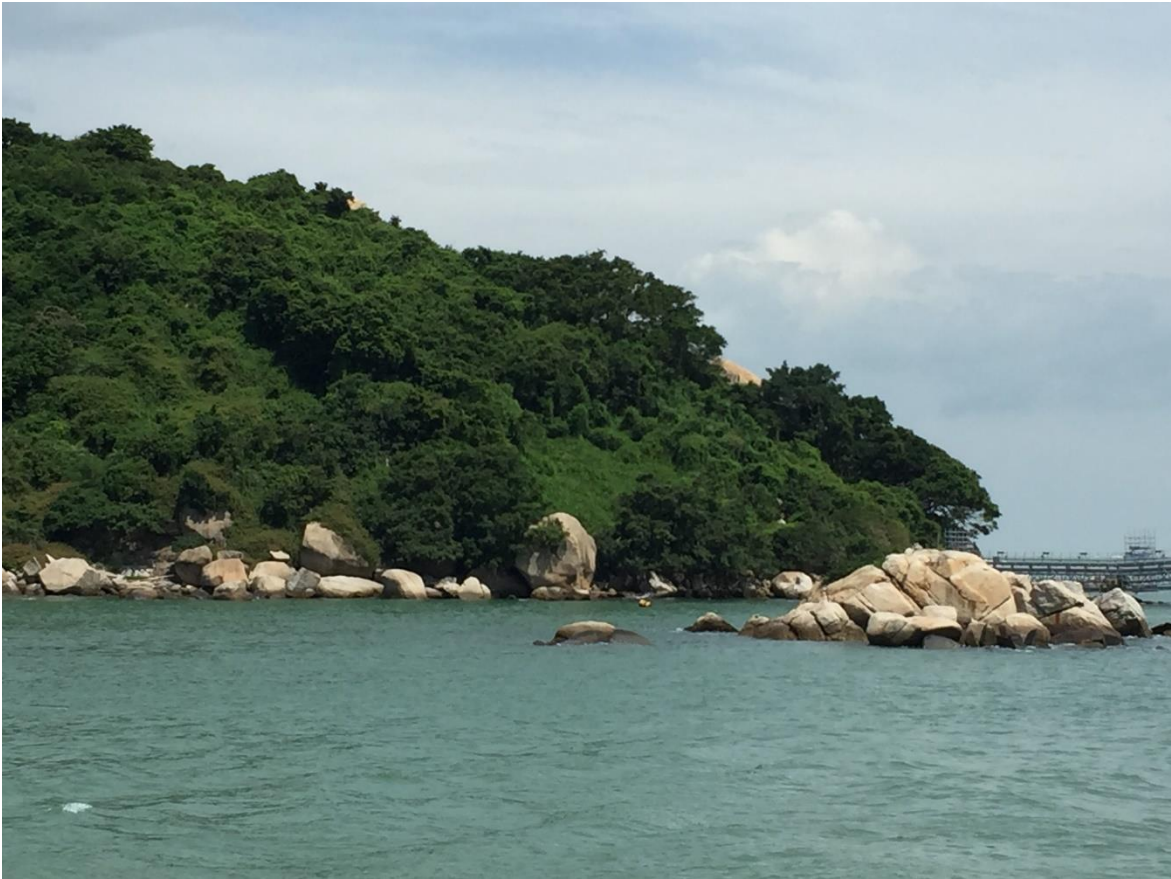
Photo record of View 1

August 2018

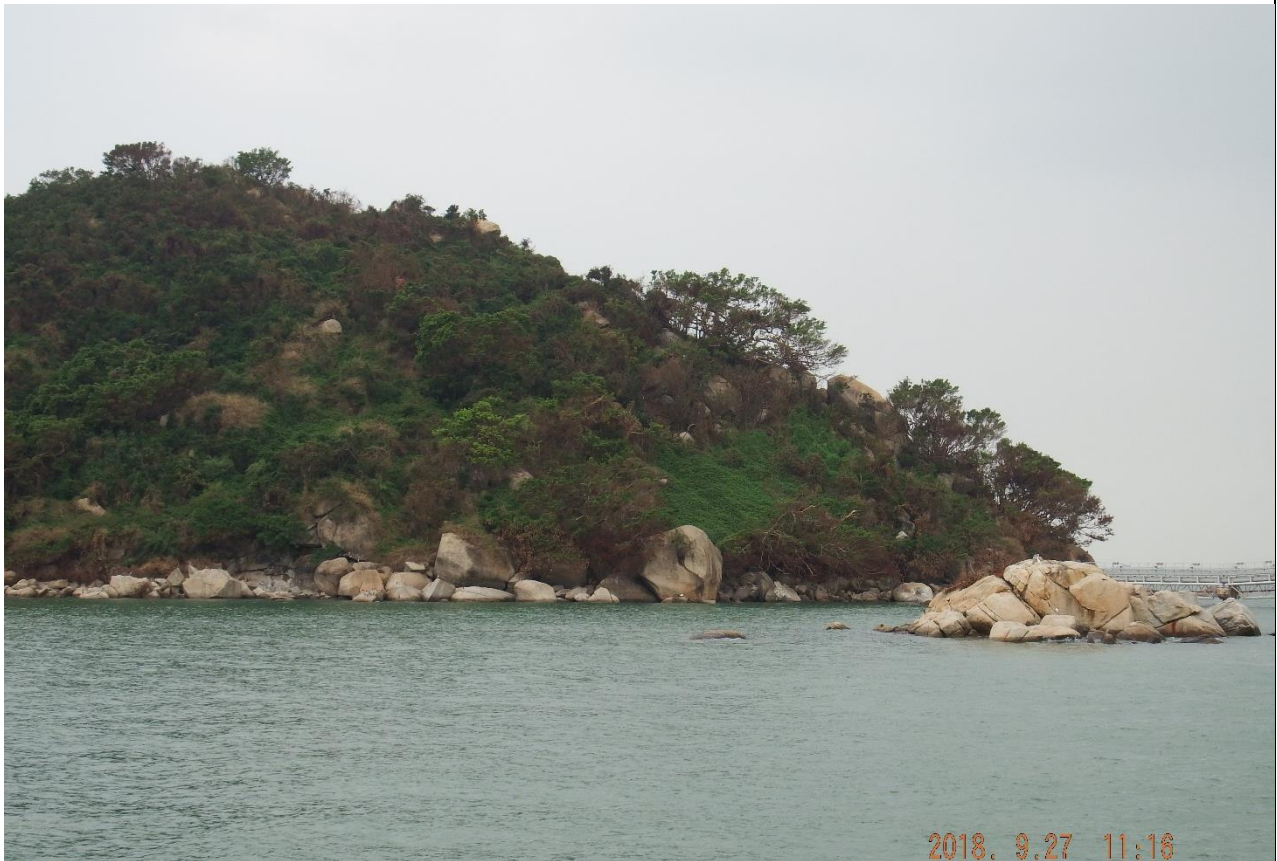
Photo record of View 1

September 2018
