Expansion of Hong Kong International Airport into a Three-Runway System

Construction Phase Quarterly EM&A Report
No.12 (1 October to 31 December 2018)

March 2019

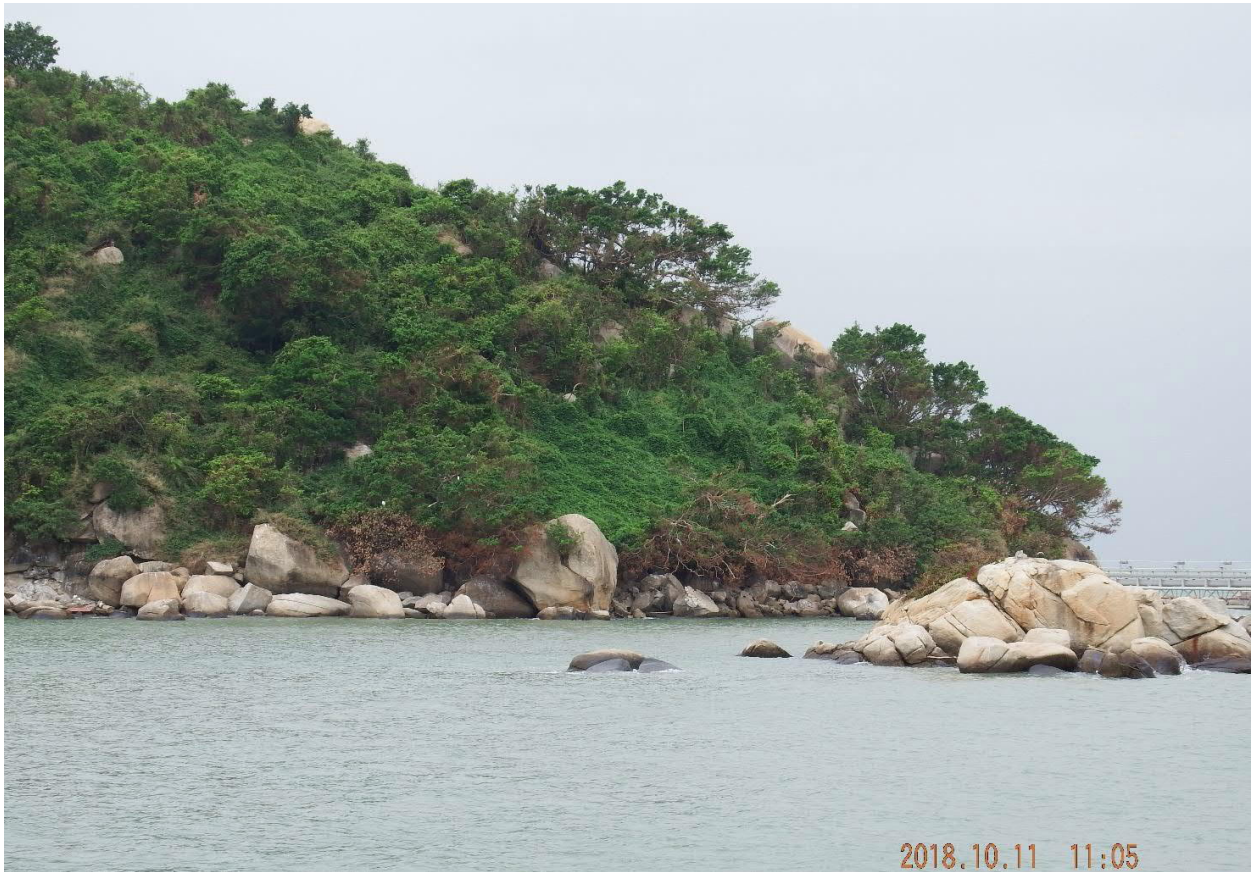
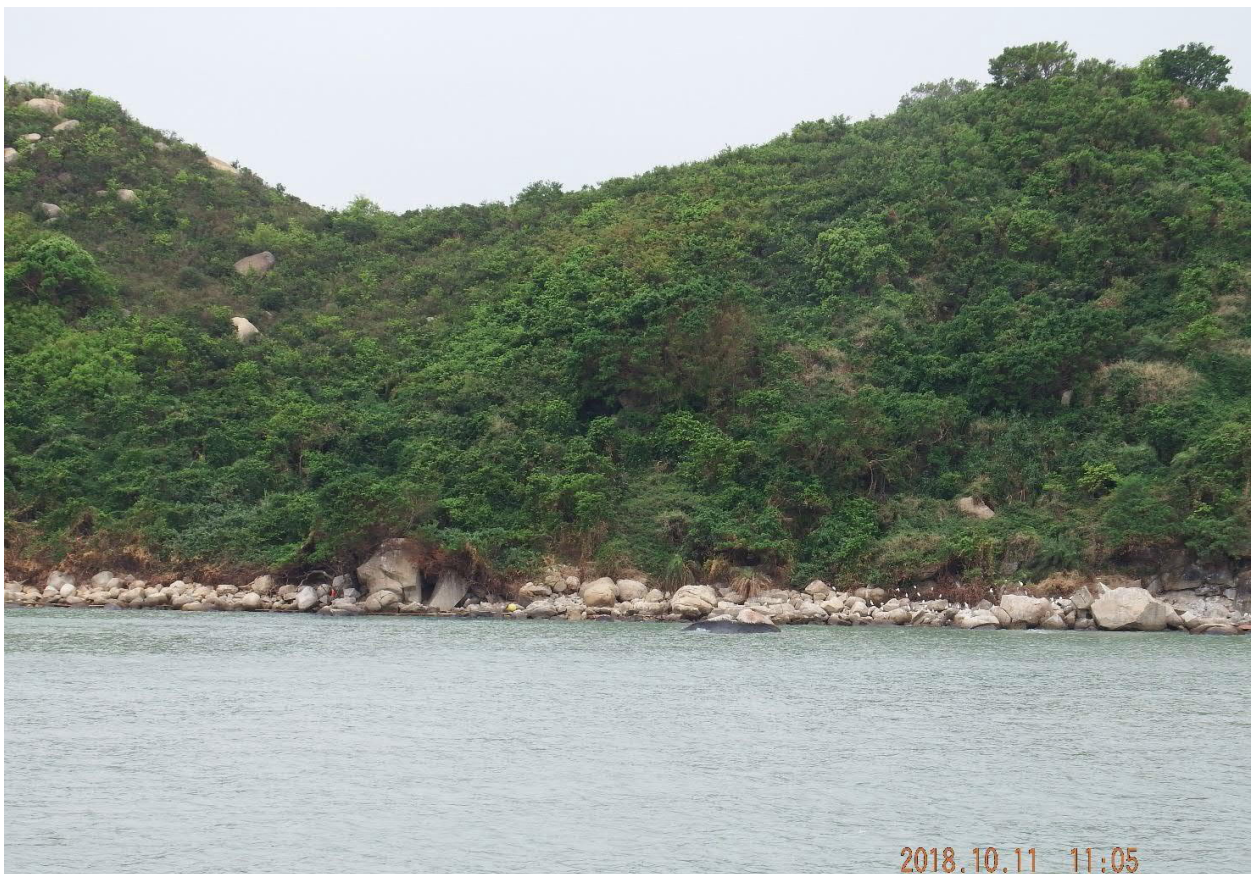
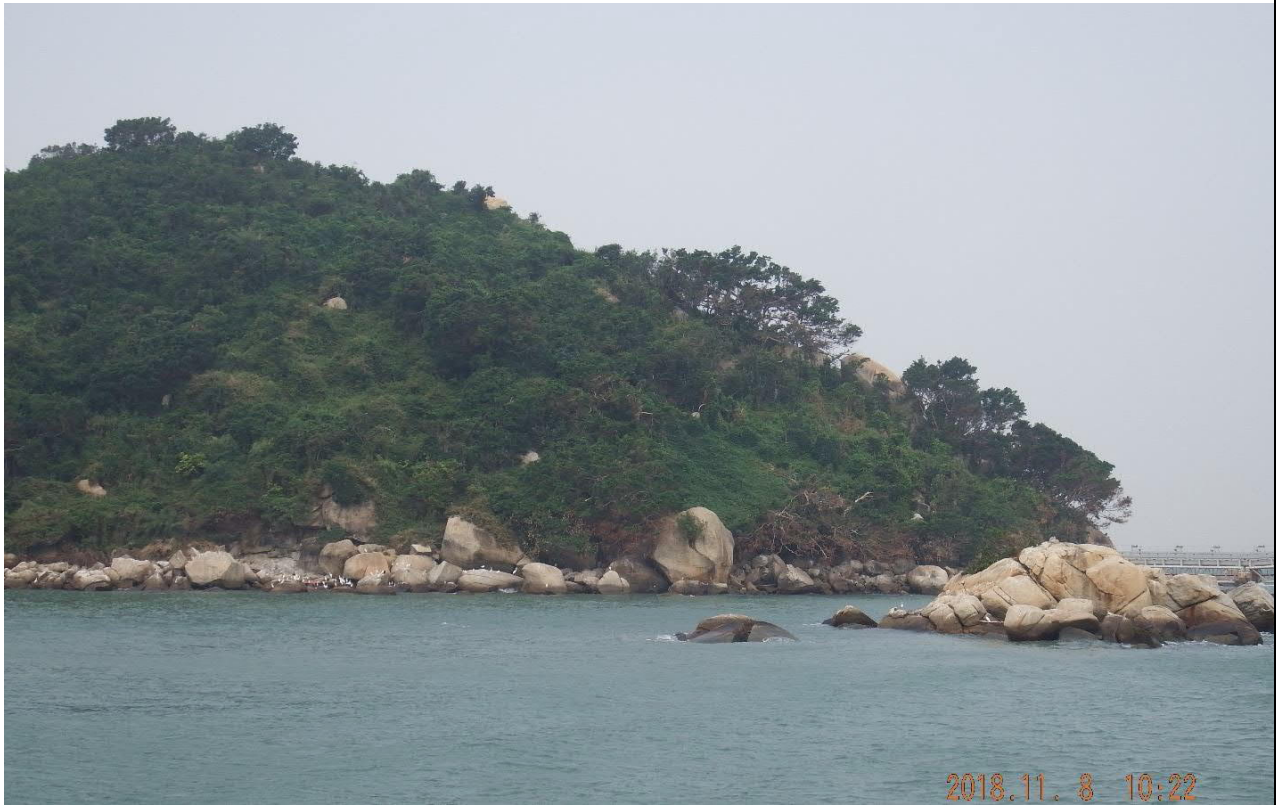
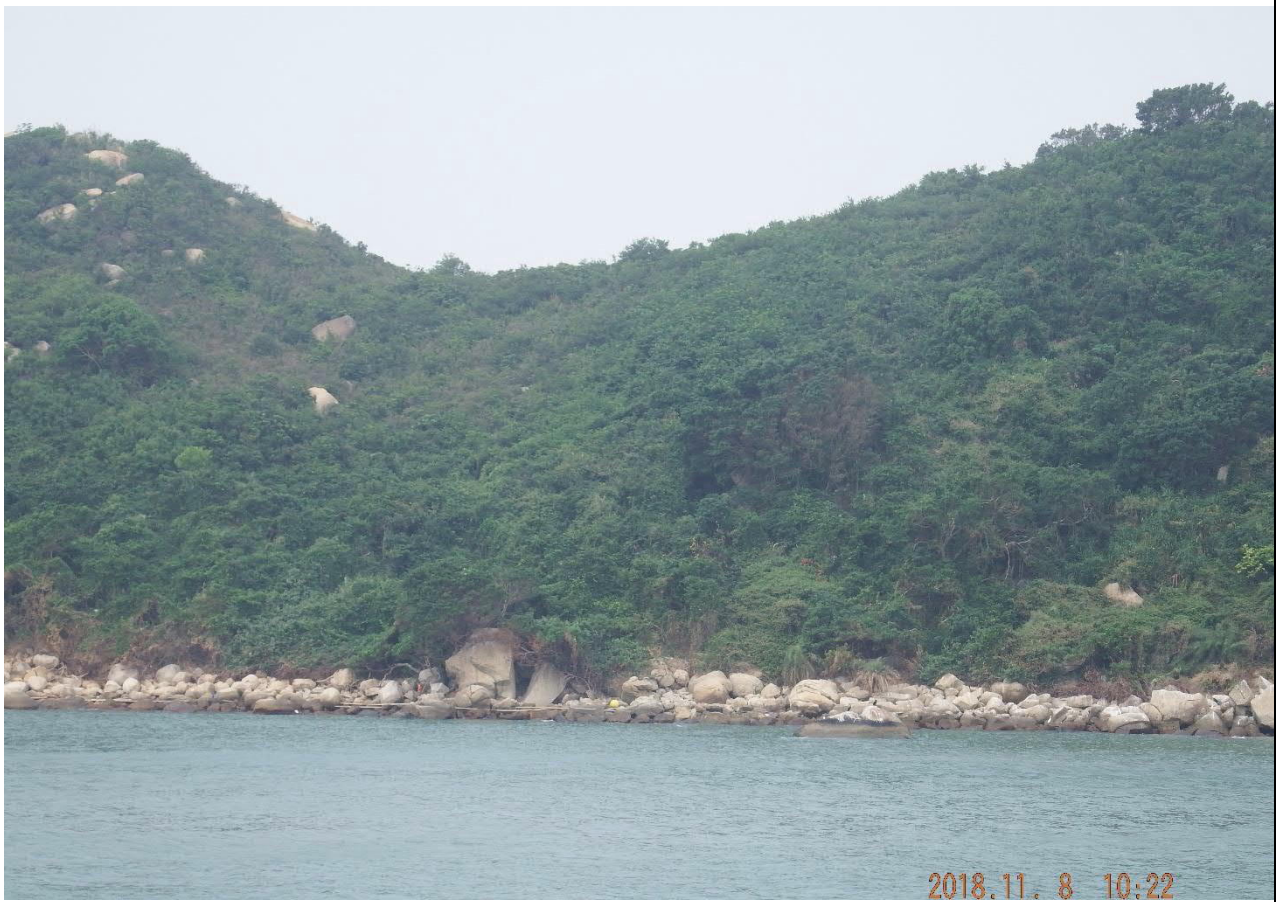
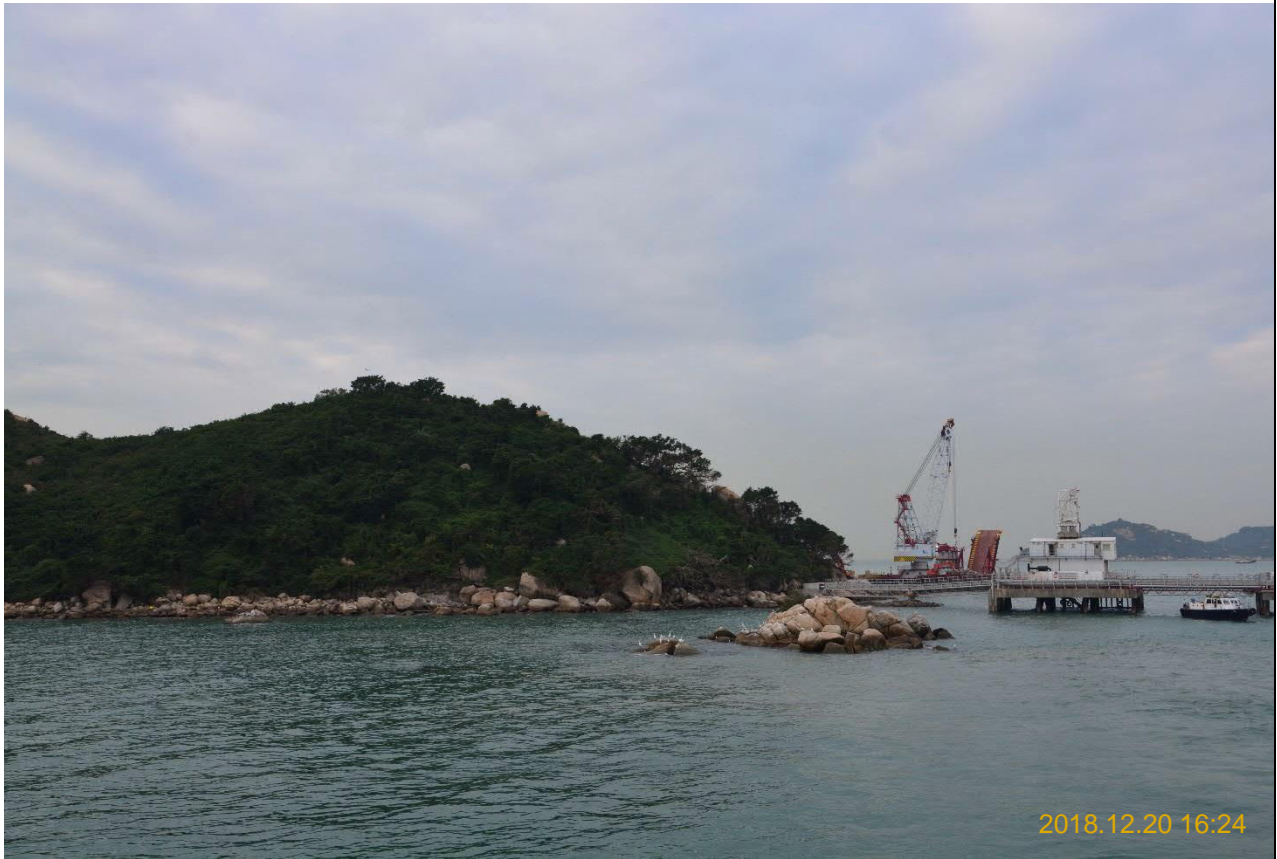
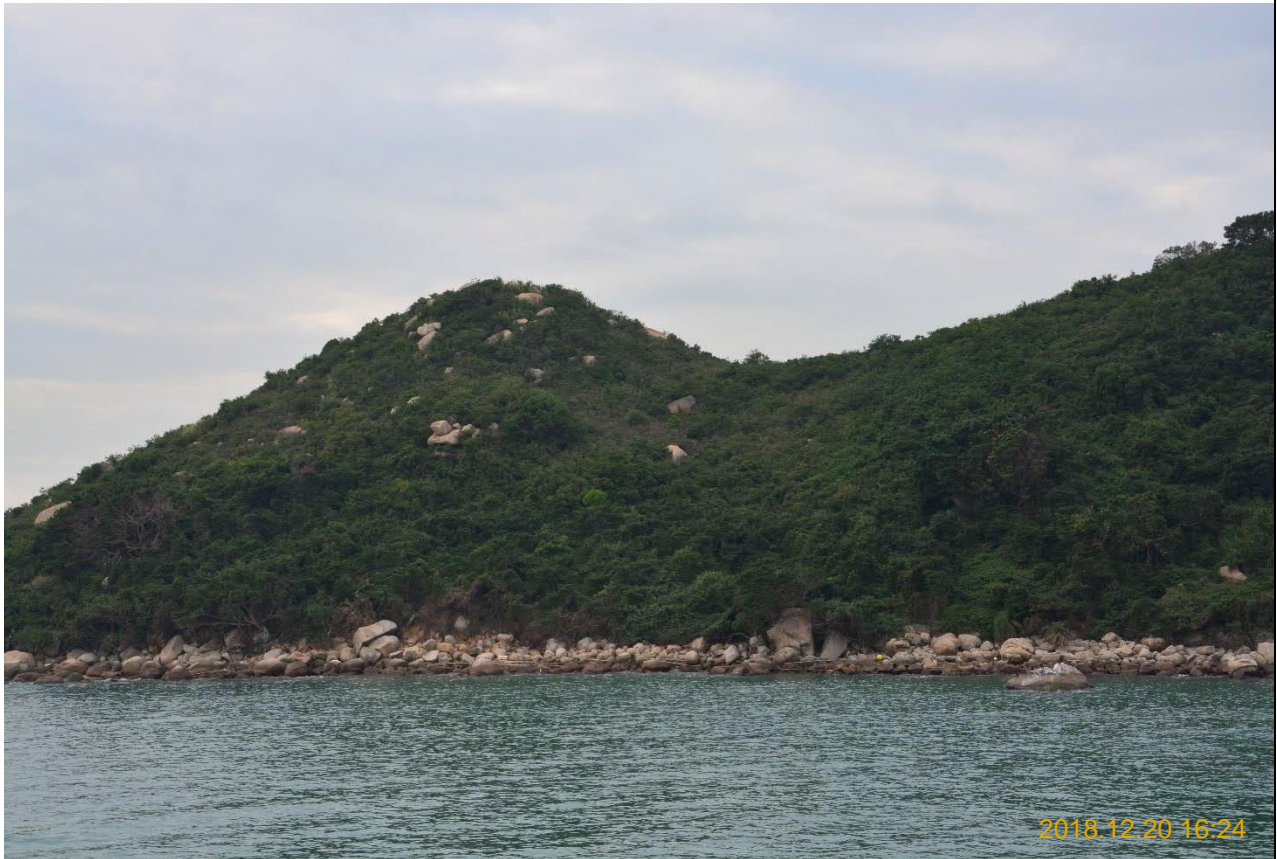
Terrestrial Ecological Monitoring – location map and site photos regarding the monthly ecological monitoring for the egret area on Sheung Sha Chau and the HDD daylighting location

Monthly ecological monitoring was carried out in October, November and December 2018 on Sheung Sha Chau Island in accordance with the Manual. No encroachment of any works upon the egret area nor any significant disturbance to the ardeids foraging at Sheung Sha Chau by the works were recorded during ecological monitoring. No signs of breeding or nursery activities were observed. At the HDD daylighting location, neither nest nor breeding activity of ardeids were found during the monthly ecological monitoring and weekly site inspections from October to December 2018. The site photos and location map regarding the ecological monitoring for HDD daylighting location and egret area are provided in **Appendix C** for reference.
