Expansion of Hong Kong International Airport into a Three-Runway System

Construction Phase Quarterly EM&A Report
No.20 (1 October to 31 December 2020)

March 2021

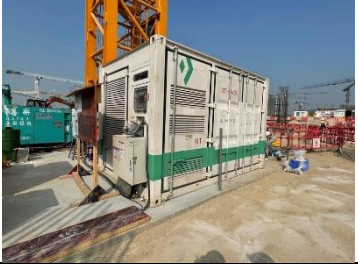
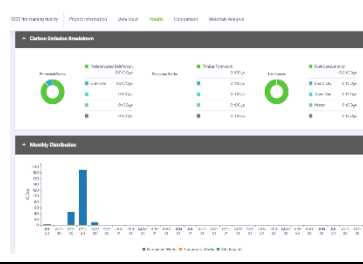
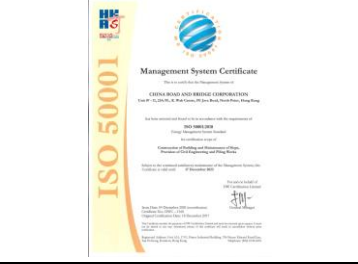
Snapshots of Good Environmental Practices in the Reporting Period

<p>Installation of Energy Efficient Battery System</p>	<p>Use of CIC carbon assessment tool to monitor carbon emissions of on-site construction process</p>	<p>Obtained ISO 50001:2018 Energy Management System Certification</p>

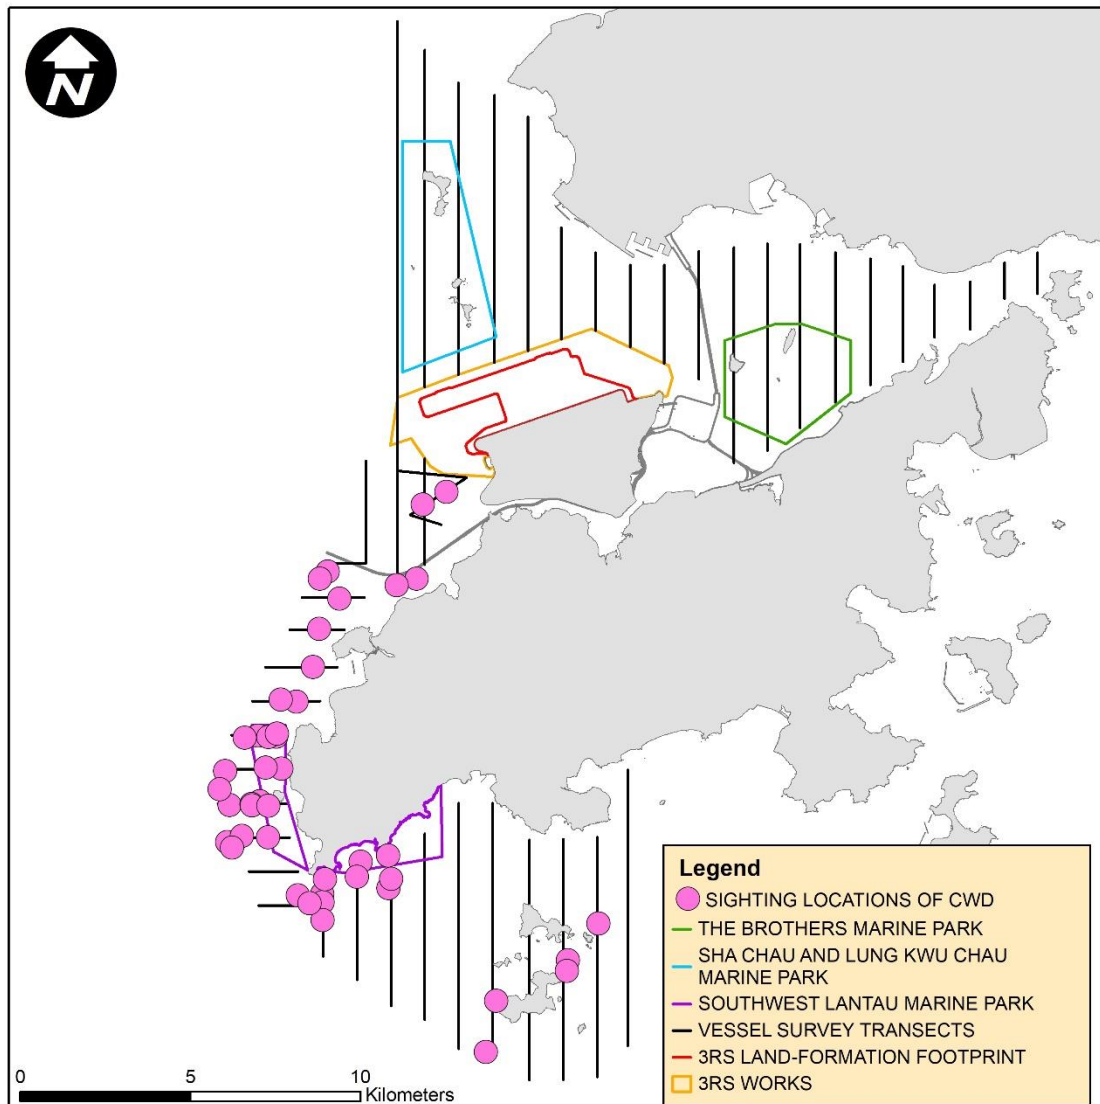
Figure 2.5: Sightings Distribution of Chinese White Dolphins from October to December 2020

The distribution of CWD sightings recorded from October to December 2020 is illustrated in **Figure 2.5**. In NWL including AW transects, all the CWD sightings were recorded at the southwestern part of the survey area with two sightings located west to the existing Hong Kong International Airport, while another two sightings located between Hong Kong-Zhuhai-Macao Bridge Hong Kong Link Road and the north Lantau coast near Sham Wat Wan. In WL, CWD sightings scattered amongst the survey area with the majority clustered near Peaked Hill and Yi O. In SWL, most of the dolphin sightings were recorded in the waters around Fan Lau and some sightings were scattered around the Soko Islands. No CWD sightings were recorded in NEL survey area. Details of the sighting data are presented in **Appendix C**.

Remarks: (1) Please note that there are 45 pink circles on the map indicating the sighting locations of CWD. Some of them were very close to each other and therefore appear overlapped on this sighting distribution map. (2) Marine park excludes land area and the landward boundary generally follows the high water mark along the coastline.

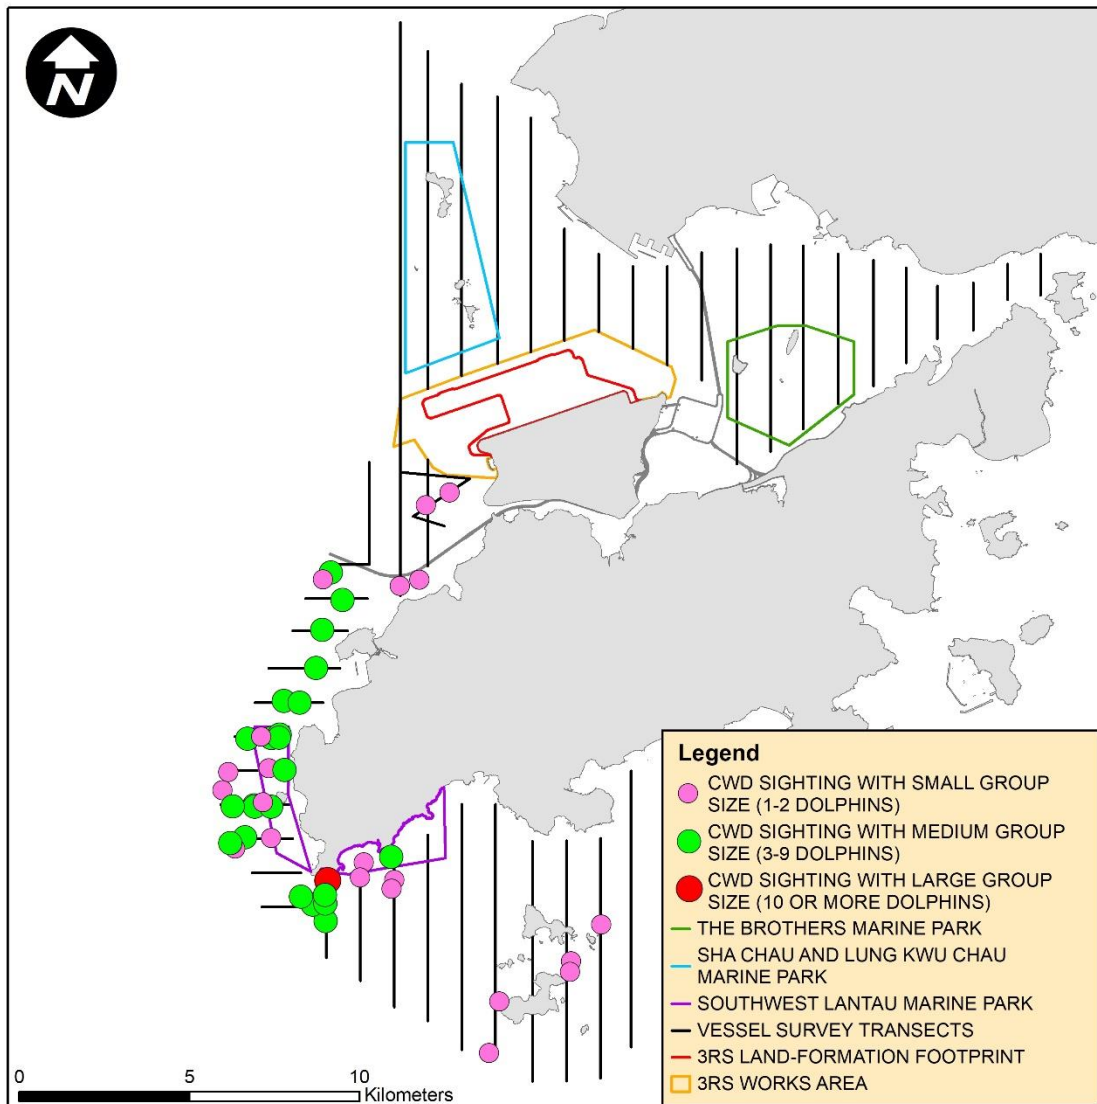
Figure 2.6: Sighting Locations of Chinese White Dolphins with Different Group Sizes

The majority of the medium sized dolphin groups were recorded over the entire WL survey area and also in SWL near Fan Lau. All sightings recorded at the southwestern part of NWL survey area and also around the Soko Islands in SWL were small sized groups. The only CWD sighting with large group size was recorded at Fan Lau in SWL survey area. Sighting locations of CWD groups with different group sizes are depicted in **Figure 2.6**.

Remarks: (1) Please note that there are 45 circles on the map indicating the sighting locations of CWD. Some of them were very close to each other and therefore appear overlapped on this sighting distribution map. (2) Marine park excludes land area and the landward boundary generally follows the high water mark along the coastline.

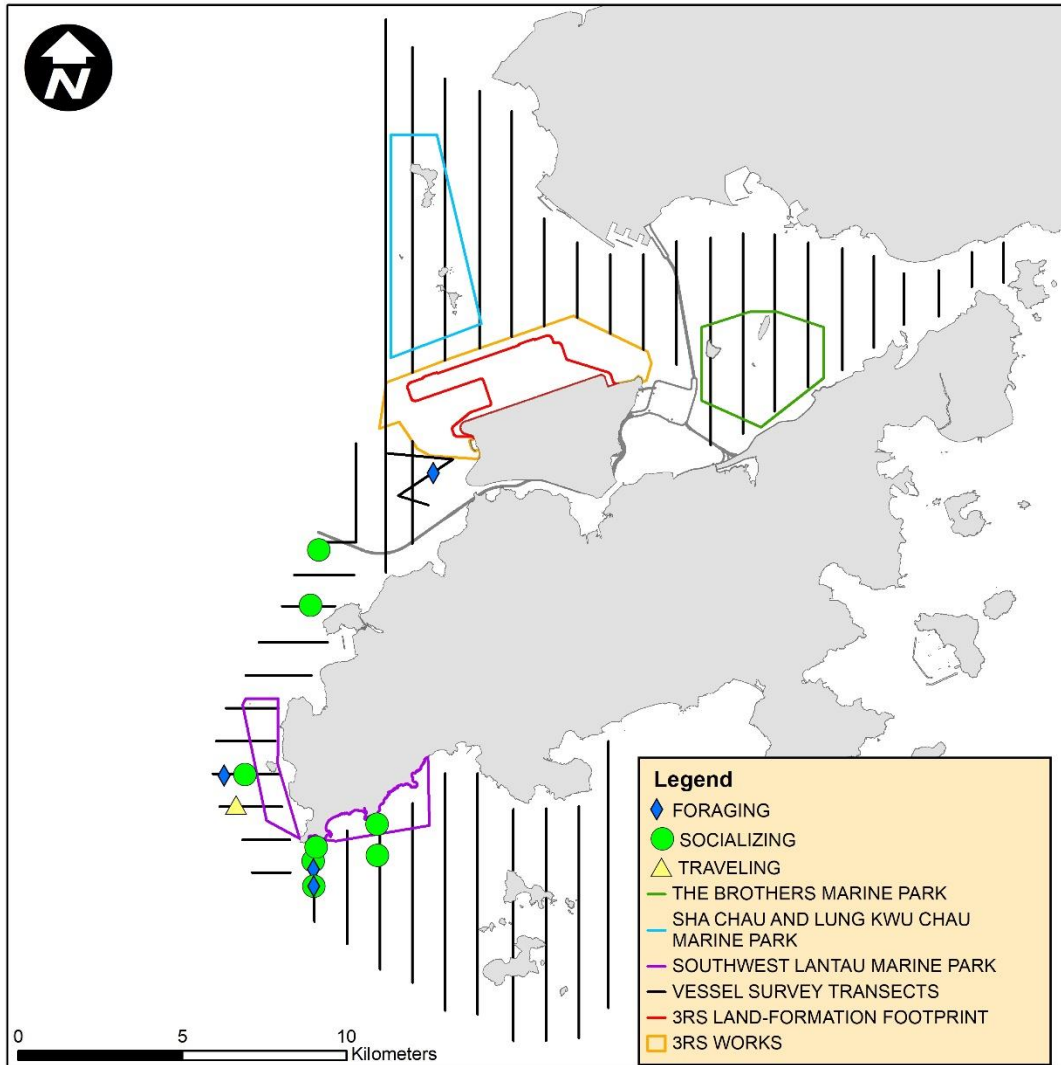
Figure 2.7: Sighting Locations of Chinese White Dolphins Engaged in Different Behaviours

From October to December 2020, four sightings of CWDs were recorded with feeding activities. Amongst these sightings, one was observed in association with operating gillnetter in AW.

The sighting locations of CWDs engaged in different behaviour during the current reporting period are illustrated in **Figure 2.7**.

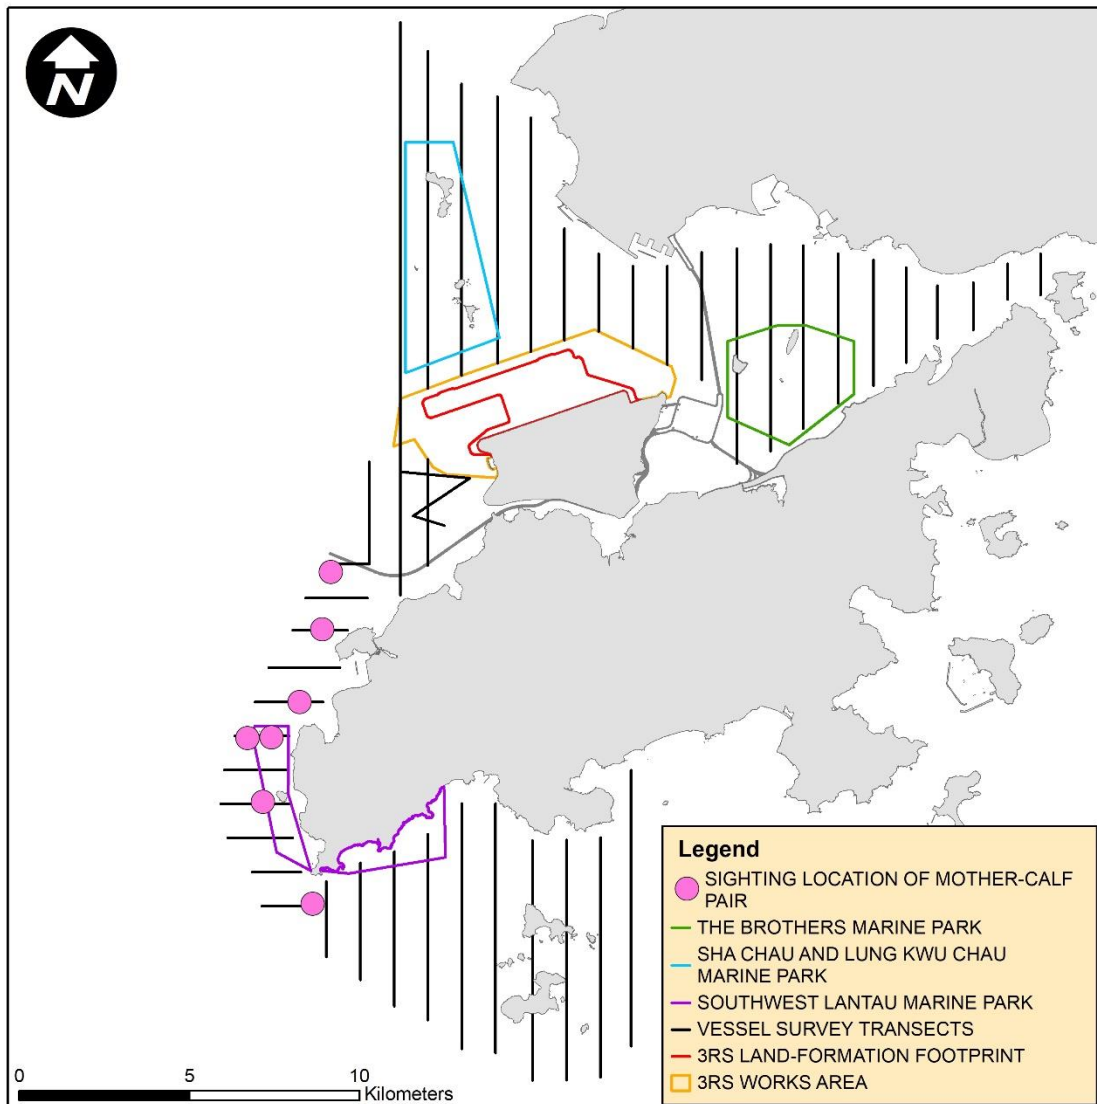
Figure 2.8: Sighting Locations of Mother-calf Pairs

The locations of CWD sightings with the presence of mother-and-calf and/or mother-and-unspotted juvenile pairs are shown in **Figure 2.8**.

Remarks: (1) Please note that there are seven circles on the map indicating the sighting locations of Mother-Calf pair. (2) Marine park excludes land area and the landward boundary generally follows the high water mark along the coastline.

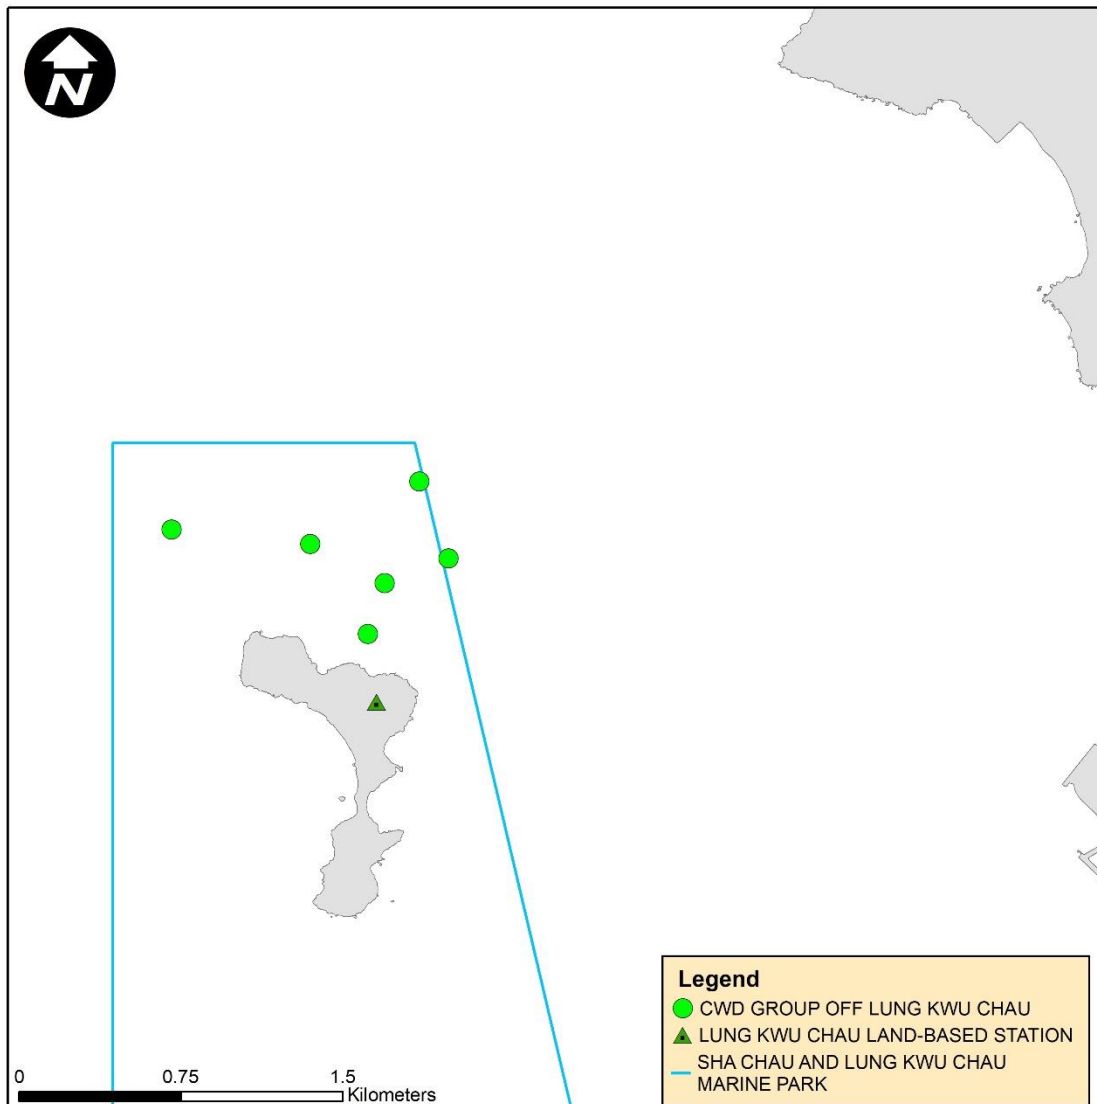
Figure 2.9: Plots of First Sightings of All CWD Groups from Land-based Stations

Land-based Station	# of Survey Sessions	Survey Effort (hh:mm)	# CWD Groups Sighted	CWD Group Sighting per Survey Hour
October 2020				
Lung Kwu Chau	1	06:00	1	0.17
Sha Chau	1	06:00	0	0
TOTAL	2	12:00	1	0.08
November 2020				
Lung Kwu Chau	1	06:00	2	0.33
Sha Chau	1	06:00	0	0
TOTAL	2	12:00	2	0.17
December 2020				
Lung Kwu Chau	1	06:00	3	0.5
Sha Chau	1	06:00	0	0
TOTAL	2	12:00	3	0.25
OVERALL	6	36:00	6	0.17

Remark: Marine park excludes land area and the landward boundary generally follows the high water mark along the coastline.

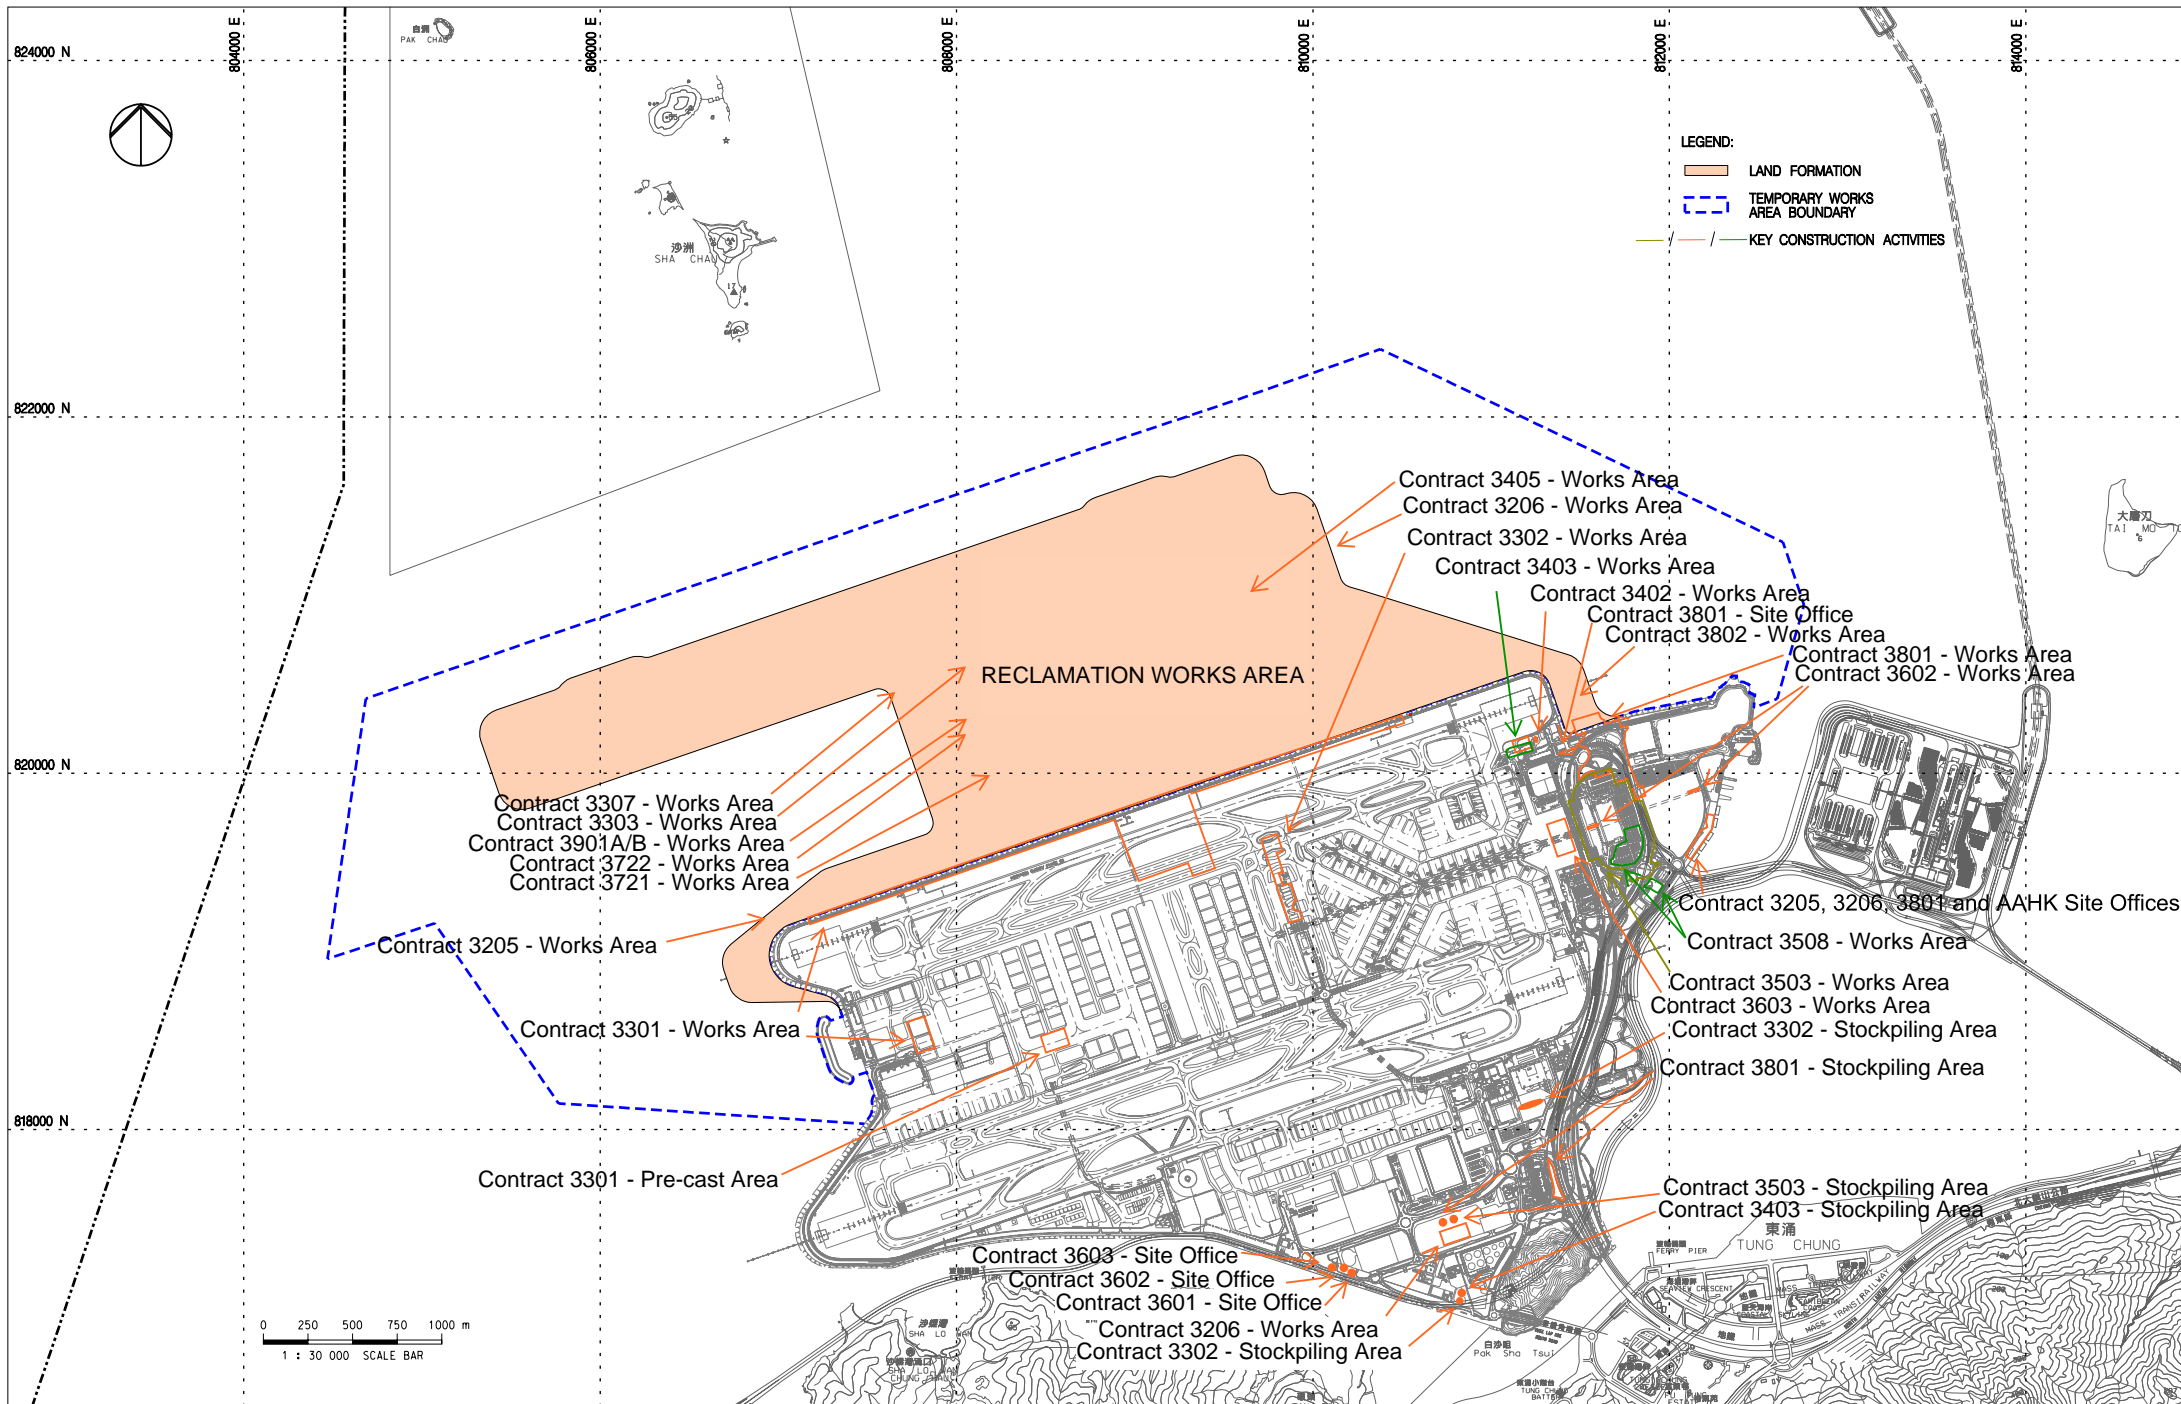
FIGURE 1.1 LOCATIONS OF KEY CONSTRUCTION ACTIVITIES

Note: The locations are for indicative purpose. The actual construction work locations are in accordance with the construction work programme.

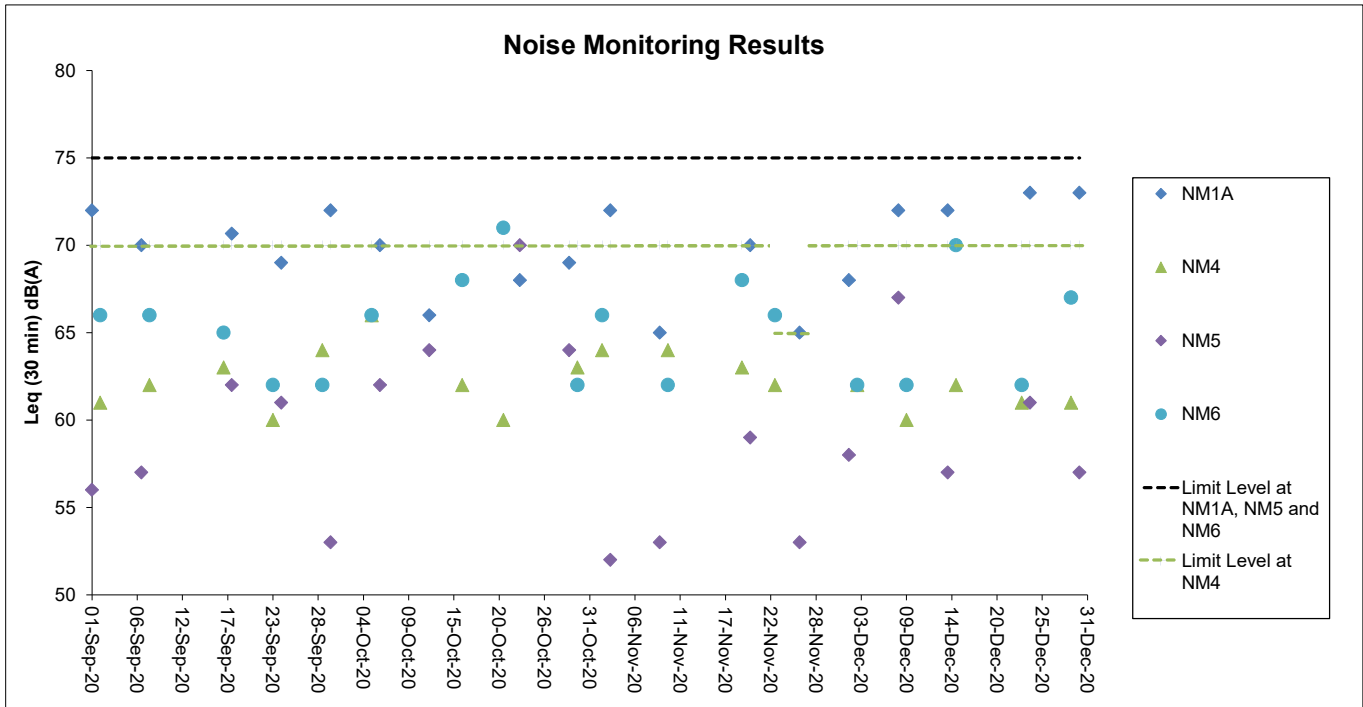
Noise Monitoring Results

1. The Limit Level is reduced to 70dB(A) for school and 65dB(A) during school examination period at NM4. School examination took place from 23 to 27 November during this reporting period.
