# **Expansion of Hong Kong International Airport into a Three-Runway System**

Construction Phase Quarterly EM&A Report  
No.24 (1 October to 31 December 2021)

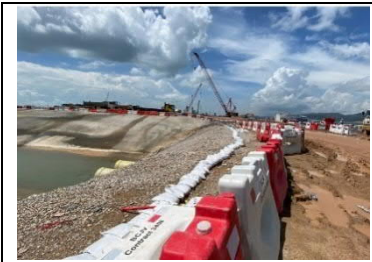
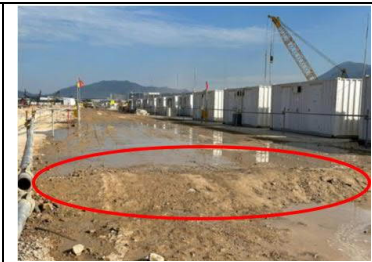
| <p>Use of sandbags and water-filled barriers for muddy water discharge prevention</p> | <p>Use of earth bund as speed cushion for dust suppression purpose</p> | <p>Provision of environmental training for site personnel</p> |
