Expansion of Hong Kong International Airport into a Three-Runway System

Construction Phase Quarterly EM&A Report No.6
(1 April to 30 June 2017)

September 2017

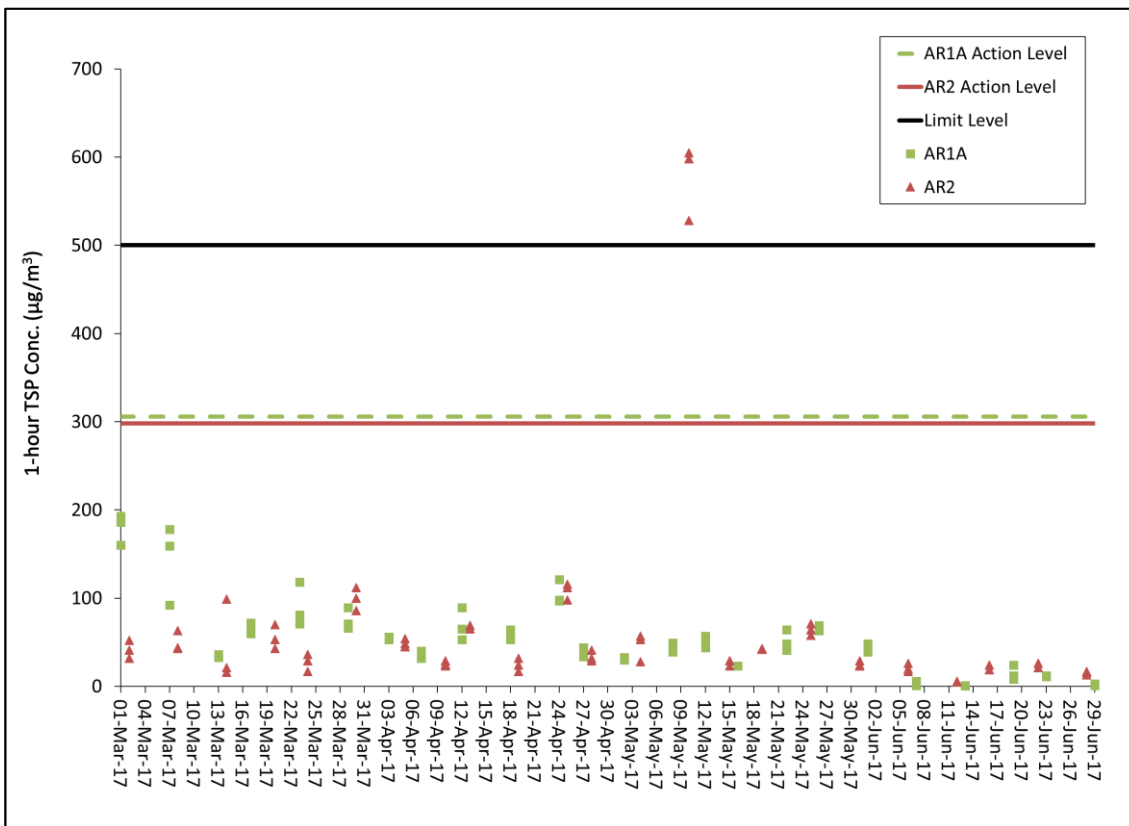
Graph 1: Graphical Plot of 1-hour TSP concentration at AR1A and AR2 during the Reporting Period

The graphical plot of impact air quality monitoring results during the reporting period is presented in **Graph 1**.

Three Limit Level exceedance cases of air quality monitoring were recorded at AR2 on 10 May 2017 in the 1-hour TSP monitoring. Actions were taken accordingly based on the established Event and Action Plan as presented in the Manual. No major construction dust emission source was observed from the field investigation. It was also confirmed with the contractors that no major dusty construction works was undertaken when the exceedances were recorded. Dust suppression measures were properly implemented by relevant contractors during the monitoring period. Investigation found that Hong Kong was being affected by an airstream with high background pollutant concentration and poor atmospheric conditions for pollutant dispersion on the monitoring day, thus the exceedances were likely due to the adverse ambient air quality, but not due to Project activities.

The active construction site is around 3 km away from the nearest air sensitive receiver in Tung Chung. The major dust sources during the reporting period were observed to be local air pollution and nearby traffic emissions. It is considered that the monitoring work in the reporting period was effective and there was no adverse impact attributable to the works of the Project.

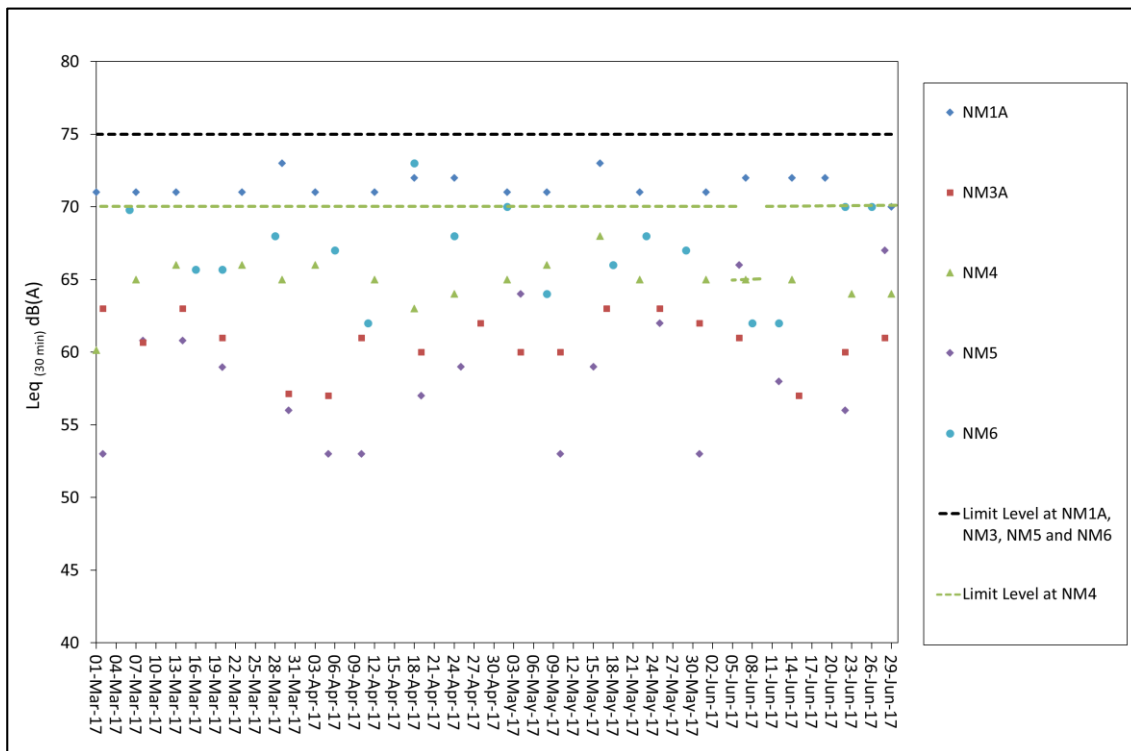
Graph 2: Graphical Plot of Leq (30min) at NM1A, NM3A, NM4, NM5 and NM6 during the Reporting Period

Note: School examination took place from 5 to 9 June 2017 in the reporting period.

No exceedance of the Action and Limit Level was recorded at all monitoring stations in the reporting period.

The active construction work is around 900 m away from the nearest noise sensitive receivers in the villages in North Lantau. The major noise sources during the reporting period were observed to be road traffic at NM1A, aircrafts and helicopters at NM3A, school activities at NM4, helicopters at NM5, and aircrafts, helicopters, and marine vessels at NM6. It is considered that the monitoring work in the reporting period was effective and there was no adverse impact attributable to the works of the Project.

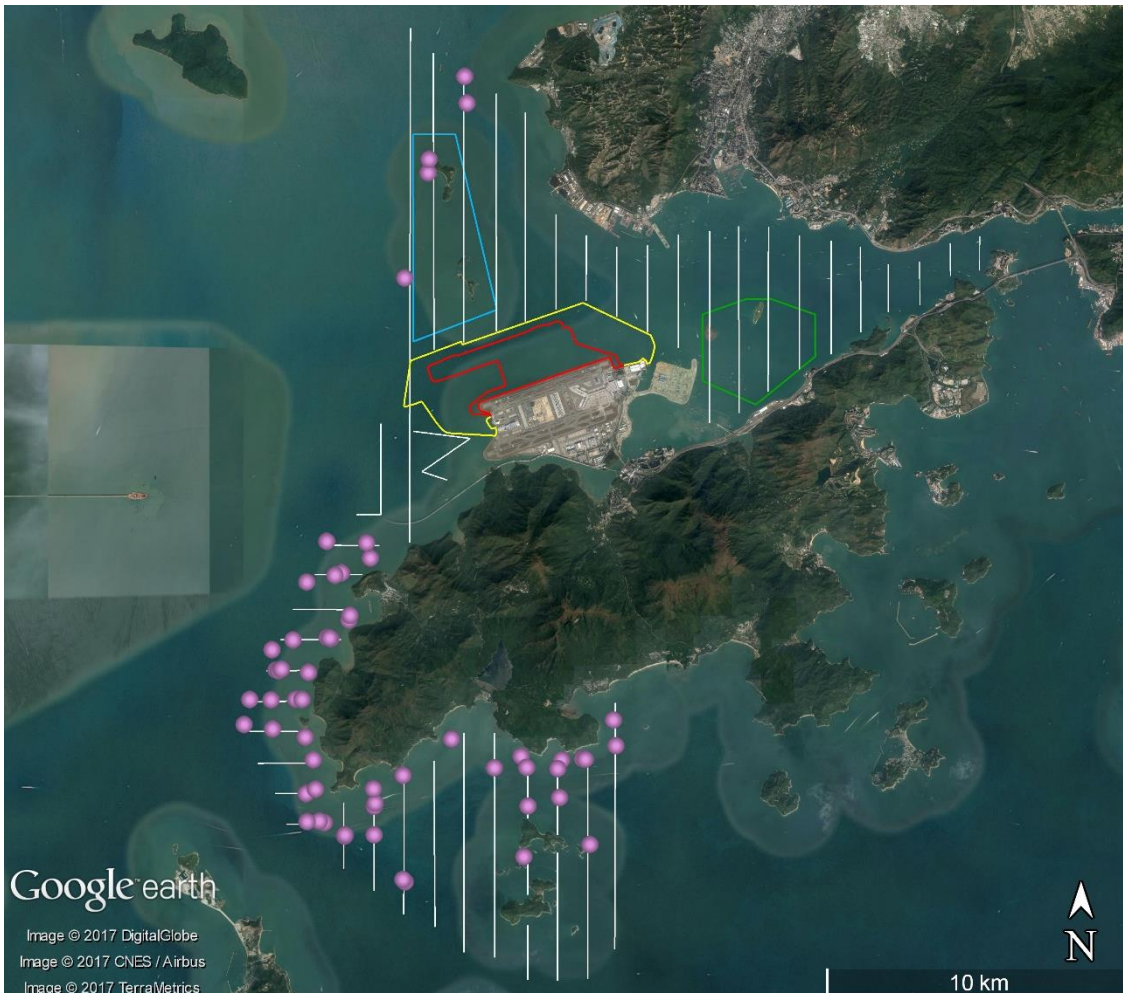
Figure 2.5: Sightings Distribution of Chinese White Dolphins

From April to June 2017, there were total 58 groups of CWDs with 226 individuals sighted (**Table 2.19**). Amongst the sightings of CWDs, 53 groups with 210 individuals were made during on-effort search under favourable weather condition.

[Pink circle: Sighting locations of CWD, White line: Vessel survey transects, Blue polygon: Sha Chau and Lung Kwu Chau Marine Park (SCLKCMP), Green polygon: Brothers Marine Park (BMP), Red polygon: 3RS land-formation footprint, Yellow line: 3RS temporary works area boundary]

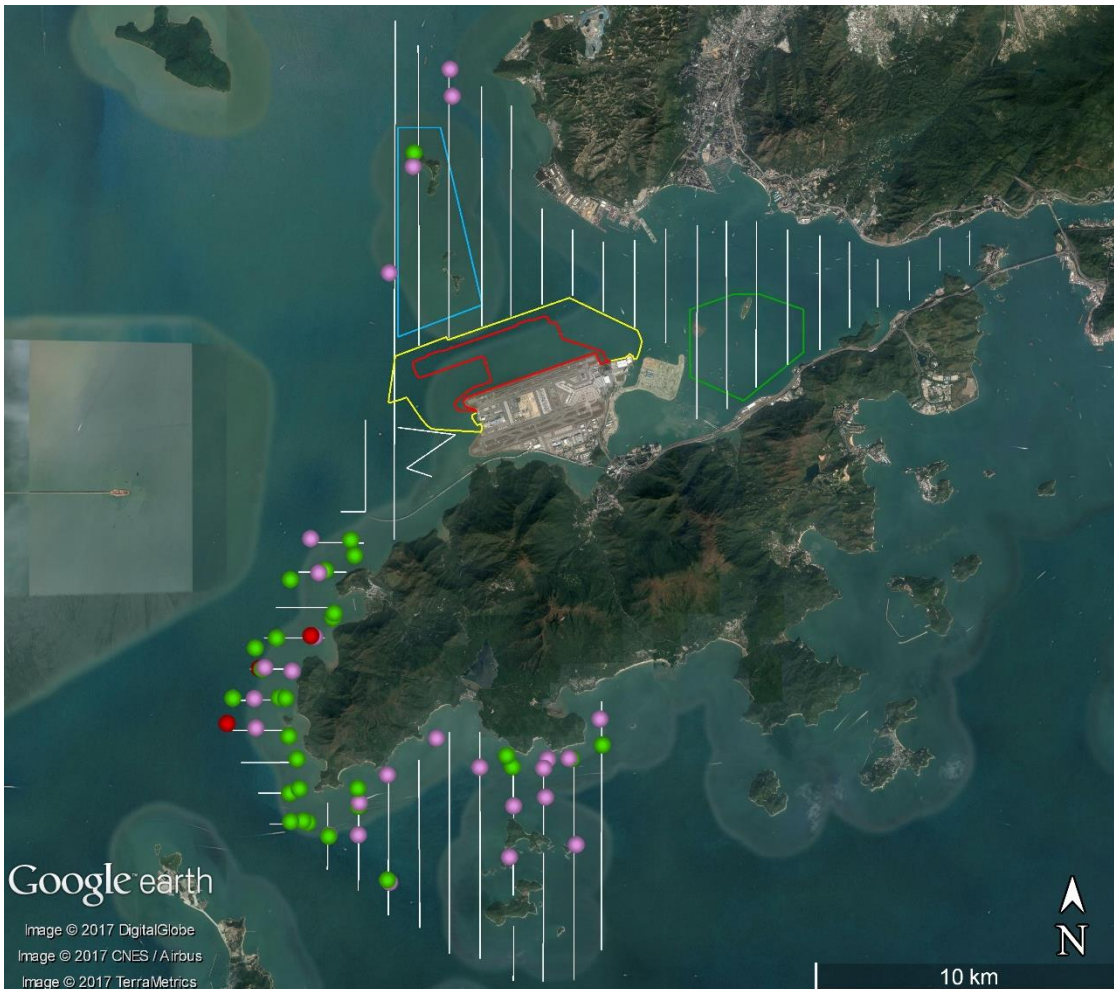
Figure 2.6: Sighting Locations of Chinese White Dolphins with Different Group Sizes

[Pink circle: Sighting locations of CWD with group size from 1 to 2 individuals, Green circle: Sighting locations of CWD with group size from 3 to 9 individuals, Red circle: Sighting locations of CWD with group size of 10 or above, White line: Vessel survey transects, Blue polygon: Sha Chau and Lung Kwu Chau Marine Park (SCLKCMP), Green polygon: Brothers Marine Park (BMP), Red polygon: 3RS land-formation footprint, Yellow line: 3RS temporary works area boundary]

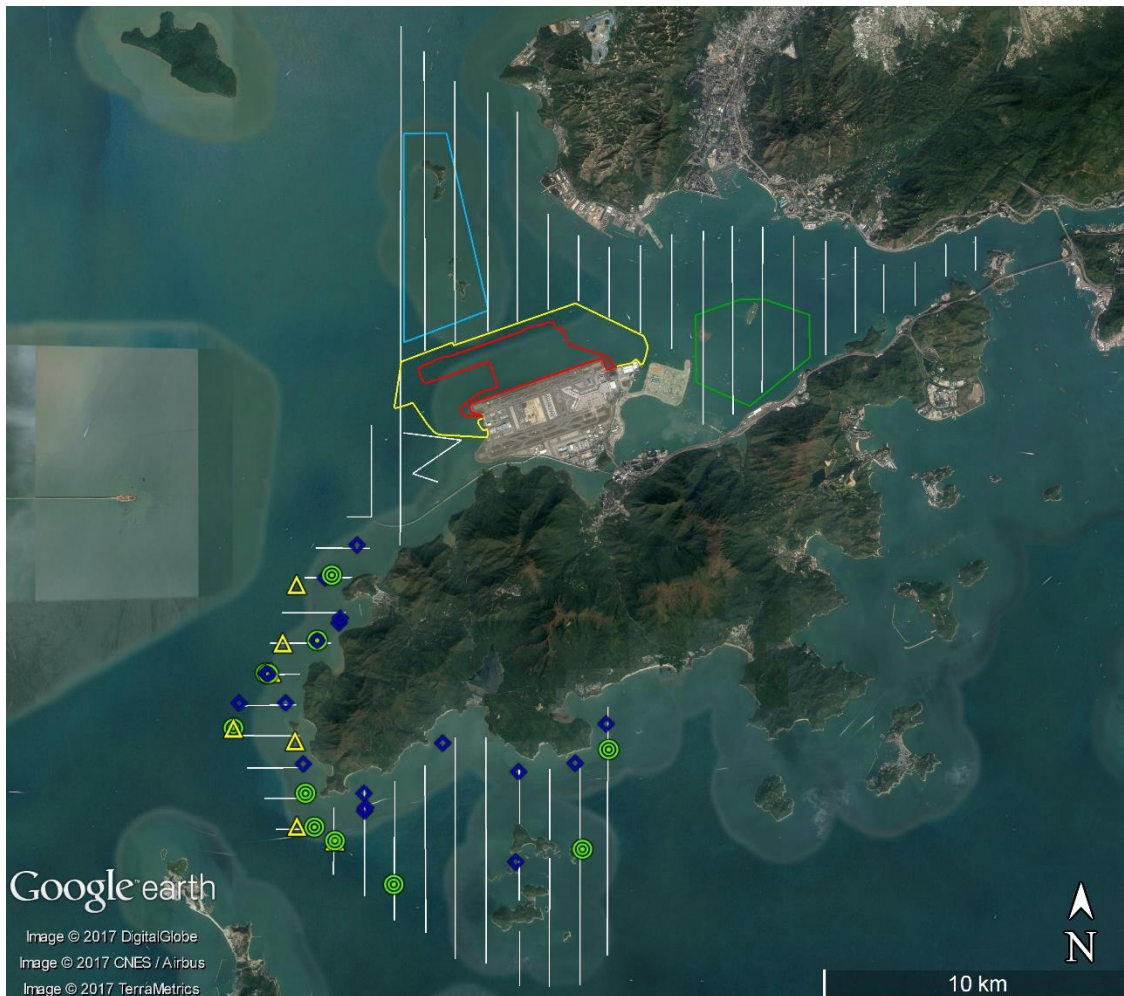
During April to June 2017, 21 groups of CWDs were sighted with feeding activities. Amongst these 21 groups of feeding CWDs, only one group was observed in association with operating fishing boat (purse seiner) in SWL. The sighting locations of CWDs engaged in different behaviours during the reporting period were illustrated in **Figure 2.7**.

[Indigo rhombus: Foraging, Green circle: Socializing, Pink square: Milling/Resting, Yellow triangle: Travelling, White line: Vessel survey transects, Blue polygon: Sha Chau and Lung Kwu Chau Marine Park]

(SCLKCMP), Green polygon: Brothers Marine Park (BMP), Red polygon: 3RS land-formation footprint, Yellow line: 3RS temporary works area boundary]

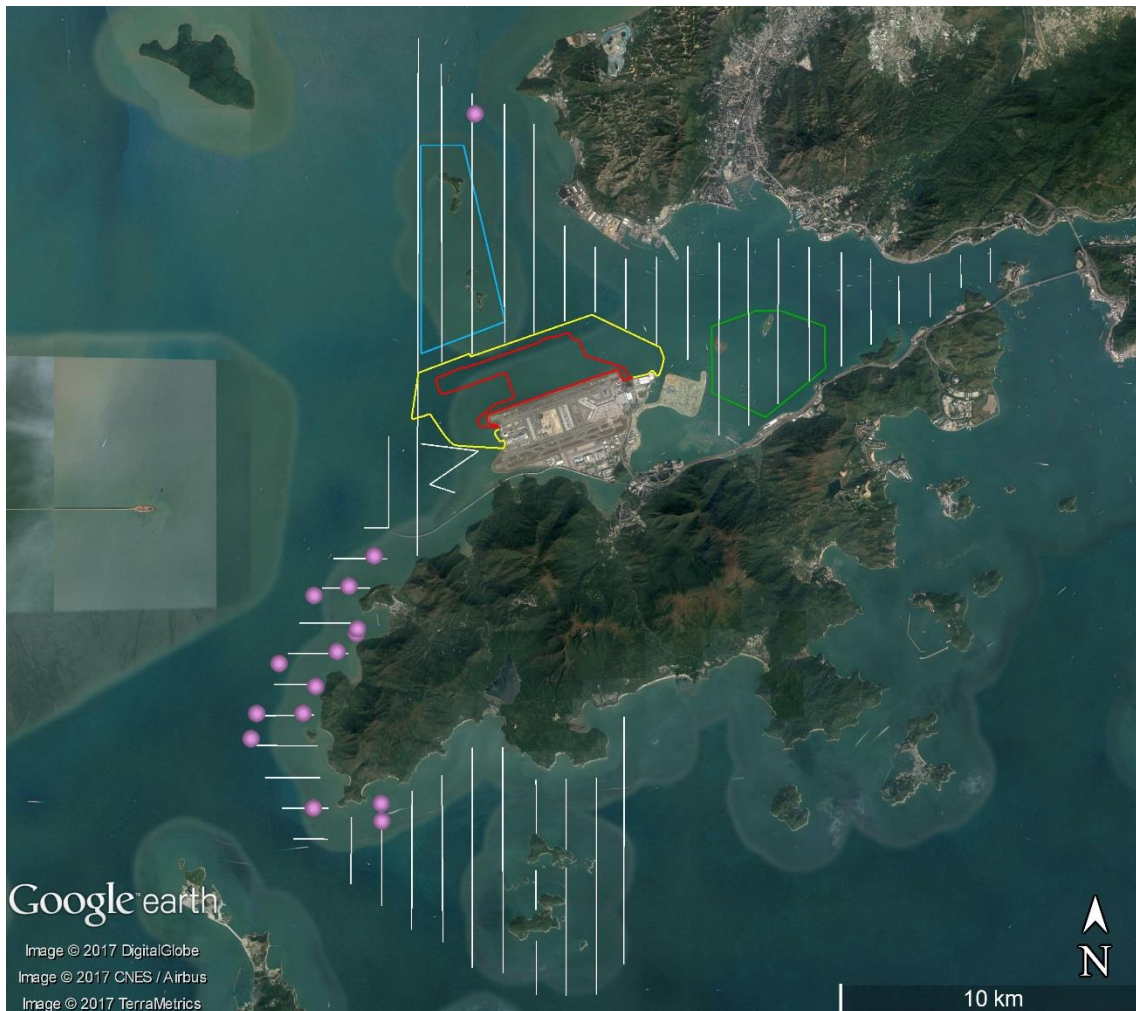
Figure 2.8: Sighting Locations of Mother-calf Pairs

From April to June 2017, 15 sightings of CWDs were recorded with the presence of mother-and-calf, mother-and-unspotted juvenile and/or mother-and-spotted juvenile pairs. Most of these mother-calf pairs were sighted in WL. The record in NWL was the mother-and-spotted juvenile pair (NLMM006 and NLMM013). This pair has not been re-sighted since December 2016 and was sighted again in June 2017. The sighting locations of mother-calf pairs were shown in **Figure 2.8**.

[Pink circle: Sighting locations of mother-calf pairs, White line: Vessel survey transects, Blue polygon: Sha Chau and Lung Kwu Chau Marine Park (SCLKCMP), Green polygon: Brothers Marine Park (BMP), Red polygon: 3RS land-formation footprint, Yellow line: 3RS temporary works area boundary]

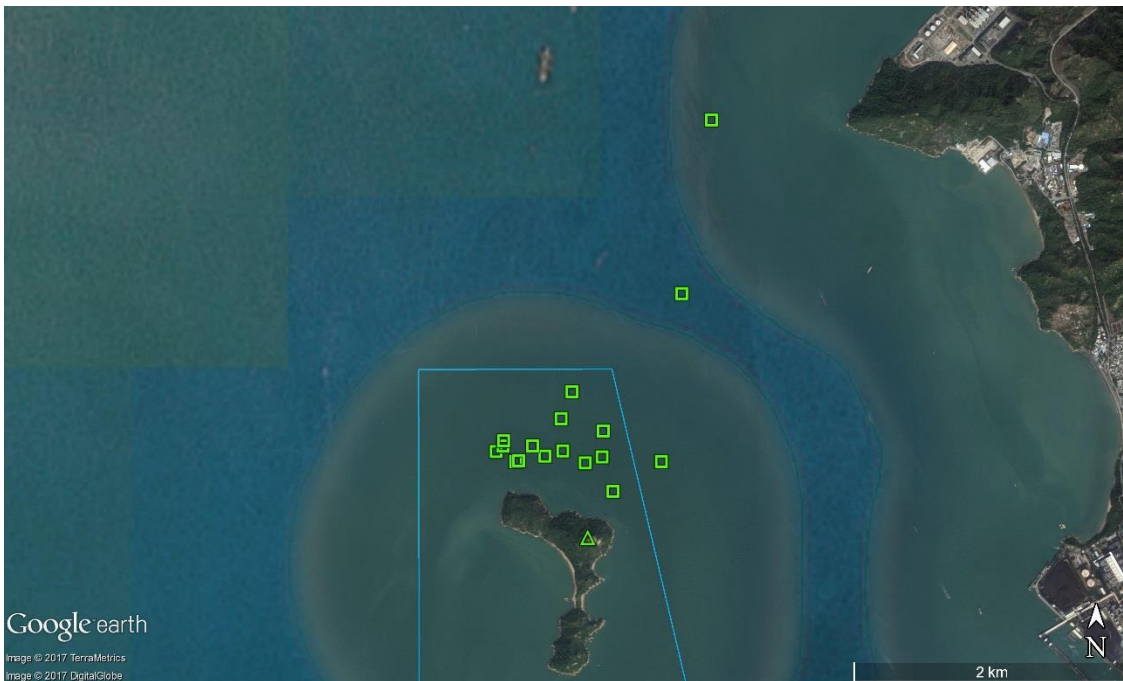
Figure 2.9: Plots of First Sightings of All CWD Groups from Land-based Stations
 [Green triangle: LKC station; Green square: CWD group off LKC; Blue line: SCLKCMP boundary]

Land-based Station	# of Survey Sessions	Survey Effort (hh:mm)	# CWD Groups Sighted	CWD Group Sighting per Survey Hour
April 2017				
Lung Kwu Chau	3	18:00	6	0.33
Sha Chau	2	12:00	0	0
TOTAL	5	30:00	6	0.20
May 2017				
Lung Kwu Chau	3	18:00	2	0.11
Sha Chau	2	12:00	0	0
TOTAL	5	30:00	2	0.07
June 2017				
Lung Kwu Chau	3	18:03	9	0.50
Sha Chau	2	12:00	0	0
TOTAL	5	30:03	9	0.30
OVERALL	15	90:03	17	0.19

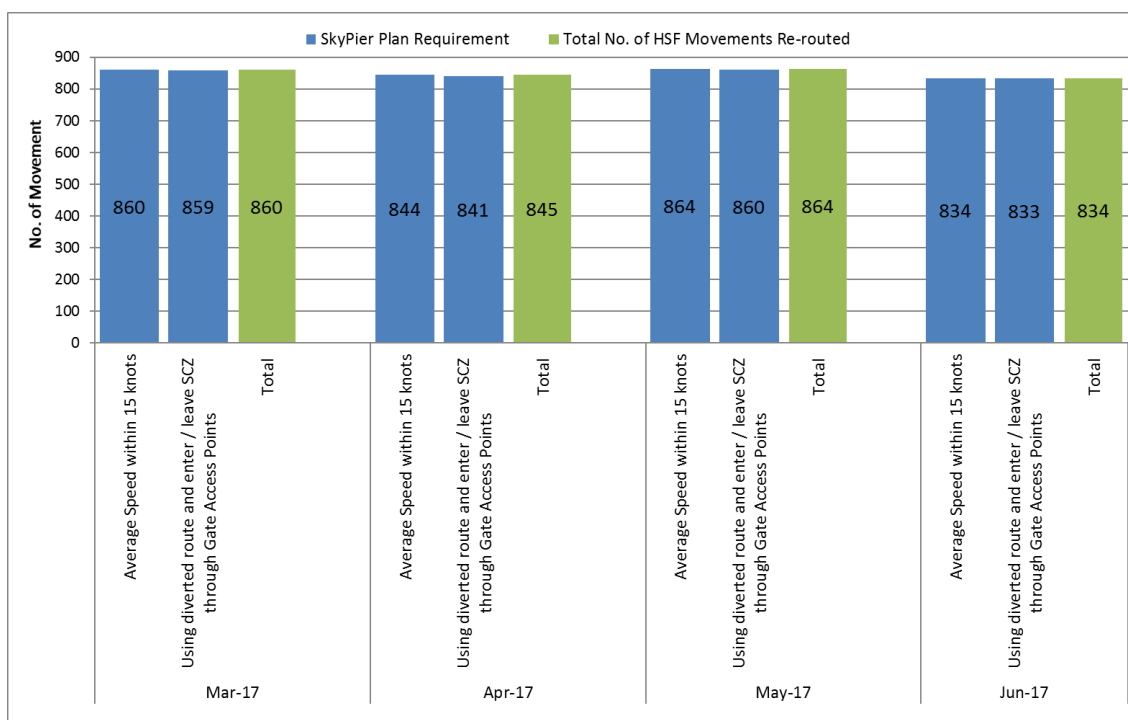
Graph 3: Summary of SkyPier Plan Monitoring Results (March 2017 to June 2017)

Insufficient Automatic Identification System (AIS) data were received from some HSFs during the reporting period. After investigation, it was found that missing of AIS data for the concerned ferries were due to interference effect of AIS signal as reported by the FO after checking the condition of the AIS transponders. Vessel captains were requested to provide the radar track photos which indicated the vessel entered the SCZ though the gate access points and no speeding in the SCZ. Ferry operator’s explanation has been accepted.

Three meetings were held with FO representatives in June 2017 to review and discuss the deviation cases happened in the past few months as well as to share experience and recommendations to further strengthen the implementation of SkyPier Plan.
