Contract No.	3/WSD/15		
Project Title:	In-situ Reprovisioning of Sha Tin Water Treatment Works (South Works) – Advance Works		
CGS No.:	3WSD15/CGS/SEQ/ALL/JV0250A	Issue:	A
		Date:	10/03/2017
To:	Engineer's Representative	Your Ref:	
Attention:	Mr. Derek K H Ng		
From:	Ming Hing – Ming Hing Civil – Vastream Joint Venture		
Title:	EM&A Impact Monitoring Report (February)		
Specification:	---		
Purpose:	<input type="checkbox"/> For Information <input type="checkbox"/> For Comment <input type="checkbox"/> For Approval <input checked="" type="checkbox"/> For Record		
Description of Contents:			
<p>We herewith submit the EM&A Impact Monitoring Report (February 2017) for your perusal and record.</p>			
Attachment:	<input checked="" type="checkbox"/> Yes <input type="checkbox"/> No	Number of Copies:	5+5 CD
Expected reply date:	24 March 2017		
Issued By:	  _____ (ET/lp)	Printed Name:	Mr. Eros To
Designation:	Site Agent _____	Date:	10 March 2017

In-Situ Re provisioning of Sha Tin Water Treatment Works – South Works

Submission of 12th monthly EM&A Report

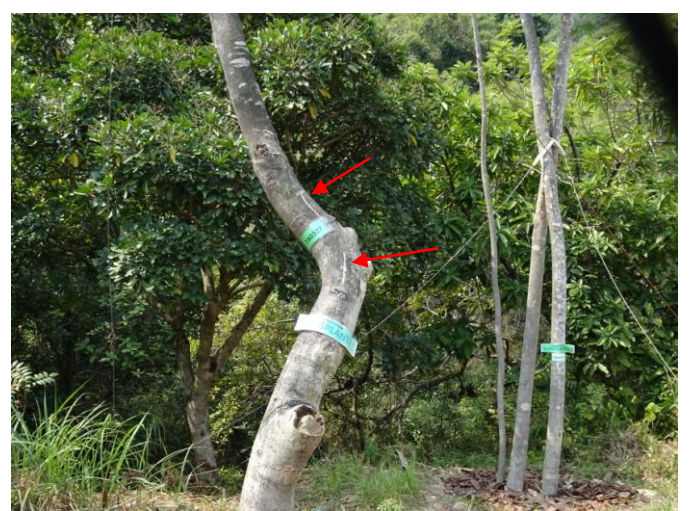
2.5.4 *Ailanthus* (*Ailanthus fordii*) and Incense Tree (*Aquilaria sinensis*) was transplanted to new location within STWTW. The condition of TA572 was observed in fair condition while TA326 and TA327 were in poor condition. Tree crown of TA326 and TA327 was observed thinner than the observation in last observation. Fungi attack (species: *Schizophyllum commune*) was observed on TA572 during current inspection. Fungicide was recommended to control the growth of fungal attack. In addition, it is recommended to wrap a layer of shade cloth (遮光網) on tree trunk for TA572 and TA327 in order to reduce the intensity of sunlight. Transplanted Lamb of Tartary (*Cibotium barometz*) seems to be received too much sunlight. Leaves of them were observed yellowish in colour. Shade cloth (遮光網) was recommended to reduce the intensity of sunlight. Hong Kong Eagle's Claw was observed dead during inspection on 20 August 2016. New fronds of transplanted Lamb of Tartary were observed growing out. Lamb of Tartary was under recovery after transplantation. Currently, Lamb of Tartary were temporally stored on Nursery garden at Wang Toi Shan, Kam Tin. It is recommended to retain them at the nursery garden under proper maintenance during current recovery stage.

Photo 10. Cracks on TA327.

2.5.7 After transplantation, root ball of TA572, TA326 and TA327 tree should be kept moisture especially during dry and non-raining day.

- 4.5 After transplantation, root ball of TA572, TA326 and TA327 tree should be kept moisture especially during non-raining day.

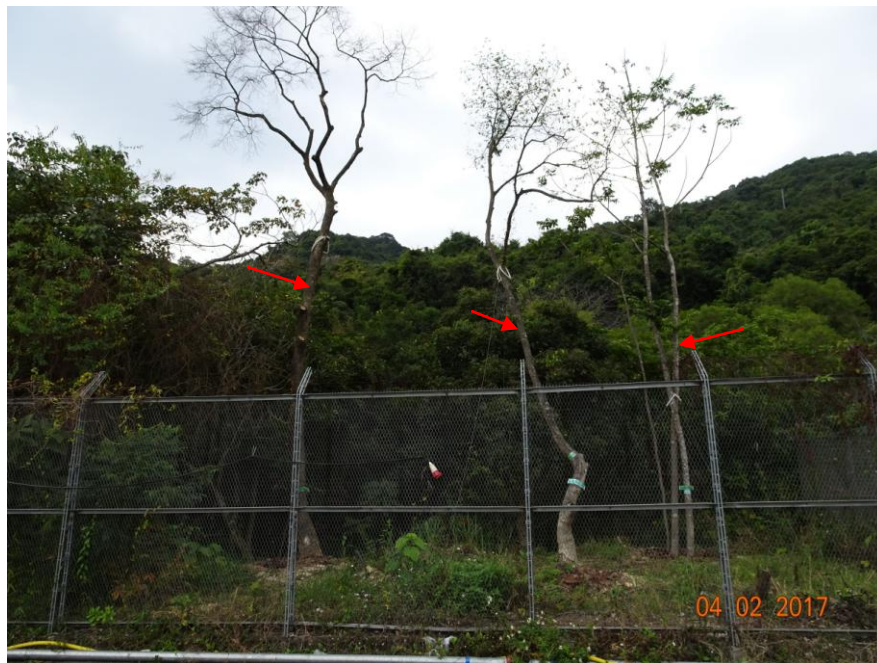
Photo 11. Incense Tree after transplantation (*Aquilaria sinensis*) – TA326 (left) and TA327 (middle), (*Ailanthus fordii*) – TA572 (right)

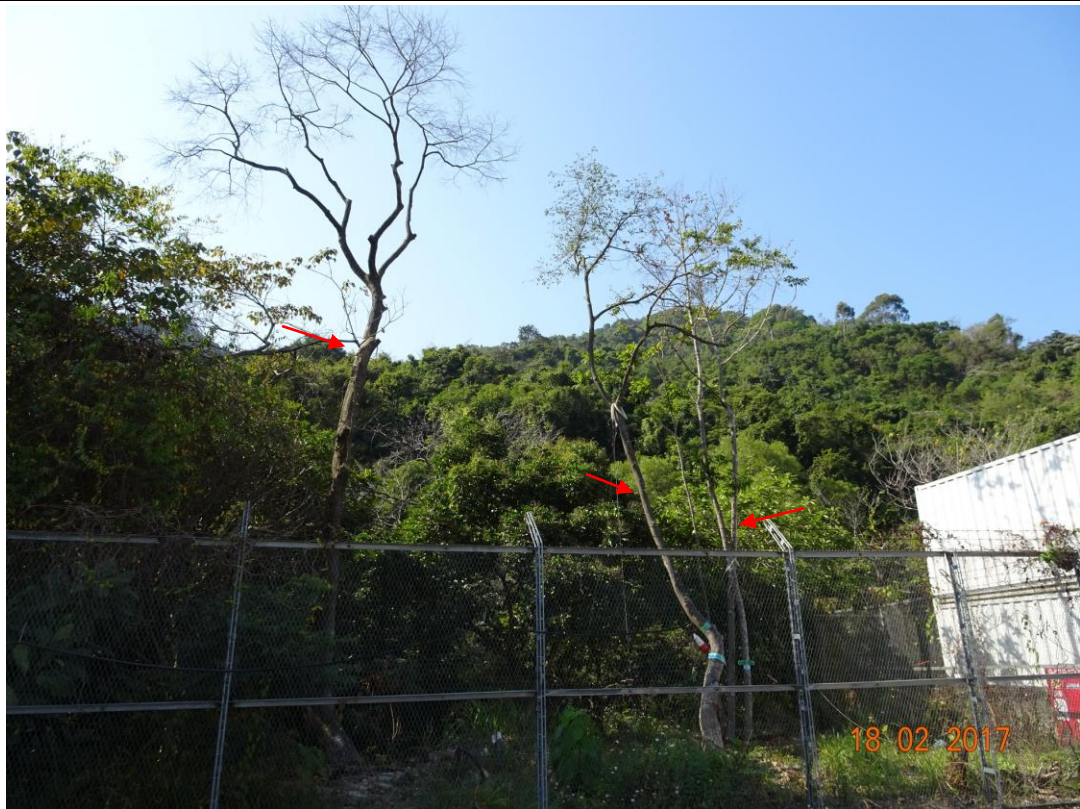
Photo 9. Incense Tree after transplantation (*Aquilaria sinensis*) – TA326 (left) and TA327 (middle), (*Ailanthus fordii*) – TA572 (right)
