Contract No.	3/WSD/15					
Project Title:	In-situ Reprovisioning of Sha Tin Water Treatment Works (South Works) – Advance Works					
CGS No.:	3WSD15/CGS/SEQ/ALL/JV	0280A	Issue:	Α	Date:	10/04/2017
To:	Engineer's Representative		Your Ref:			
Attention:	Mr. Derek K H Ng			4.70-101	Luni.	
From:	Ming Hing – Ming Hing Civ	il – Vasteam Joi	nt Venture			
Title:	Title					
Specification:	N/A or PS 1.9.2				(if a	oplicable)
Purpose:	☐ For Information	☐ For Comme	nt 🗆 For	r Appro	val	✓ For Record
Description of Con	tents:					
We herewith submit the EM&A Impact Monitoring Report (March 2017) for your perusal and record.						
Attachment:	✓ Yes □ No	Number of Copies:	5+5 CD	7		
Expected reply dat	e: 24 April 2017					
Issued By:	(ET/LP/cy)	P	rinted Name:		Mr.	Eros To
Designation:	Site Agent		Date:		10 A	pril 2017
Received By:	(Signature & Receive		ceived Date:

In-Situ Reprovisioning of Sha Tin Water Treatment Works – South Works Environmental Permit EP-494/2015
Submission of 13th monthly EM&A Report

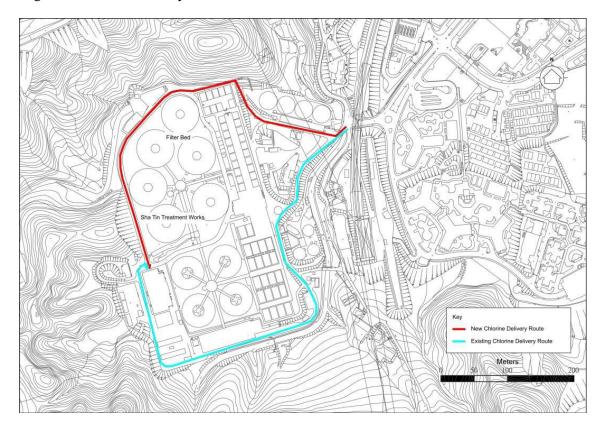
Figure 2: Chlorine Delivery Route at Sha Tin WTW

- 2.7.2 Unloading takes place inside the Chlorination House, with the doors closed, in a designated truck unloading bay. The movement of drums within the storage area and 'drive-through' unloading bay is carried out using a hoist/monorail system with a purpose-built lifting beam. Prior to usage, the drums are stored on cradles within the chlorine storage area.
- 2.7.3 The on-site chlorine delivery route is shown in Figure 2.

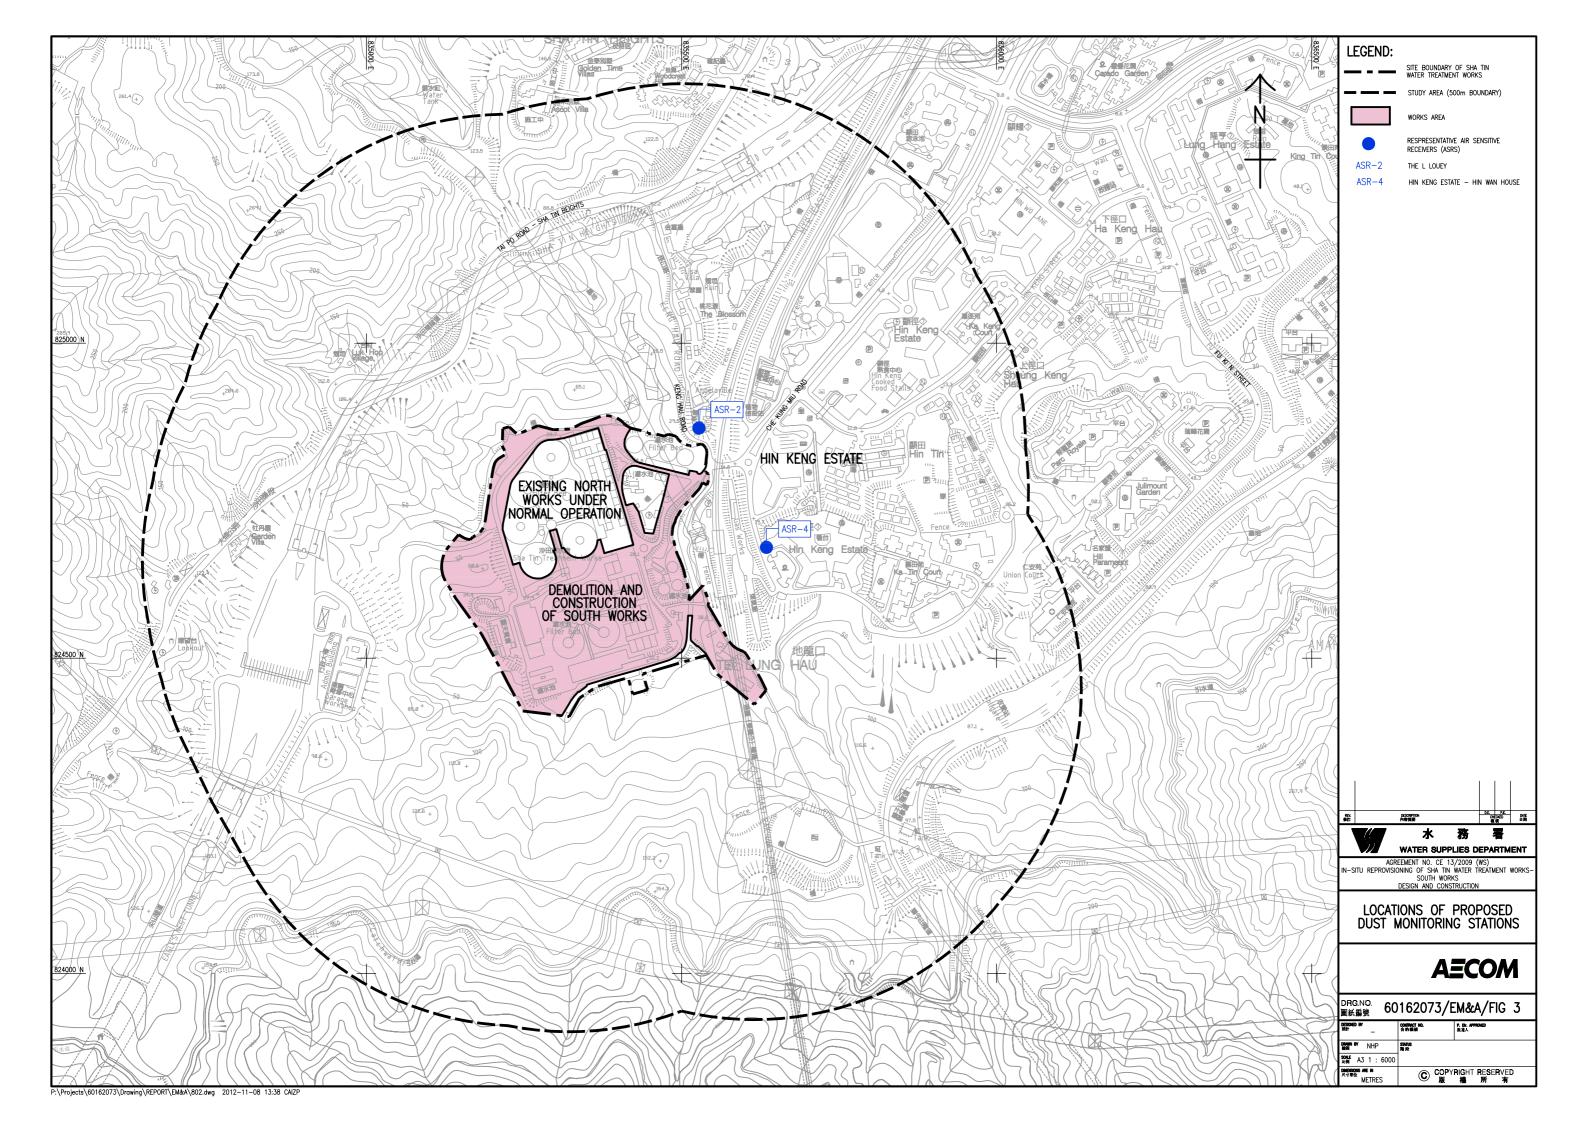
Appendix I Location Plan of Air Quality Monitoring Station

- 2.2.2 Two (2) designated monitoring stations, AM1 located at the L Louey and AM2 located at Hin Keng Estate Hin Wan House, were recommended in Section 2.18 of the approved EM&A Manual. In order to identify and seek for the access of the air monitoring locations designated in the EM&A Manual, site visit was conducted among ET, IEC and EPD.

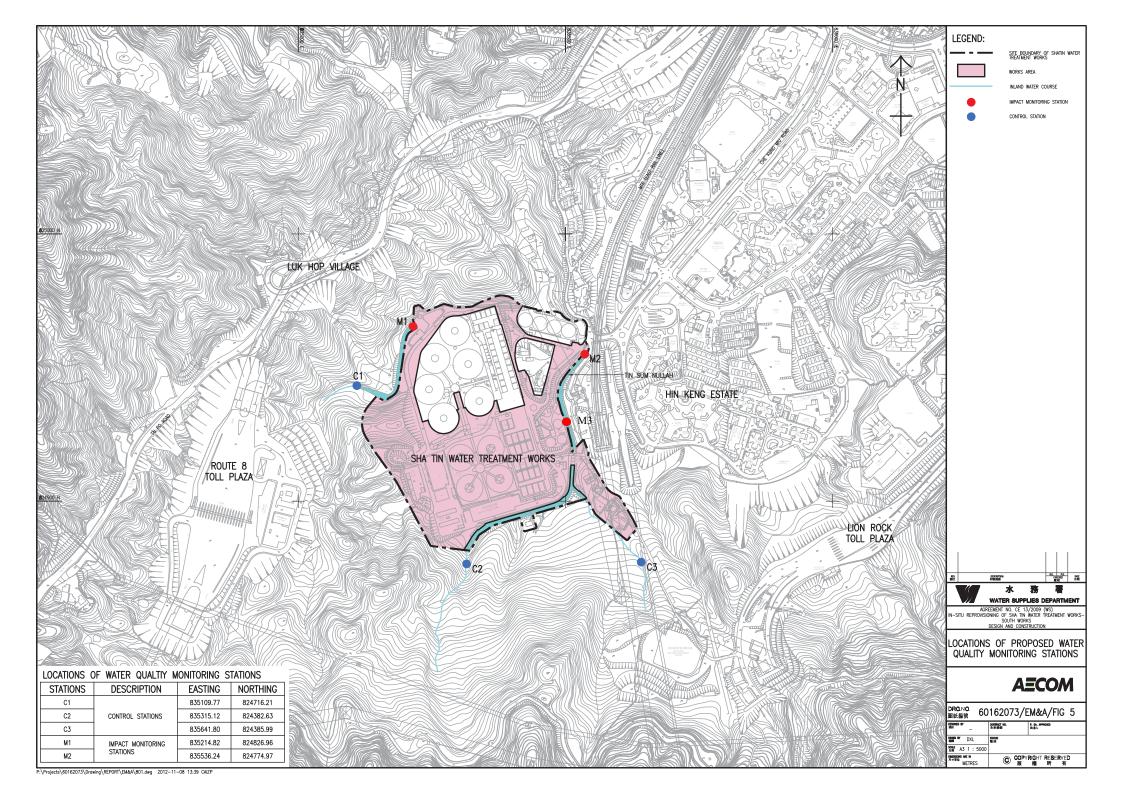
Appendix O Location Plan of Water Quality Monitoring Station

- 2.4.2 Three (3) control and two (2) impact stations were recommended in the Section 4.7 of the approved EM&A Manual to carry out water quality monitoring. In order to identify and seek for the access of the water monitoring locations designated in the approved EM&A Manual, site visit was conducted among ET, IEC and Environmental Protection Department (EPD).

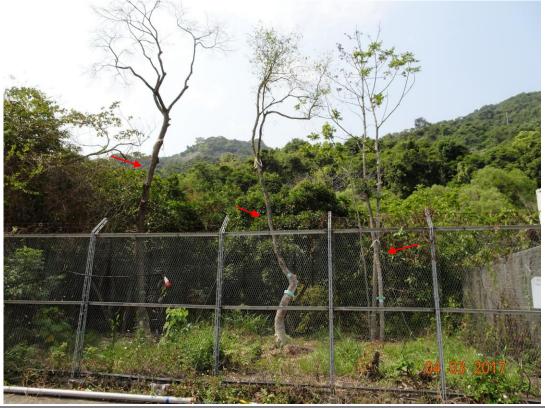
- 2.5.4 Ailanthus (Ailanthus fordii) and Incense Tree (Aquilaria sinensis) was transplanted to new location within STWTW. The condition of TA572 was observed in fair condition while TA326 and TA327 were in poor condition. Tree crown of TA326 and TA327 was observed thinner than the observation in last observation. Fungi attack (species: Schizophyllum commune) was observed on TA572 during current inspection. Fungicide was recommended to control the growth of fungal attack. In addition, it is recommended to wrap a layer of shelter (such as 遮光網) on tree trunk for TA572 and TA327 in order to reduce the intensity of sunlight. Transplanted Lamb of Tartary (Cibotium barometz) seems to be received too much sunlight. Leaves of them were observed yellowish in colour. Shelter (遮光網) was recommended to reduce the intensity of sunlight. Hong Kong Eagle's Claw was observed dead during inspection on 20 August 2016. New fronds of transplanted Lamb of Tartary were observed growing out. Lamb of Tartary was under recovery after transplantation. Currently, Lamb of Tartary were temporally stored on Nursery garden at Wang Toi Shan, Kam Tin. It is recommended to retain them at the nursery garden under proper maintenance during current recovery stage.

Photo 9. Incense Tree after transplantation (*Aquilaria sinensis*) – TA326 (left) and TA327 (middle), (*Ailanthus fordii*) – TA572 (right)

- 2.5.7 After transplantation, root ball of TA572, TA326 and TA327 tree should be kept moisture especially during dry and non-raining day.

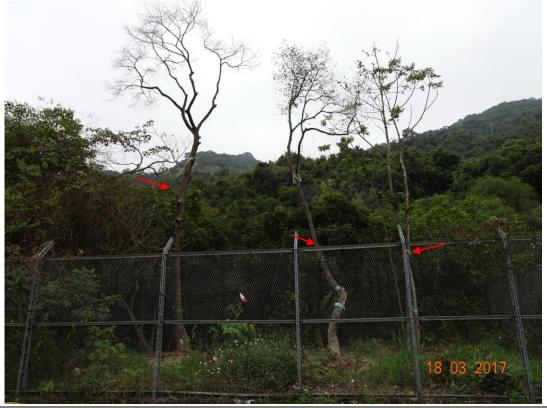
Photo 9. Incense Tree after transplantation (*Aquilaria sinensis*) – TA326 (left) and TA327 (middle), (*Ailanthus fordii*) – TA572 (right)
