<b>Contract No.</b>	3/WSD/15		
<b>Project Title:</b>	In-situ Re-provisioning of Sha Tin Water Treatment Works (South Works) – Advance Works		
<b>CGS No.:</b>	3WSD15/CGS/SEQ/ALL/JV0394A	<b>Issue:</b>	A
		<b>Date:</b>	09/09/2017
<b>To:</b>	Engineer's Representative	<b>Your Ref:</b>	
<b>Attention:</b>	Mr. Derek K H Ng		
<b>From:</b>	Ming Hing – Ming Hing Civil – Vasteam Joint Venture		
<b>Title:</b>	EM & A Impact Monitoring Report (August)		
<b>Specification:</b>	---		
<b>Purpose:</b>	<input type="checkbox"/> For Information <input type="checkbox"/> For Comment <input type="checkbox"/> For Approval <input checked="" type="checkbox"/> For Record		
<b>Description of Contents:</b>			
We herewith submit the EM&A Impact Monitoring Report (August 2017) for your perusal and record.			
<b>Attachment:</b>	<input checked="" type="checkbox"/> Yes <input type="checkbox"/> No	<b>Number of Copies:</b>	5 + 5 CD
<b>Expected reply date:</b>

**In-Situ Reprovisioning of Sha Tin Water Treatment Works – South Works**

**Environmental Permit EP-494/2015**

**Submission of 18<sup>th</sup> monthly EM&A Report**

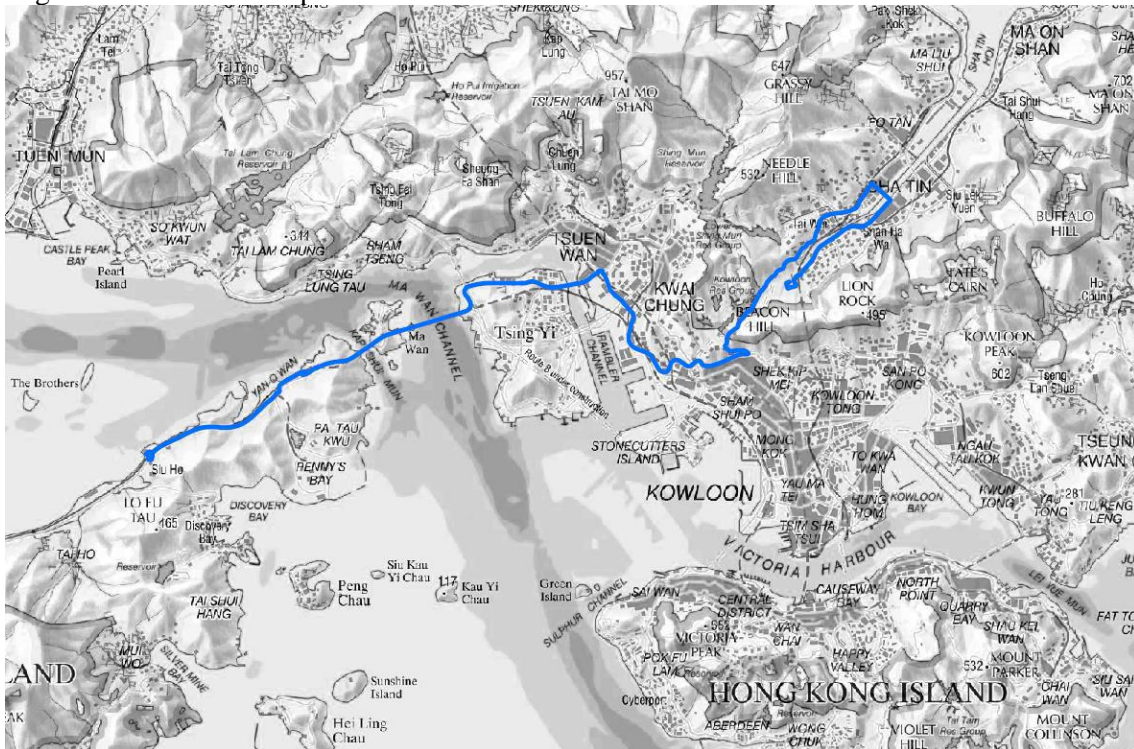
Figure 1: Chlorine Transport Route to Sha Tin Water Treatment Works

- 2.7.1 Chlorine is delivered to Sha Tin WTW in batches of up to 6×1-tonne drums. The transport route from Sham Shui Kok dock on North Lantau is shown in **Figure 1**. The route passes along the North Lantau Expressway, around the northern edge of Tsing Yi, through Tsuen Wan and along Tai Po Road (Piper's Hill) to Sha Tin (Table 2-15).

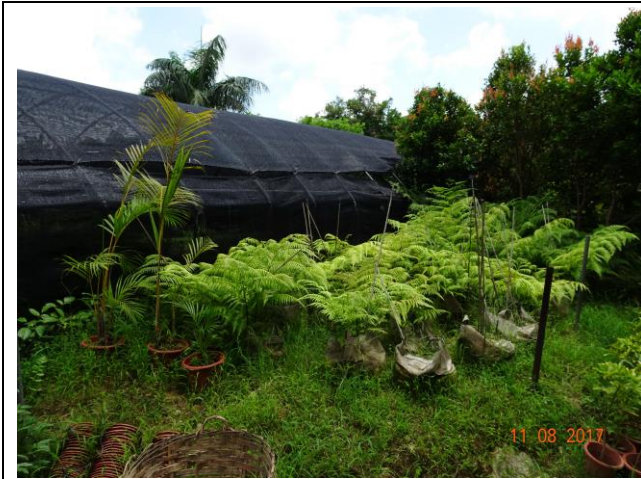
Photo 1. General view of transplanted target vegetation

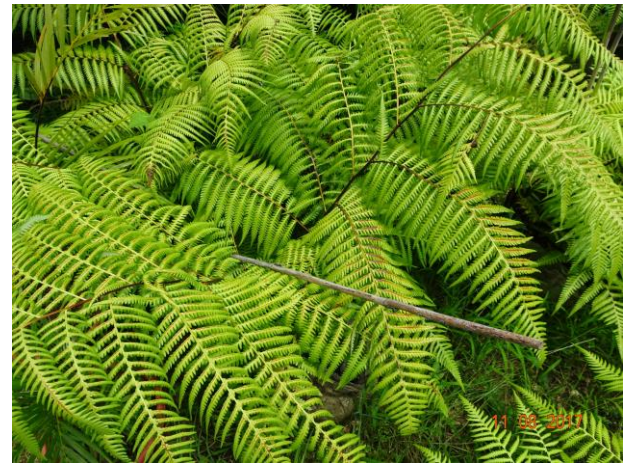
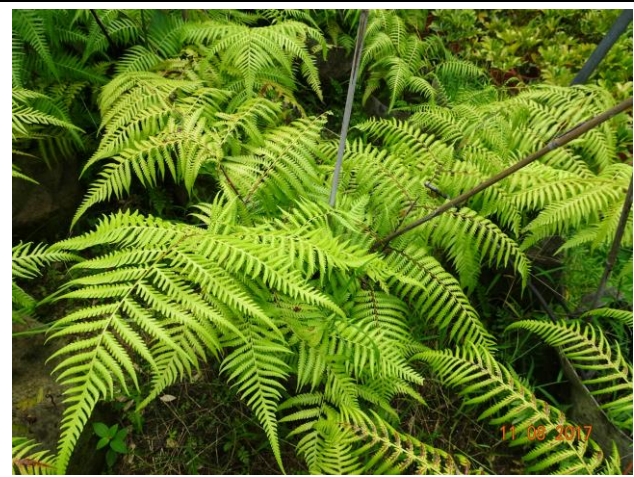
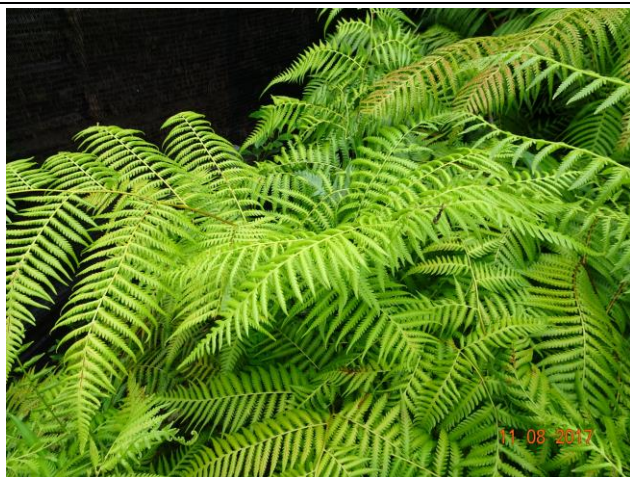
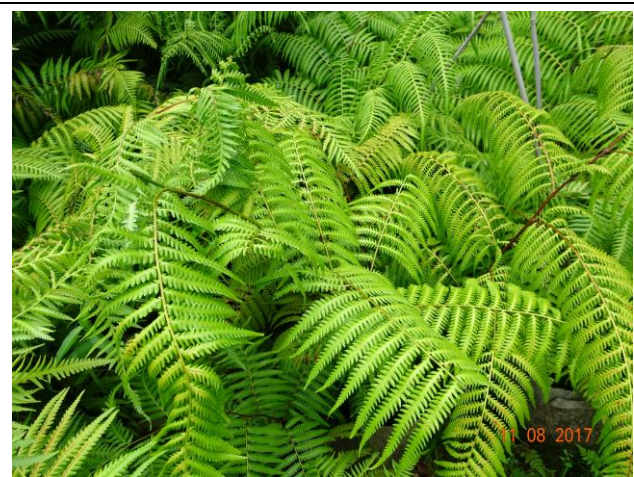
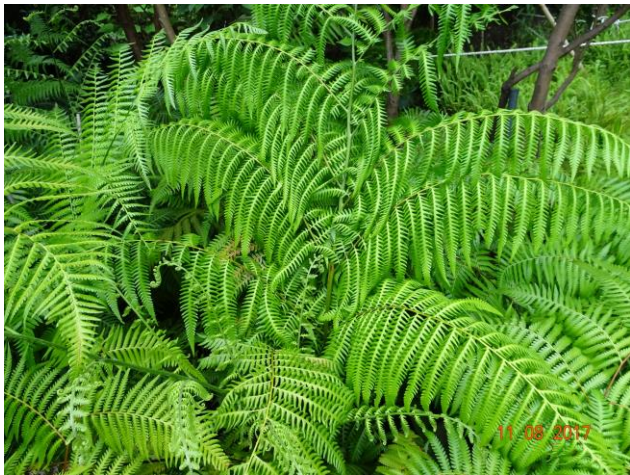
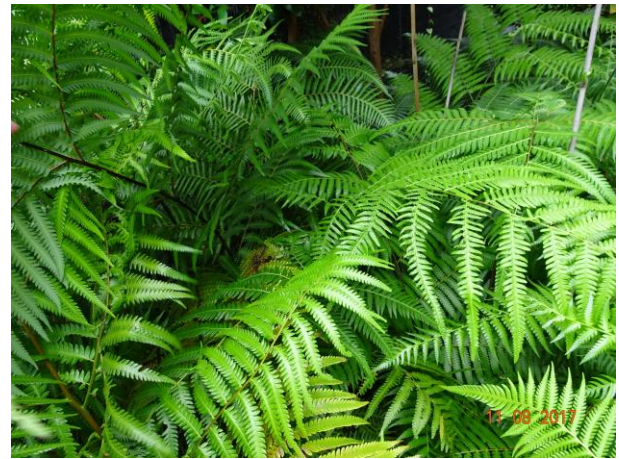
2016. New fronds of transplanted Lamb of Tartary were observed growing out. Lamb of Tartary was under recovery after transplantation. Currently, Lamb of Tartary were temporarily stored on Nursery garden at Wang Toi Shan, Kam Tin. It is recommended to retain them at the nursery garden under proper maintenance during current recovery stage.

Photo 2. New frond of *Cibotium barometz*.

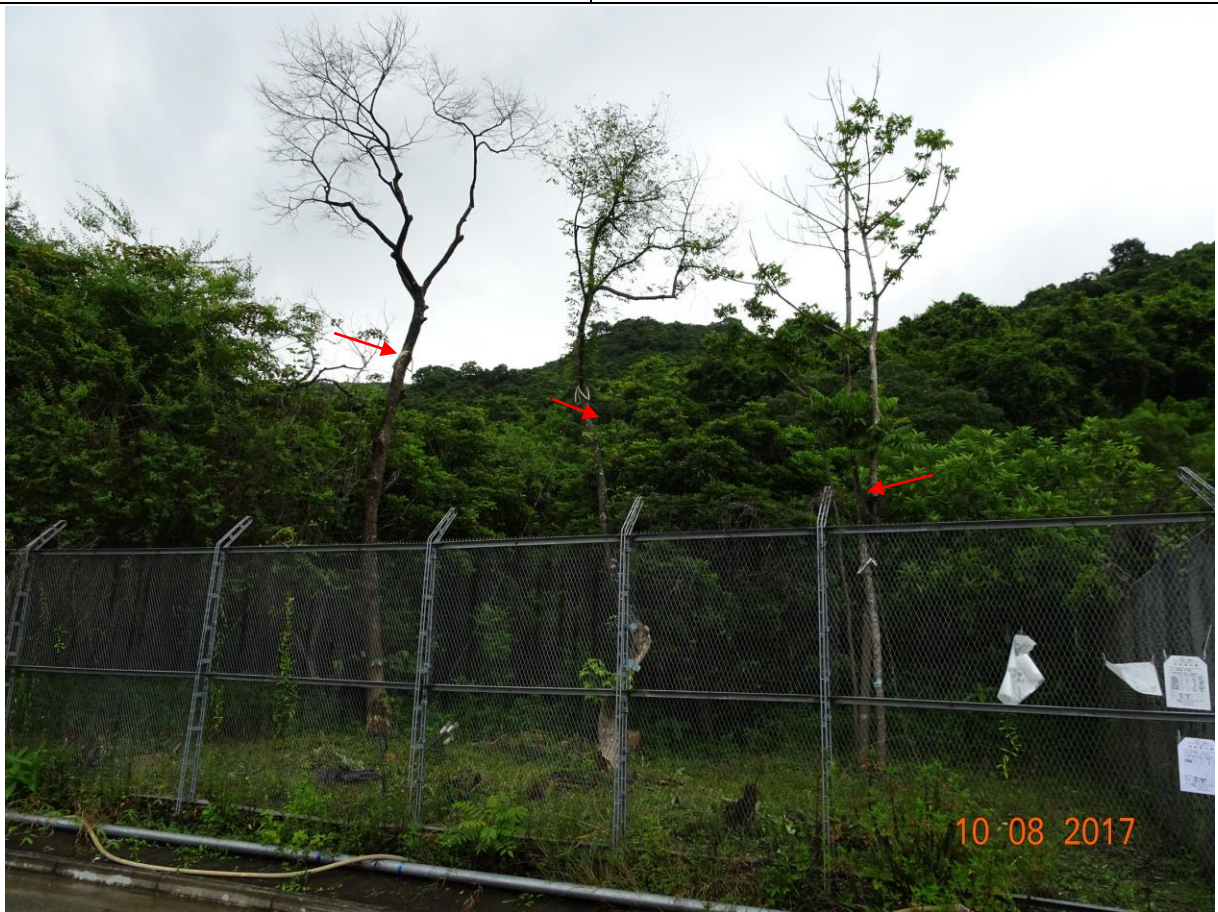
Photo 9. Incense Tree after transplantation (*Aquilaria sinensis*) – TA326 (left) and TA327 (middle), (*Ailanthus fordii*) – TA572 (right) (Before Typhoon attack)

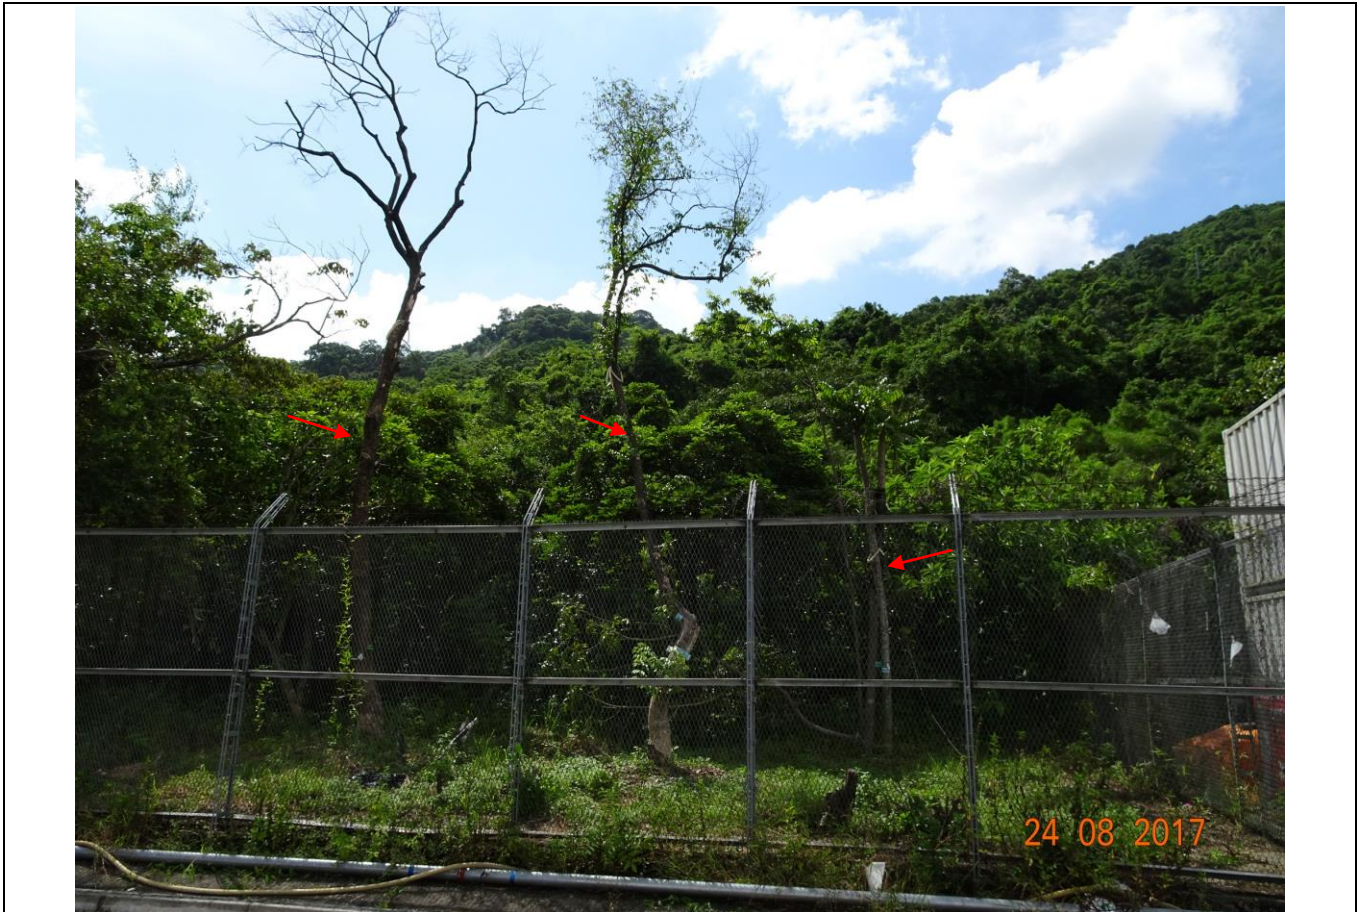
2.5.4 Ailanthus (*Ailanthus fordii*) and Incense Tree (*Aquilaria sinensis*) was transplanted to new location within STWTW. Two typhoons have been visited Hong Kong this monitoring month. Two main trunk of TA572 were broken during typhoon (No. 10 signal) on 23 August 2017. Contactor was advised to clean cut on broken end of main truck for TA572. No damage on TA326 and TA327 during typhoon period.

2.5.5 The condition of TA572 was observed in poor condition due to broken of main trunk while TA326 and TA327 were dead and in poor condition respectively. Water sprouts were observed on TA327. Transplanted Lamb of Tartary (*Cibotium barometz*) seems to be received too much sunlight. Leaves of them were observed yellowish in colour. Shelter (遮光網) was recommended to reduce the intensity of sunlight. Hong Kong Eagle's Claw was observed dead during inspection on 20 August

Photo 10. Incense Tree after transplantation (*Aquilaria sinensis*) – TA326 (left) and TA327 (middle), (*Ailanthus fordii*) – TA572 (right) (After Typhoon attack)

- 2.5.6 In general, all transplanted Lamb of Tartary were in fair condition while Hong Kong Eagle's Claw (*Artabotrys hongkongensis*) and one Incense Tree (*Aquilaria sinensis*) TA326 were observed dead during inspection on 20 August 2016 and on 10 August 2017 respectively.
- 2.5.7 In order to compensate for the lost of transplanted Hong Kong Eagle's Claw and Incense Tree, it is recommended to plant an individual of native climber species and 3 heavy standard native tree species at compensatory planting site. The suggested species in planting list would have certain ecological value in terms of plant ecology and the associated wildlife including birds.
- 2.5.8 After transplantation, root ball of TA572 and TA327 tree should be kept moisture especially during dry and non-raining day.
