Contract No.	3/WSD/15		
Project Title:	In-situ Reprovisioning of Sha Tin Water Treatment Works (South Works) – Advance Works		
CGS No.:	3WSD15/CGS/SEQ/ALL/JV0395	Issue:	A
		Date:	13/10/2017
To:	Engineer's Representative	Your Ref:	
Attention:	Mr. Derek K H Ng		
From:	Ming Hing – Ming Hing Civil – Vasteam Joint Venture		
Title:	EM & A Impact Monitoring Report (September)		
Specification:	---		
Purpose:	<input type="checkbox"/> For Information <input type="checkbox"/> For Comment <input type="checkbox"/> For Approval <input checked="" type="checkbox"/> For Record		
Description of Contents:			
We herewith submit the EM&A Impact Monitoring Report (September 2017) for your perusal and record.			
Attachment:	<input checked="" type="checkbox"/> Yes <input type="checkbox"/> No	Number of Copies:	5 + 5 CD
Expected reply date:			
Issued By:

**In-Situ Re provisioning of Sha Tin Water Treatment Works – South Works
Environmental Permit EP-494/2015
Submission of 19th monthly EM&A Report**

Contract No.3/WSD/15
In-situ reprovisioning of Sha Tin Water Treatment Works (South Works) Advance Works
Submission of 19th Monthly EM&A Report for September 2017

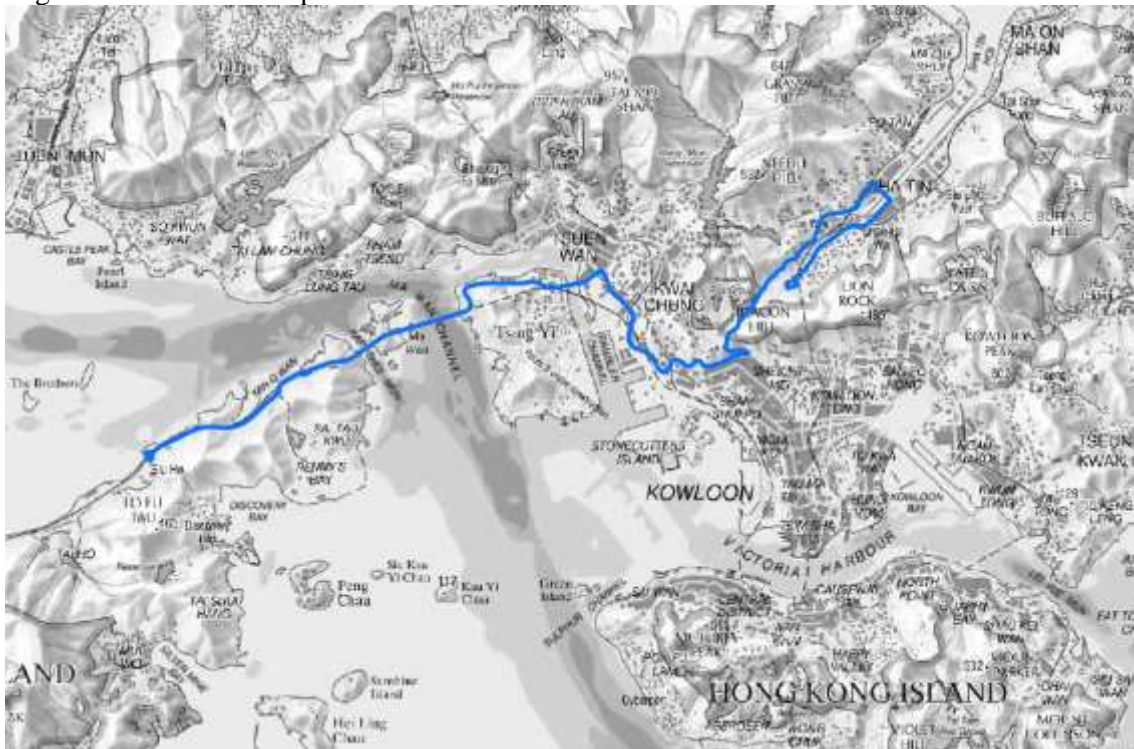
Figure 1: Chlorine Transport Route to Sha Tin Water Treatment Works

- 2.7.1 Chlorine is delivered to Sha Tin WTW in batches of up to 6×1-tonne drums. The transport route from Sham Shui Kok dock on North Lantau is shown in **Figure 1**. The route passes along the North Lantau Expressway, around the northern edge of Tsing Yi, through Tsuen Wan and along Tai Po Road (Piper's Hill) to Sha Tin (Table 2-15).

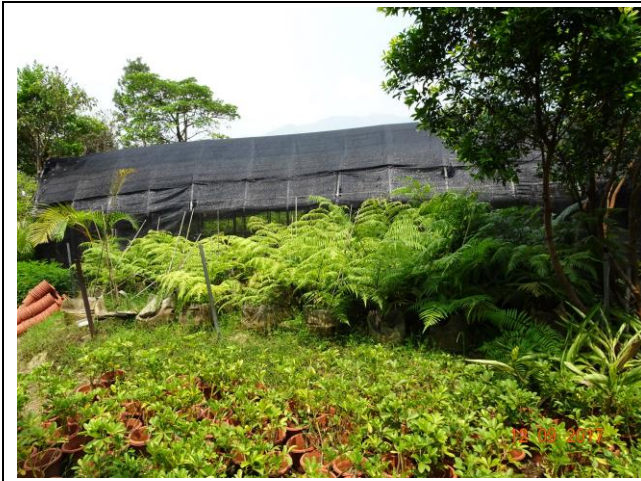
Photo 1. General view of transplanted target vegetation

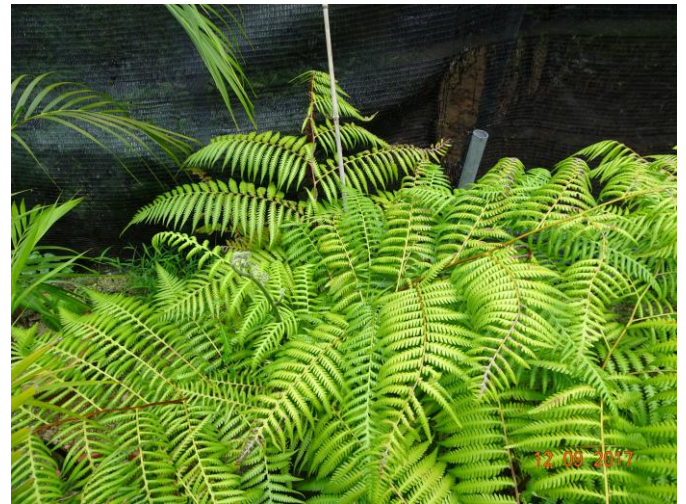
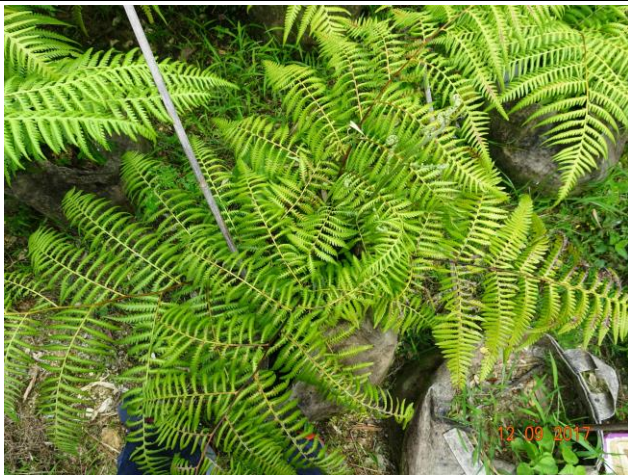
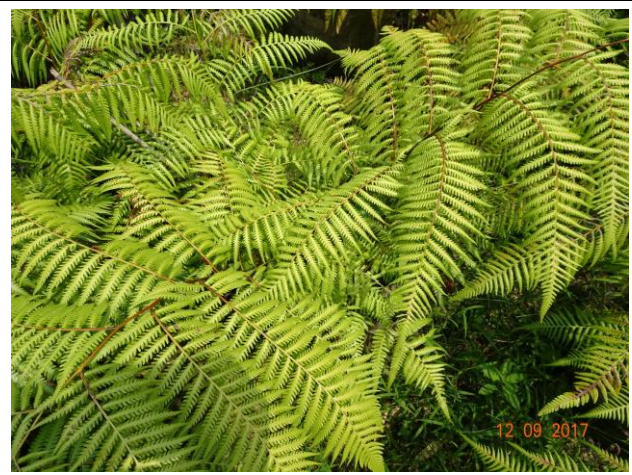
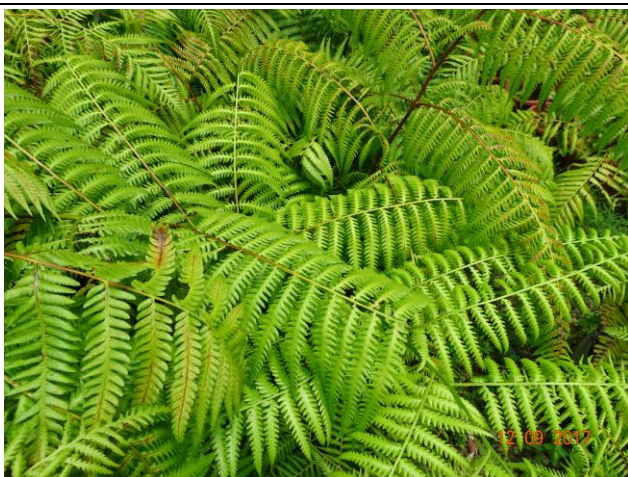
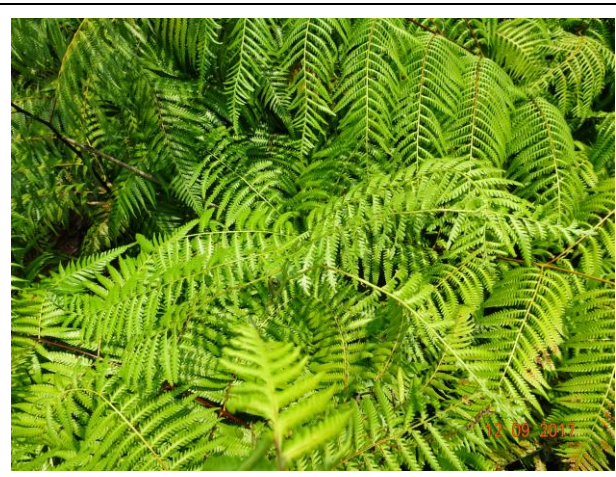
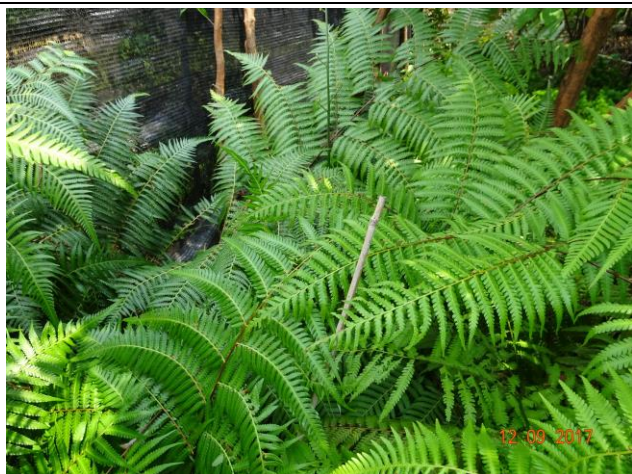
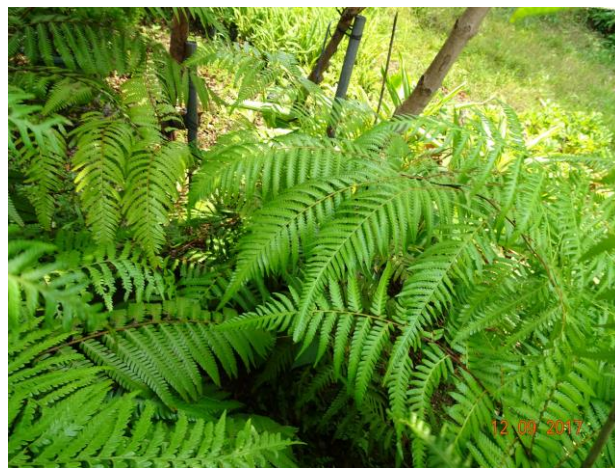
- 2.5.5 In general, all transplanted Lamb of Tartary were in fair condition while Hong Kong Eagle's Claw (*Artabotrys hongkongensis*) and one Incense Tree (*Aquilaria sinensis*) TA326 were observed dead during inspection on 20 August 2016 and on 23 August 2017 respectively.

Photo 2. New frond of *Cibotium barometz*.

Photo 3. New frond of *Cibotium barometz*.

Photo 4. New frond of *Cibotium barometz*.

Photo 5. New frond of *Cibotium barometz*.

Photo 6. New frond of *Cibotium barometz*.

Photo 7. New frond of *Cibotium barometz*.

Photo 8. New frond of *Cibotium barometz*.

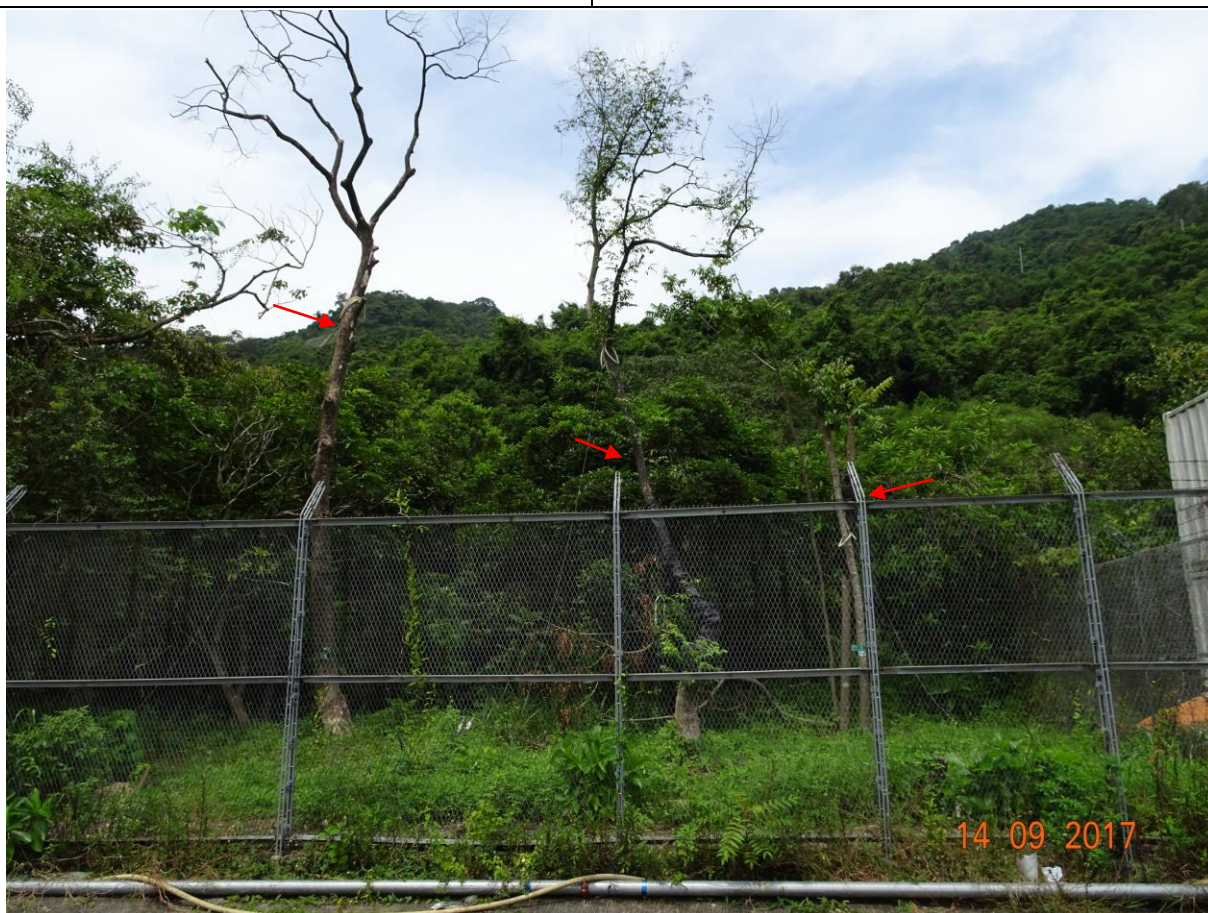
- 2.5.4 The condition of TA572 was observed in poor condition due to broken of main trunk while TA326 and TA327 were dead and in poor condition respectively. Crack on tree bark was observed on TA327 which would be sun-burnt. Shelter (遮光網) was installed on TA327 in order to reduce the light intensity on tree trunk on 14 September 2017. Transplanted Lamb of Tartary (*Cibotium barometz*) seems to be received too much sunlight. Leaves of them were observed yellowish in colour. Shelter (遮光網) was recommended to reduce the intensity of sunlight. Hong Kong Eagle's Claw was observed dead during inspection on 20 August 2016. New fronds of transplanted Lamb of Tartary were observed growing out. Lamb of Tartary was under recovery after transplantation. Currently, Lamb of Tartary were temporally stored on Nursery garden at Wang Toi Shan, Kam Tin. It is recommended to retain them at the nursery garden under proper maintenance during current recovery stage.

Photo 9. Incense Tree after transplantation (*Aquilaria sinensis*) – TA326 (left) and TA327 (middle), (*Ailanthus fordii*) – TA572 (right) (Before Typhoon attack)

- 2.5.6 In order to compensate for the lost of transplanted Hong Kong Eagle's Claw and Incense Tree, it is recommended to plant an individual of native climber species and 3 heavy standard native tree species at compensatory planting site. The suggested species in planting list would have certain ecological value in terms of plant ecology and the associated wildlife including birds.

- 2.5.7 After transplantation, root ball of TA572 and TA327 tree should be kept moisture especially during dry and non-raining day.

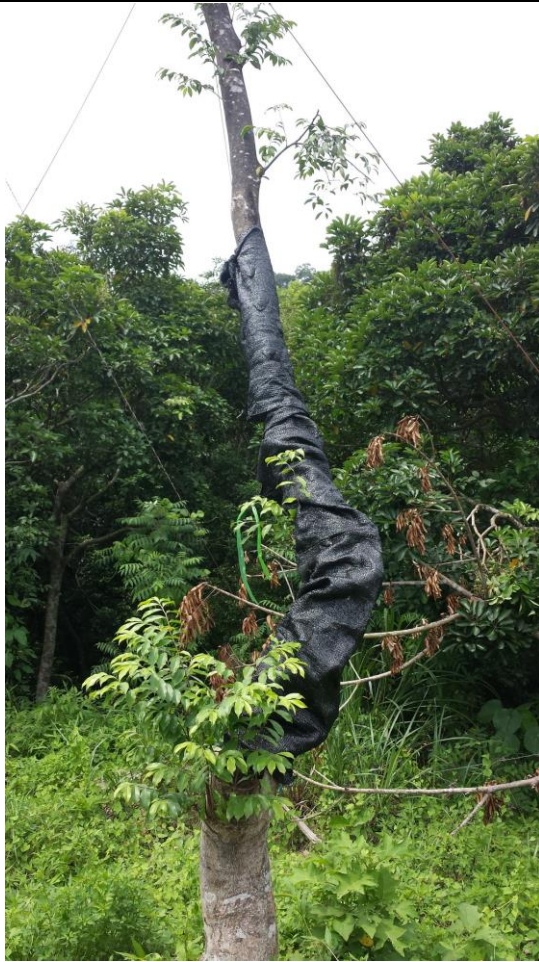
Photo 10. Shelter (遮光網) was installed on Incense Tree (*Aquilaria sinensis*) - TA327
