Contract No.	3/WSD/15		
Project Title:	In-situ Reprovisioning of Sha Tin Water Treatment Works (South Works) – Advance Works		
CGS No.:	3WSD15/CGS/SEQ/ALL/JV0441	Issue:	A
		Date:	11/04/2018
To:	Engineer's Representative	Your Ref:	
Attention:	Mr. Derek K H Ng		
From:	Ming Hing – Ming Hing Civil – Vasteam Joint Venture		
Title:	EM & A Impact Monitoring Report (March 2018)		
Specification:	---		
Purpose:	<input type="checkbox"/> For Information <input type="checkbox"/> For Comment <input type="checkbox"/> For Approval <input checked="" type="checkbox"/> For Record		
Description of Contents:			
We herewith submit the EM&A Impact Monitoring Report (March 2018) for your perusal and record.			
Attachment:	<input checked="" type="checkbox"/> Yes <input type="checkbox"/> No	Number of Copies:	5 + 5 CD
Expected reply date:			
Issued By:

In-Situ Re provisioning of Sha Tin Water Treatment Works – South Works

Submission of 24th monthly EM&A Report

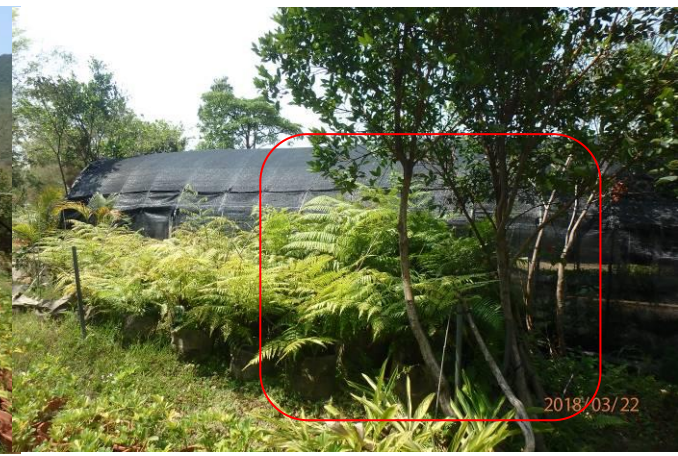
<p>A wide-angle photograph similar to Photo 1, but with a red rounded rectangle highlighting a specific area where the vegetation is under a shade net. The date '2018/03/22' is printed in the bottom right corner.</p>
<p>Photo 1. General view of transplanted target vegetation.</p>	<p>Photo 2. General view; less yellow leaves were observed for individuals under shade.</p>

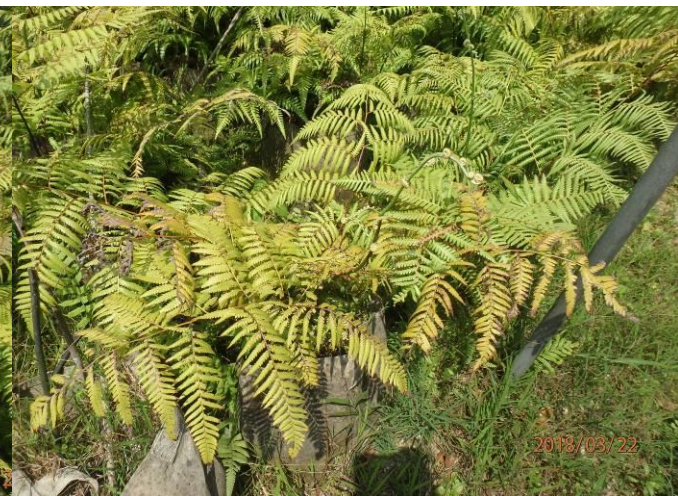
<p>A close-up photograph of an older, slightly yellowed frond of <i>Cibotium barometz</i> in a field, indicating it is to be replaced. The date '2018/03/22' is printed in the bottom right corner.</p>
<p>Photo 5. New frond of <i>Cibotium barometz</i>.</p>	<p>Photo 6. Old frond going to be replaced.</p>

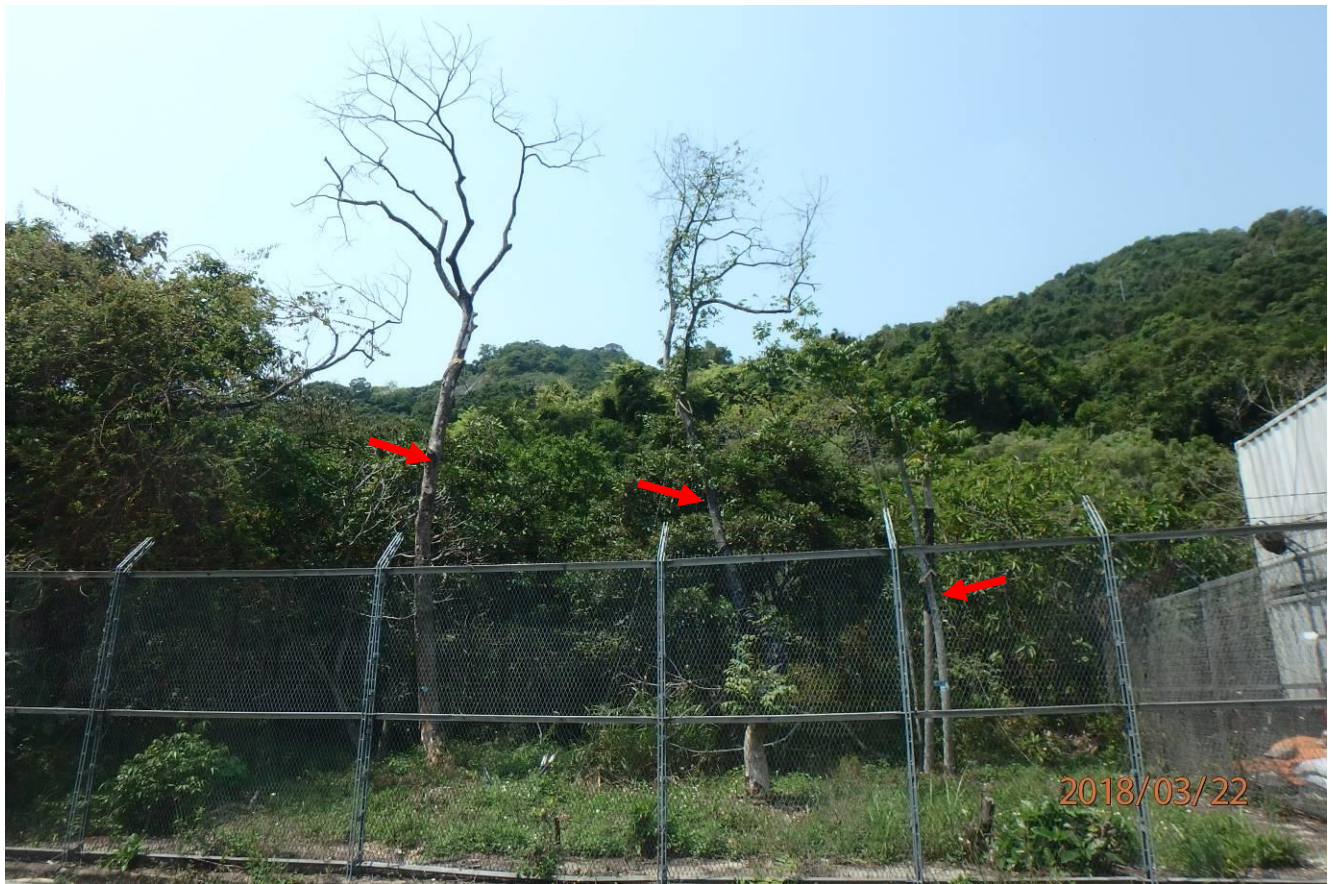
- 2.5.5 In general, all transplanted Lamb of Tartary were in fair condition while Hong Kong Eagle's Claw (*Artabotrys hongkongensis*) and one Incense Tree (*Aquilaria sinensis*) TA326 were observed dead during inspection on 20 August 2016 and on 10 August 2017 respectively. The dead tree TA326 is recommended to be removed in order to prevent tree failure.

Photo 7. Transplanted Incense Tree (*Aquilaria sinensis*) – TA326 (left, dead), TA327 (middle); and Ailanthus (*Ailanthus fordii*) – TA572 (right)

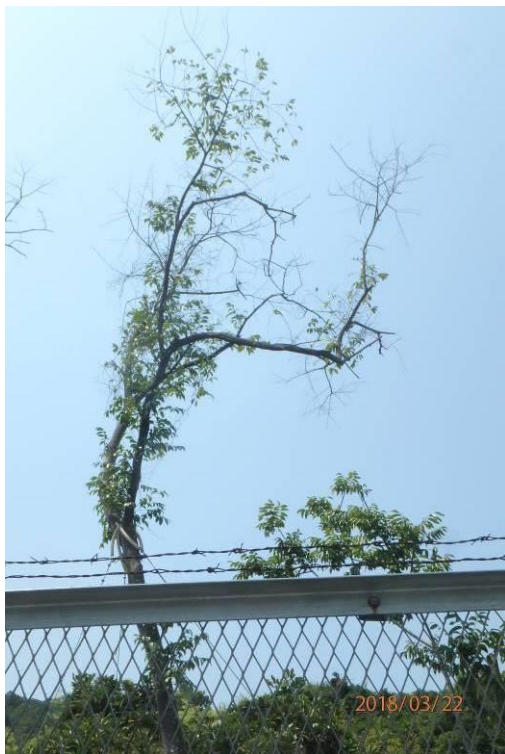
Photo 8. Weak crown with dead twigs observed in of TA327.

- 2.5.7 After transplantation, root ball of TA572 and TA327 tree should be kept moisture especially during dry and non-raining day.

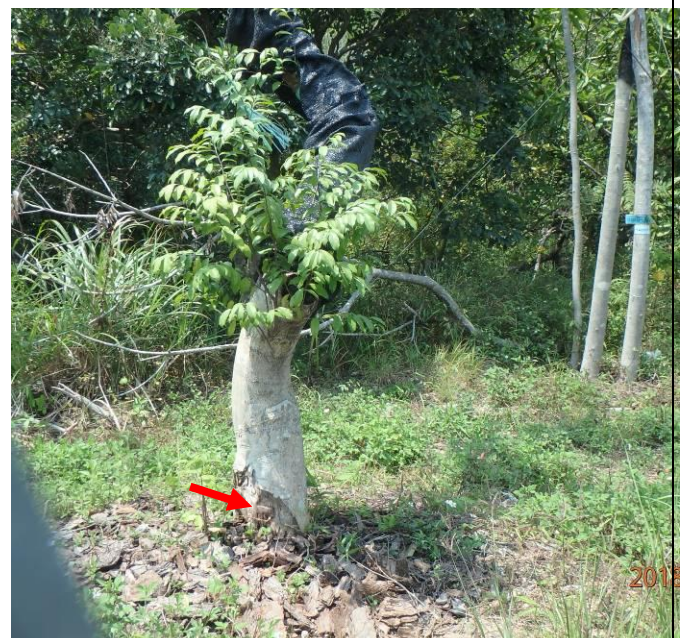
Photo 9. Old wound found at trunk base of TA327.
