Contract No.	3/WSD/15		
Project Title:	In-situ Reprovisioning of Sha Tin Water Treatment Works (South Works) – Advance Works		
CGS No.:	3WSD15/CGS/SEQ/ALL/JV00895	Issue:	A
		Date:	14/06/2019
To:	Engineer's Representative	Your Ref:	
Attention:	Mr. Derek K H Ng		
From:	Ming Hing – Ming Hing Civil – Vasteam Joint Venture		
Title:	EM & A Impact Monitoring Report (May 2019)		
Specification:	---		
Purpose:	<input type="checkbox"/> For Information <input type="checkbox"/> For Comment <input type="checkbox"/> For Approval <input checked="" type="checkbox"/> For Record		
Description of Contents:			
We herewith submit the EM&A Impact Monitoring Report (May 2019) for your perusal and record.			
Attachment:	<input checked="" type="checkbox"/> Yes <input type="checkbox"/> No	Number of Copies:	5 + 5 CD
Expected reply date:			
Issued By:

In-Situ Re provisioning of Sha Tin Water Treatment Works – South Works

Environmental Permit EP-494/2015

Submission of 39th monthly EM&A Report

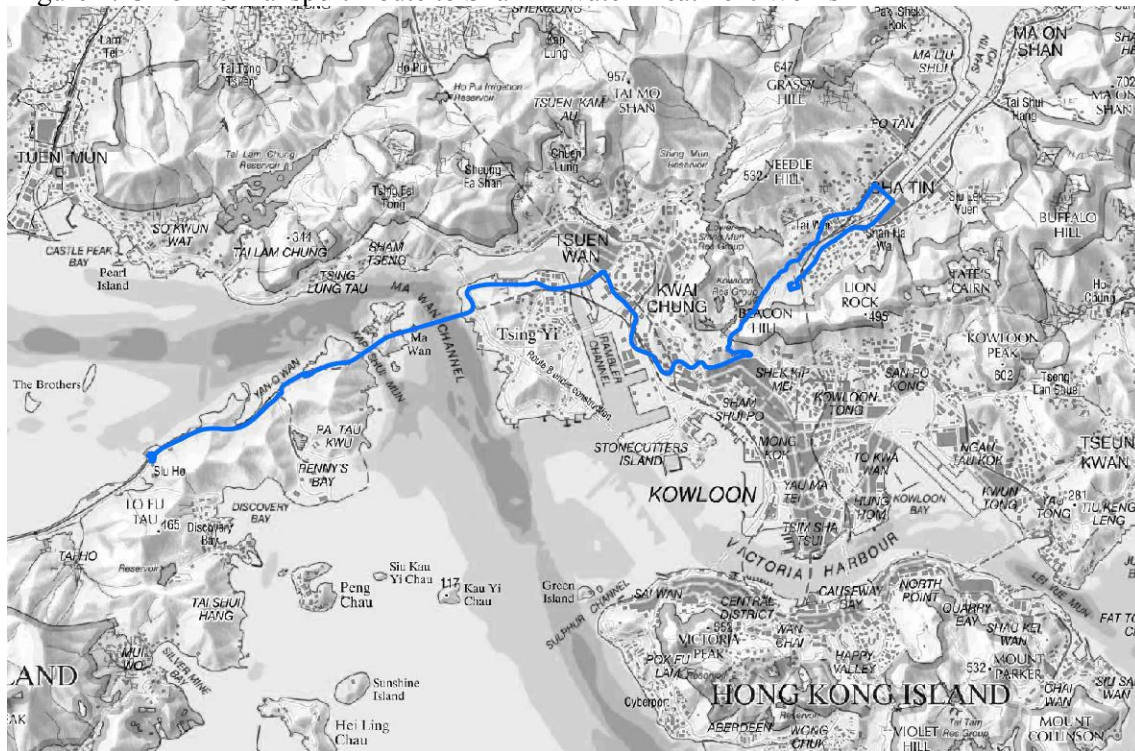
Figure 1: Chlorine Transport Route to Sha Tin Water Treatment Works

Expressway, around the northern edge of Tsing Yi, through Tsuen Wan and along Tai Po Road (Piper’s Hill) to Sha Tin (Table 2-15).

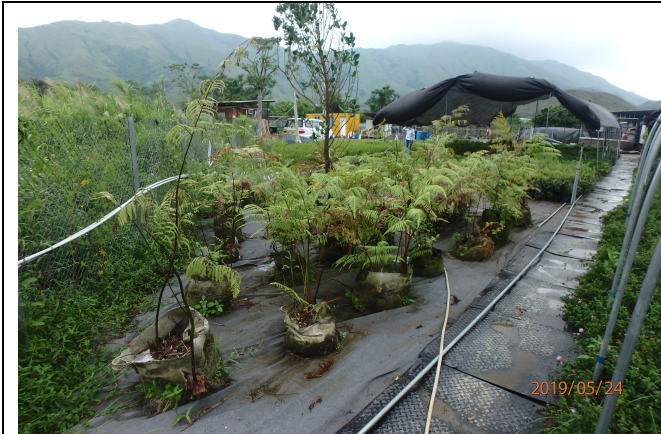
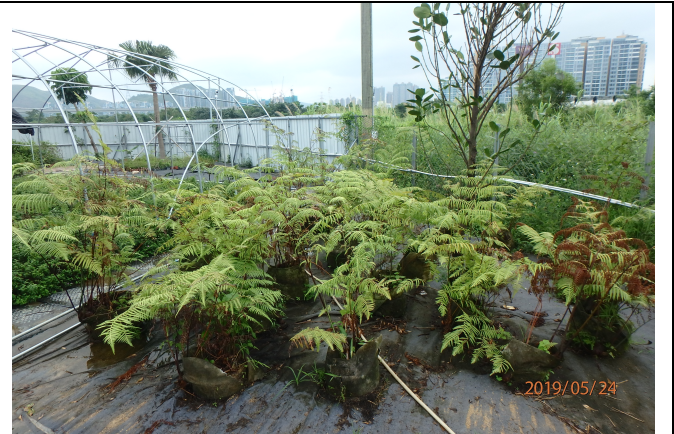
- 2.5.6 In general, all transplanted Lamb of Tartary (*Cibotium barometz*) were in fair condition while Hong Kong Eagle's Claw (*Artabotrys hongkongensis*) was observed dead during inspection on 20 August 2016. The survival rate for Lamb of Tartary (*Cibotium barometz*) and Hong Kong Eagle's Claw (*Artabotrys hongkongensis*) was 96%. The Summary table for health condition and survival rate was shown in Appendix II.

Photo 1. General view of *Cibotium barometz* to be transplanted.

Photo 2. General view of *Cibotium barometz* to be transplanted.

- 2.5.7 All transplanted Lamb of Tartary (*Cibotium barometz*) were under recovery stage. It is recommended to retain them at the nursery garden under proper maintenance during current recovery stage. Once their condition has recovered to acceptable level, they can be moved to the transplantation site at Sha Tin South Fresh Water Service Reservoir (STSFWSR) when the site is ready.

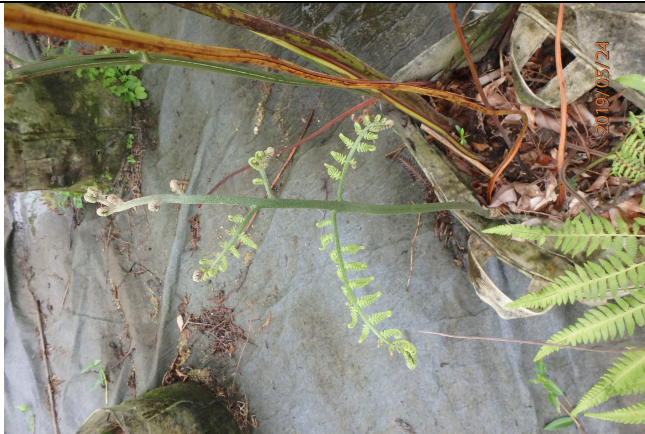
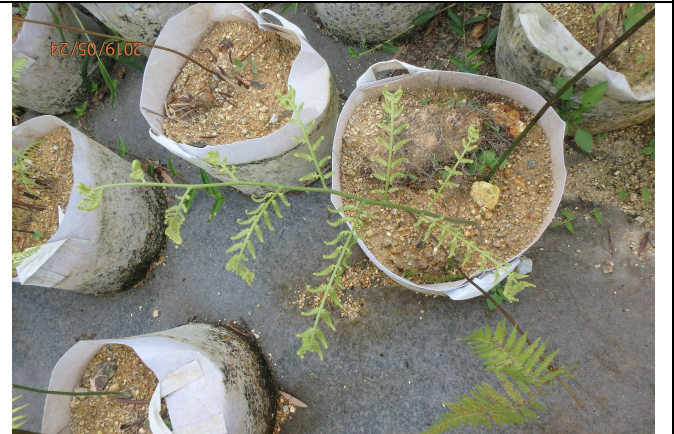
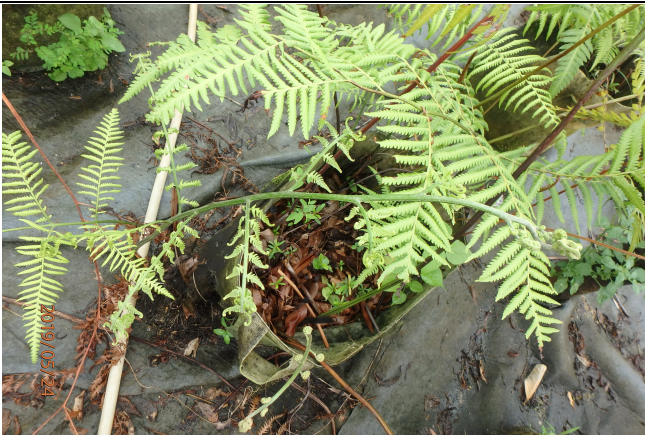
Photo 3. New sprout of *Cibotium barometz*.

Photo 4. New sprout of *Cibotium barometz*.

Photo 5. New sprout of *Cibotium barometz*.

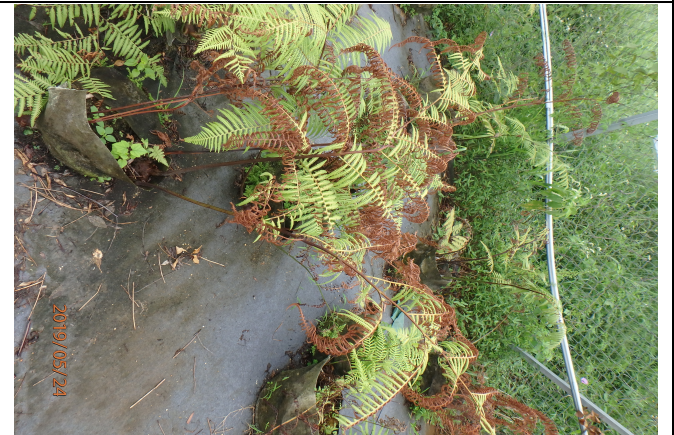
Photo 6. Old frond going to be replaced. Shelter (such as 遮光網) is recommended for reducing intensity of sunlight on the plants.

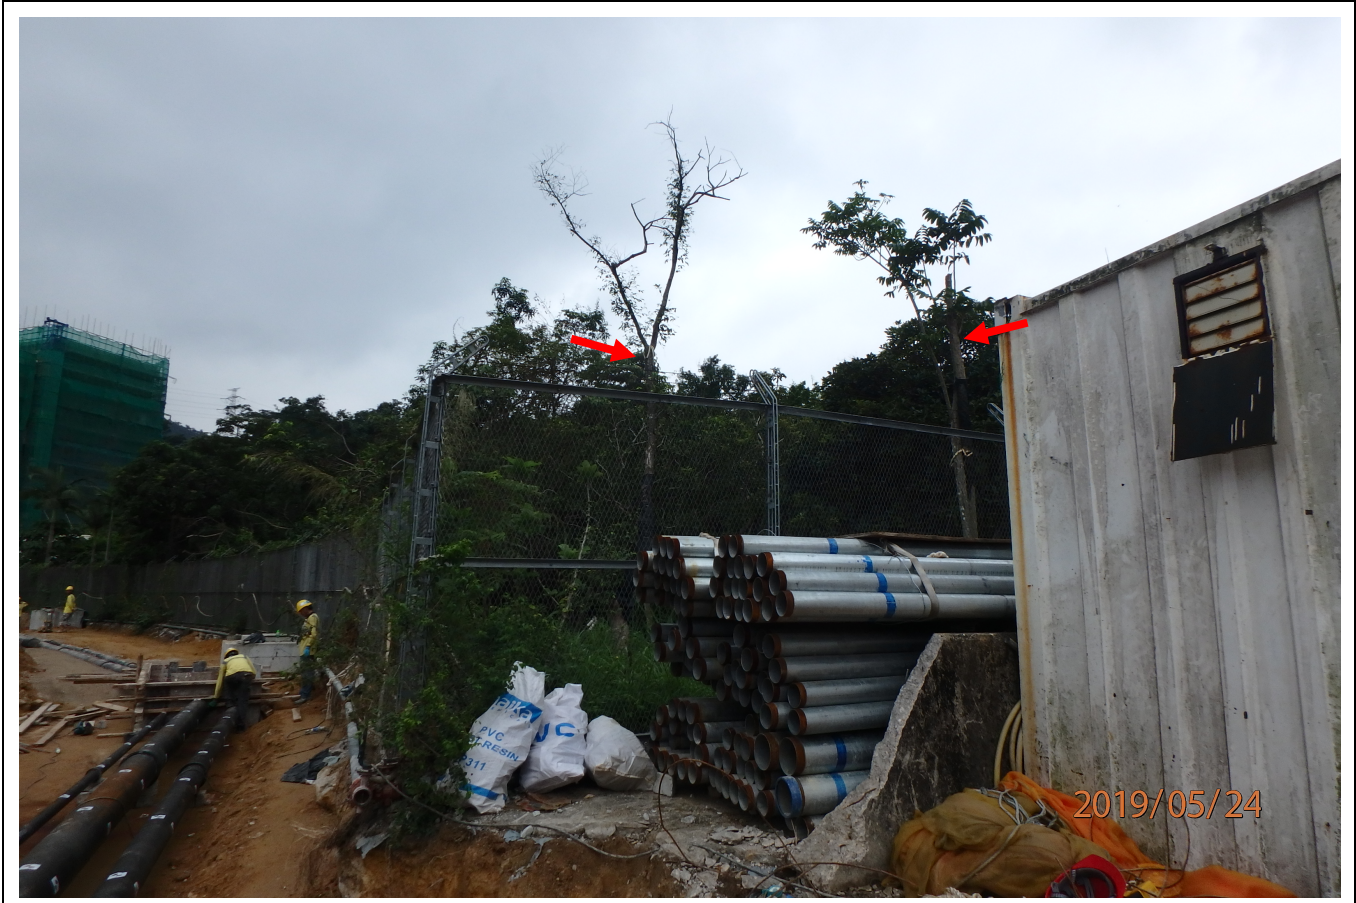
- 2.5.4 The condition of TA572 was observed in poor condition due to the damage of two main trunks. TA327 was also in poor condition. The already dead tree TA326 collapsed due to big hit by the Signal No.10 typhoon Mangkhut on 16 September 2018. Tree guying cables have been installed to provide external support to the remaining two transplanted trees. Transplanted Lamb of Tartary (*Cibotium barometz*) seems to be received too much sunlight. Leaves of them were observed yellowish in colour. On the other hand, young foliage was growing out to replace the old one.

Photo 7. Transplanted Incense Tree (*Aquilaria sinensis*) – TA327 (left); and Ailanthus (*Ailanthus fordii*) – TA572 (right)

- 2.5.8 After transplantation, root ball of TA572 and TA327 tree should be kept moisture especially during non-raining day.

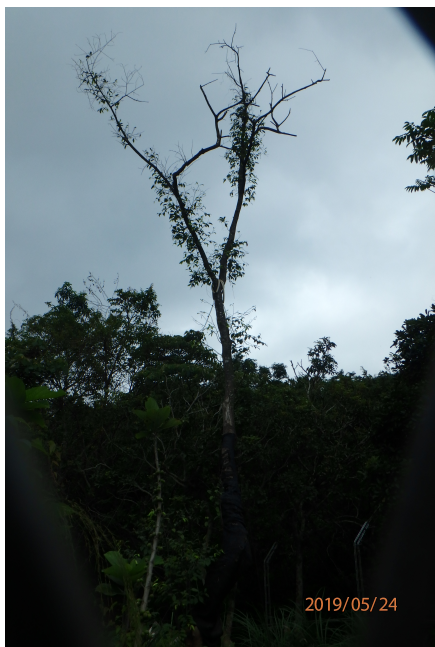
Photo 8. Weak crown with dead twigs observed in of TA327.

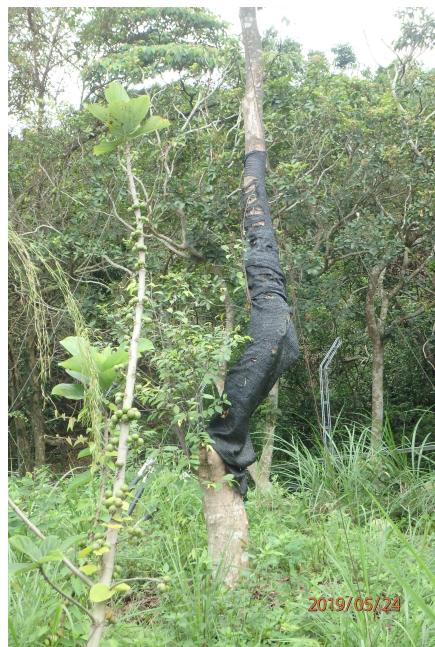
Photo 9. Watersprouts at lower trunk of TA327.

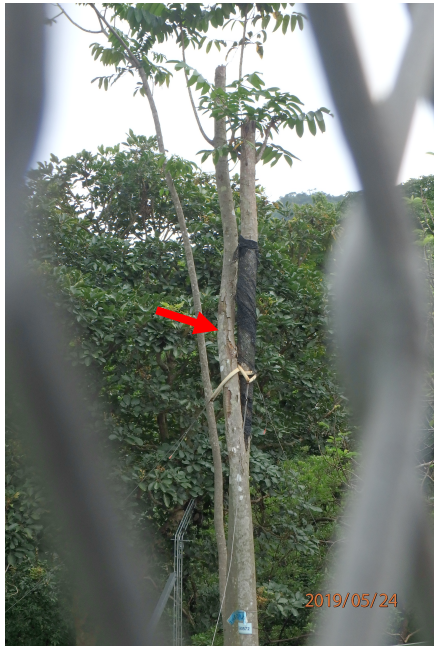
Photo 10. Cracks and wounds observed in one of the trunks of TA572.

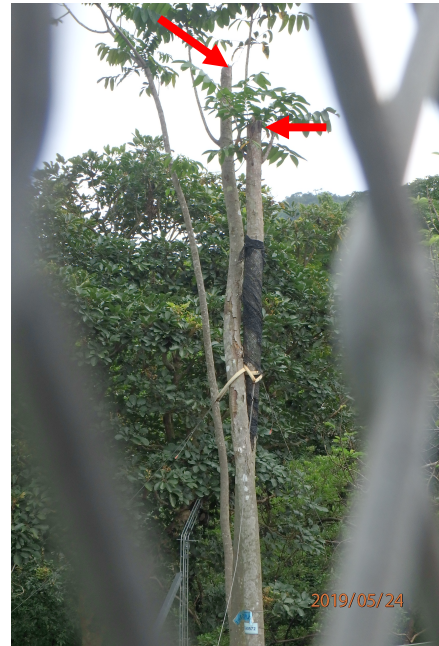
Photo 11. Weak crown and two broken trunks of TA572.
