**In-Situ Re provisioning of Sha Tin Water Treatment Works – South Works**

**Environmental Permit EP-494/2015**

**Submission of 41<sup>st</sup> monthly EM&A Report**

**Contract No.3/WSD/15q  
In-situ reprovisioning of Sha Tin Water Treatment Works (South Works) Advance Works  
Submission of 41<sup>st</sup> Monthly EM&A Report for July 2019**

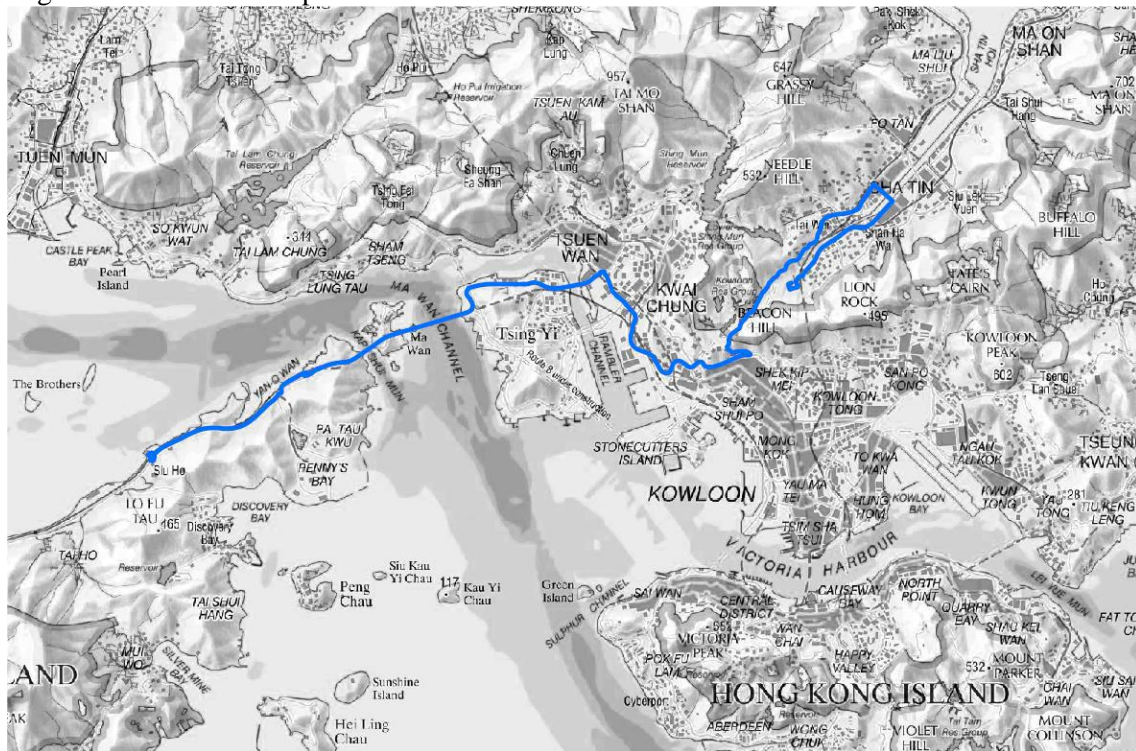
Figure 1: Chlorine Transport Route to Sha Tin Water Treatment Works

Expressway, around the northern edge of Tsing Yi, through Tsuen Wan and along Tai Po Road (Piper’s Hill) to Sha Tin (Table 2-15).

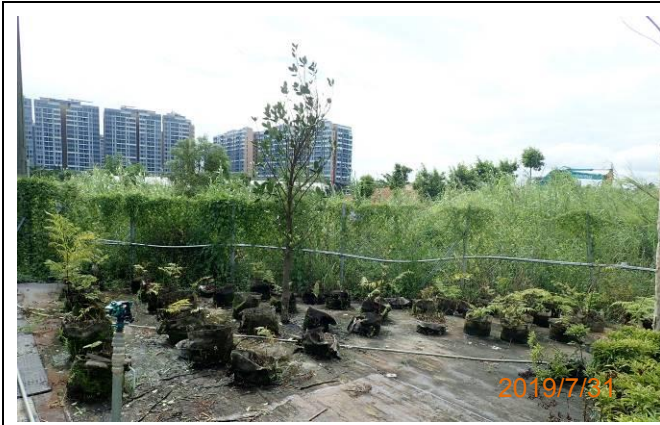
Photo 1. General view of *Cibotium barometz* to be transplanted.

- 2.5.8 It is recommended to retain transplanted Lamb of Tartary (*Cibotium barometz*) at the nursery garden under proper maintenance during current recovery stage. Once their condition has recovered to acceptable level, they can be moved to the transplantation site at Sha Tin South Fresh Water Service Reservoir (STSFWSR) when the site is ready.

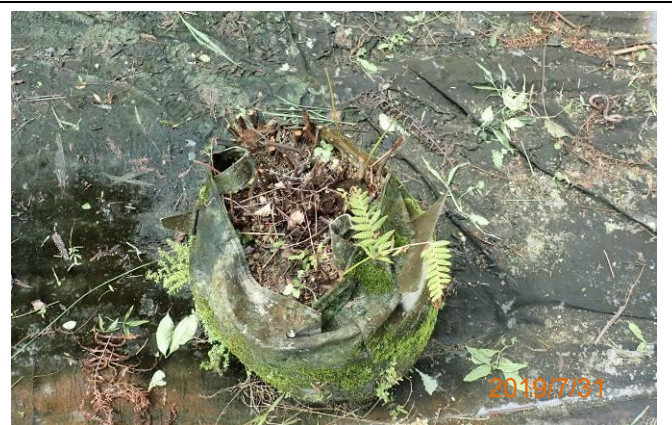
- 2.5.7 All transplanted Lamb of Tartary (*Cibotium barometz*) have been severely damaged by Typhon Wipha on 30-31 July 2019; the next few monitoring will be critical to assess their survival and recovery progress.

Photo 2. *Cibotium barometz* severely damaged by Typhoon Wipha

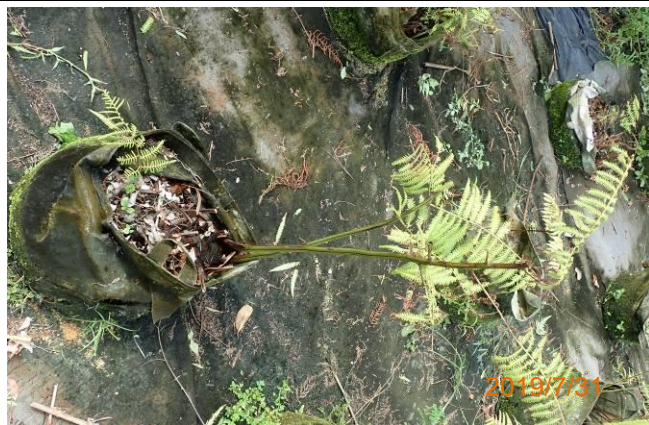
Photo 3. *Cibotium barometz* severely damaged by Typhoon Wipha

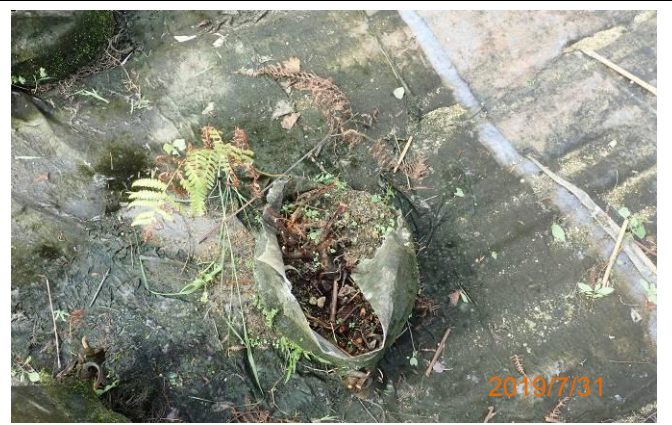
Photo 4. *Cibotium barometz* severely damaged by Typhoon Wipha

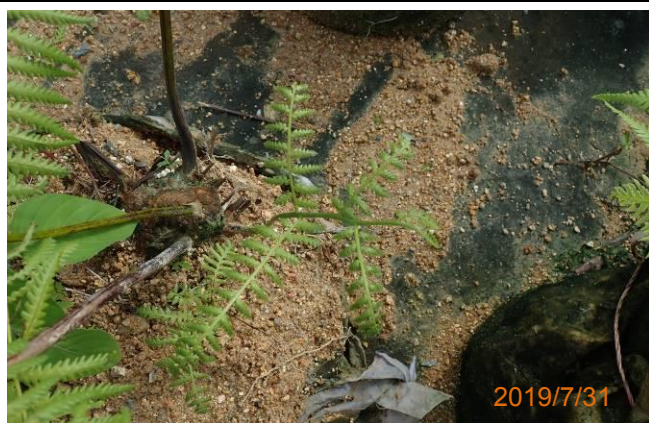
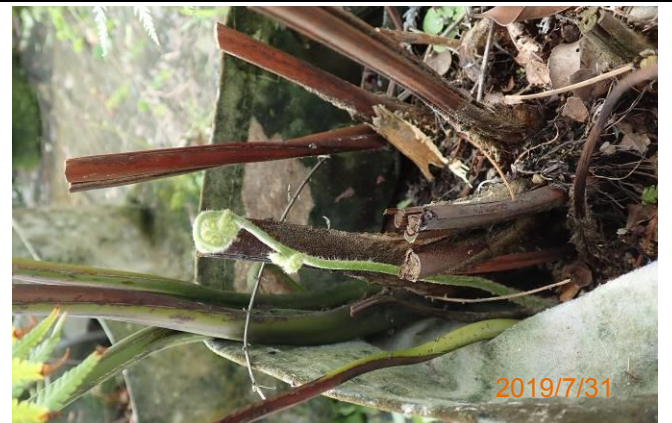
Photo 5 & 6. New sprout of *Cibotium barometz*. Shelter (such as 遮光網) is recommended for reducing intensity of sunlight and avoid direct hit of rainstorm/ typhoon on the plants.

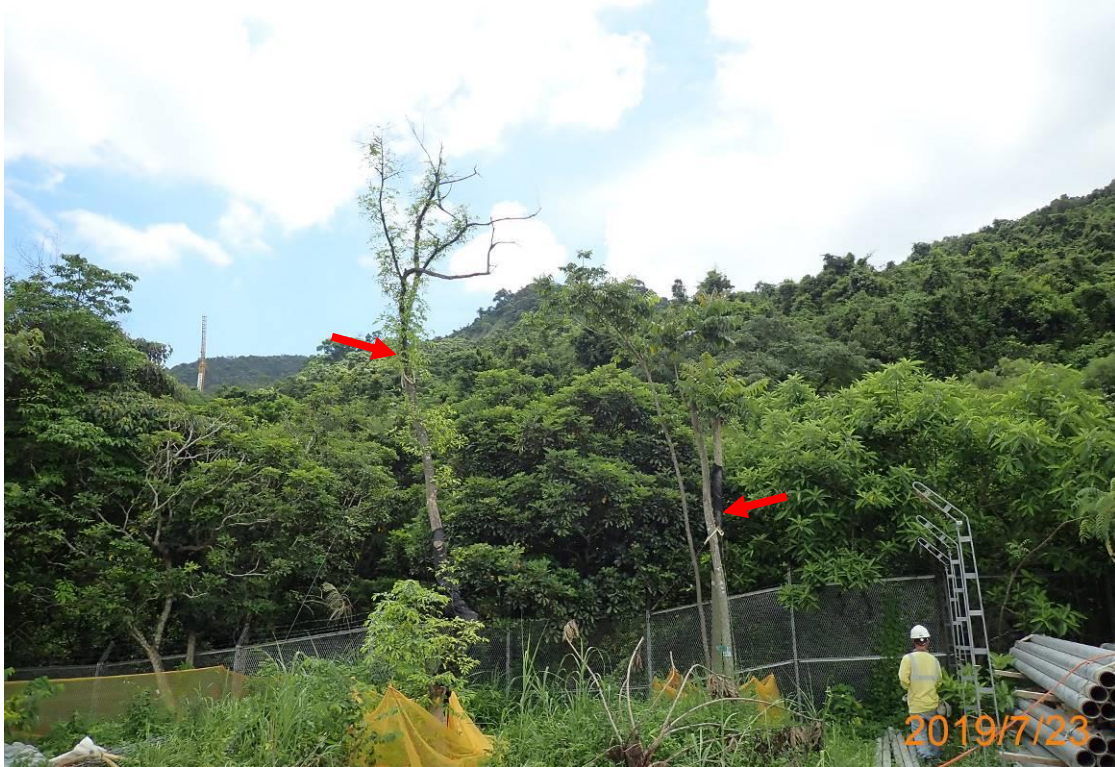
- 2.5.4 The condition of TA572 was observed in poor condition due to the damage of two main trunks. TA327 was also in poor condition. The already dead tree TA326 collapsed due to big hit by the Signal No.10 typhoon Mangkhut on 16 September 2018. Tree guying cables have been installed to provide external support to the remaining two transplanted trees. Transplanted Lamb of Tartary (*Cibotium barometz*) seems to be received too much sunlight. Leaves of them were observed yellowish in colour. On the other hand, young foliage was growing out to replace the old one.

Photo 7. Transplanted Incense Tree (*Aquilaria sinensis*) – TA327 (left); and Ailanthus (*Ailanthus fordii*) – TA572 (right)

- 2.5.9 After transplantation, root ball of TA572 and TA327 tree should be kept moisture especially during non-raining day.

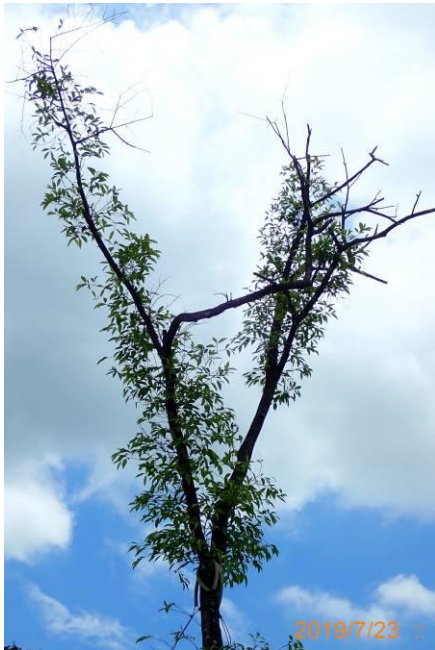
Photo 8. Weak crown with dead twigs observed in of TA327.

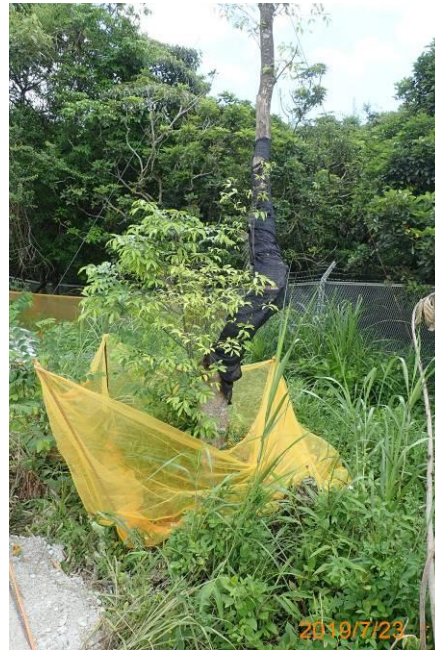
Photo 9. Watersprouts at lower trunk of TA327.

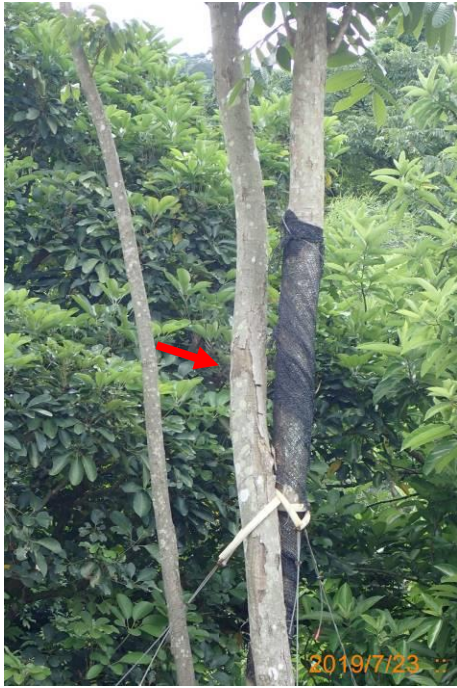
Photo 10. Cracks and wounds observed in one of the trunks of TA572.

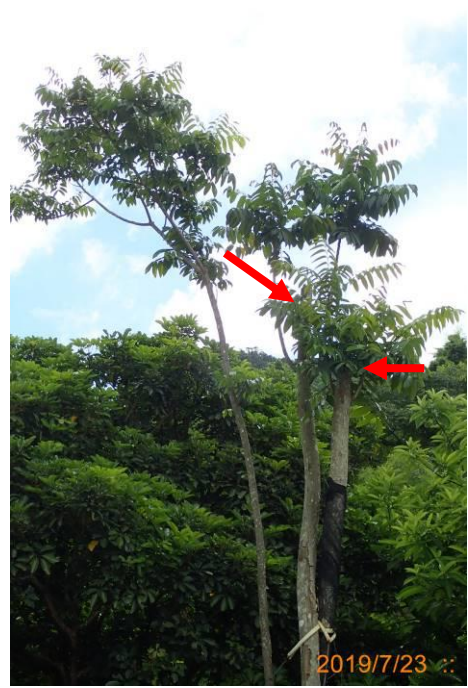
Photo 11. Weak crown and two broken trunks of TA572.
