CONTRACT NO. 1/WSD/19

**IN-SITU REPROVISIONING OF SHA TIN WATER
TREATMENT WORKS (SOUTH WORKS) – WATER TREATMENT WORKS AND
ANCILLARY FACILITIES
Environmental Permit EP-494/2015**

**In-Situ Re provisioning of Sha Tin Water Treatment Works (South Works) – Water Treatment Works and Ancillary Facilities
Environmental Permit EP-494/2015
Submission of 71st monthly EM&A Report**

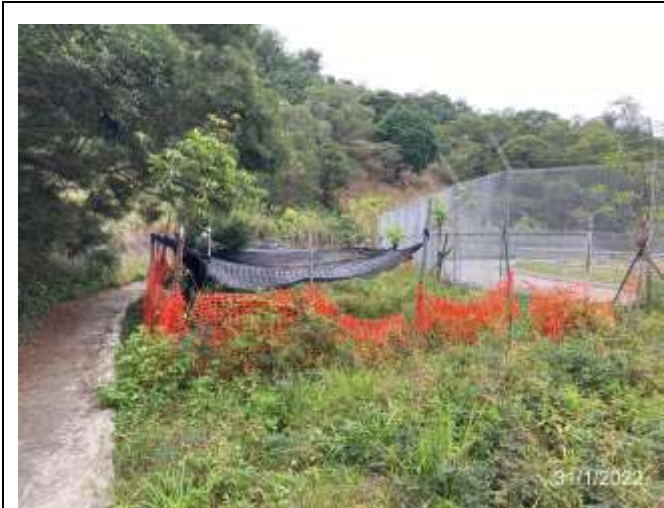
Photo 1. Broken fencing to be rectified

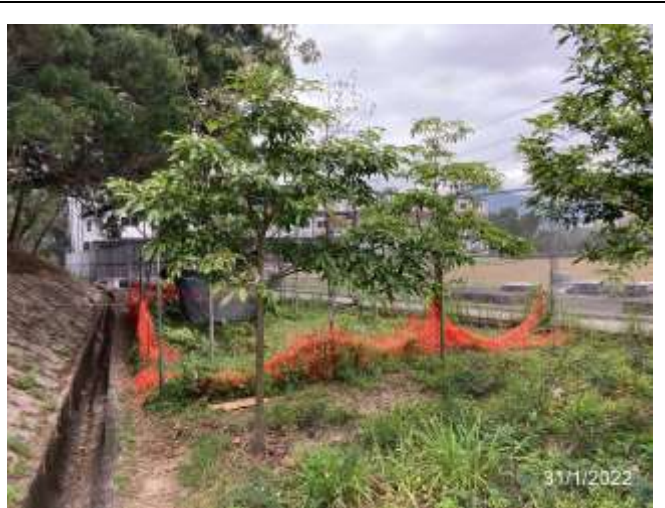
Photo 2. Broken fencing to be rectified

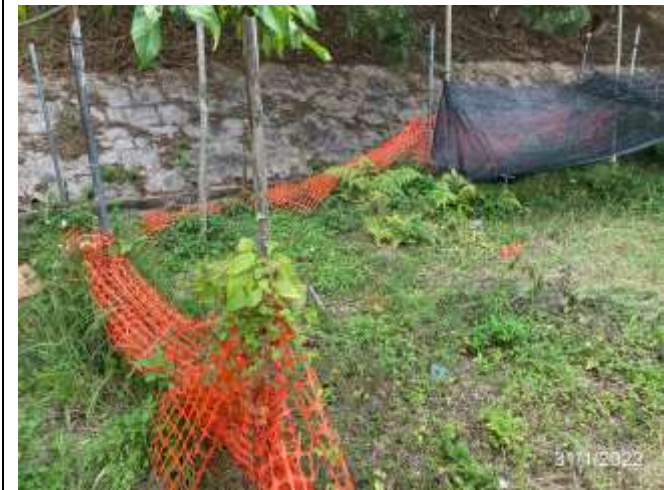
Photo 3. Broken fencing to be rectified

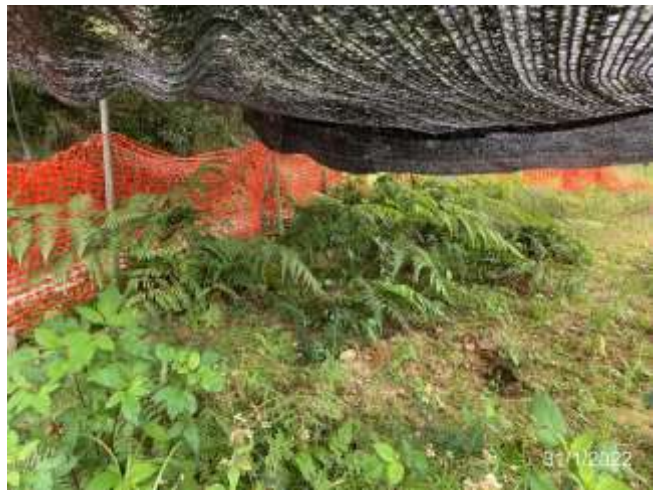
Photo 4. The shelter effectively reduced the amount of direct sunlight to *Cibotium barometz*

- 2.5.5 They are at acceptable condition to be transplanted back at Portion E of STSFWSR on 23 April 2021.
- 2.5.6 In order to enhance a sustainable survival during the post-transplantation stage, a shelter (such as 遮光網) has been installed to reduce intensity of direct sunlight received and avoid direct hit of rainstorm/ typhoon to the 27 nos. *Cibotium barometz*.

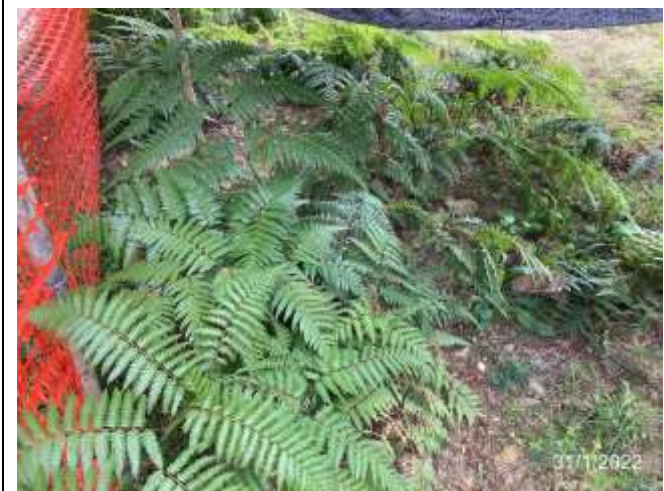
Photo 5. *Cibotium barometz* under the shelter

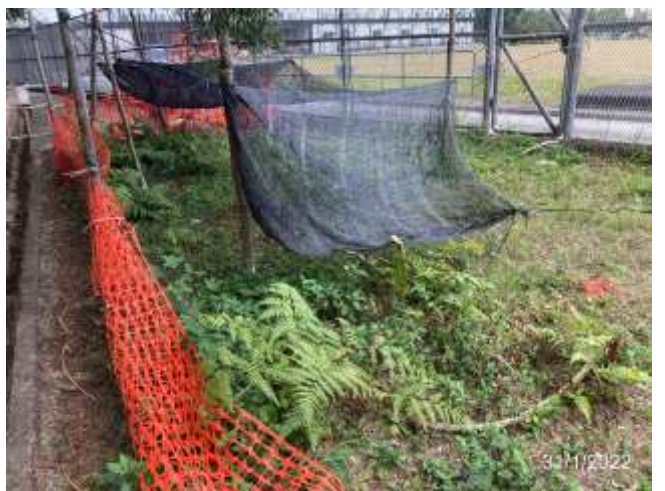
Photo 6. Collapsed shelter to be rectified to cover the exposed *Cibotium barometz*

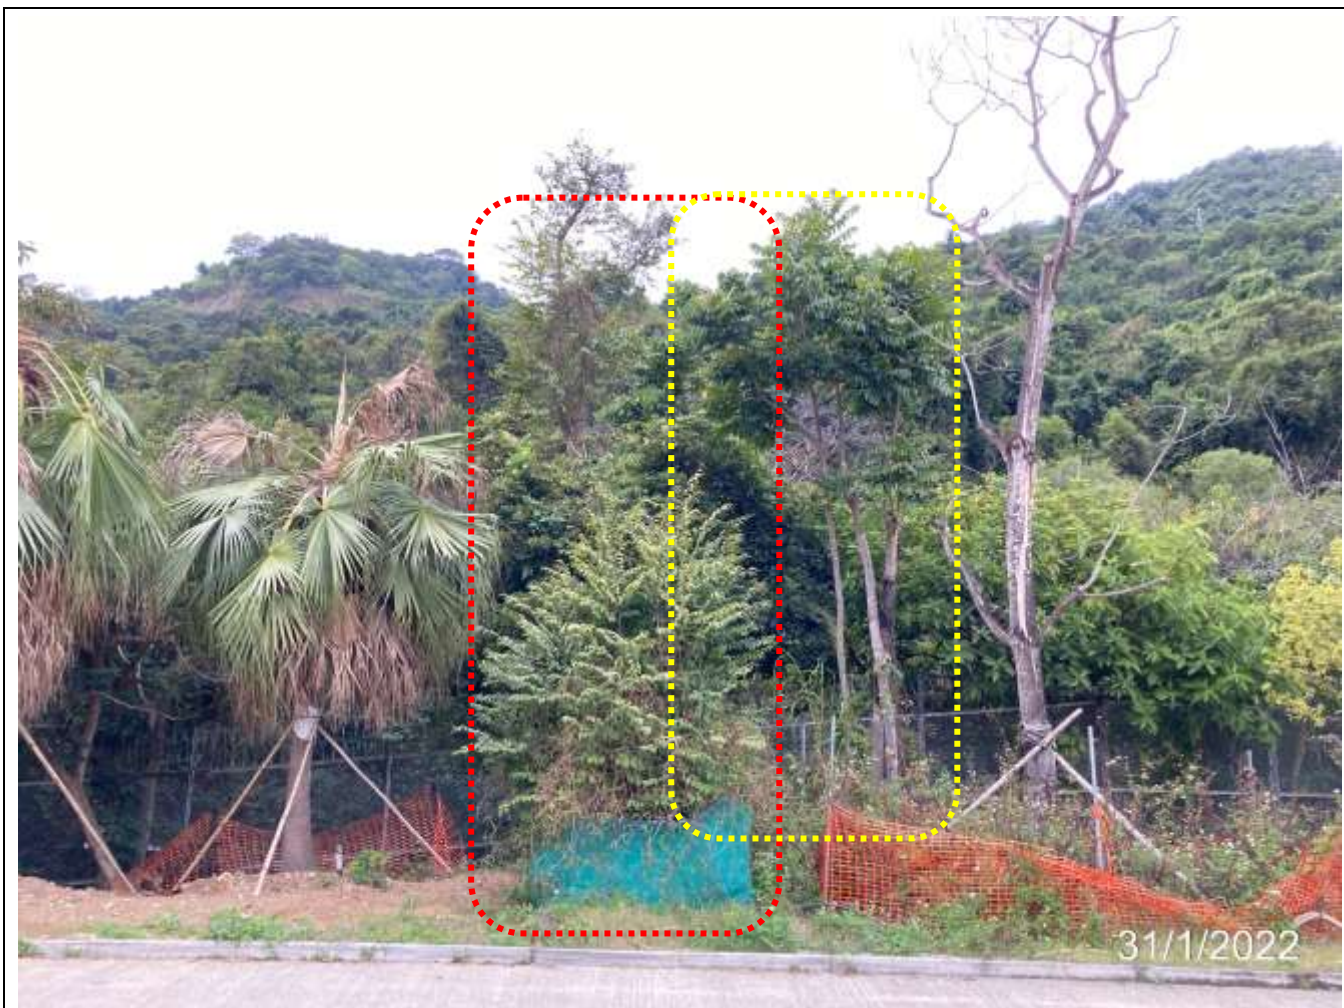
- 2.5.1 The condition of TA572 was observed in poor condition due to broken of main trunk. TA327 was also in poor condition; while already dead TA326 collapsed under Signal No. 10 typhoon Mangkhut in September 2018. Tree guying cables have been installed to provide external support to the two remaining transplanted trees.

Photo 7. Transplanted Incense Tree (*Aquilaria sinensis*) – TA327 (left); and Ailanthus (*Ailanthus fordii*) – TA572 (right)

- 2.5.8 Root ball of TA572 and TA327 tree should be kept moisture especially during dry and non-raining day.

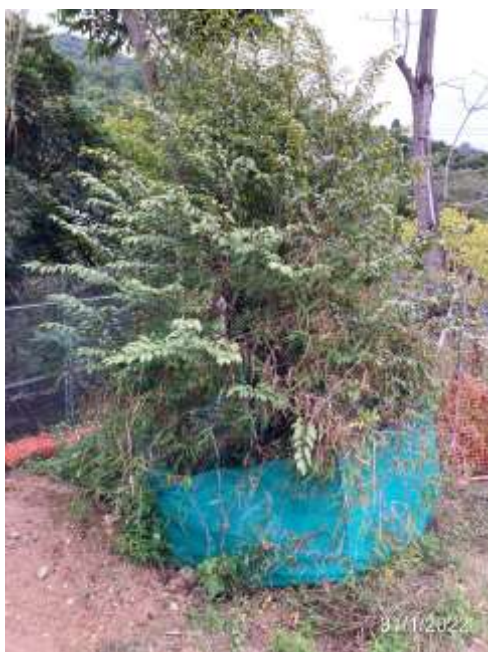
Photo 8. Weeding around TA327 shall be conducted.

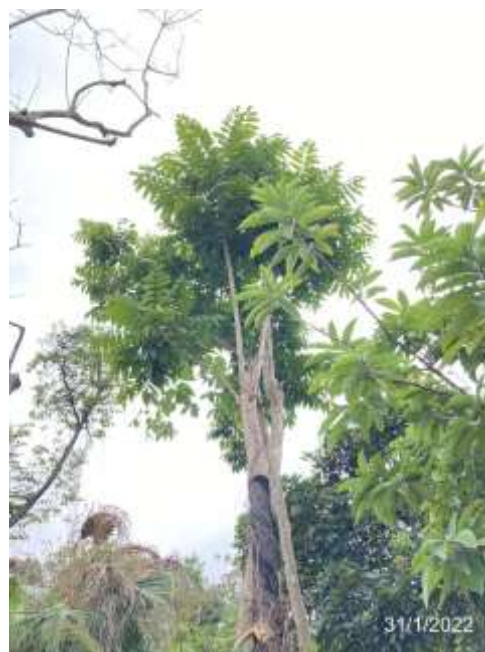
Photo 9. Two broken trunks of TA572.

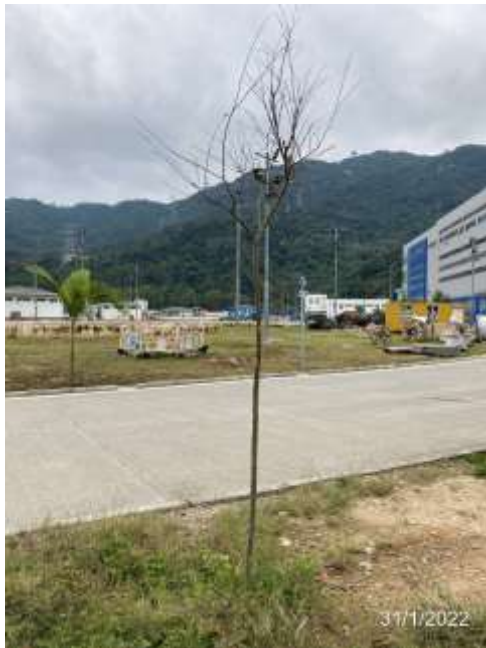
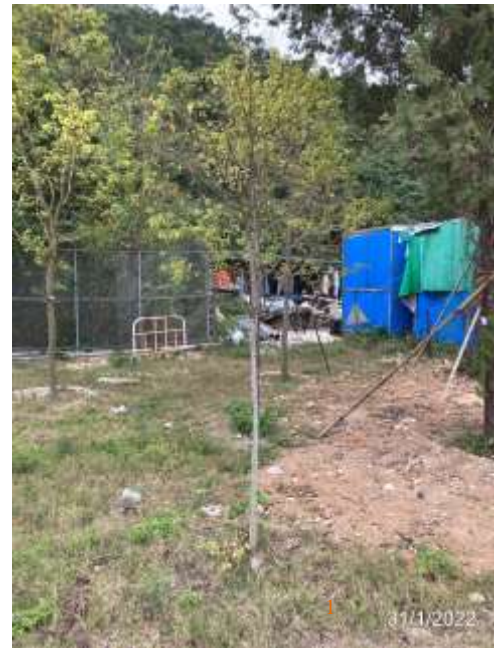
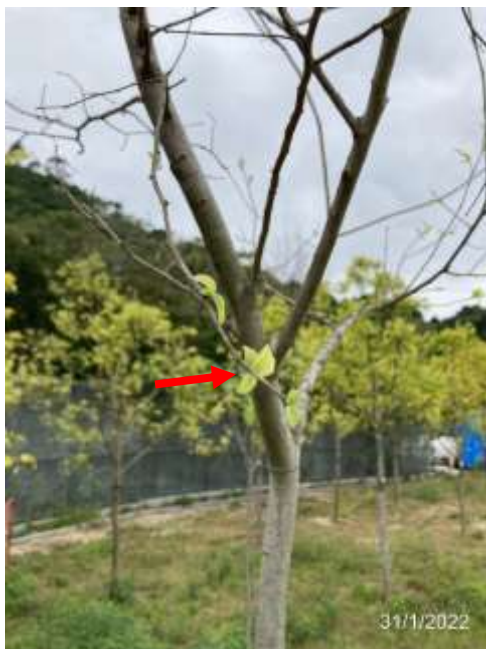
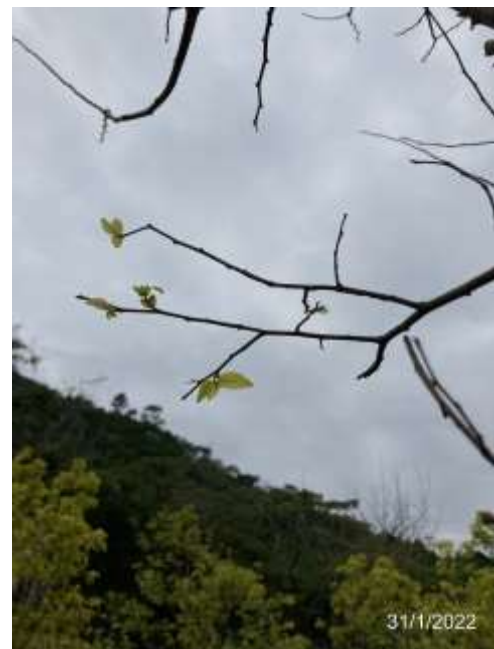
- 2.5.2 Compensatory planting of TA326 has been completed on 25 March 2020 by planting two *Syzygium levinei* and one *Schefflera heptaphylla*. However, the two native *Syzygium levinei* were mis-planted by two exotic *Syzygium jambos*, which has been replaced by another native tree species *Celtis sinensis* on 31 May 2021.

Photo 13 & 14. The two exotic *Syzygium jambos* (mis-treated as the native *Syzygium levinei*) are replaced by another native tree *Celtis sinensis* (due to market availability at this moment) as compensatory planting of TA326. *Celtis sinensis* is a deciduous species.

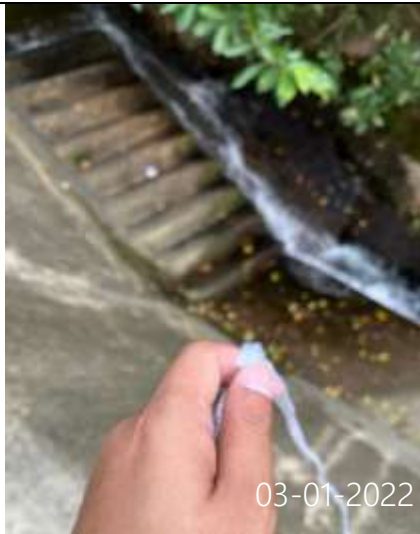
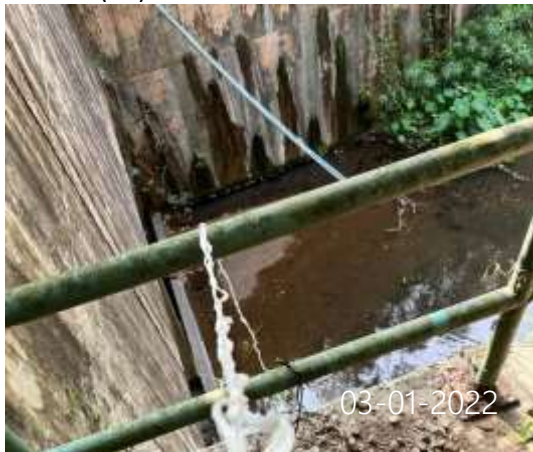
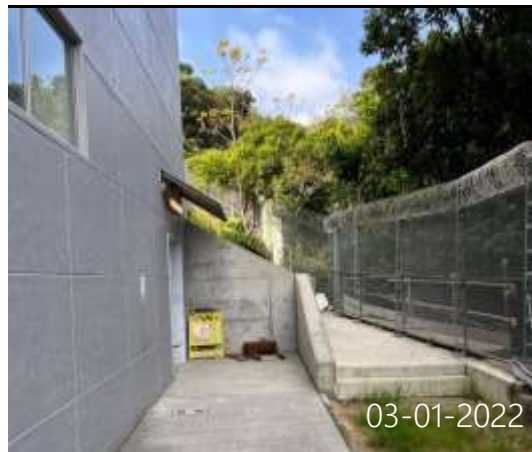
According to the field observation from ET on 3 January 2022, no polluted discharge was observed at C1 and M1 during the water monitoring and the water condition C1 and M1 was generally in order. The construction of Logistic center (next to C1, Photo 3) have been completed in December 2020, thus no construction work was conducted nearby.

- 5) Nevertheless, the Contractor should continually fully implement the water mitigation measures as recommended in the implementation schedule for environmental mitigation measures in the EM&A Manual.

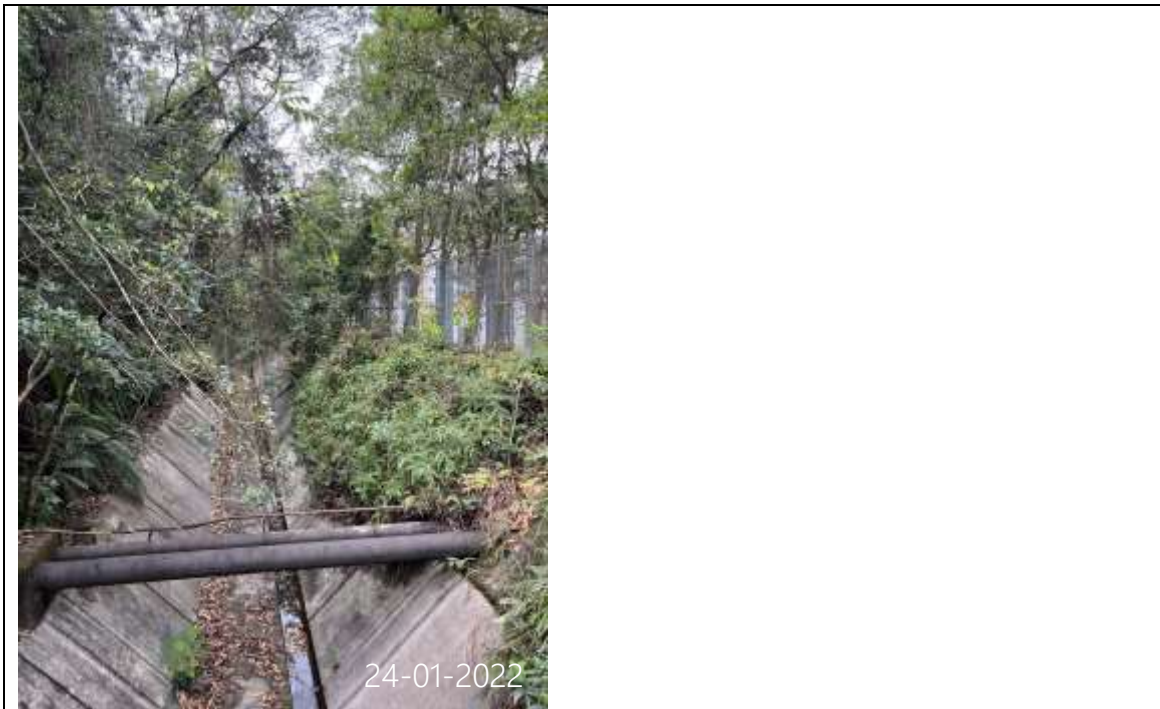
Photo 1

According to the field observation from ET on 28 January 2022, no polluted discharge was observed at C2 during the water monitoring and the water condition at Control Station C2 was generally in order.

- 4) Nevertheless, the Contractor should continually fully implement the water mitigation measures as recommended in the implementation schedule for environmental mitigation measures in the EM&A Manual.

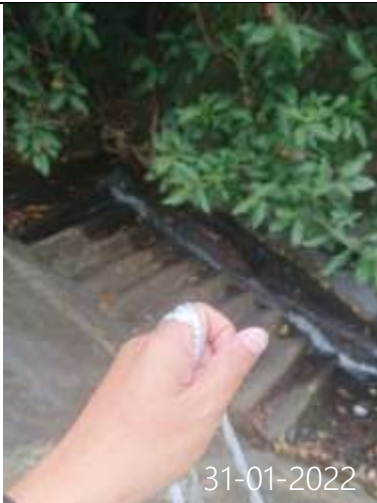
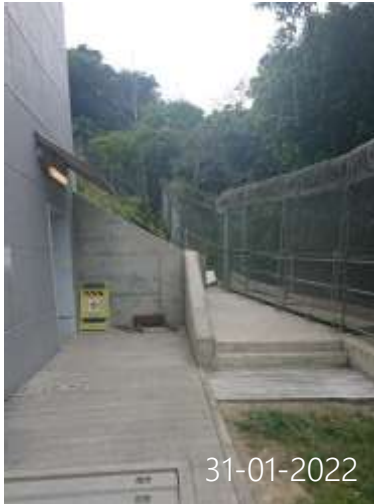
According to the field observation from ET on 31 January 2022, no polluted discharge was observed at C1 during the water monitoring and the water condition C1 was generally in order. The construction of Logistic center (next to C1, Photo 2) have been completed in December 2020, thus no construction work was conducted nearby.

- 4) Nevertheless, the Contractor should continually fully implement the water mitigation measures as recommended in the implementation schedule for environmental mitigation measures in the EM&A Manual.
