**IN-SITU REPROVISIONING OF SHA TIN WATER
TREATMENT WORKS (SOUTH WORKS) – WATER TREATMENT WORKS AND
ANCILLARY FACILITIES
Environmental Permit EP-494/2015**

- (a) Three hard copies,
- (b) Two copies of the 74th monthly Environmental Monitoring and Audit (EM&A) Report (Rev.0). (Register No.: AEIAR-187/2015)

**In-Situ Reprovisioning of Sha Tin Water Treatment Works (South Works) – Water Treatment Works and Ancillary Facilities
Environmental Permit EP-494/2015
Submission of 74th monthly EM&A Report**

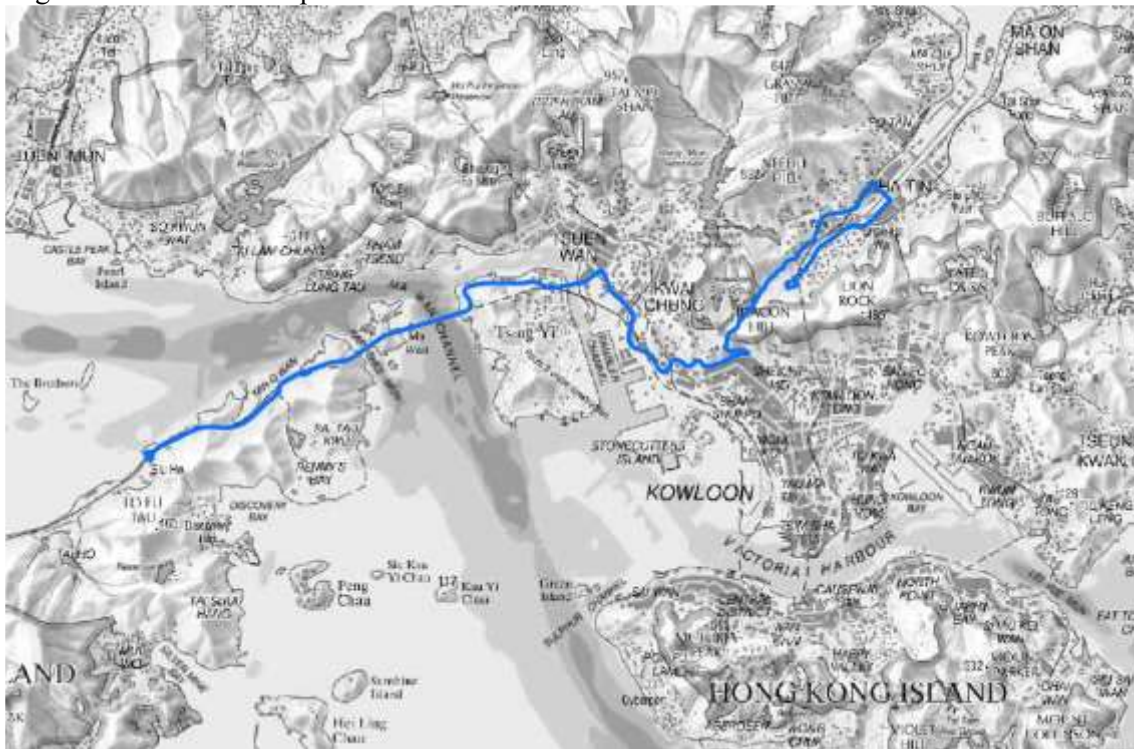
Figure 1: Chlorine Transport Route to Sha Tin Water Treatment Works

- 2.7.1 Chlorine is delivered to Sha Tin WTW in batches of up to 6×1-tonne drums. The transport route from Sham Shui Kok dock on North Lantau is shown in **Figure 1**. The route passes along the North Lantau Expressway, around the northern edge of Tsing Yi, through Tsuen Wan and along Tai Po Road (Piper's Hill) to Sha Tin (Table 2-15).

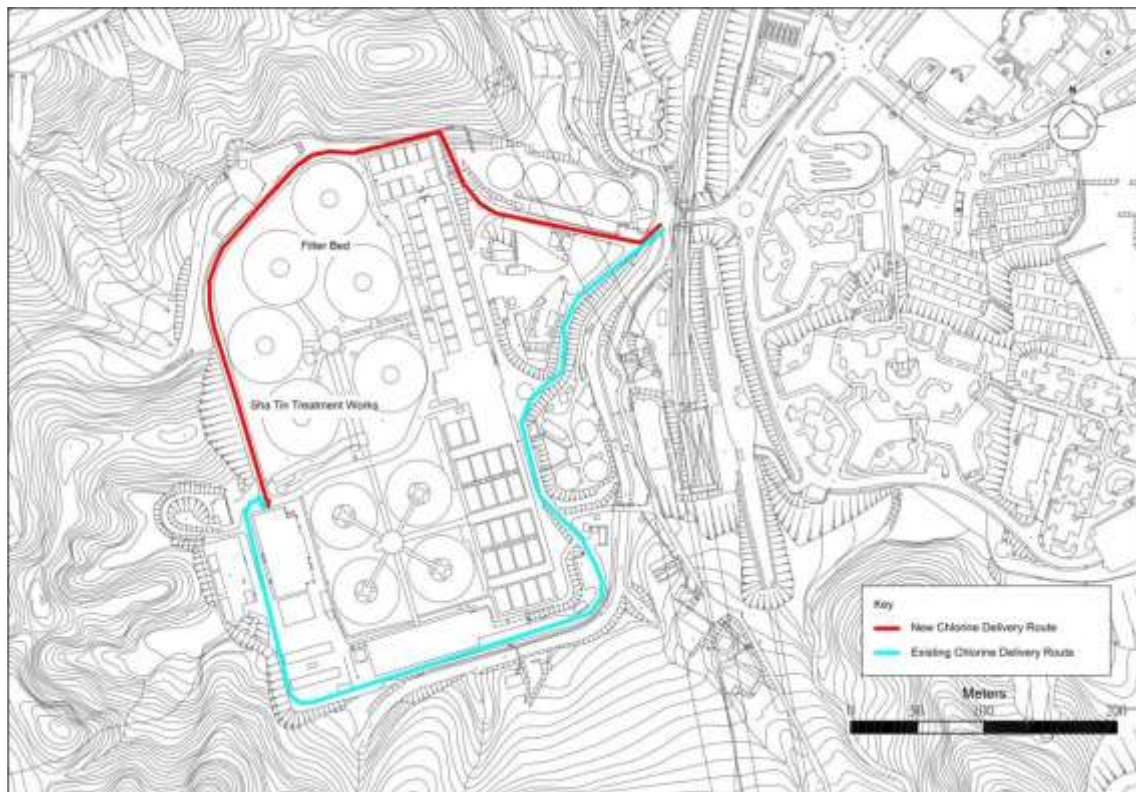
Figure 2: Chlorine Delivery Route at Sha Tin WTW

2.7.3 The on-site chlorine delivery route is shown in **Figure 2**.

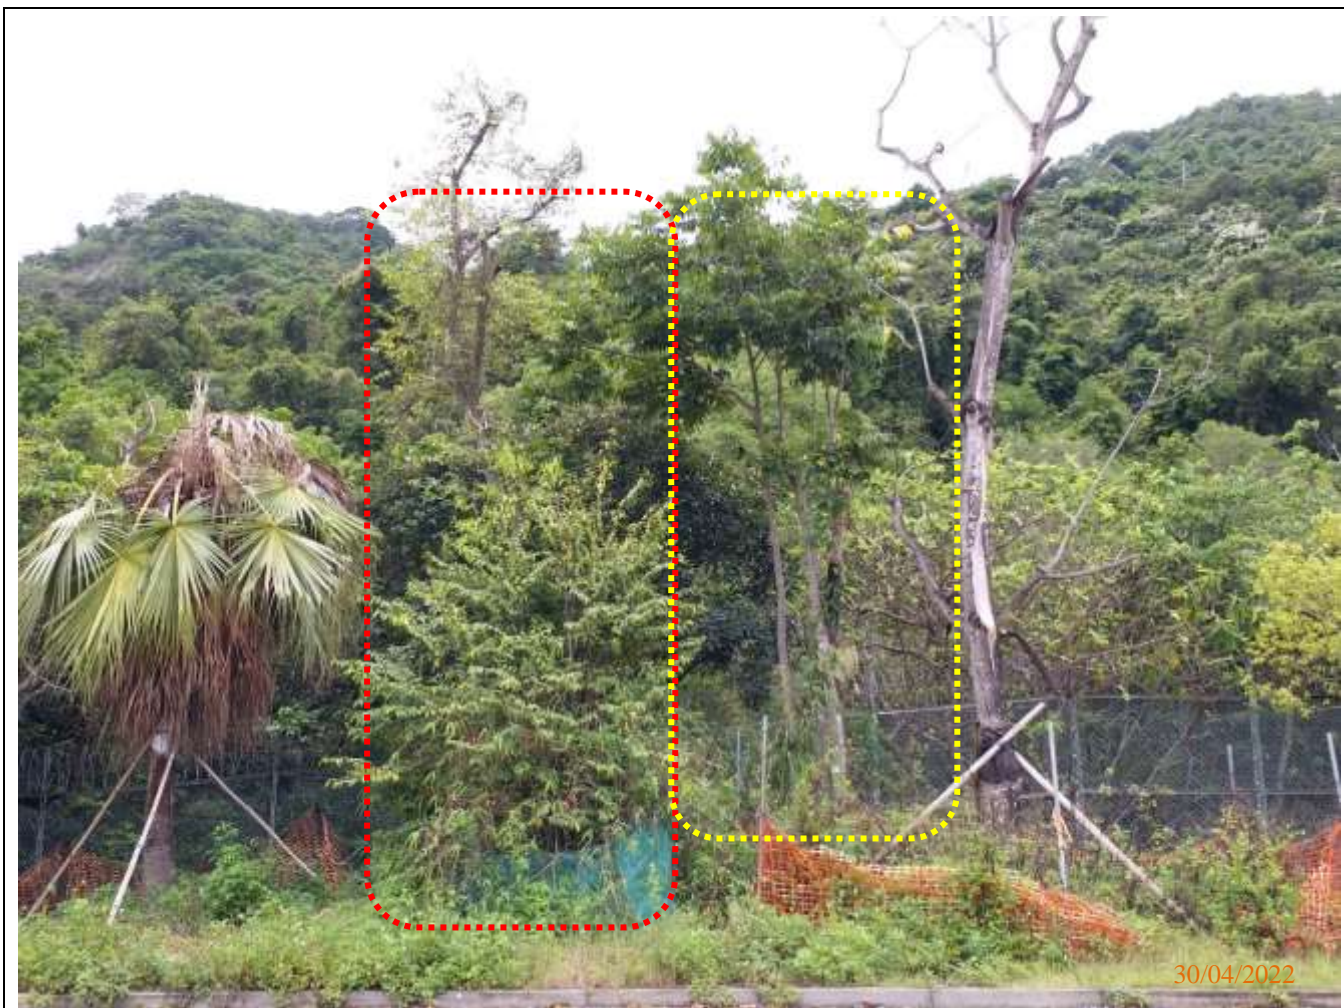
Photo 7. Transplanted Incense Tree (*Aquilaria sinensis*) – TA327 (left); and Ailanthus (*Ailanthus fordii*) – TA572 (right)

- 2.5.8 Root ball of TA572 and TA327 tree should be kept moisture especially during dry and non-raining day.

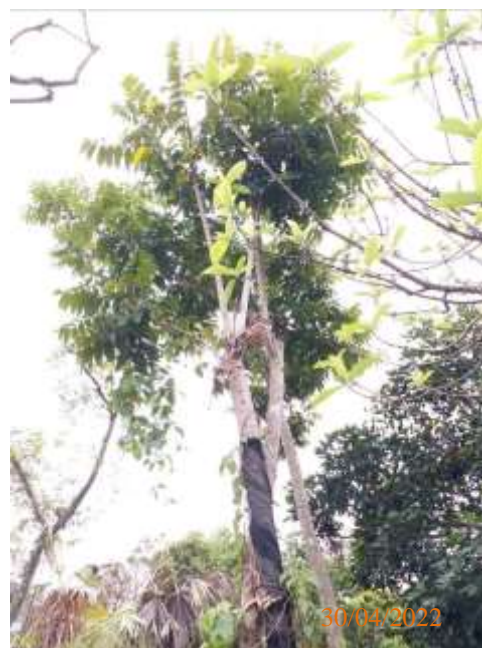
- 2.5.1 The condition of TA572 was observed in poor condition due to broken of main trunk. TA327 was also in poor condition; while already dead TA326 collapsed under Signal No. 10 typhoon Mangkhut in September 2018. Tree guying cables have been installed to provide external support to the two remaining transplanted trees.

Photo 9. Two broken trunks of TA572.

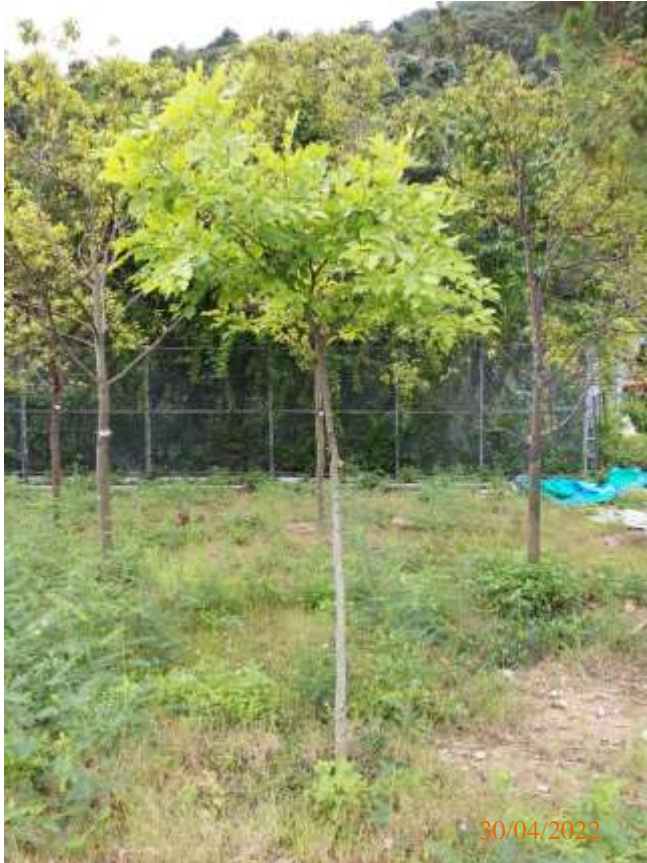
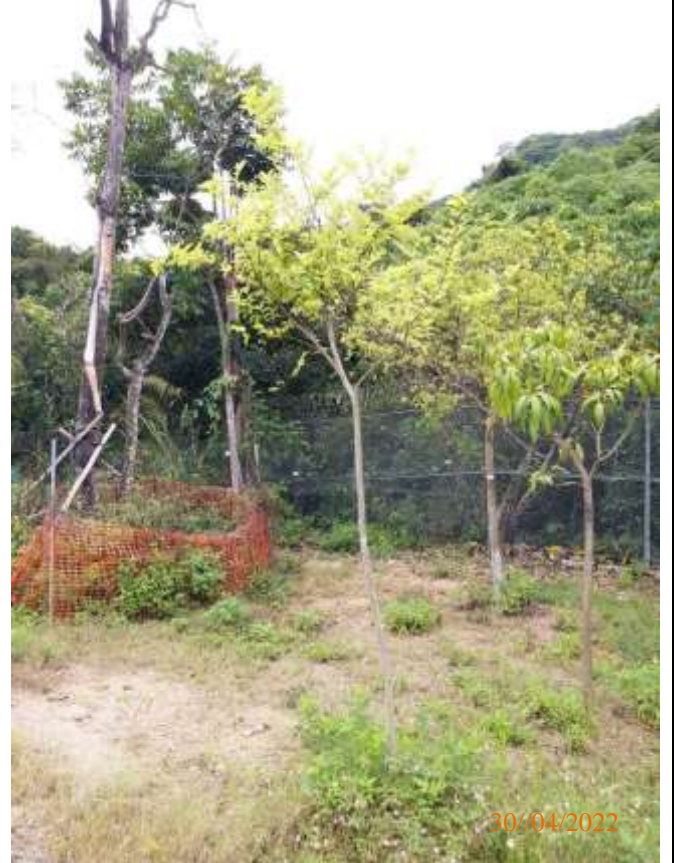
- 2.5.2 Compensatory planting of TA326 has been completed on 25 March 2020 by planting two *Syzygium levinei* and one *Schefflera heptaphylla*. However, the two native *Syzygium levinei* were mis-planted by two exotic *Syzygium jambos*, which has been replaced by another native tree species *Celtis sinensis* on 31 May 2021.

Photo 12 to 14. The two exotic *Syzygium jambos* (mis-treated as the native *Syzygium levinei*) are replaced by another native tree *Celtis sinensis* (due to market availability at this moment) as compensatory planting of TA326. *Celtis sinensis* is a deciduous species.

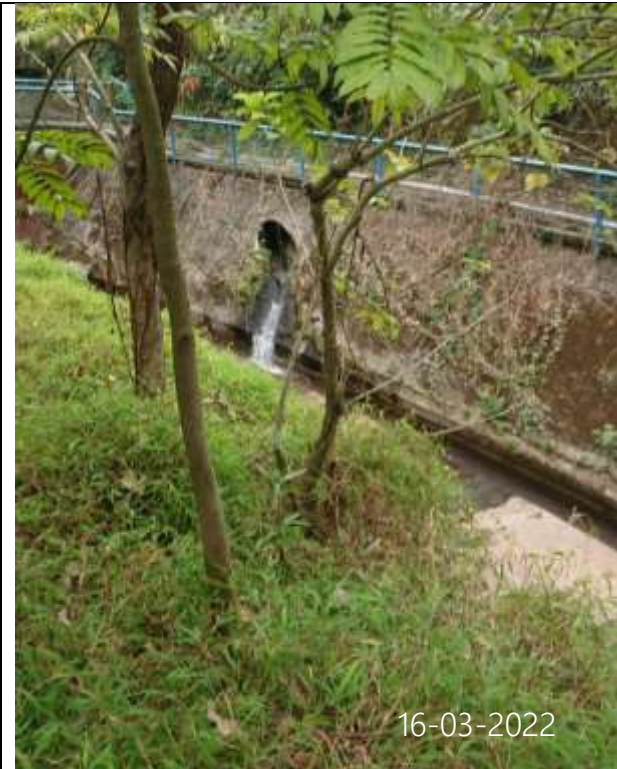
Photo 4

According to the field observation from ET on 16 March 2022, no polluted discharge was observed at C1, M1 and M3 during the water monitoring and the water condition C1, M1 and M3 was generally in order. The construction of Logistic center (next to C1, Photo 3) have been completed in December 2020, thus no construction work was conducted nearby.
