**MONTHLY ENVIRONMENTAL MONITORING AND AUDIT  
(EM&A) REPORT (NO. 8)**

**CONTRACT NO. 3/WSD/15  
IN-SITU REPROVISIONING OF SHA TIN  
WATER TREATMENT WORKS – SOUTH WORKS**

**(Rev. 0)**

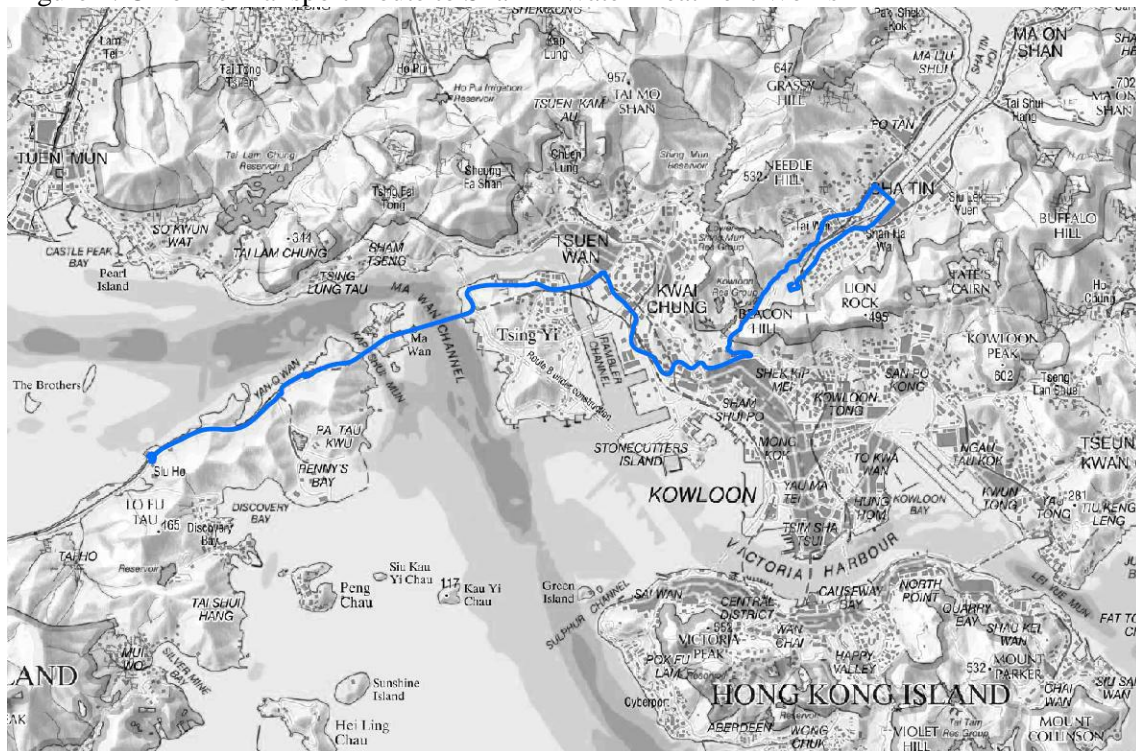
Figure 1: Chlorine Transport Route to Sha Tin Water Treatment Works

- 2.7.1 Chlorine is delivered to Sha Tin WTW in batches of up to 6×1-tonne drums. The transport route from Sham Shui Kok dock on North Lantau is shown in **Figure 1**. The route passes along the North Lantau Expressway, around the northern edge of Tsing Yi, through Tsuen Wan and along Tai Po Road (Piper's Hill) to Sha Tin (Table 2-15)

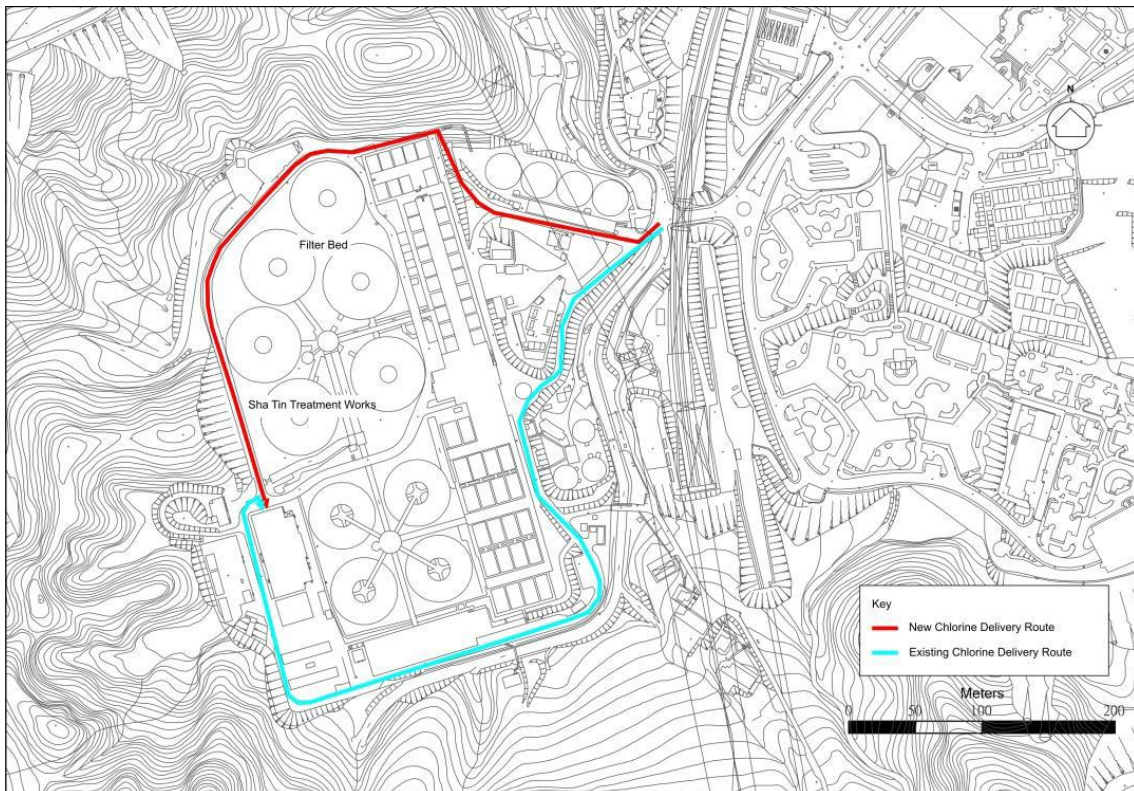
Figure 2: Chlorine Delivery Route at Sha Tin WTW

2.7.3 The on-site chlorine delivery route is shown in Figure 2.
