**IN-SITU REPROVISIONING OF SHA TIN WATER
TREATMENT WORKS (SOUTH WORKS) – WATER TREATMENT WORKS AND
ANCILLARY FACILITIES
Environmental Permit EP-494/2015**

- (a) Three hard copies,
- (b) Two copies of the 80th monthly Environmental Monitoring and Audit (EM&A) Report (Rev.0). (Register No.: AEIAR-187/2015)

**In-Situ Re provisioning of Sha Tin Water Treatment Works (South Works) – Water Treatment Works and Ancillary Facilities
Environmental Permit EP-494/2015
Submission of 80th monthly EM&A Report**

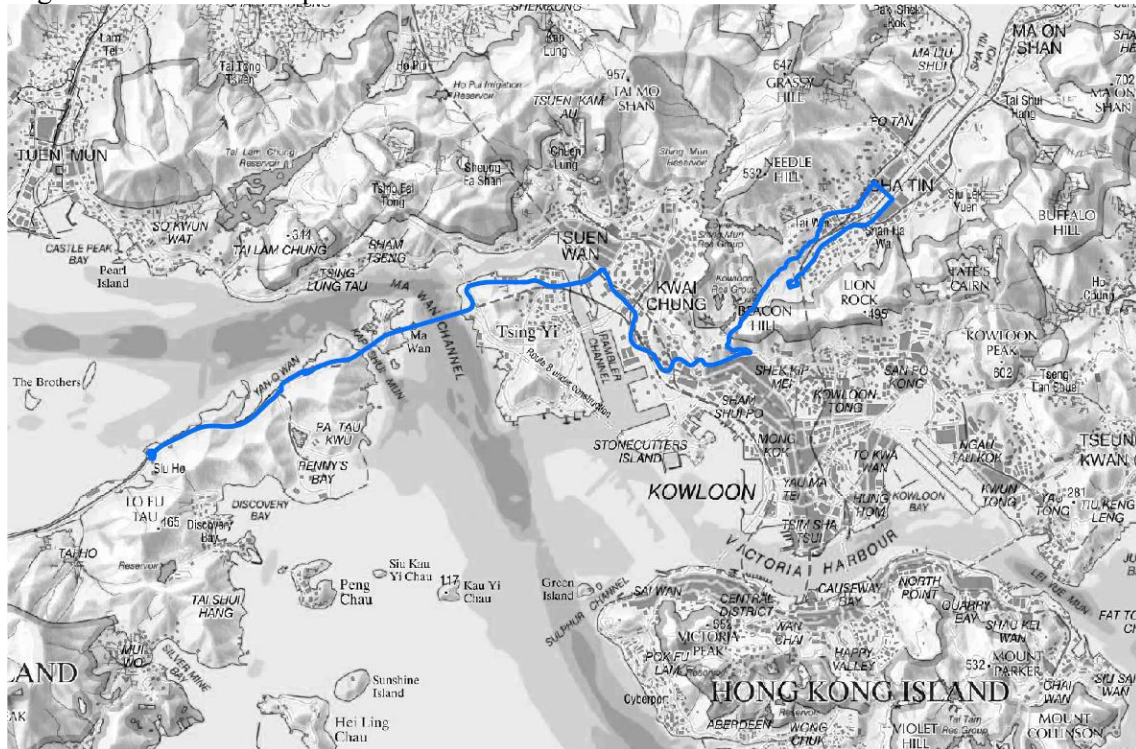
Figure 1: Chlorine Transport Route to Sha Tin Water Treatment Works

2.7.1 Chlorine is delivered to Sha Tin WTW in batches of up to 6×1-tonne drums. The transport route from Sham Shui Kok dock on North Lantau is shown in **Figure 1**. The route passes along the North Lantau Expressway, around the northern edge of Tsing Yi, through Tsuen Wan and along Tai Po Road (Piper's Hill) to Sha Tin (Table 2-15).

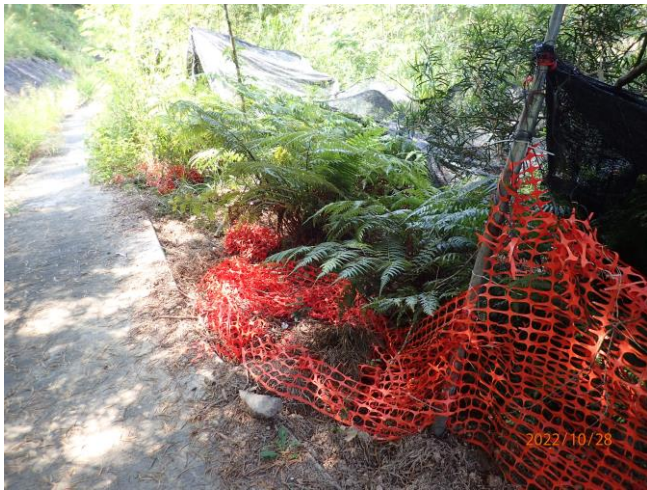
Photo 1. Broken orange fencing to be rectified

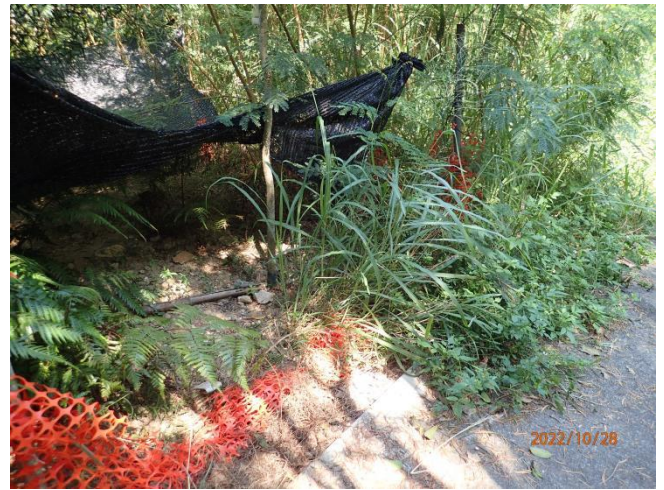
Photo 2. Overgrowing weeds to be removed

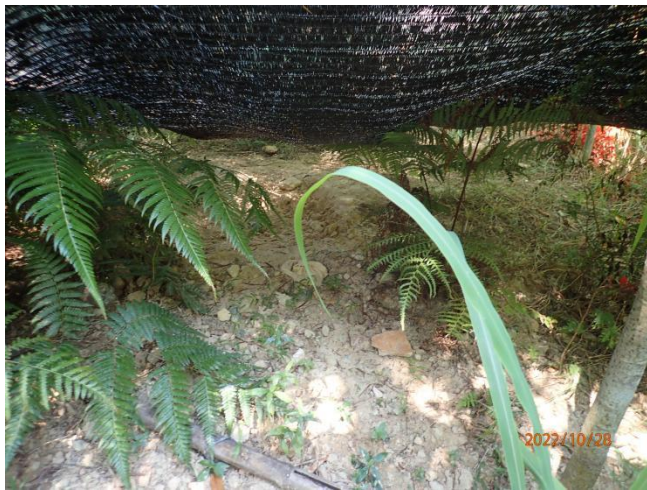
Photo 3. Sign of ploughing of wild boar

- 2.5.7 Root ball of TA572 and TA327 tree should be kept moisture especially during dry and non-raining day.
- 2.5.8 Signs of ploughed soil by wild boar(s) were found at the two groups of transplanted *Cibotium barometz*, making them exposed under sunlight or even uprooted. Installation of robust fencing, such as mesh wire, is recommended to protect the group of *Cibotium barometz* from damage caused by wild boars.

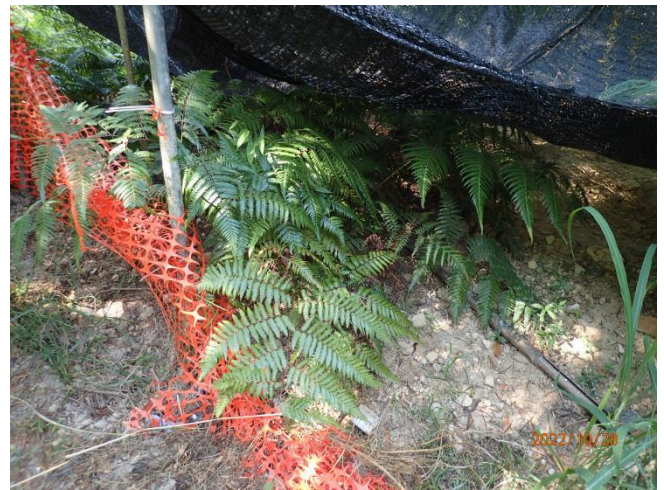
Photo 4. Broken orange fencing to be rectified

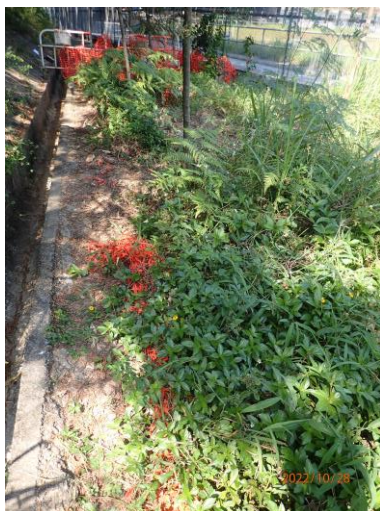
Photo 5. The shelter was severely damaged by wild boars. *Cibotium barometz* were exposed under direct sunlight and are vulnerable to uprooting

- 2.5.9 Given that leftover was observed nearby, illegal feeding of wild pigs or other wild animals was also suspected to occur. Warning signs of illegal feeding and plant protection zone may be put along the receptor site to remind the hikers. Reporting the case to the relevant government department, i.e. AFCD, is suggested to prevent further aggregation of wild boars in the area.

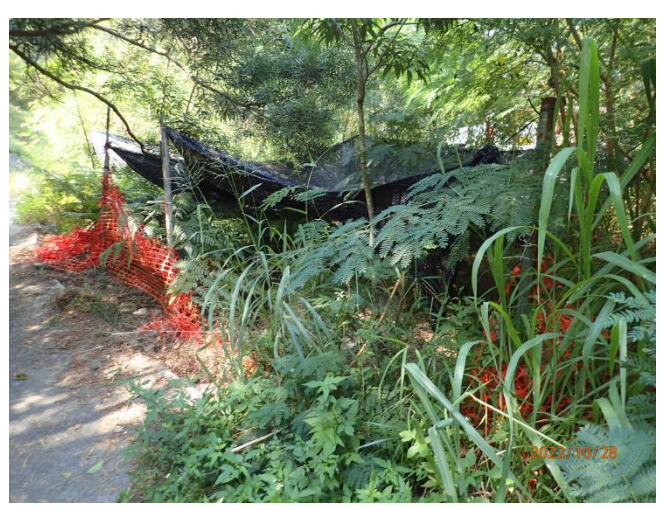
Photo 6. The shelter effectively reduced the amount of direct sunlight to *Cibotium barometz*. Broken orange fencing to be rectified.

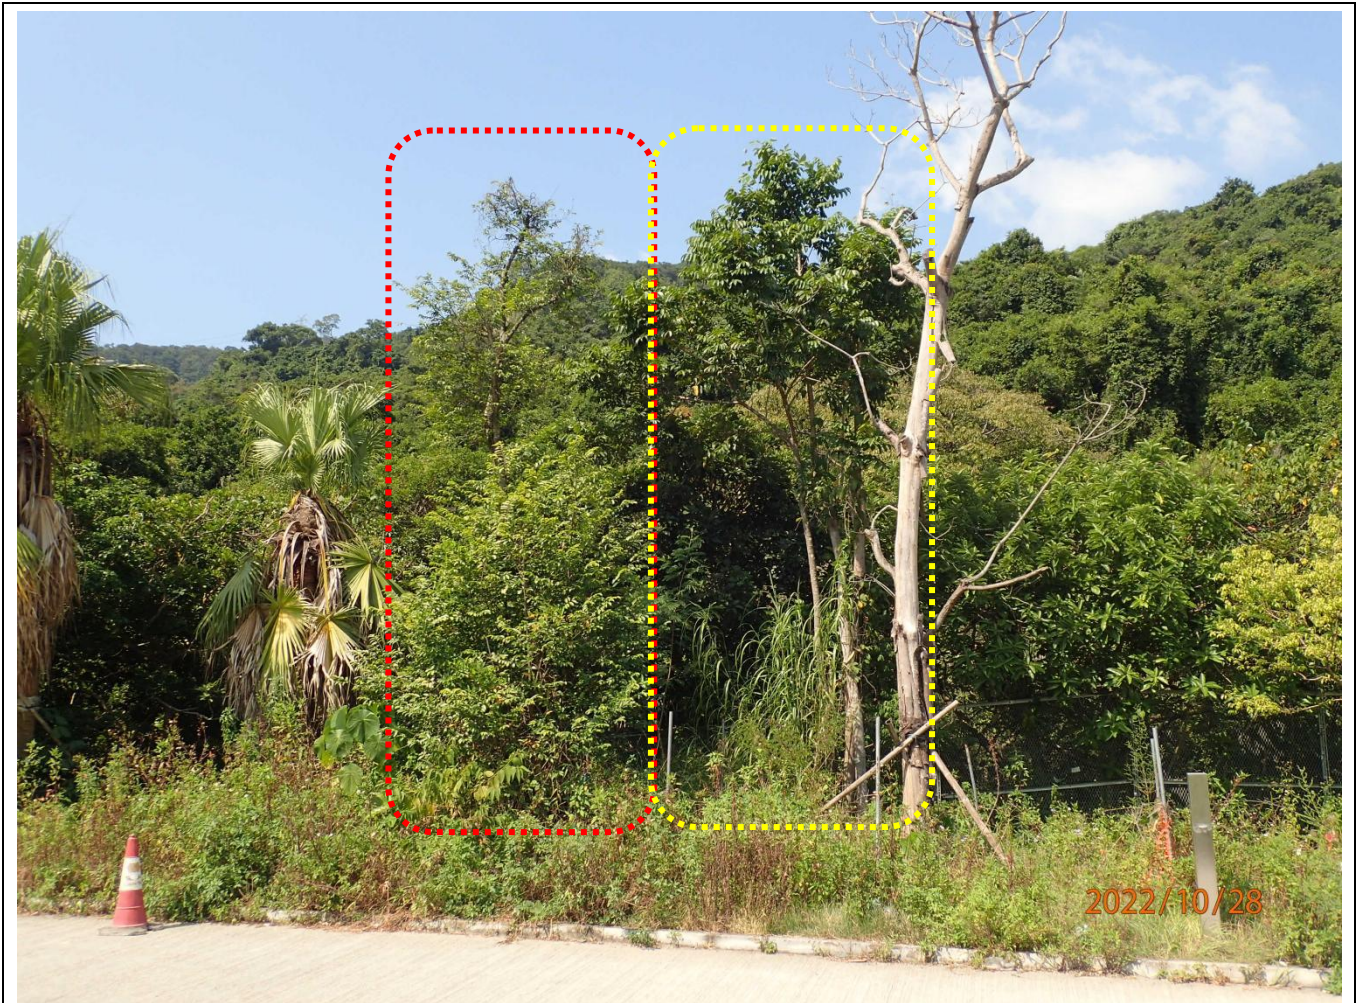
- 2.5.1 The condition of TA572 was observed in poor condition due to broken of main trunk. TA327 was also in poor condition; while already dead TA326 collapsed under Signal No. 10 typhoon Mangkhut in September 2018. Tree guying cables have been installed to provide external support to the two remaining transplanted trees.

Photo 7. Transplanted Incense Tree (*Aquilaria sinensis*) – TA327 (left); and Ailanthus (*Ailanthus fordii*) – TA572 (right)

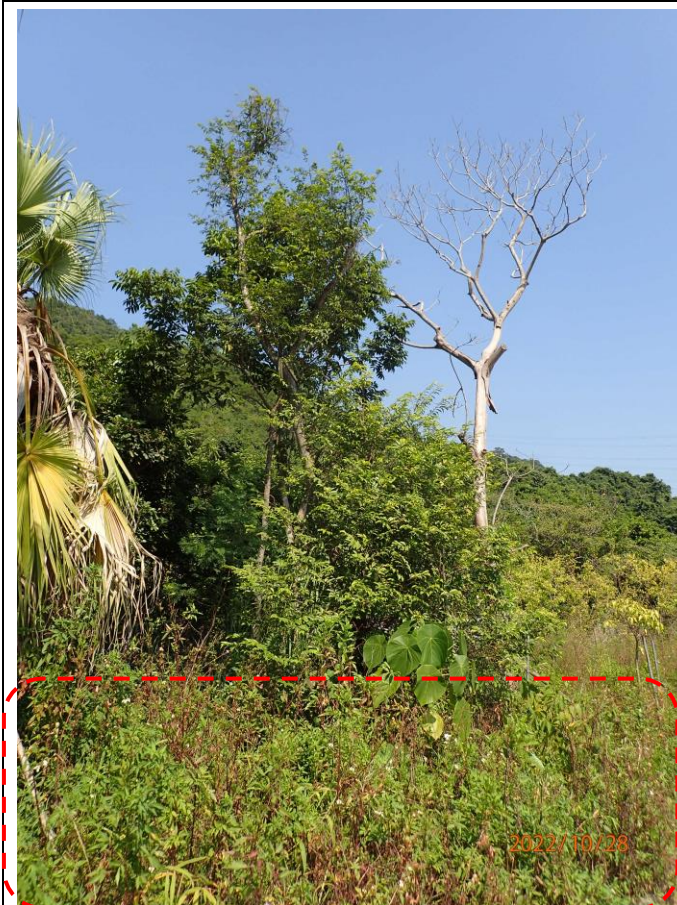
Photo 8. Weeding around TA327 shall be conducted (red zone).

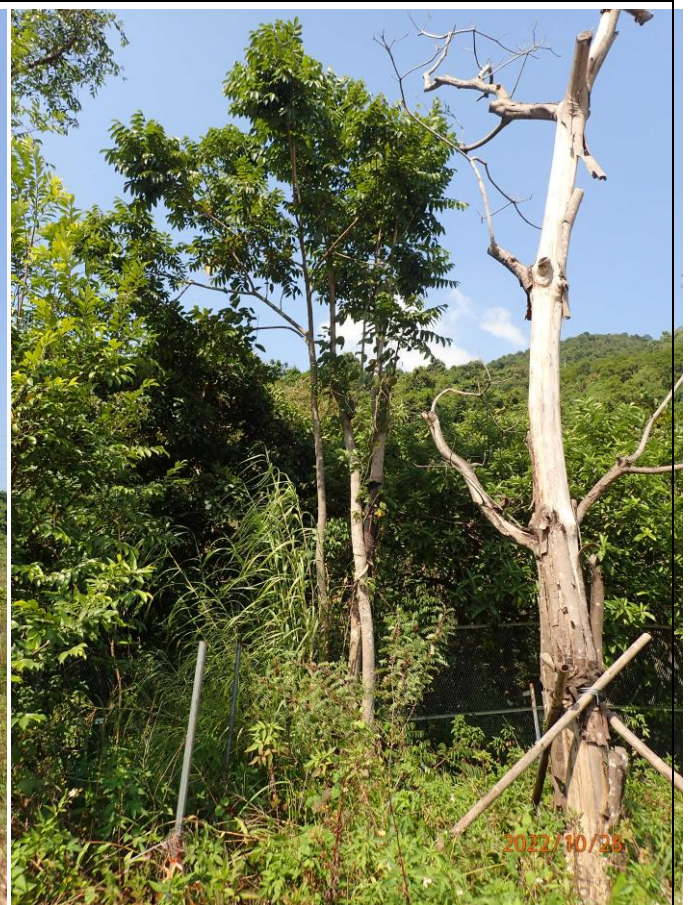
Photo 9. Overview of TA572.

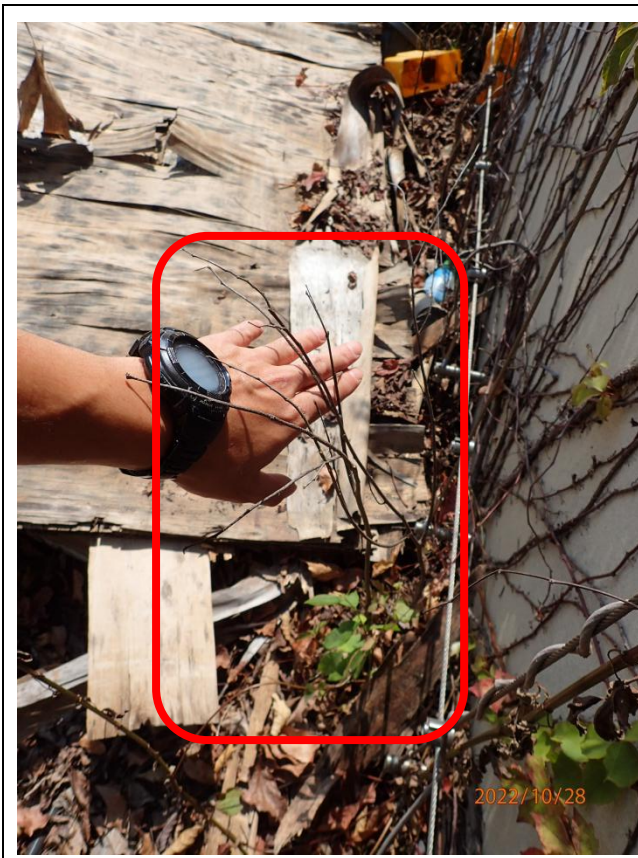
- 2.5.4 The two planted *Desmos chinensis* were found in very poor condition during this monitoring. Construction materials were also found too close to the planter. Replanting with an eye-catching protective fence shall be carried out.

Photo 10. Dead *Desmos chinensis*. Construction materials shall be taken away from the planting zone to avoid soil compaction and potential disturbance to the plant before re-planting.

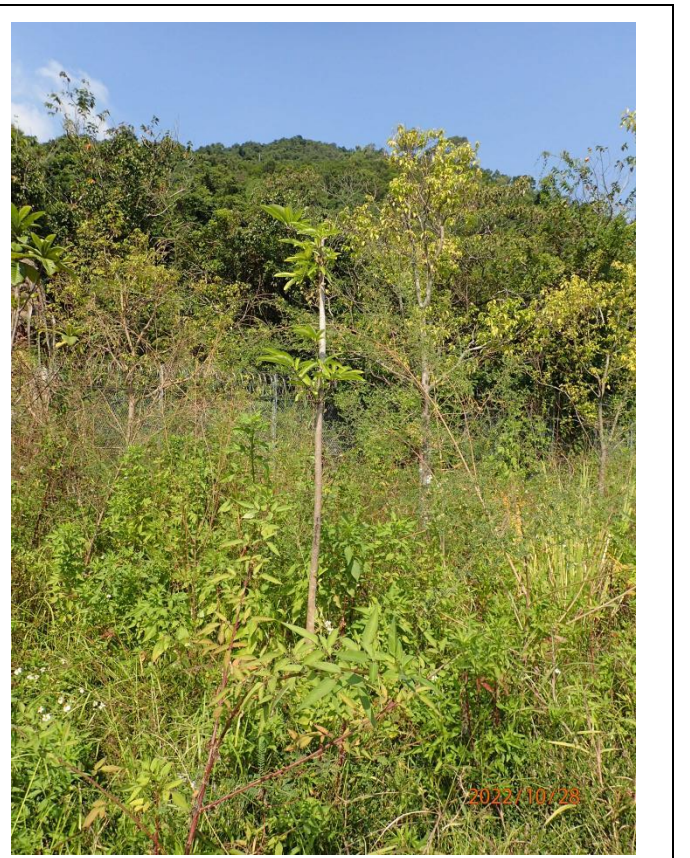
- 2.5.2 Compensatory planting of TA326 has been completed on 25 March 2020 by planting two *Syzygium levinei* and one *Schefflera heptaphylla*. However, the two native *Syzygium levinei* were mis-planted by two exotic *Syzygium jambos*, which has been replaced by another native tree species *Celtis sinensis* on 31 May 2021.

Photo 11. *Schefflera heptaphylla* as compensatory planting of TA326; sign of chlorosis.

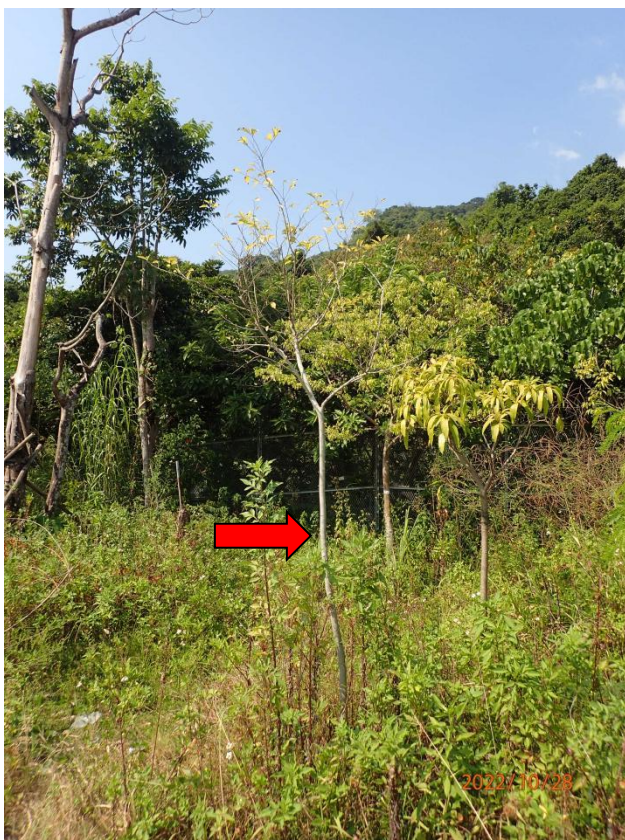
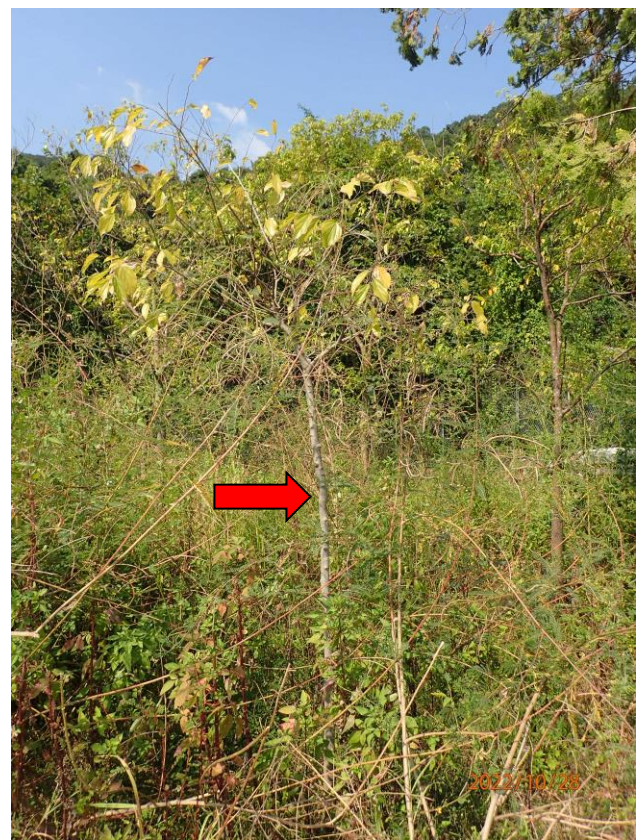
Photo 12 and 13. The two exotic *Syzygium jambos* (mis-treated as the native *Syzygium levinei*) are replaced by another native tree *Celtis sinensis* (due to market availability) as compensatory planting of TA326. *Celtis sinensis* is a deciduous species.
Weeding shall be carried out during routine maintenance work
