**CONTRACT NO. 1/WSD/19 & 6/WSD/21**

**IN-SITU REPROVISIONING OF SHA TIN WATER  
TREATMENT WORKS (SOUTH WORKS) – WATER TREATMENT WORKS AND  
ANCILLARY FACILITIES  
Environmental Permit EP-494/2015**

**In-Situ Re provisioning of Sha Tin Water Treatment Works (South Works) – Water Treatment Works and Ancillary Facilities  
Environmental Permit EP-494/2015  
Submission of 85<sup>th</sup> monthly EM&A Report**

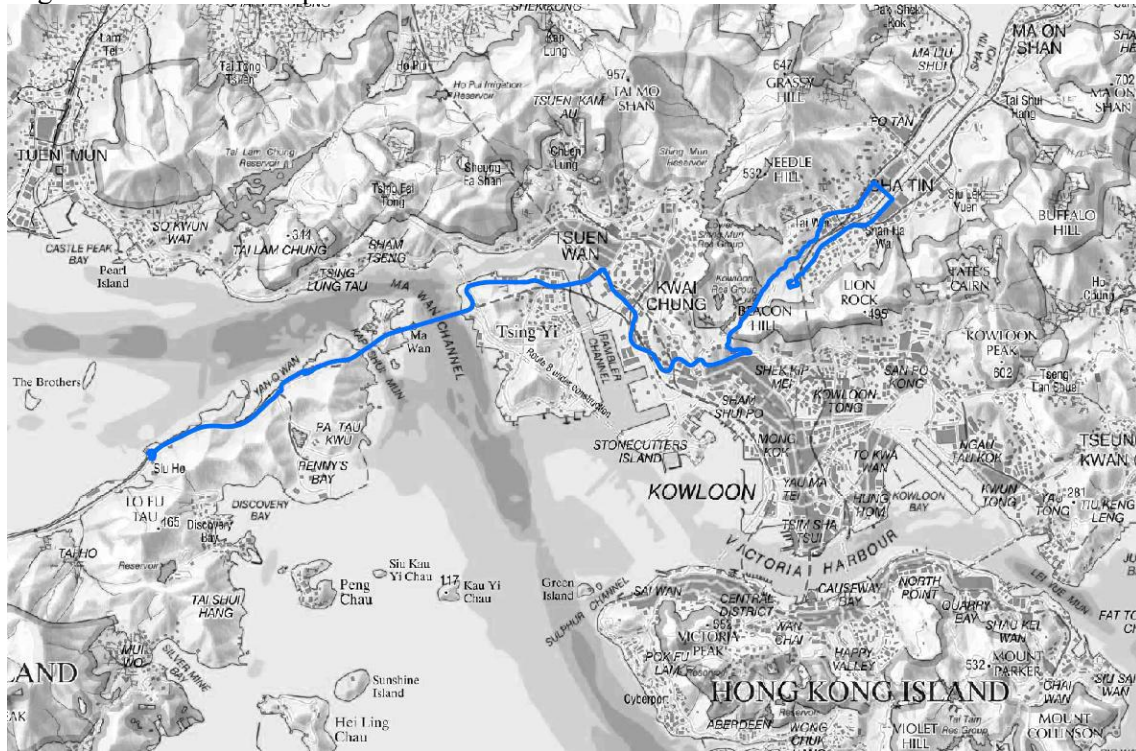
Figure 1: Chlorine Transport Route to Sha Tin Water Treatment Works

2.7.1 Chlorine is delivered to Sha Tin WTW in batches of up to 6×1-tonne drums. The transport route from Sham Shui Kok dock on North Lantau is shown in **Figure 1**. The route passes along the North Lantau Expressway, around the northern edge of Tsing Yi, through Tsuen Wan and along Tai Po Road (Piper's Hill) to Sha Tin (Table 2-15).

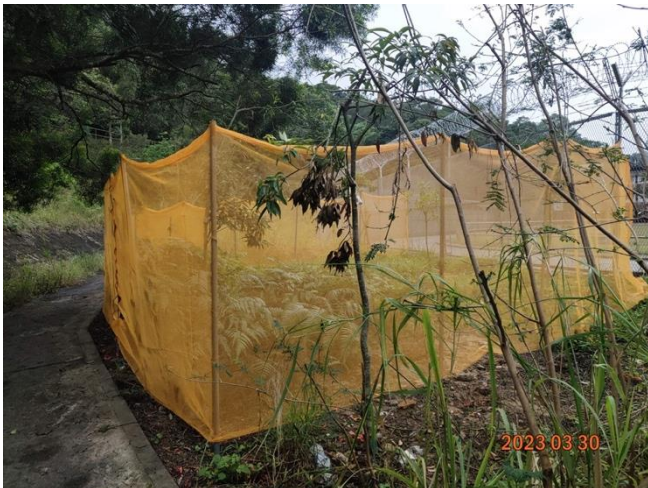
Photo 1. A robust protection zone with eye-catching color was set up in both patches of *Cibotium barometz*.

- 2.5.7 Root ball of TA572 and TA327 tree should be kept moisture especially during dry and non-raining day.
- 2.5.8 Signs of ploughed soil by wild boar(s) at the two groups of transplanted *Cibotium barometz* were reported in previous monitoring. A robust fencing was recently installed to protect the group of *Cibotium barometz* from further damage caused by wild boars.

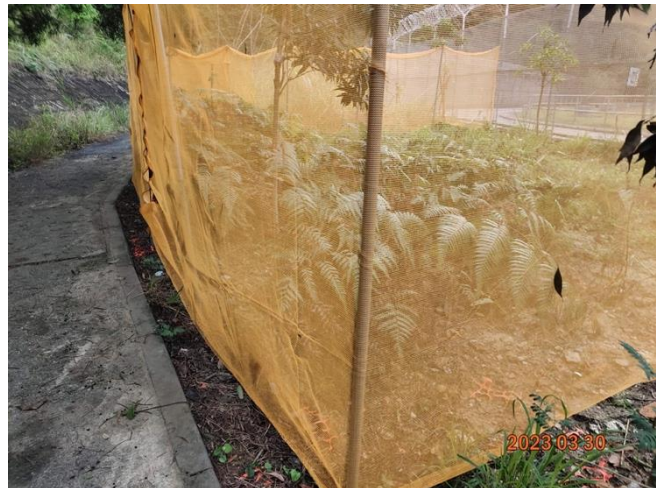
Photo 2. A protective fence for another patch of *Cibotium barometz*.

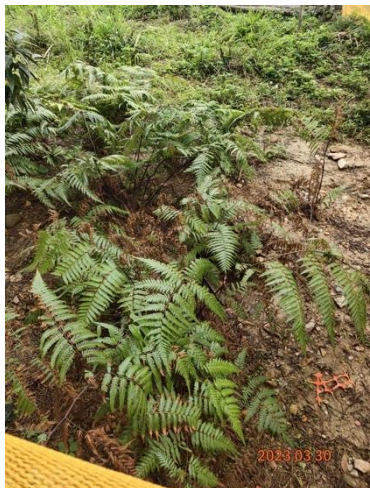
Photo 3. Garbage was cleared out of the protection zone

- 2.5.9 Given that leftover/ garbage was observed nearby, illegal feeding of wild pigs or other wild animals was also suspected to occur. Warning signs of illegal feeding and plant protection zone may be put along the receptor site to remind the hikers. Reporting the case to the relevant government department, i.e. AFCD, is suggested to prevent further aggregation of wild boars in the area.

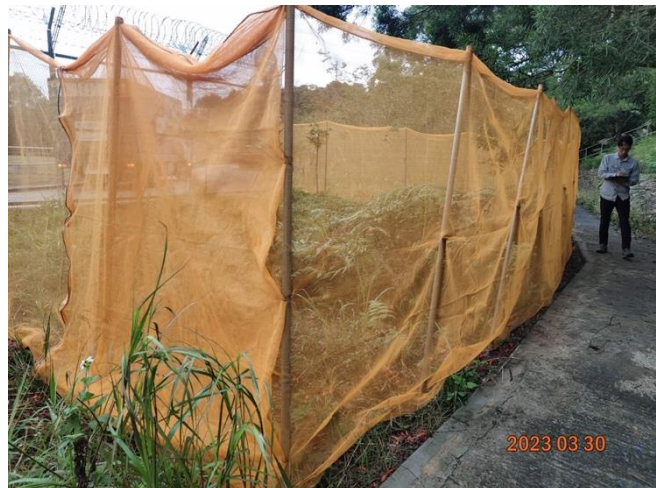
Photo 4. The protective fence provides half-shade for the *Cibotium barometz*.

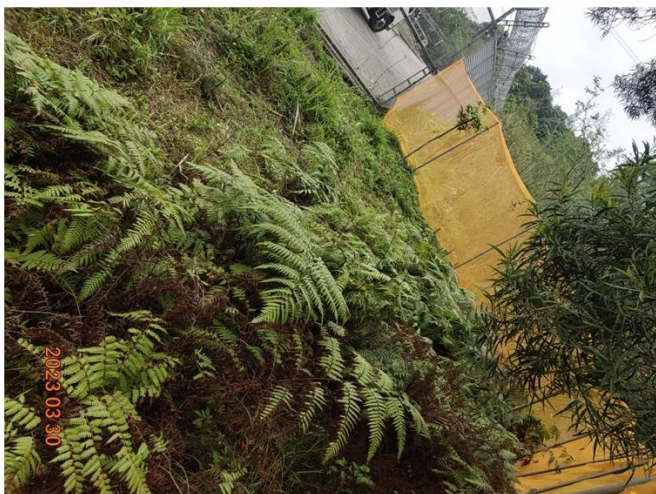
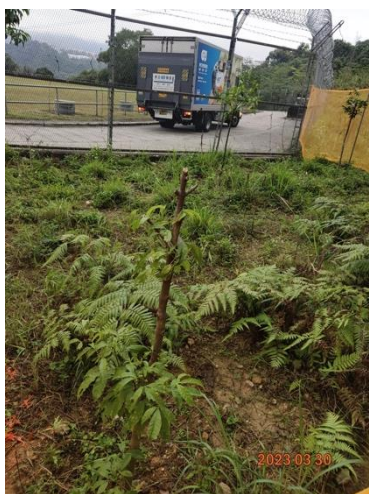
Photo 5 & 6. All *Cibotium barometz* individuals are now protected by robust fencing and growing in satisfactory condition.

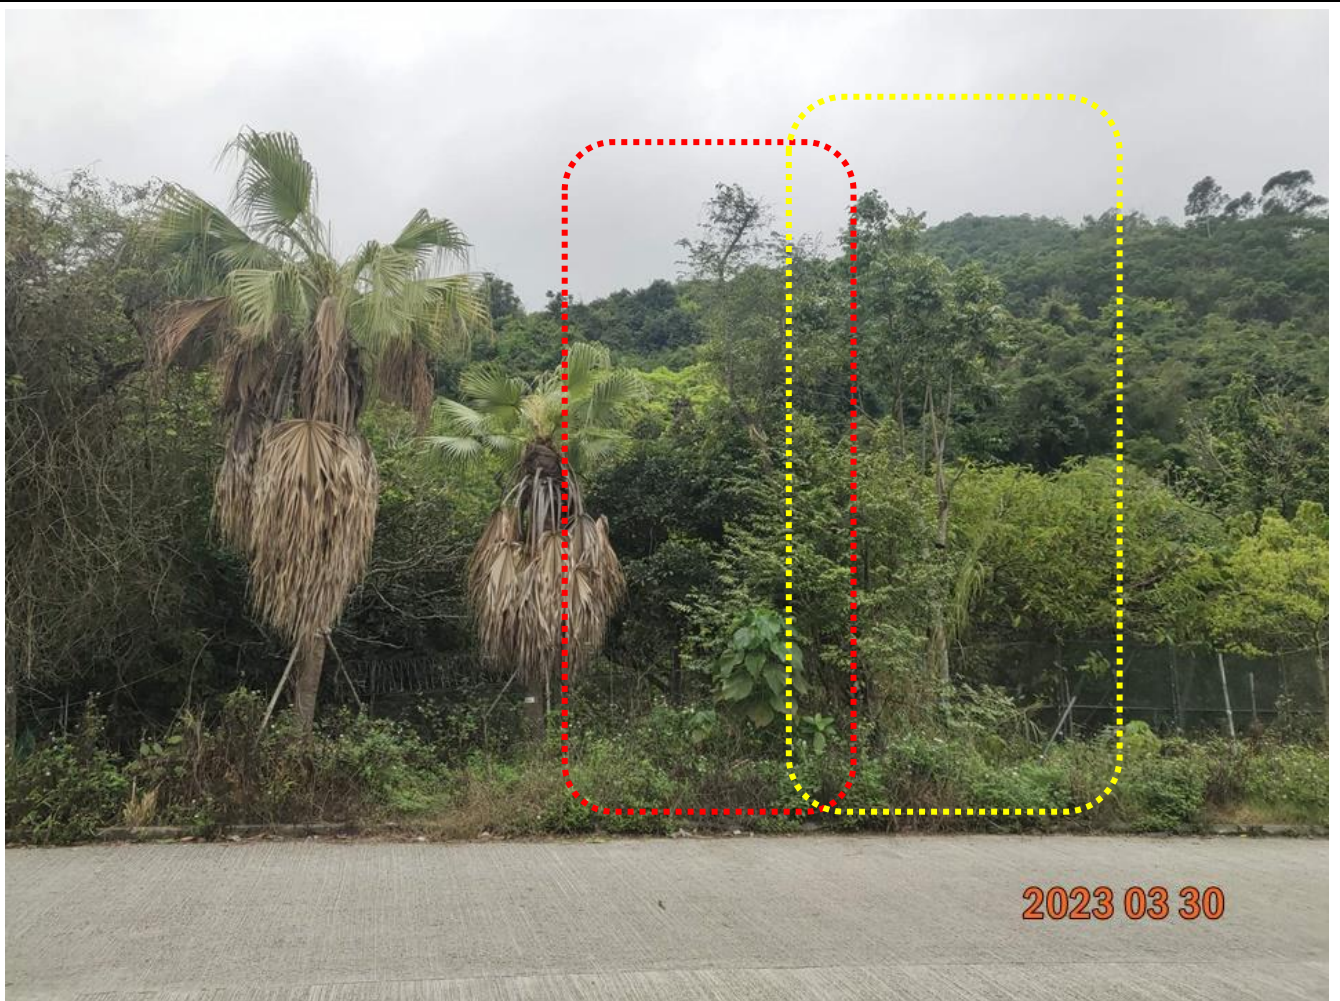
- 2.5.1 The condition of TA572 was observed in fair health despite in poor form. TA327 was also in poor condition; while already dead TA326 collapsed under Signal No. 10 typhoon Mangkhut in September 2018. Tree guying cables have been installed to provide external support to the two remaining transplanted trees.

Photo 7. Transplanted Incense Tree (*Aquilaria sinensis*) – TA327 (left); and Ailanthus (*Ailanthus fordii*) – TA572 (right)

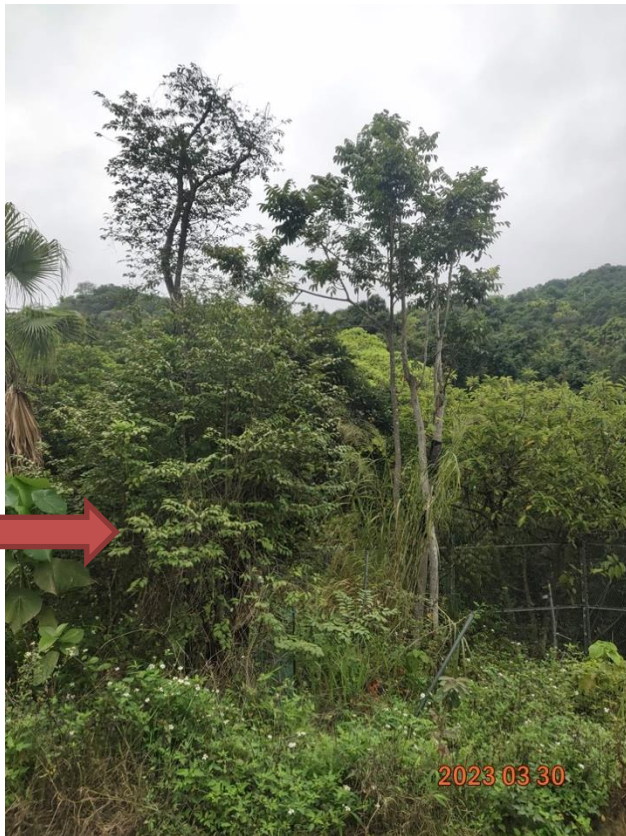
Photo 8. Sprouts at lower trunk of TA327 (*Aquilaria sinensis*).

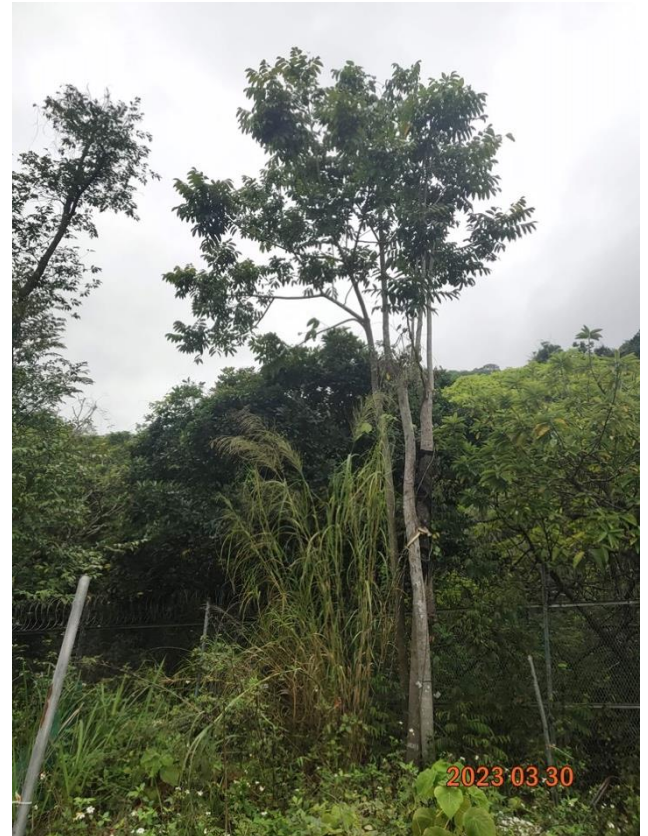
Photo 9. TA572 (*Ailanthus fordii*) was found vigorous and in good condition.

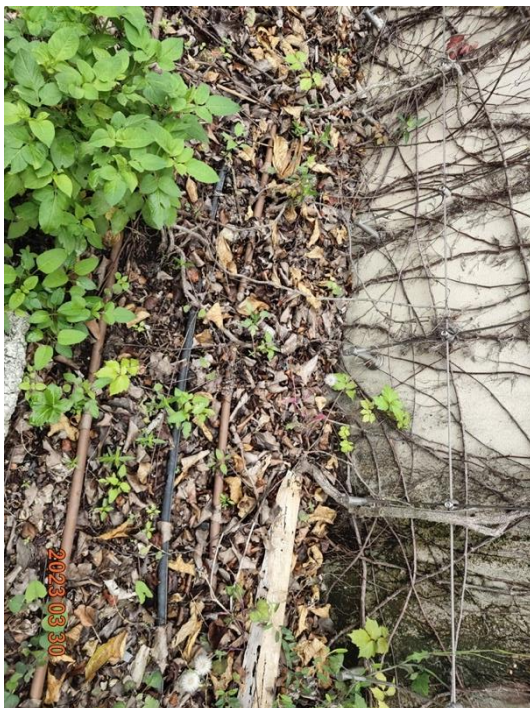
- 2.5.4 New small sprouts keep emerging from the two *Desmos chinensis* that have been reported dead previously. Construction materials was also found too close to the planter. An eye-catching protective fence shall be set up as a protection zone. No construction materials shall be placed near/ within the protection zone.

Photo 10. New sprouts keep emerging from the *Desmos chinensis* that reported dead previously. Construction materials nearby have been taken away.

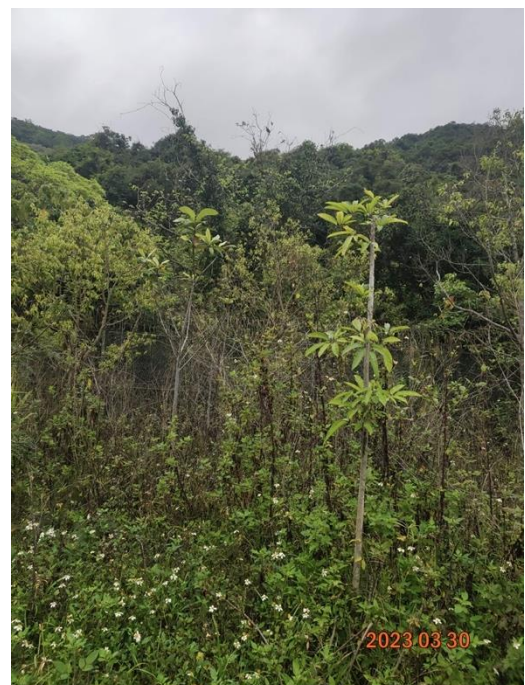
Photo 11. *Schefflera heptaphylla* as compensatory planting of TA326; sign of chlorosis.

- 2.5.2 Compensatory planting of TA326 has been completed on 25 March 2020 by planting two *Syzygium levinei* and one *Schefflera heptaphylla*. However, the two native *Syzygium levinei* were mis-planted by two exotic *Syzygium jambos*, which has been replaced by another native tree species *Celtis sinensis* on 31 May 2021.

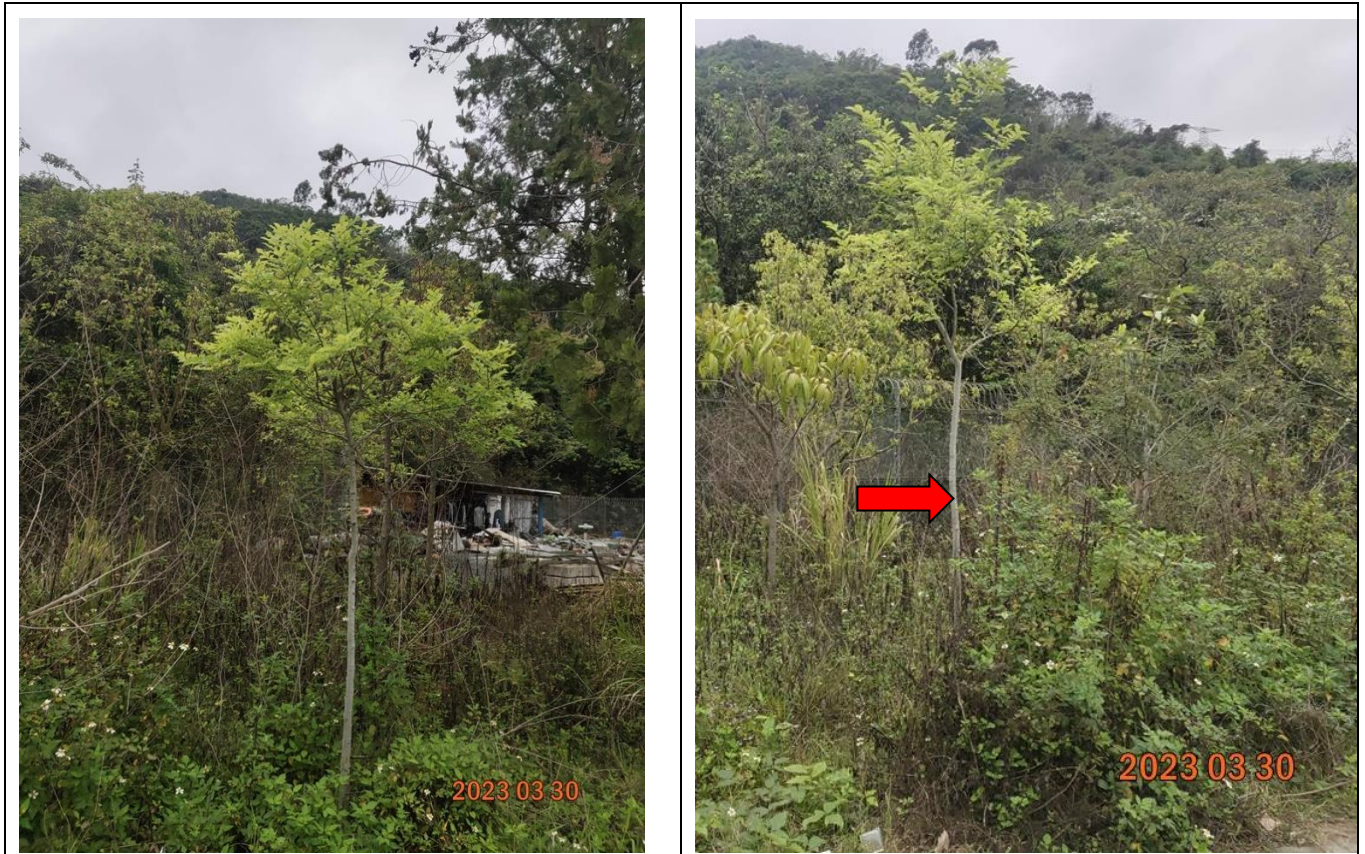
Photo 12 and 13. The two exotic *Syzygium jambos* (mis-treated as the native *Syzygium levinei*) are replaced by another native tree *Celtis sinensis* (due to market availability) as compensatory planting of TA326. *Celtis sinensis* is a deciduous species and they were found producing new leaves.  
Weeding shall be carried out during routine maintenance work
