**CONTRACT NO. 1/WSD/19 & 6/WSD/21**

**IN-SITU REPROVISIONING OF SHA TIN WATER  
TREATMENT WORKS (SOUTH WORKS) – WATER TREATMENT WORKS AND  
ANCILLARY FACILITIES  
Environmental Permit EP-494/2015**

**In-Situ Re provisioning of Sha Tin Water Treatment Works (South Works) – Water Treatment Works and Ancillary Facilities  
Environmental Permit EP-494/2015  
Submission of 88<sup>th</sup> monthly EM&A Report**

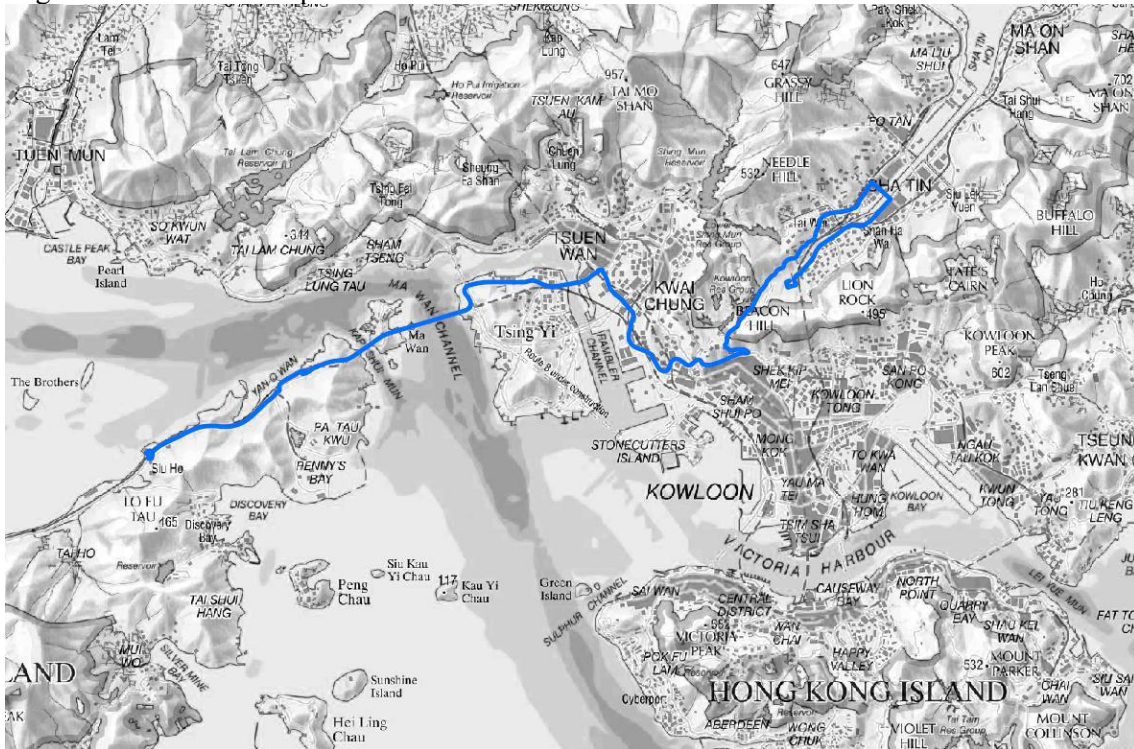
Figure 1: Chlorine Transport Route to Sha Tin Water Treatment Works

2.7.1 Chlorine is delivered to Sha Tin WTW in batches of up to 6×1-tonne drums. The transport route from Sham Shui Kok dock on North Lantau is shown in **Figure 1**. The route passes along the North Lantau Expressway, around the northern edge of Tsing Yi, through Tsuen Wan and along Tai Po Road (Piper's Hill) to Sha Tin (Table 2-15).

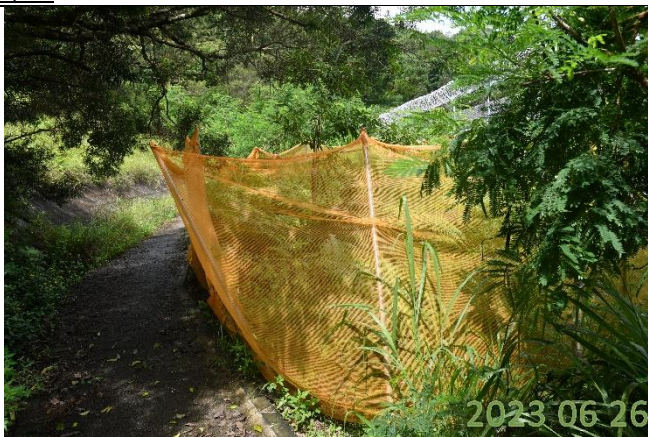
Photo 1. A robust protection zone with eye-catching color was set up in both patches of *Cibotium barometz*.

- 2.5.7 Root ball of TA572 and TA327 tree should be kept moisture especially during dry and non-raining day.
- 2.5.8 Signs of ploughed soil by wild boar(s) at the two groups of transplanted *Cibotium barometz* were reported in previous monitoring. A robust fencing was recently installed to protect the group of *Cibotium barometz* from further damage caused by wild boars.

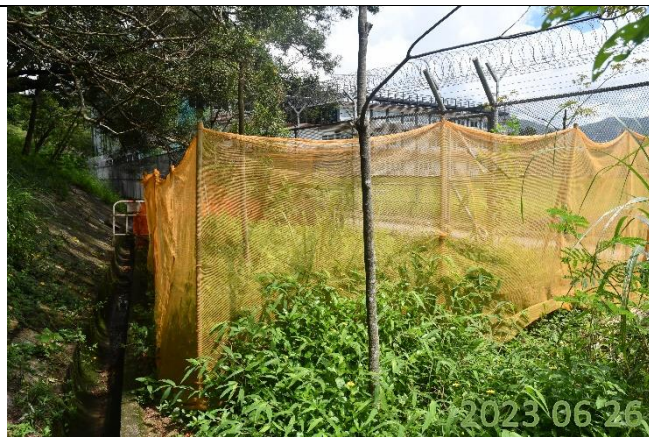
Photo 2. A protective fence for another patch of *Cibotium barometz*.

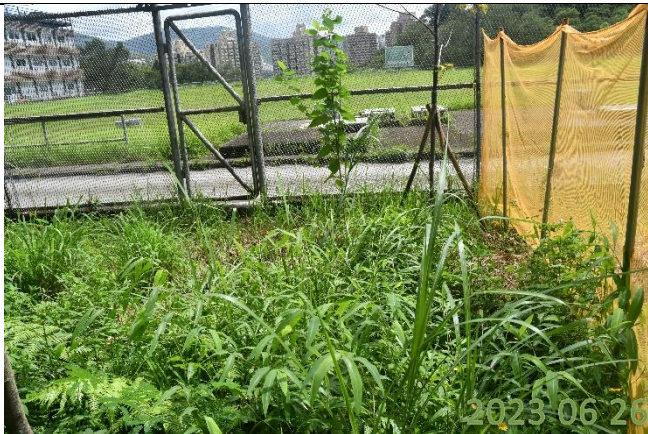
Photo 3. Garbage was cleared out of the protection zone

- 2.5.9 Given that leftover/ garbage was observed nearby, illegal feeding of wild pigs or other wild animals was also suspected to occur. Warning signs of illegal feeding and plant protection zone may be put along the receptor site to remind the hikers. Reporting the case to the relevant government department, i.e. AFCED, is suggested to prevent further aggregation of wild boars in the area.

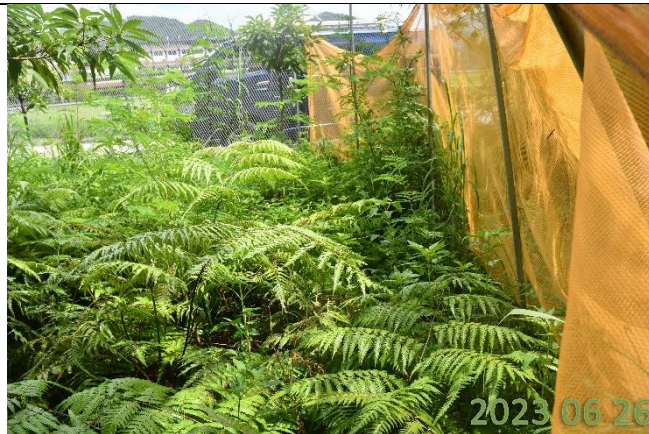
Photo 4. The protective fence provides half-shade for the *Cibotium barometz*.

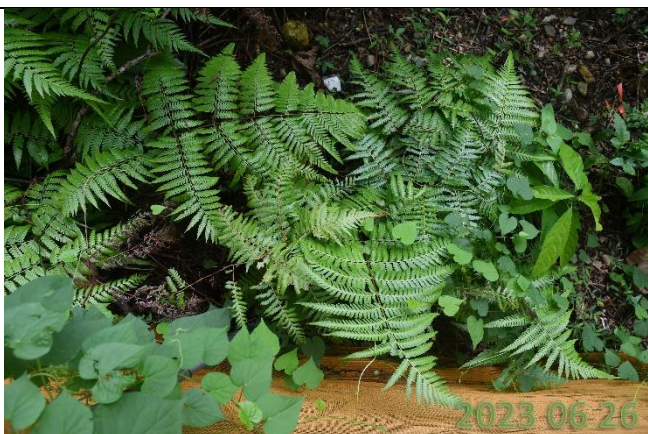
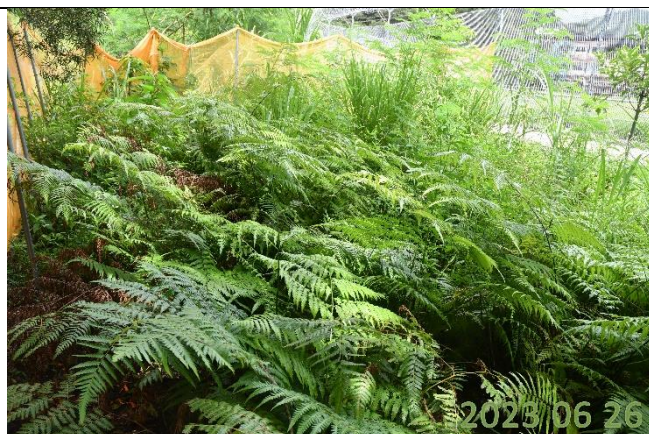
Photo 5 & 6. All *Cibotium barometz* individuals are now protected by robust fencing and growing in satisfactory condition.

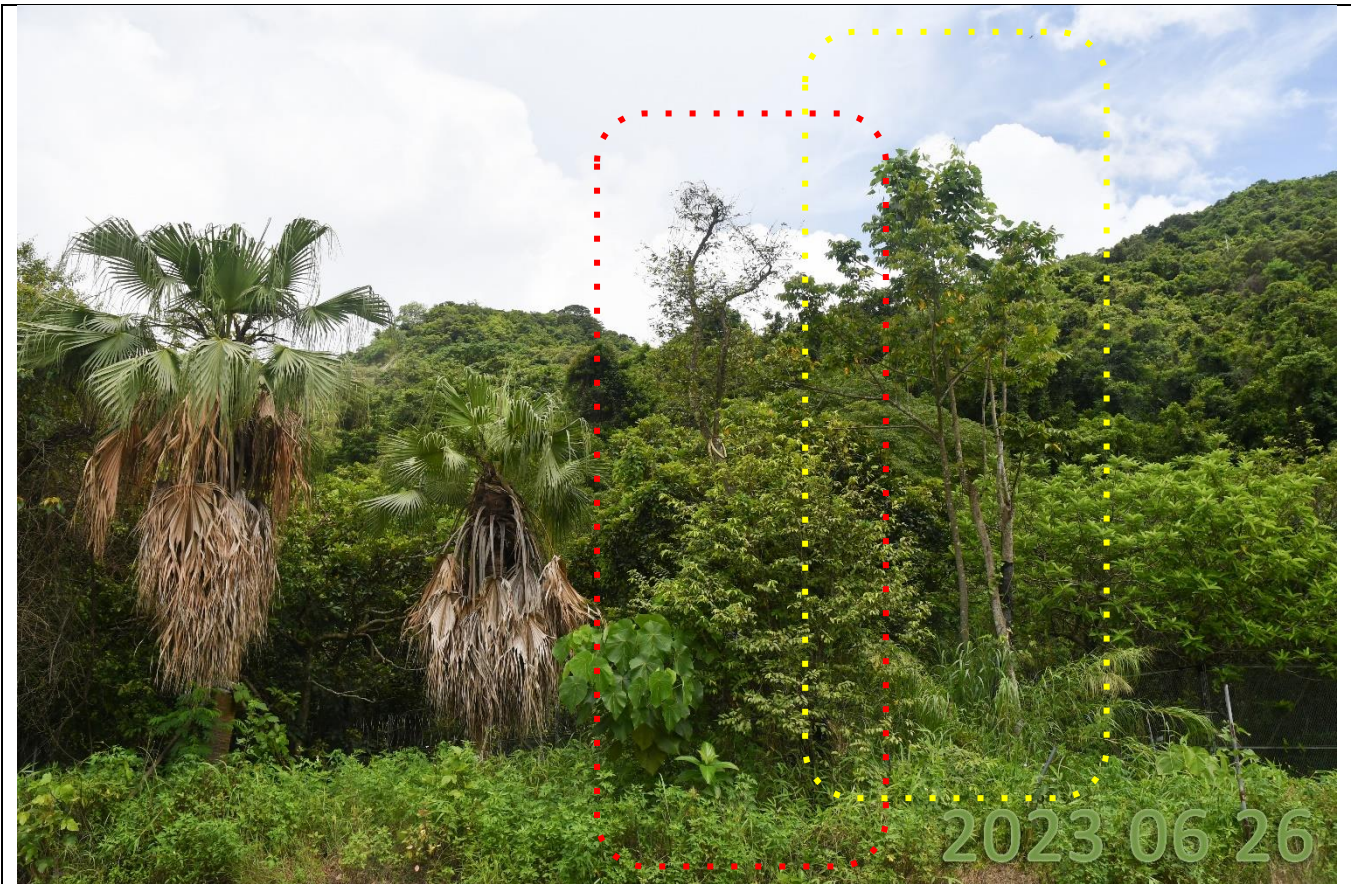
- 2.5.1 The condition of TA572 was observed in fair health despite in poor form. TA327 was also in poor condition; while already dead TA326 collapsed under Signal No. 10 typhoon Mangkhut in September 2018. Tree guying cables have been installed to provide external support to the two remaining transplanted trees.

Photo 7. Transplanted Incense Tree (*Aquilaria sinensis*) – TA327 (left); and Ailanthus (*Ailanthus fordii*) – TA572 (right)

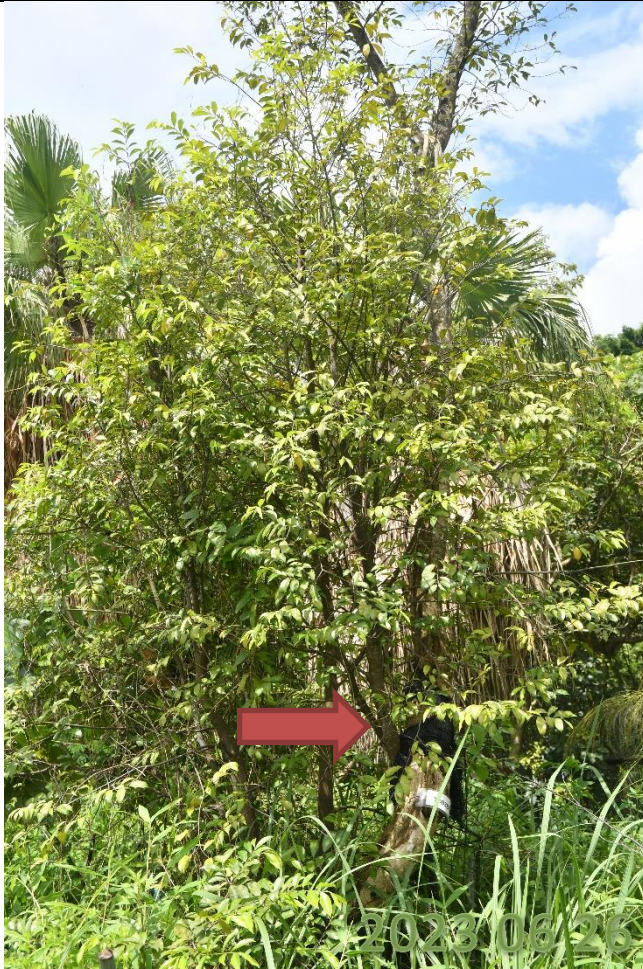
Photo 8. Sprouts at lower trunk of TA327 (*Aquilaria sinensis*).

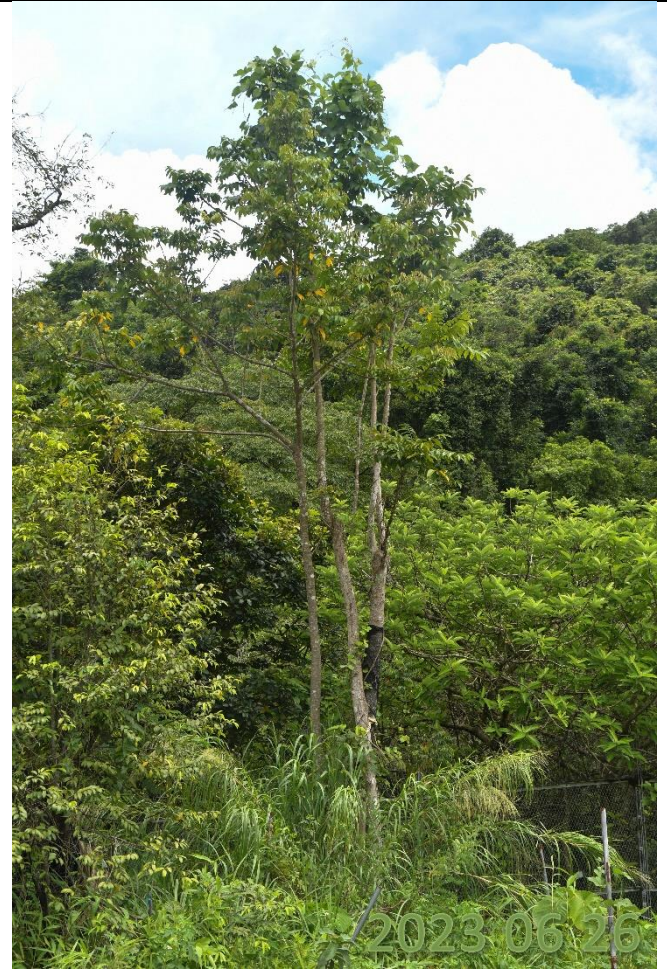
Photo 9. TA572 (*Ailanthus fordii*) was found vigorous and in good condition.

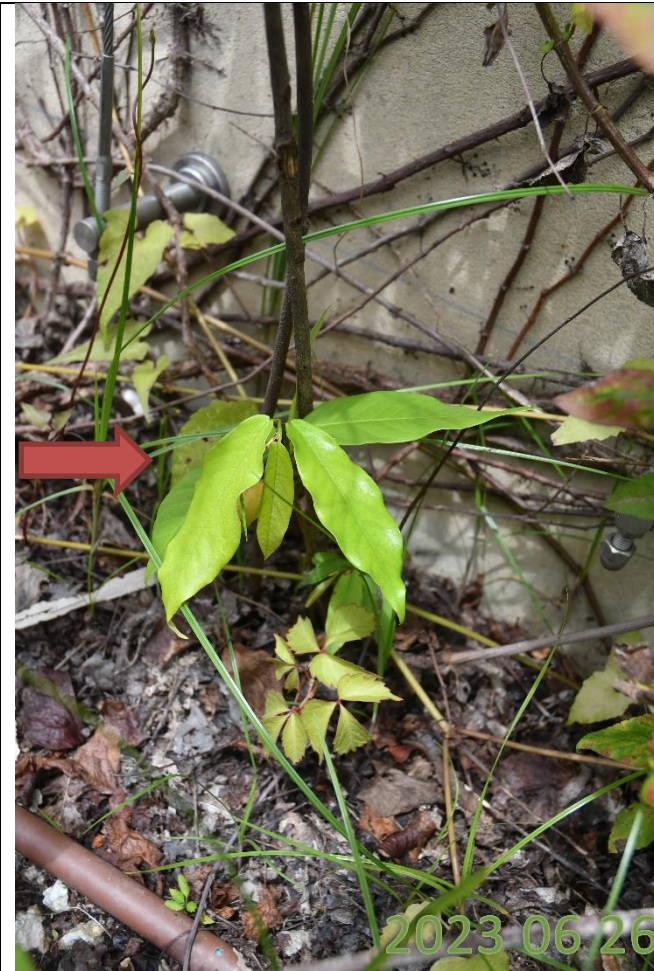
- 2.5.4 New small sprouts keep emerging from the two *Desmos chinensis* that have been reported dead previously. Construction materials was also found too close to the planter. An eye-catching protective fence shall be set up as a protection zone. No construction materials shall be placed near/ within the protection zone.

Photo 10. New sprouts keep emerging from the *Desmos chinensis* that reported dead previously. Construction materials nearby have been taken away.

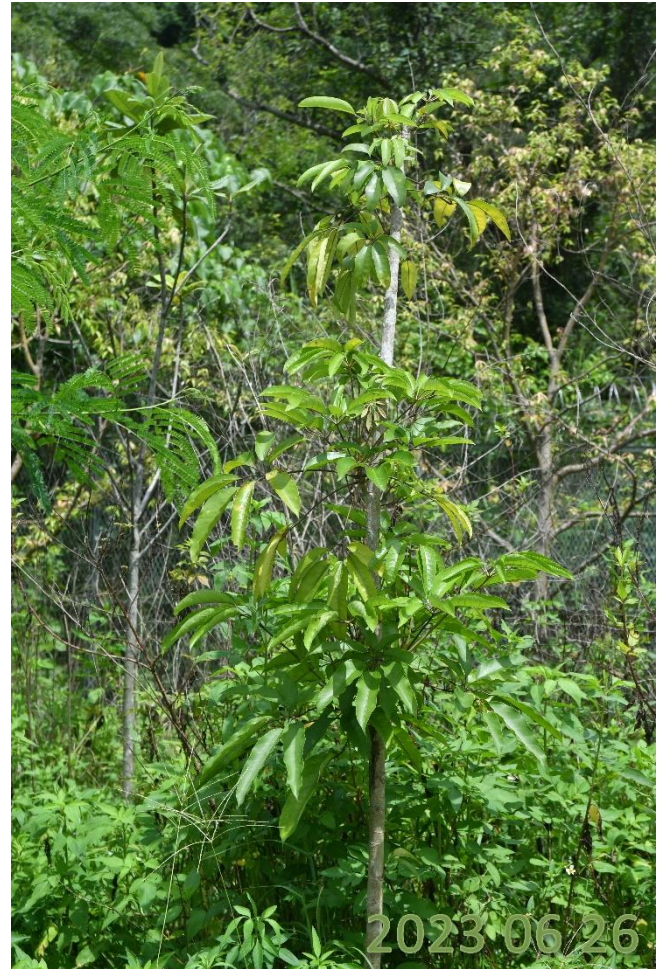
- 2.5.2 Compensatory planting of TA326 has been completed on 25 March 2020 by planting two *Syzygium levinei* and one *Schefflera heptaphylla*. However, the two native *Syzygium levinei* were mis-planted by two exotic *Syzygium jambos*, which has been replaced by another native tree species *Celtis sinensis* on 31 May 2021.

Photo 11. *Schefflera heptaphylla* as compensatory planting of TA326

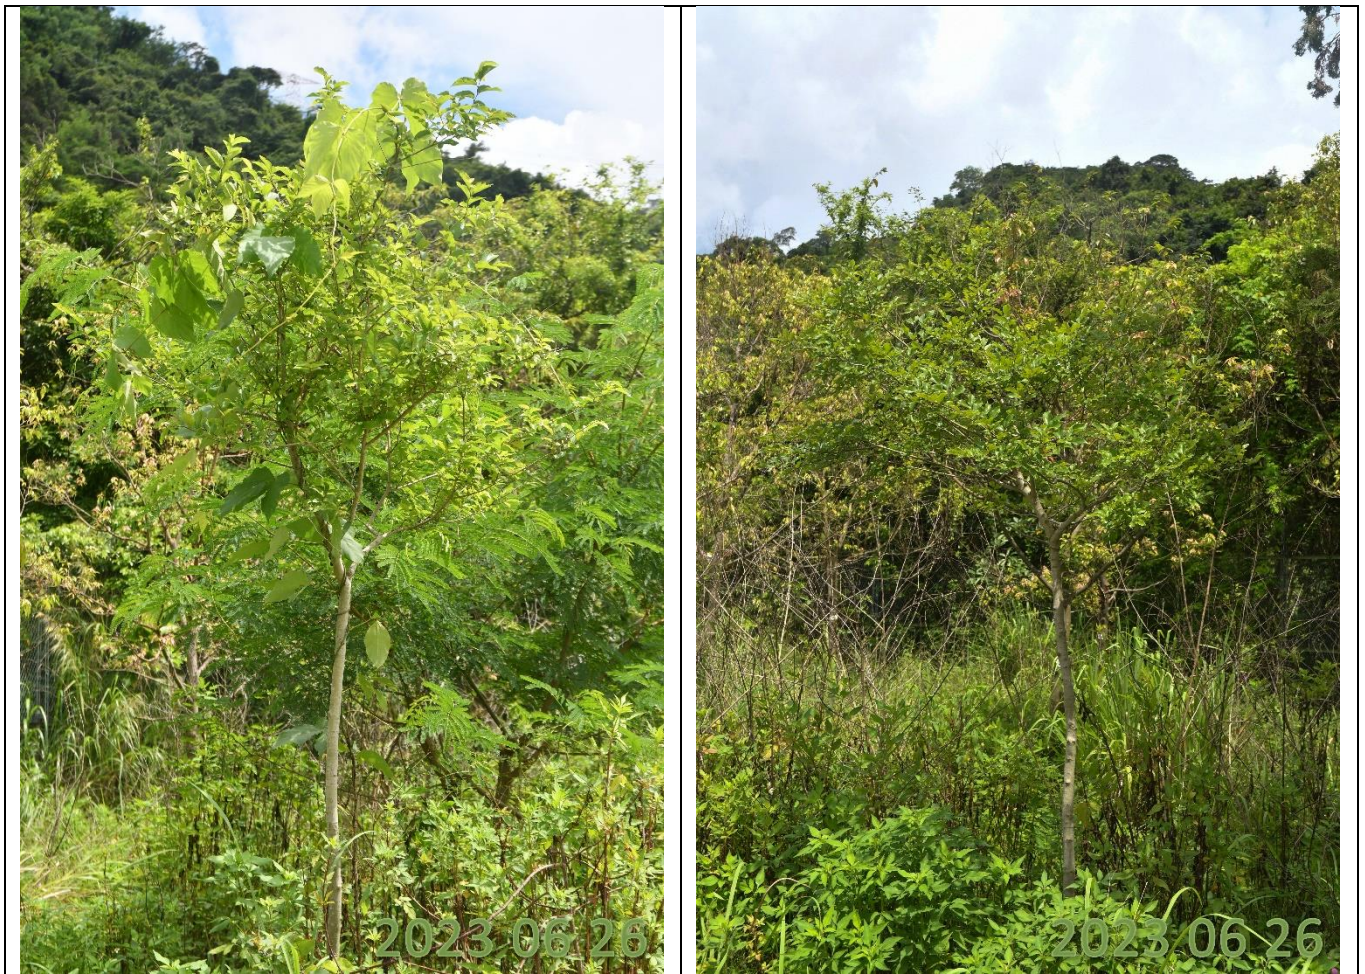
Photo 12 and 13. The two exotic *Syzygium jambos* (mis-treated as the native *Syzygium levinei*) are replaced by another native tree *Celtis sinensis* (due to market availability) as compensatory planting of TA326. *Celtis sinensis* is a deciduous species and they were found producing new leaves.  
Weeding shall be carried out during routine maintenance work.

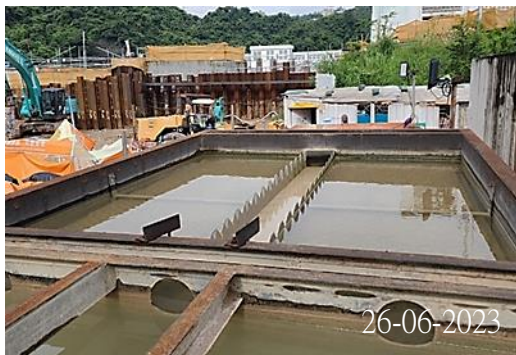
Photo 2 (Water quality of water treatment tank at 6/WSD)

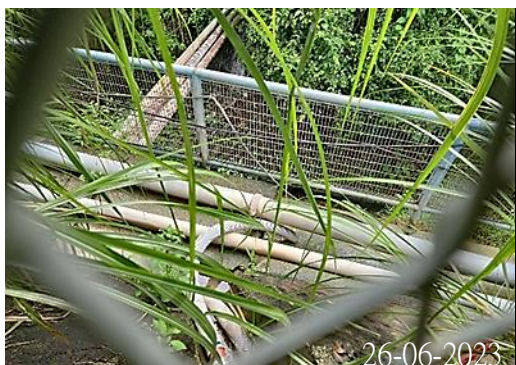
Photo 3 (Discharge point at 6/WSD)

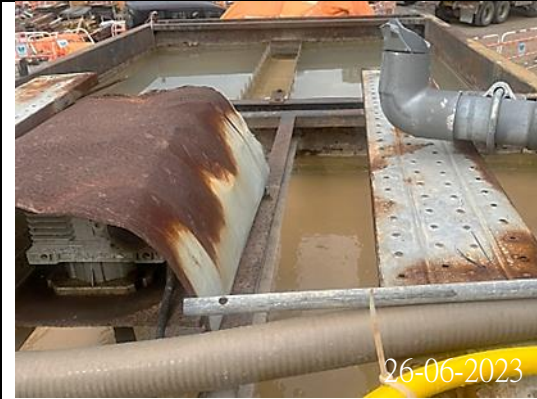
Photo 4 (Water quality of water treatment tank at 1/WSD)
