**CONTRACT NO. 1/WSD/19 & 6/WSD/21**

IN-SITU REPROVISIONING OF SHA TIN WATER TREATMENT WORKS (SOUTH WORKS) – WATER TREATMENT WORKS AND **ANCILLARY FACILITIES Environmental Permit EP-494/2015**

<u>Submission of 91<sup>st</sup> monthly EM&A Report</u>

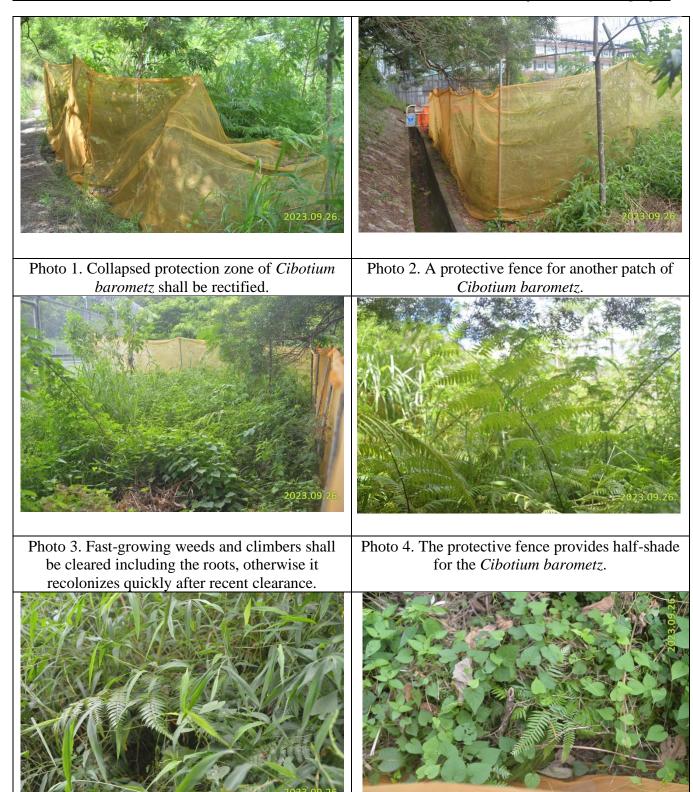
Photo 5 & 6. Despite the *Cibotium barometz* are growing in satisfactory condition, it has already been hidden by weeds and climbers, which may deplete their health/ growth condition.

- 2.5.7 Root ball of TA572 and TA327 tree should be kept moisture especially during dry and non-raining day.
- 2.5.8 Signs of ploughed soil by wild boar(s) at the two groups of transplanted *Cibotium barometz* were reported in previous monitoring. A robust fencing was recently installed to protect the group of *Cibotium barometz* from further damage caused by wild boars.

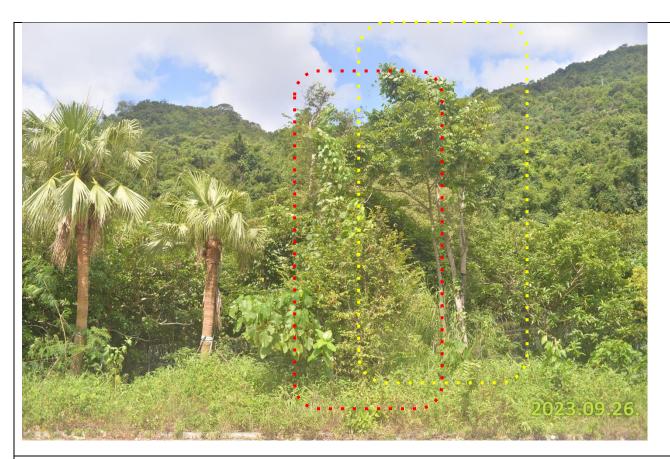
Photo 7. Transplanted Incense Tree (*Aquilaria sinensis*) – TA327 (red); and Ailanthus (*Ailanthus fordii*) – TA572 (yellow)

- 2.5.1 The condition of TA572 was observed in fair health despite in poor form. TA327 was also in poor condition; while already dead TA326 collapsed under Signal No. 10 typhoon Mangkhut in September 2018. Tree guying cables have been installed to provide external support to the two remaining transplanted trees.

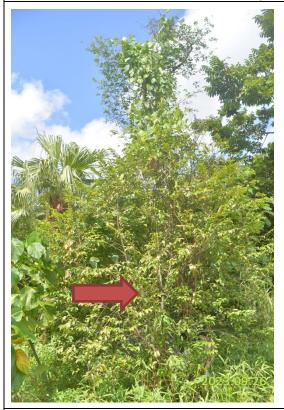
Photo 8. Sprouts at lower trunk of TA327 (*Aquilaria sinensis*).

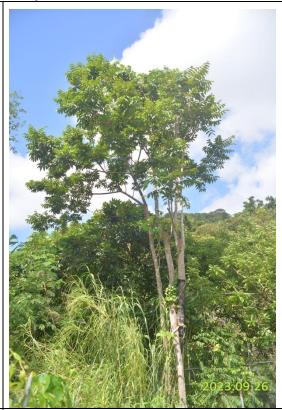
Photo 9. TA572 (*Ailanthus fordii*) was found vigorous and in generally good condition.

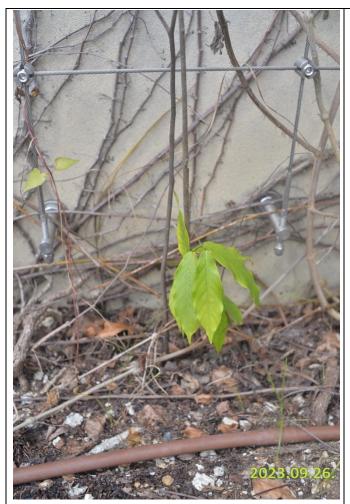
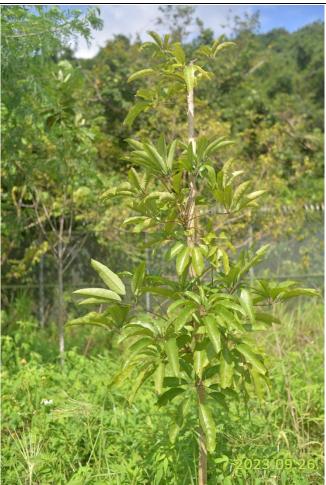
Photo 10. New sprouts keep emerging from the *Desmos chinensis* that reported dead previously. Construction materials nearby have been taken away.

Photo 11. *Schefflera heptaphylla* as compensatory planting of TA326.

- 2.5.4 New small sprouts keep emerging from the two *Desmos chinensis* that have been reported dead previously. Construction materials was also found too close to the planter. An eye-catching protective fence shall be set up as a protection zone. No construction materials shall be placed near/ within the protection zone.

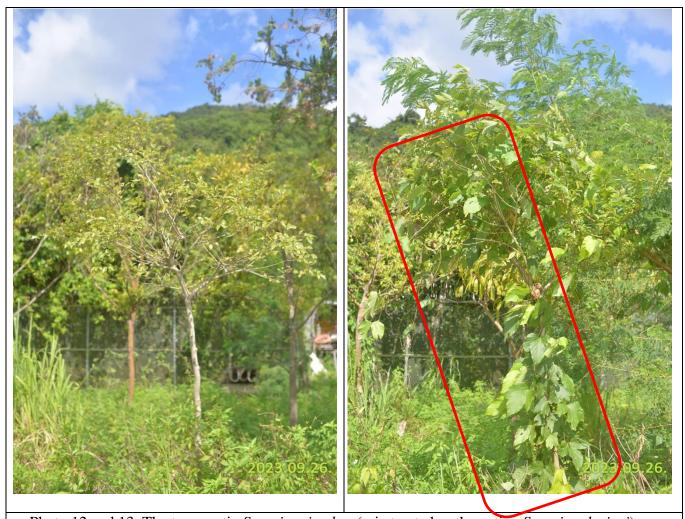
Photo 12 and 13. The two exotic *Syzygium jambos* (mis-treated as the native *Syzygium levinei*) are replaced by another native tree *Celtis sinensis* (due to market availability) as compensatory planting of TA326. Note: *Celtis sinensis* is a deciduous species.

Fast-growing climber was observed in one of the *Celtis sinensis* (right). Root removal may be necessary when recolonization of weeds is fast after recent routine maintenance work.

- 2.5.2 Compensatory planting of TA326 has been completed on 25 March 2020 by planting two *Syzygium levinei* and one *Schefflera heptaphylla*. However, the two native *Syzygium levinei* were mis-planted by two exotic *Syzygium jambos*, which has been replaced by another native tree species *Celtis sinensis* on 31 May 2021.
