IN-SITU REPROVISIONING OF SHA TIN WATER TREATMENT WORKS (SOUTH WORKS) – WATER TREATMENT WORKS AND **ANCILLARY FACILITIES Environmental Permit EP-494/2015**

- (a) Three hard copies,
- (b) Two copies of the 93<sup>rd</sup> monthly Environmental Monitoring and Audit (EM&A) Report (Rev.0). (Register No.: AEIAR-187/2015)

In-Situ Reprovisioning of Sha Tin Water Treatment Works (South Works) – Water Treatment Works and Ancillary Facilities
Environmental Permit EP-494/2015
Submission of 93<sup>rd</sup> monthly EM&A Report

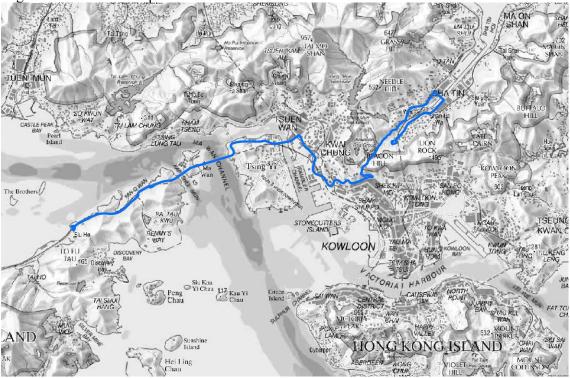
Figure 1: Chlorine Transport Route to Sha Tin Water Treatment Works

2.7.1 Chlorine is delivered to Sha Tin WTW in batches of up to 6×1-tonne drums. The transport route from Sham Shui Kok dock on North Lantau is shown in Figure 1. The route passes along the North Lantau Expressway, around the northern edge of Tsing Yi, through Tsuen Wan and along Tai Po Road (Piper's Hill) to Sha Tin (Table 2-15).

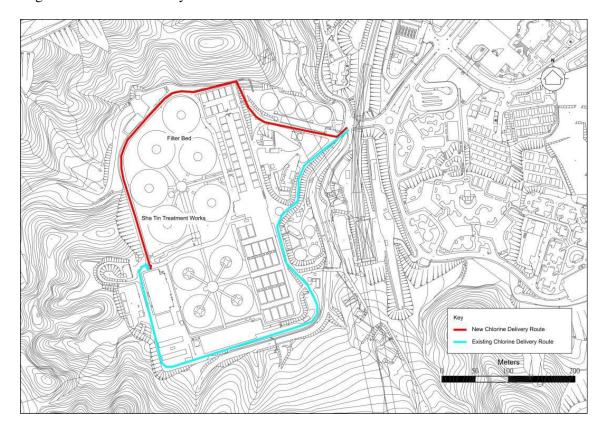
Figure 2: Chlorine Delivery Route at Sha Tin WTW

- 2.7.2 Unloading takes place inside the Chlorination House, with the doors closed, in a designated truck unloading bay. The movement of drums within the storage area and 'drive-through' unloading bay is carried out using a hoist/monorail system with a purpose-built lifting beam. Prior to usage, the drums are stored on cradles within the chlorine storage area.
- 2.7.3 The on-site chlorine delivery route is shown in **Figure 2**.

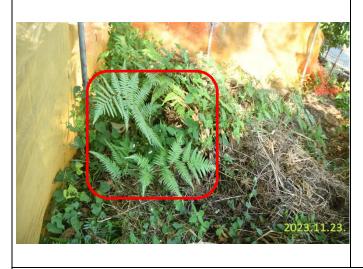
Photo 4. The protective fence provides half-shade for the *Cibotium barometz*.

- 2.5.8 Signs of ploughed soil by wild boar(s) at the two groups of transplanted *Cibotium barometz* were reported in previous monitoring. A robust fencing was recently installed to protect the group of *Cibotium barometz* from further damage caused by wild boars.

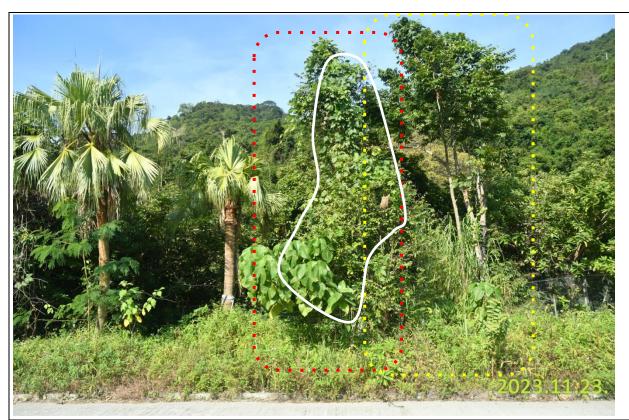
Photo 5 & 6. Despite the *Cibotium barometz* (red) are growing in satisfactory condition, it has already been hidden by weeds and climbers, which may deplete their health/ growth condition.

- 2.5.6 Weeding by hand held tools within protection zone of Cibotium barometz is urgently needed.
- 2.5.7 Root ball of TA572 and TA327 tree should be kept moisture especially during dry and non-raining day.

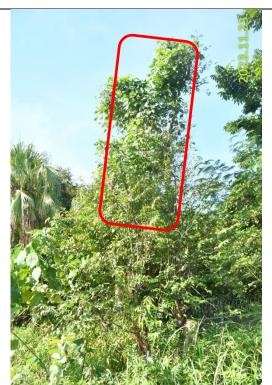
Photo 7. Transplanted Incense Tree (*Aquilaria sinensis*) – TA327 (red); and Ailanthus (*Ailanthus fordii*) – TA572 (yellow). Climber (white) should be removed, including the roots, to relieve the canopy

- 2.5.1 The condition of TA572 was observed in fair health despite in poor form. TA327 was in fair condition; while already dead TA326 collapsed under Signal No. 10 typhoon Mangkhut in September 2018. Tree guying cables have been installed to provide external support to the two remaining transplanted trees. Climbing vines on TA327 should be removed, including the roots, to reduce rapid colonization covering the canopy.

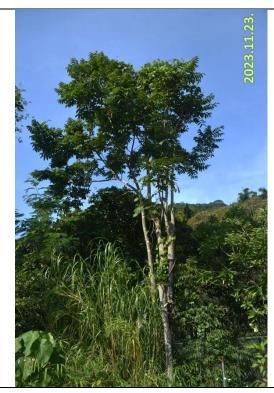
Photo 8. Sprouts at lower trunk of TA327 (*Aquilaria sinensis*). Climber (red) should be removed, including the roots, to relieve the canopy

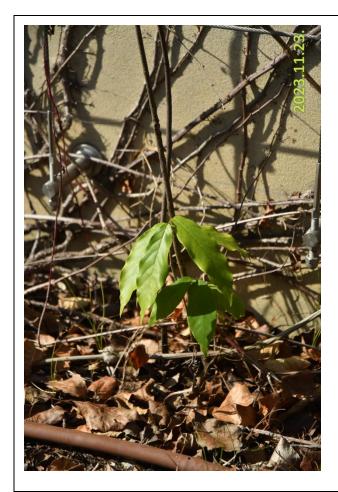
Photo 9. TA572 (*Ailanthus fordii*) was found vigorous and in generally good condition.

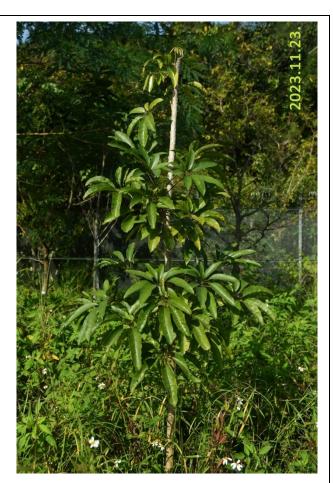
Photo 10. New sprouts keep emerging from the *Desmos chinensis* that reported dead previously. Chlorosis probably due to vigorous sunlight and dehydration

- 2.5.4 New small sprouts keep emerging from the two *Desmos chinensis* that have been reported dead previously. Construction materials was also found too close to the planter. An eye-catching protective fence shall be set up as a protection zone. No construction materials shall be placed near/ within the protection zone.

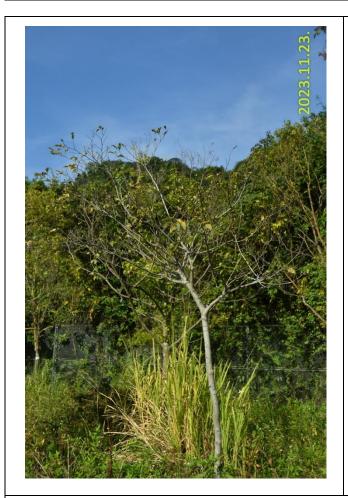
Photo 11. *Schefflera heptaphylla* as compensatory planting of TA326.

- 2.5.2 Compensatory planting of TA326 has been completed on 25 March 2020 by planting two *Syzygium levinei* and one *Schefflera heptaphylla*. However, the two native *Syzygium levinei* were mis-planted by two exotic *Syzygium jambos*, which has been replaced by another native tree species *Celtis sinensis* on 31 May 2021. Climbing vines on one of the Celtis sinensis should be removed, including the roots, to reduce rapid colonization covering the canopy.

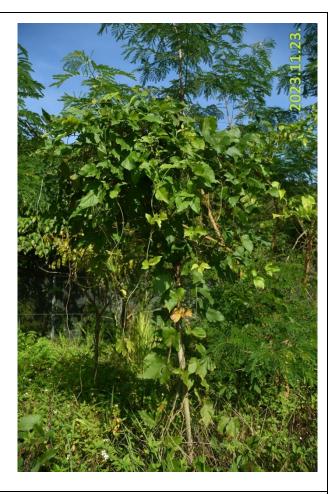
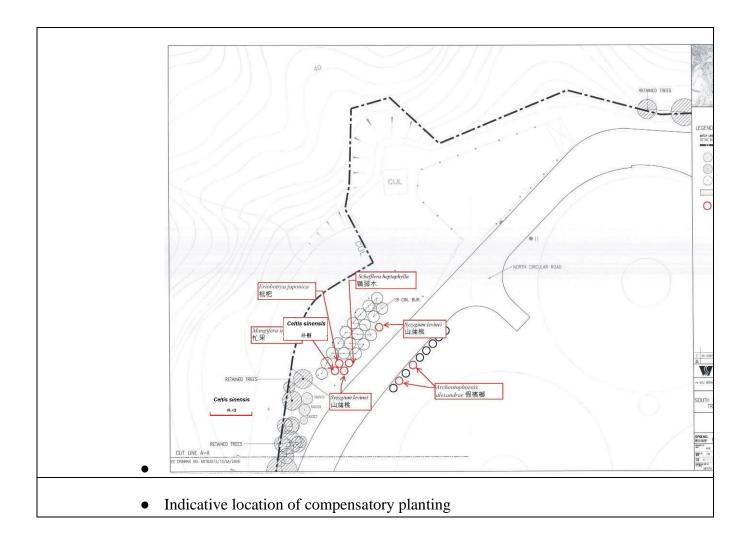
Photo 12 and 13. The two exotic *Syzygium jambos* (mis-treated as the native *Syzygium levinei*) are replaced by another native tree *Celtis sinensis* (due to market availability) as compensatory planting of TA326. Note: *Celtis sinensis* is a deciduous species.

Fast-growing climber was observed in one of the *Celtis sinensis* (right; compared to the left). The climber should be removed immediately otherwise it will affect the health of the tree. Root removal is necessary when recolonization of weeds is fast after recent routine maintenance work.
