## **Woodland Compensation Plan**

**FOR AGREEMENT NO. CE 13/2009 (WS)  
IN-SITU REPROVISIONING OF SHA TIN WATER TREATMENT WORKS – SOUTH  
WORKS**

**(Rev. 4)**

**IN-SITU REPROVISIONING OF SHA TIN WATER  
TREATMENT WORKS – SOUTH WORKS**

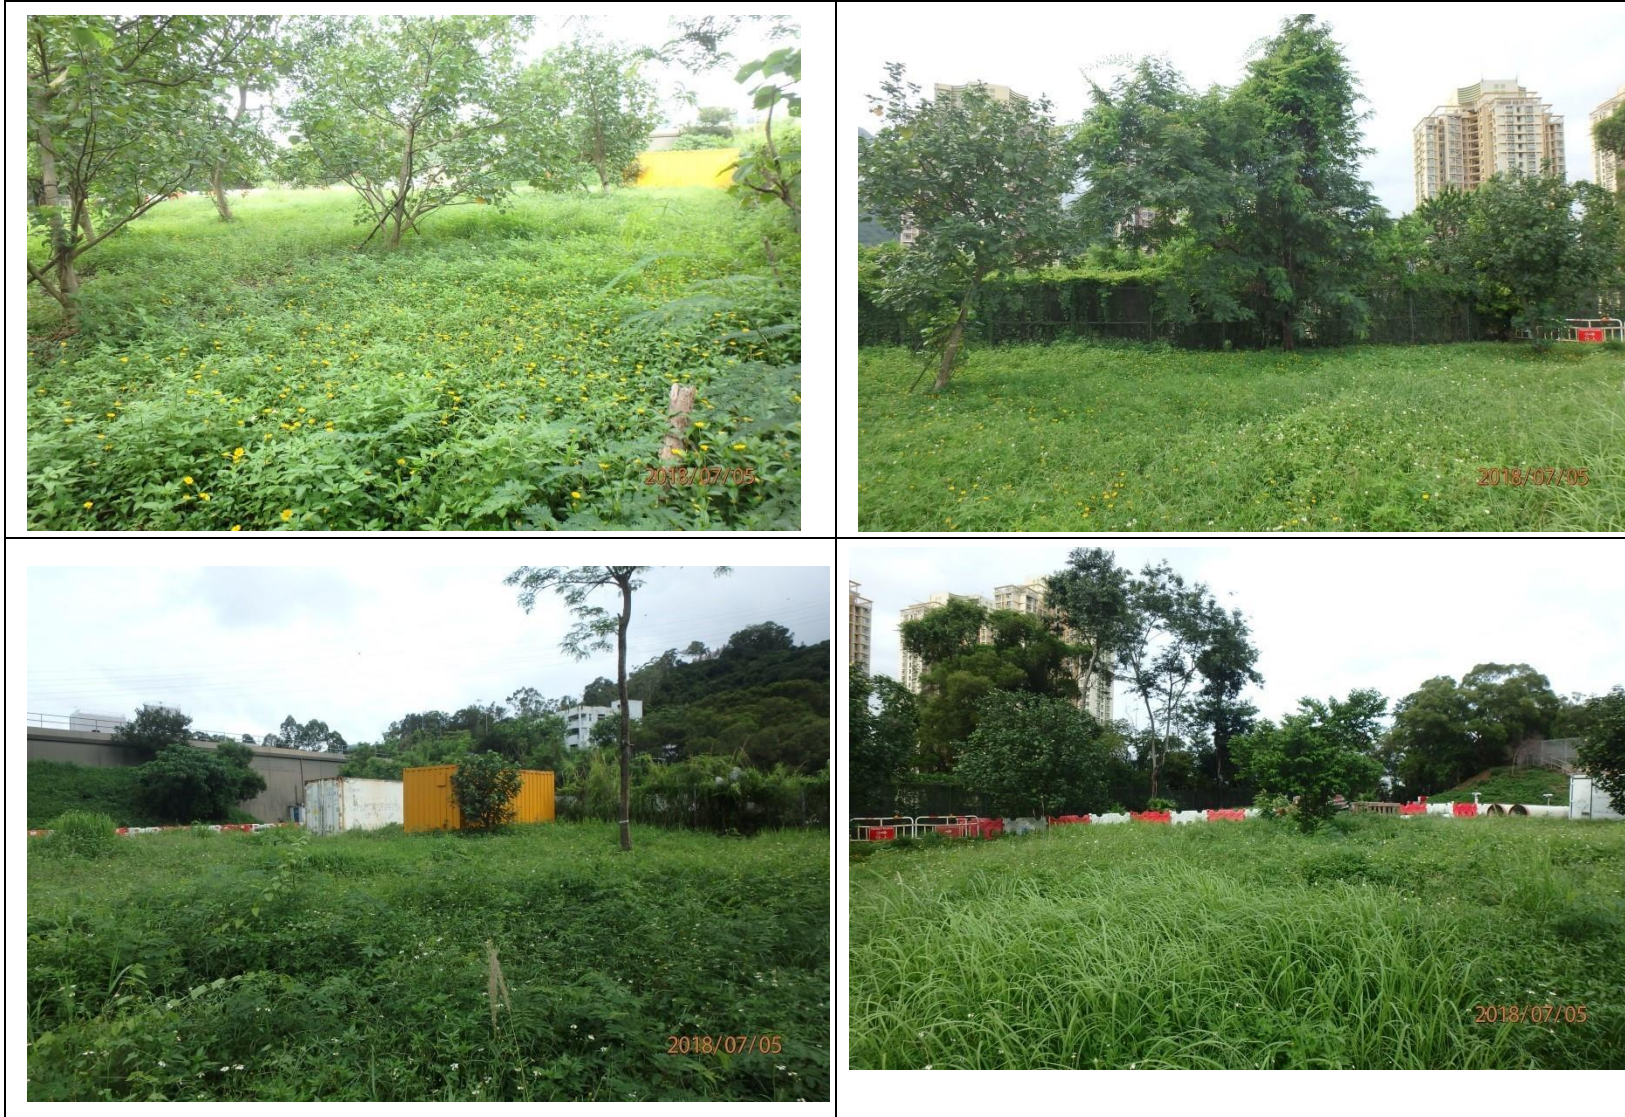
**Plate 1.** General view of the newly proposed compensation planting site. It is a grassland mixed with landscape plantation of spare trees.

The main habitat type is grassland mixed with landscape plantation (**Plate 1**). About 10 trees were planted at the western corner of the site. Dominant trees species include *Hibiscus tiliaceus* (黃槿), *Senna siamea* (鐵刀木) and the undesirable exotic *Leucaena leucocephala* (銀合歡). The canopy cover is very sparse and reaches about 4 – 10m high on average. The ground was densely covered by *Bidens alba* (白花鬼針草), *Imperata cylindrica* var. *major* (大白茅), *Mimosa pudica* (含羞草), *Panicum maximum* (大黍), *Passiflora foetida* (龍珠果), *Praxelis clematidea* (假臭草) and *Wedelia trilobata* (三裂葉蟛蜞菊). Most of these are exotic and even invasive species. *Wedelia trilobata* (三裂葉蟛蜞菊) is commonly used as ground cover for landscape softwork.

The newly proposed site is rather isolated by road and developed area, with enclosure of wire mesh. It is dominated by exotic or invasive plants, which is unfavourable to native wildlife (**Plate 1**). Therefore faunal diversity and abundance was found low. The survey did not yield any herpetofauna and Odonate. Such extent of suboptimal habitat is probably used by limited wildlife as passing corridor rather than important resting or breeding ground.

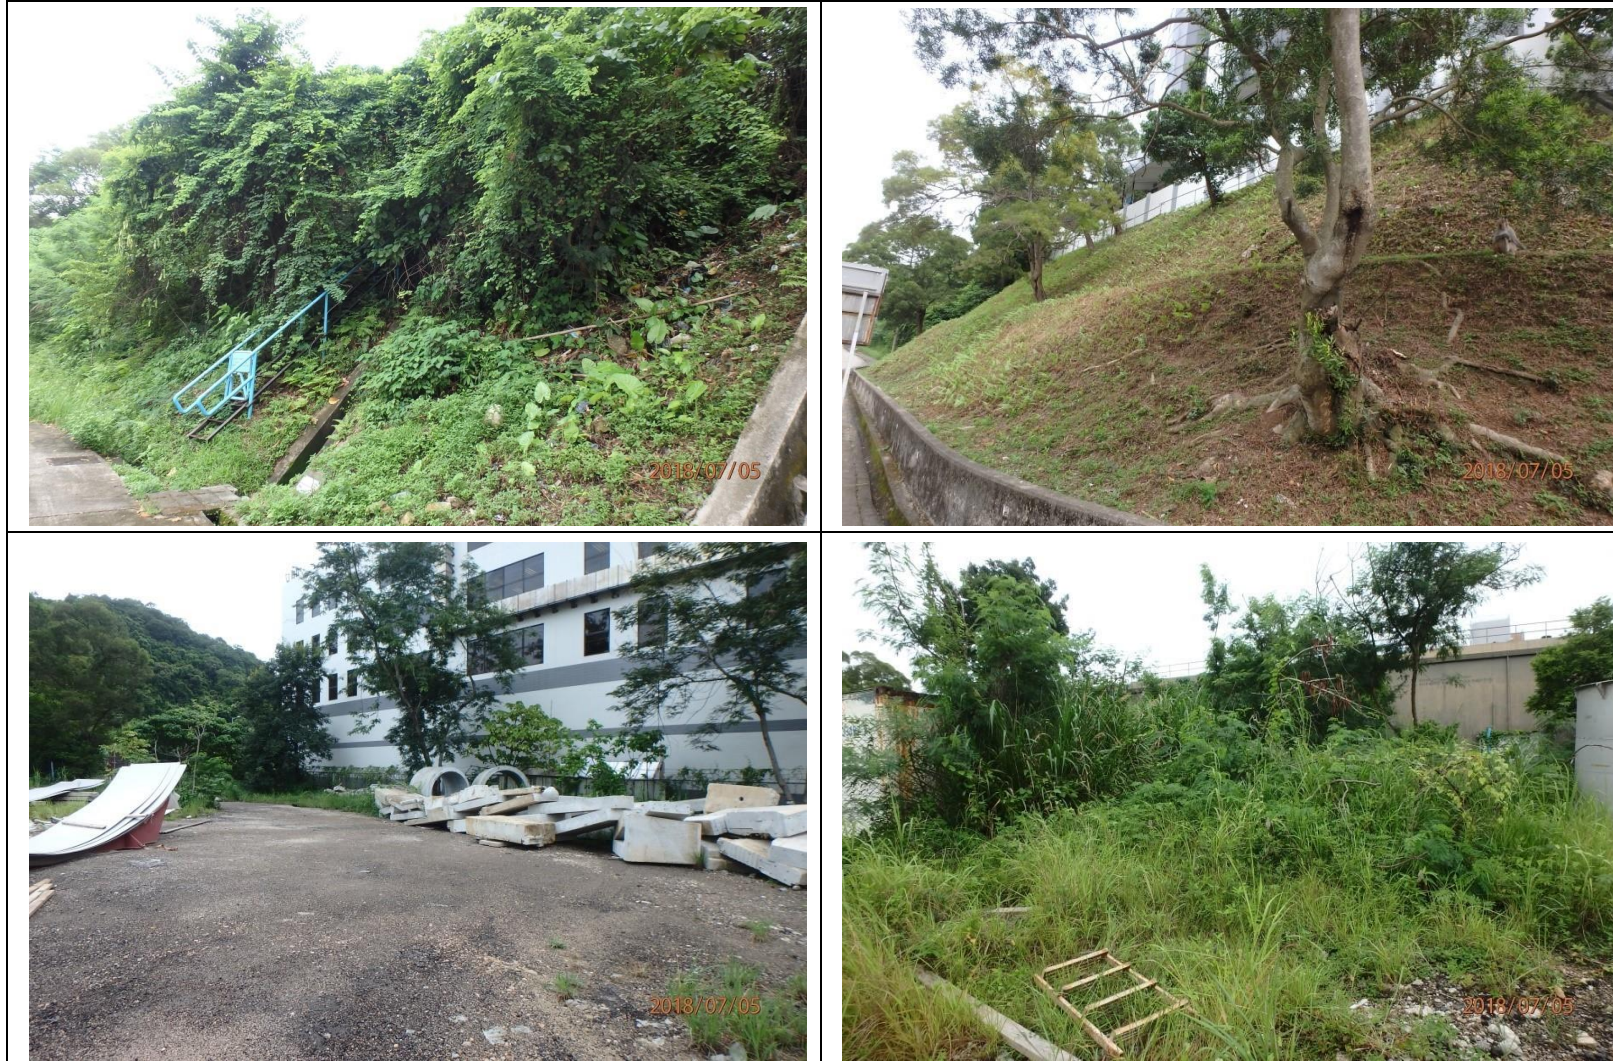
**Plate 2.** General view of adjacent habitats of the newly proposed compensation planting site. Vegetated man-made slopes (above) and the originally wasteland proposed for compensation planting (below).

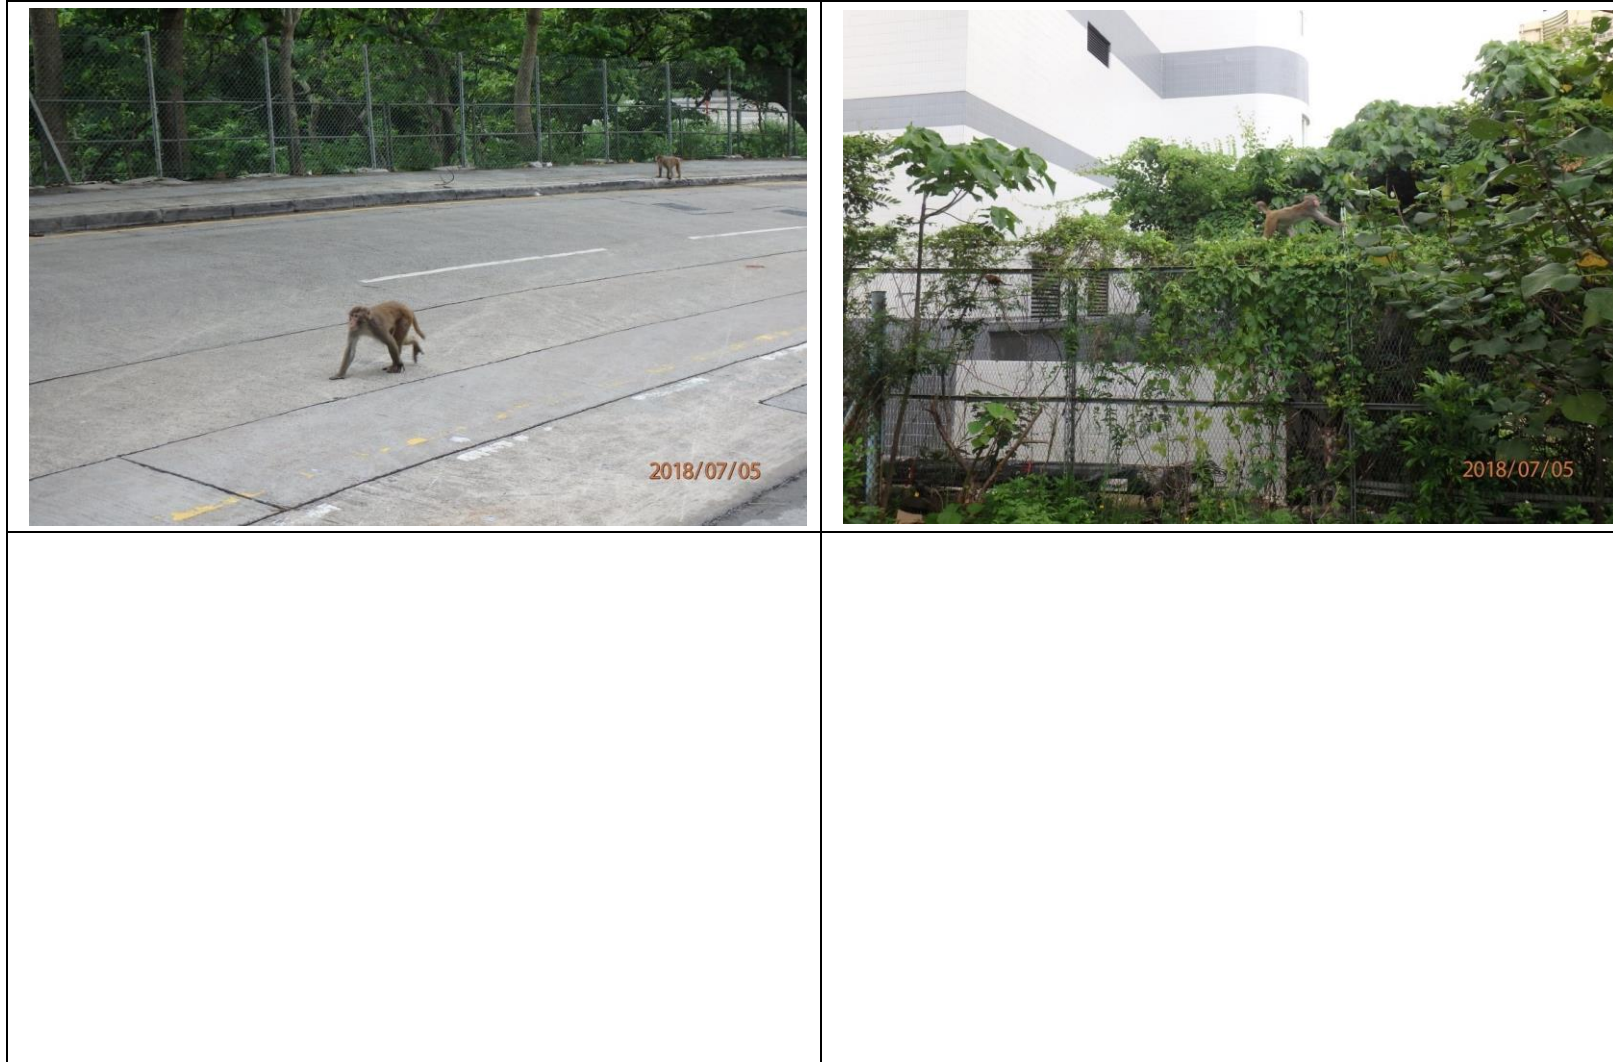
A group of Rhesus Macaques (*Macaca mulatta*) was observed climbing along the wire mesh of both the original and newly proposed planting site. They were using such corridor to move among connected canopy at man-made features outside the survey extent (**Plate 3**). No foraging and roosting behaviour was observed within the survey extent.

**Plate 3. Rhesus Macaques (*Macaca mulatta*) observed around the survey extent.**

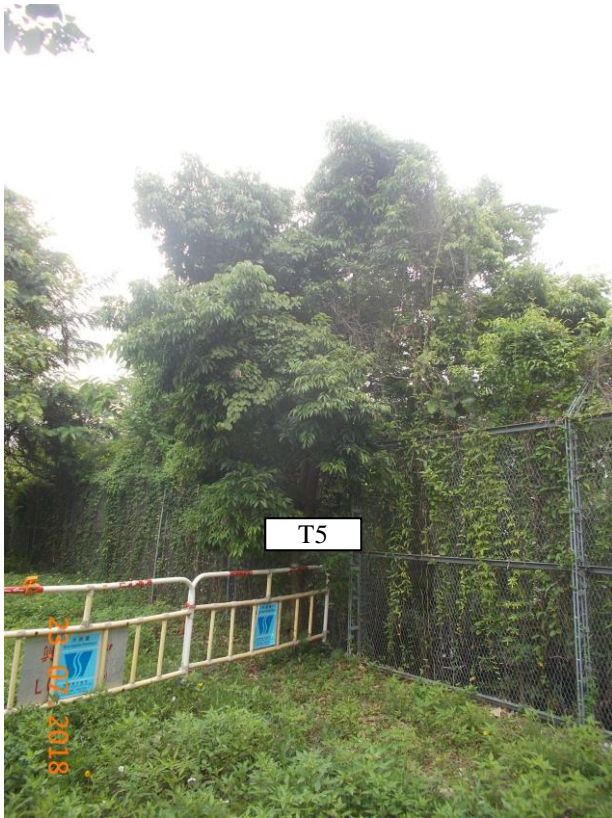
Tree No. T5

T6	<i>Hibiscus tiliaceus</i>	黃槿	5	135	4	F	F	L	L	Retain	Leaning tree; large cavity on lower trunk	
T7	<i>Senna siamea</i>	鐵刀木	8	285	5	F	F	L	L	Retain	Vines on crown	
T8	<i>Hibiscus tiliaceus</i>	黃槿	5	125	4	F	F	L	L	Retain	Leaning tree; broken branches and hanger	
T9	<i>Hibiscus tiliaceus</i>	黃槿	7	260	5	F	F	L	L	Retain	Leaning tree; broken branches and hanger	
T10	<i>Ficus hispida</i>	對葉榕	4	95	2	F	F	L	L	Retain	Dead branches; broken branches and hanger	
T11	<i>Hibiscus tiliaceus</i>	黃槿	4	134	4	F	F	L	L	Retain	Leaning tree	
T12	<i>Hibiscus tiliaceus</i>	黃槿	4	128	4	F	F	L	L	Retain	Multi trunks; cavity on lower trunk	
T13	<i>Senna siamea</i>	鐵刀木	8	265	6	F	F	L	L	Retain	Vines; broken branches	
T14	<i>Hibiscus tiliaceus</i>	黃槿	4	139	6	F	F	L	L	Retain	Multi trunks	
T15	<i>Hibiscus tiliaceus</i>	黃槿	4	192	4	F	F	L	L	Retain	Leaning tree; broken branches and hanger	
T16	<i>Dalbergia assamica</i>	南嶺黃檀	9	233	7	F	F	L	L	Retain	Co-dominant trunks; dead twigs

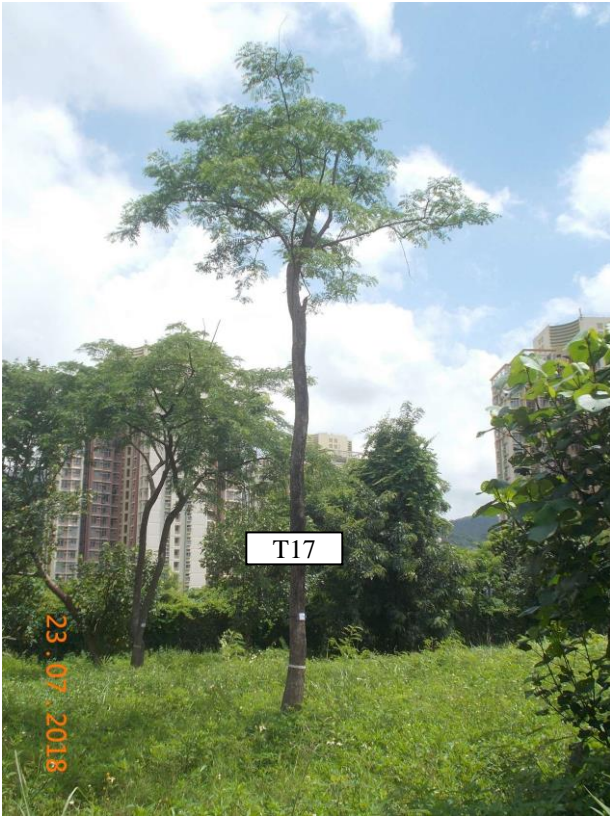
Tree No. T17

T17	<i>Dalbergia assamica</i>	南嶺黃檀	6	170	4	F	F	L	L	Retain	Dead twigs	
T18	<i>Hibiscus tiliaceus</i>	黃槿	2	105	2	F	F	L	L	Retain	Large decay on trunk; dual trunks	
T19	<i>Hibiscus tiliaceus</i>	黃槿	4	150	4	F	F	L	L	Retain	Crossed branches; leaning tree
