Environmental Team for Hung Shui Kiu/Ha Tsuen
New Development Area Stage 1 –
Site Formation and Engineering Infrastructure

Monthly EM&A Report
(March 2023)

(Environmental Permit No. EP-528/2017)

Investigation Report for Exceedances of Limit Levels of Water Quality Monitoring on 9 March 2023

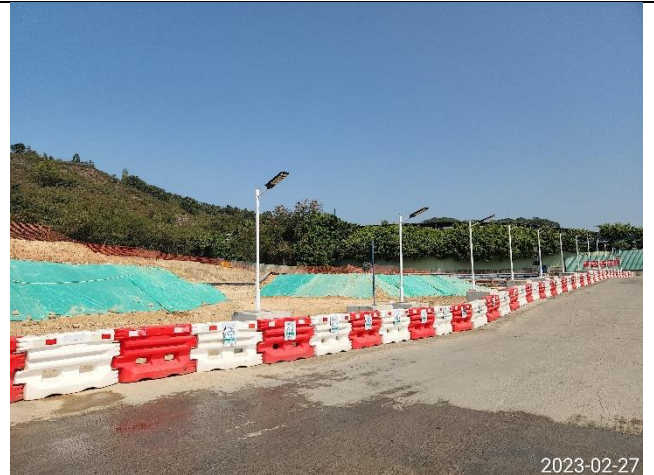
(P1)

Stockpile of dusty materials was covered properly to avoid generation of muddy runoff

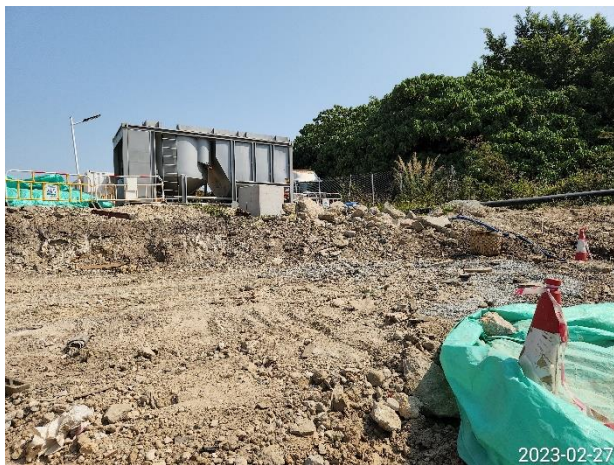
(P2)

No muddy surface runoff and direct effluent discharge was observed during site inspection.

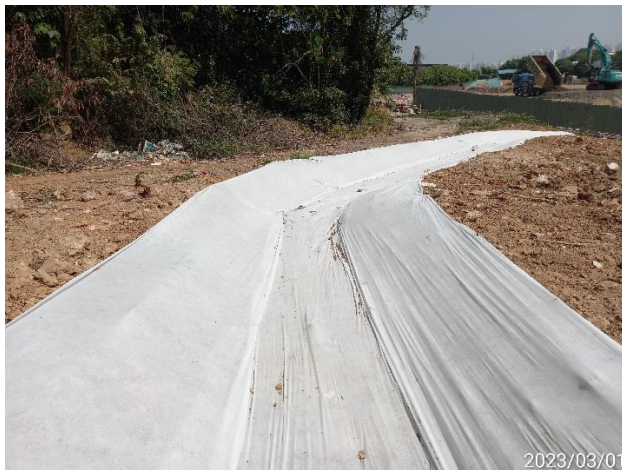
(R2)

Rolling pass was provided to prevent dust emission and generation of muddy runoff.

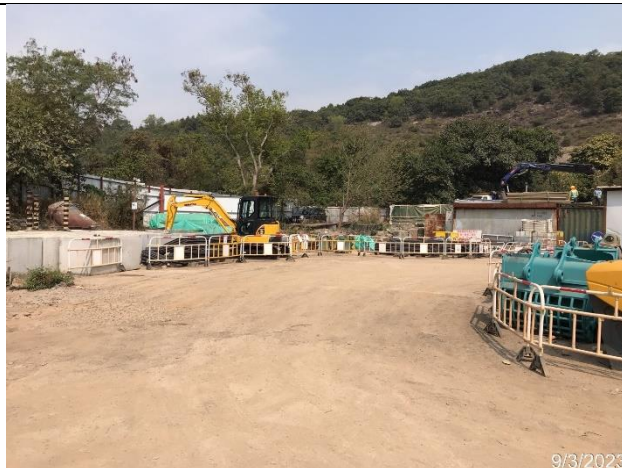
(R3)

Earth bund was provided to avoid muddy surface runoff. No muddy surface runoff and direct discharge of ground water was observed.
