DECOMMISSIONING AND DISPOSAL OF CLINICAL WASTE INCINERATORS AT BLOCK K, QUEEN MARY HOSPITAL SITE AUDIT REPORT NO. 3

SITE AUDIT REPORT NO. 3

PROJECT NO.: 2535419A
DATE: 31 MAY 2018

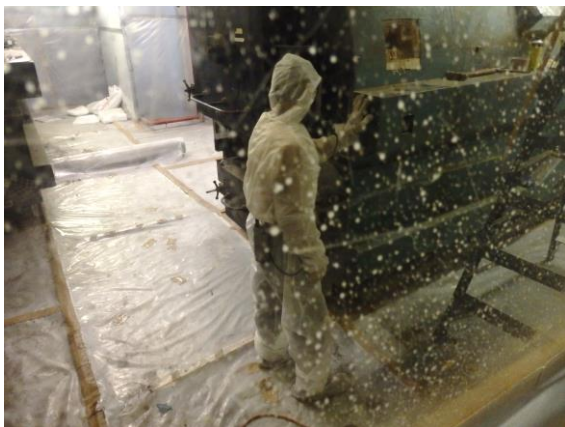
Figure 3.1 Worker wearing full Personal Protective Equipment (PPE)

3.2.5 PPE including particulate filters and disposal coverall were provided on-site. All workers have worn full PPE which include disposable protective overall with hood, nitrile gloves, shoe covers, and full-face positive pressure respirators equipped with a combination cartridge.

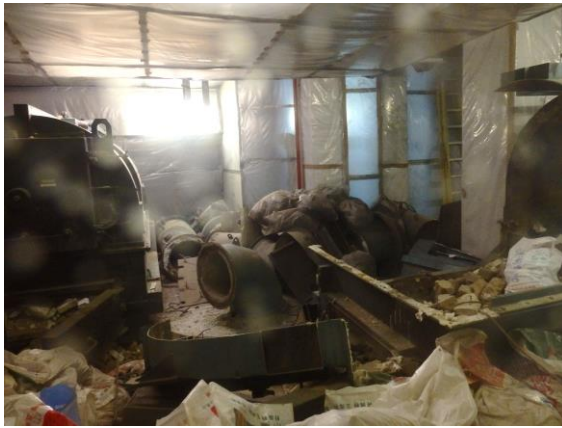
Figure 3.2 View of Incinerator Room

- 3.2.7 During the site audit conducted on 13 April 2018, no specific observation was identified from the site inspection.
- 3.2.8 The refractory bricks of the combustion chamber were removed individually and the outer steel shell was cut to smaller pieces for disposal at designated landfill.

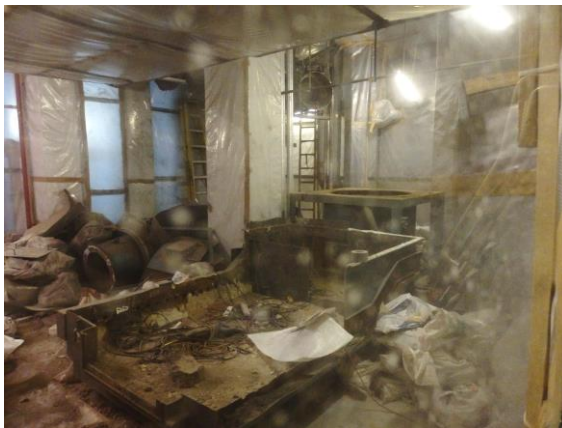
Figure 3.3 Demolition of Incinerator No.2

- 3.2.10 Removal and decommissioning of incinerator No.2 were in progress on 20 April 2018.
- 3.2.11 During the site audit conducted on 20 April 2018, no specific observation was identified from the site inspection.

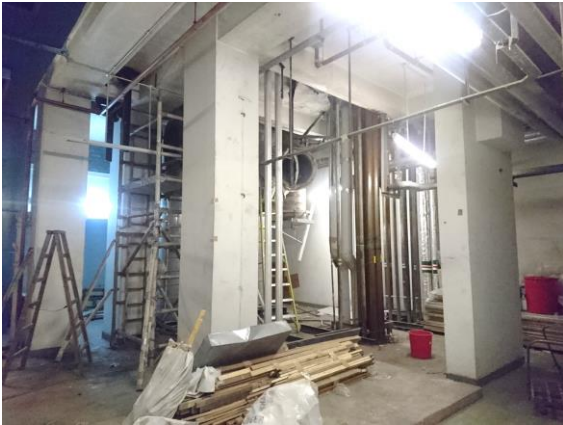
Figure 3.4 View of Incinerator Room

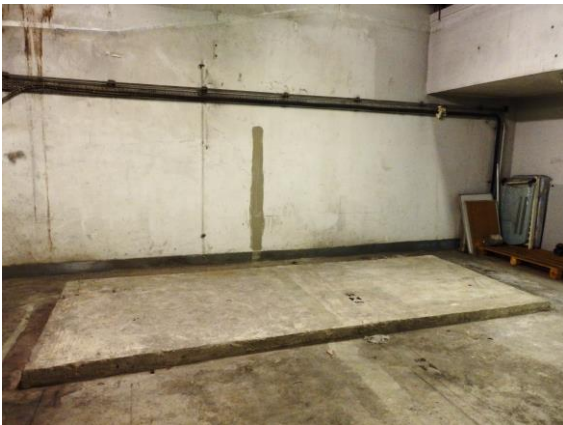
Figure 3.5 Demolition of Incinerator No.1 was completed

- 3.2.14 Removal and decommissioning of incinerators, as well as clearance of compartments and the site are completed on 11 May 2018.
- 3.2.15 During the site audits conducted on 05 May 2018 and 11 May 2018, no specific observation was identified from the site inspection.

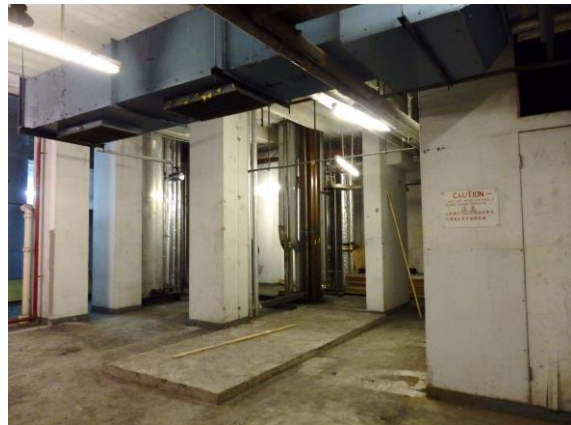
Figure 3.6 Demolition of Incinerator No.2 was completed

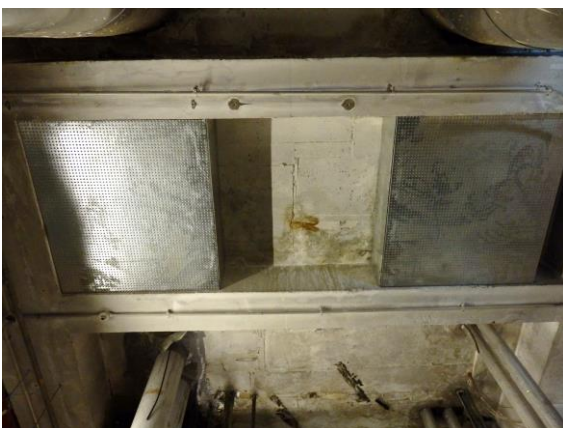
Figure 3.7 Chimneys were sealed up

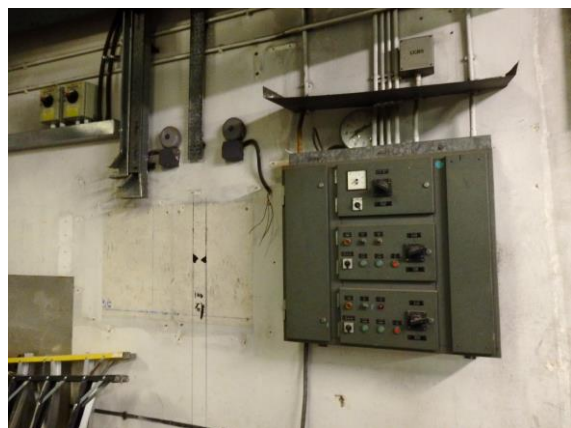
Figure 3.8 Wall-mounted control panel for incinerators was demolished

- 3.2.18 Other wastes such as the combustion chambers and outer shell panels and ductworks, polythene wrapping sheets, used PPE, waste generated from the dismantling work of the containment and cloths used for wet wiping were properly stored and waiting for disposal of at designated landfill site. The wall-mounted control panel for incinerators was removed for disposal of at designated landfill site as well. The control panel for exhaust fan for LG501D compressor / vacuum EQP. Room, fused link boxes, DDC control panel, FAD KLG6 and air conditioning ductworks are retained (**Figures 3.8 and 3.10**).

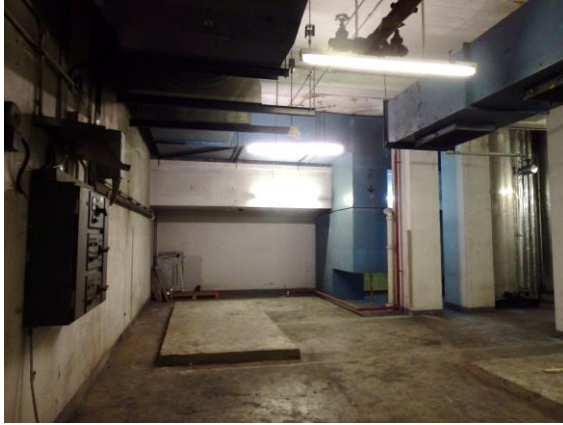
Figure 3.9 View of Incinerator Room

- 3.2.16 Upon completion of the demolition work, all surfaces in the incinerator room were decontaminated by HEPA vacuuming and wet wiping. Then the innermost polythene sheet was sprayed with Polyvinyl Alcohol (PVA) and upon drying, the inner polythene sheet was peeled off. The PVA decontamination process was repeated for the second and third layers of the polythene sheets. All residual ash collected from the incinerator, used HEPA filters, scrubbed materials, the HEPA filtered materials and the gaskets to the primary and secondary burner of the incinerators were disposal of at Chemical Waste Treatment Centre. Good quality containers compatible with the chemical wastes were used. Appropriate labels were affixed securely on each chemical waste container indicating the chemical characteristics of the chemical waste.

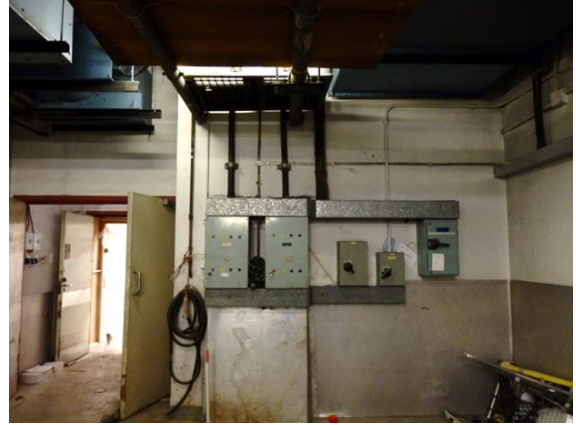
Figure 3.10 Fused link boxes to be retained
