Contract NO. DC/2007/12 - Design and  
Construction of Tsuen Wan Drainage Tunnel

Quarterly EM&A Report (October to December 2011)

**Report No** EB000364R0741

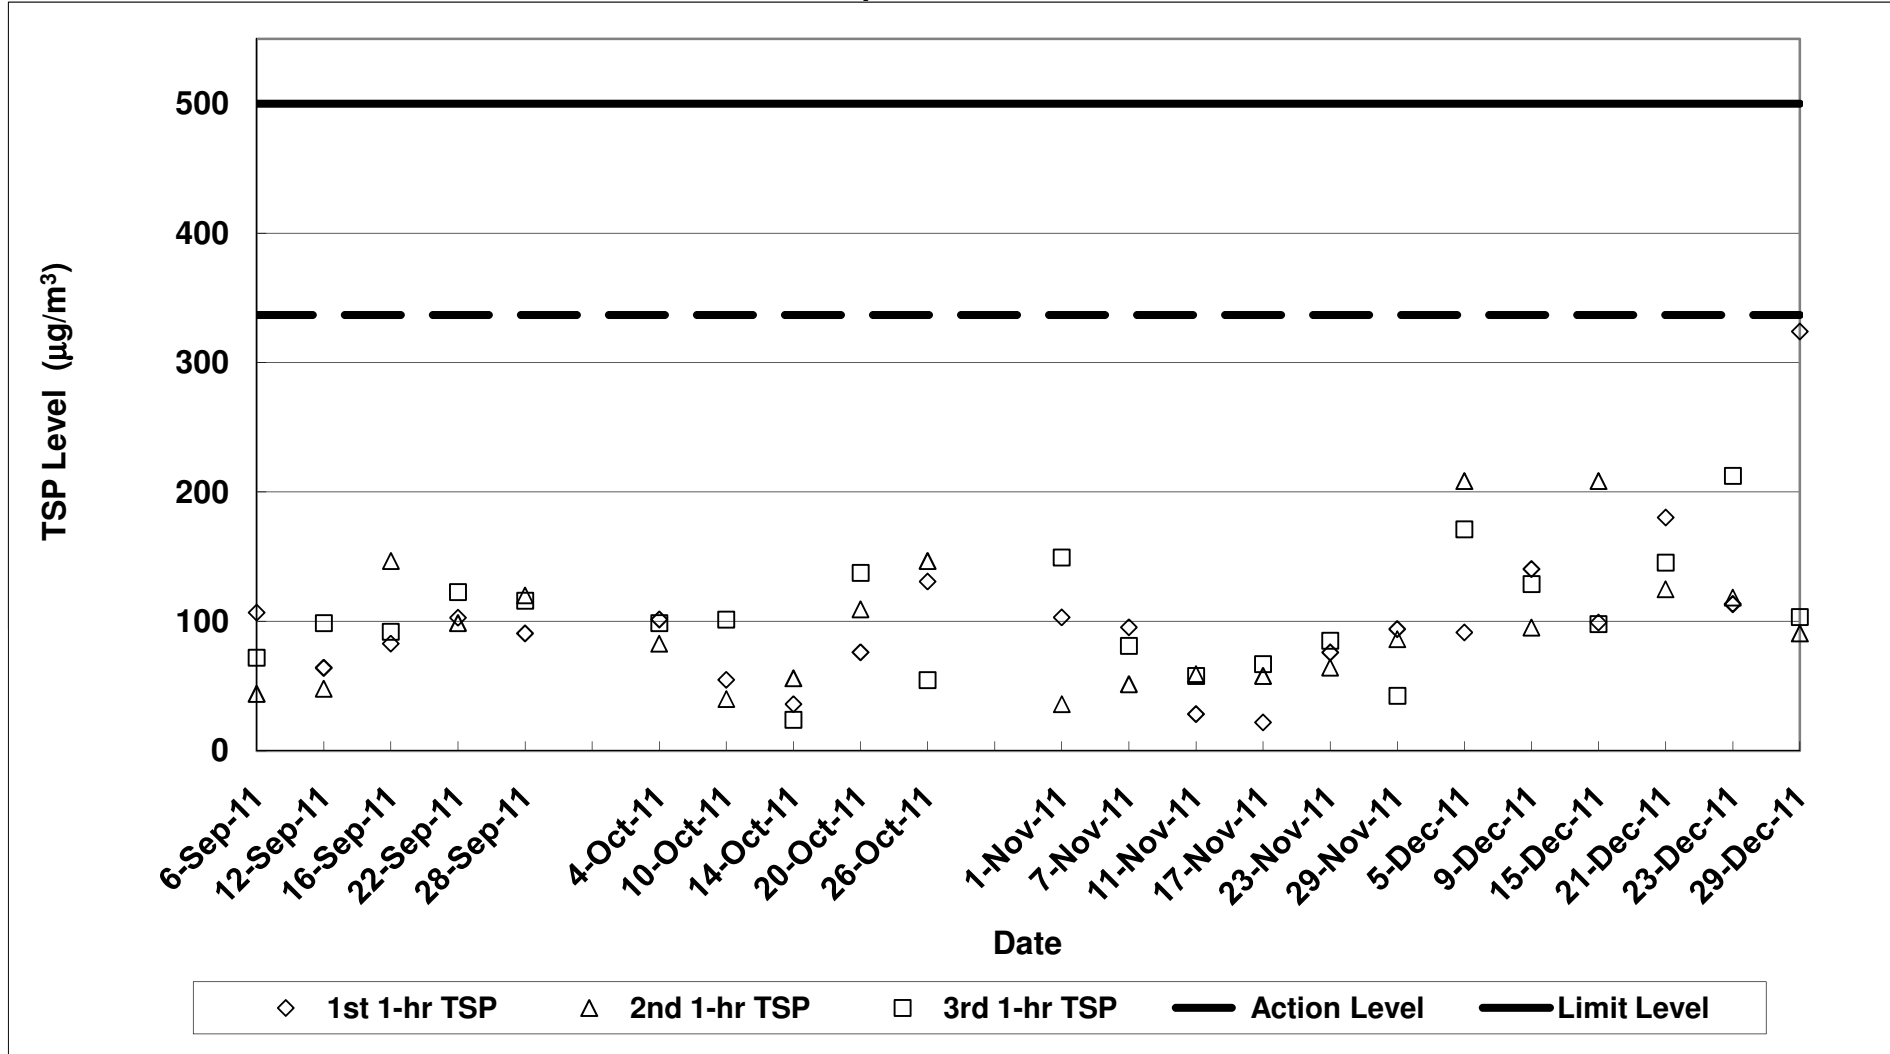
**Contract No. DC/2007/12 - Design and Construction of Tsuen Wan Drainage Tunnel  
 Air Quality Monitoring (1-hr TSP) Results at Long Beach Gardens - Outfall (ASR8)  
 Sep-11 to Dec-11**

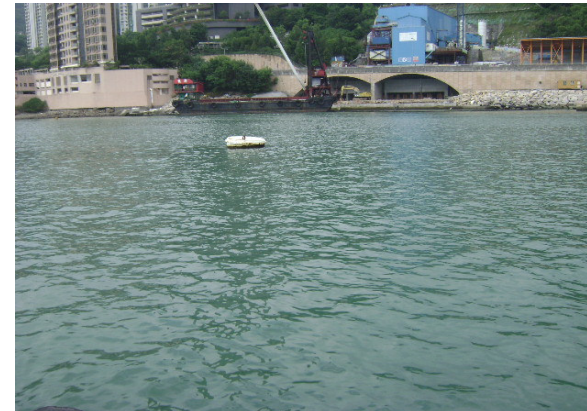
Site photo

**Photographic record for exceedance of Dissolved Oxygen (marine surface) recorded at O-1(FT) on 06-Oct-11**

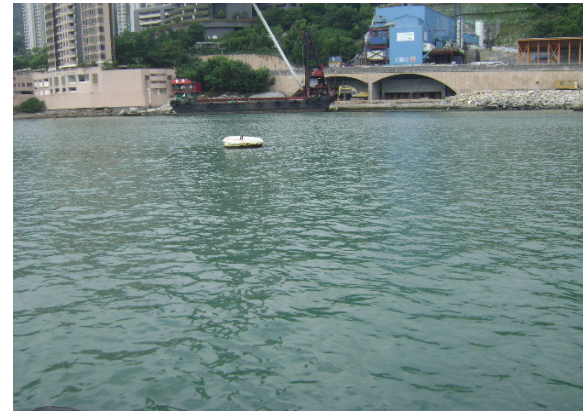
Site photo

**Photographic record for exceedance of Dissolved Oxygen (marine bottom) recorded at O-1(FT) on 06-Oct-11**

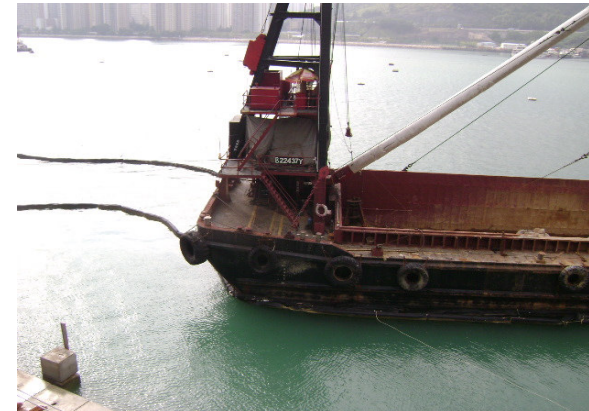
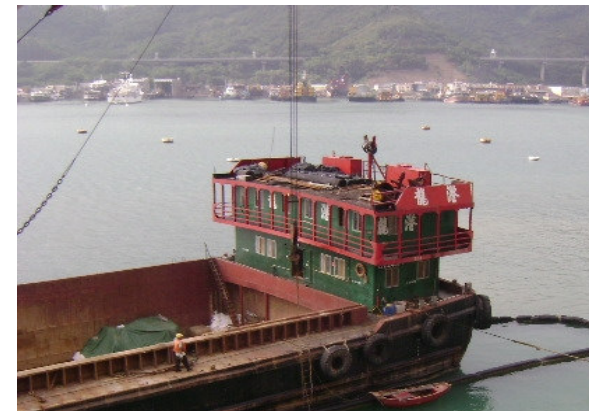
Site photo

**Photographic record for exceedance of Dissolved Oxygen (marine surface) recorded at O-1(ET) on 06-Oct-11**

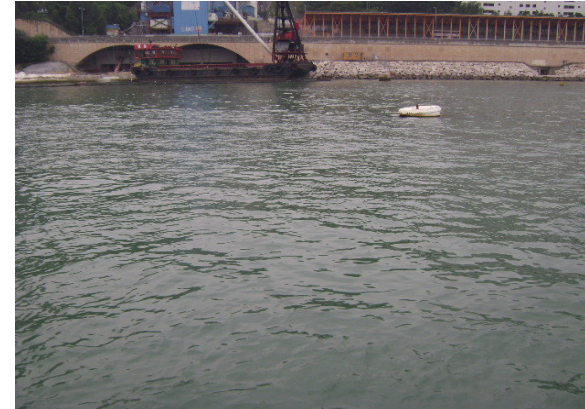
Site photo

**Photographic record for exceedance of Dissolved Oxygen (marine surface) recorded at O-1(FT) on 08-Oct-11**

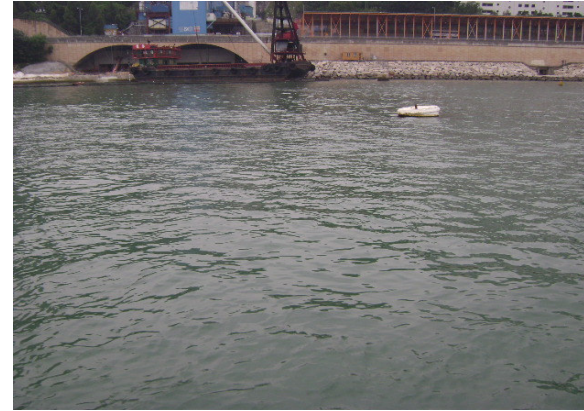
Site photo

**Photographic record for exceedance of Dissolved Oxygen (marine bottom) recorded at O-1(FT) on 08-Oct-11**

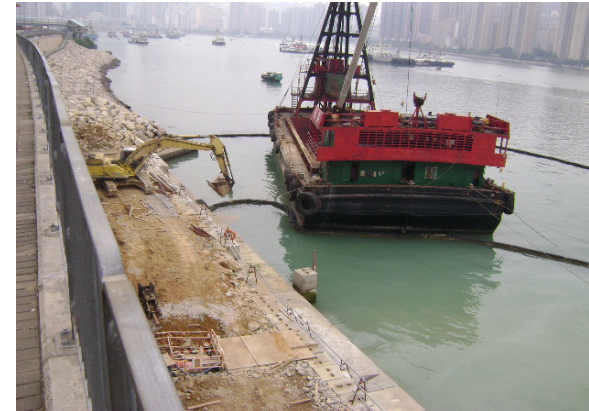
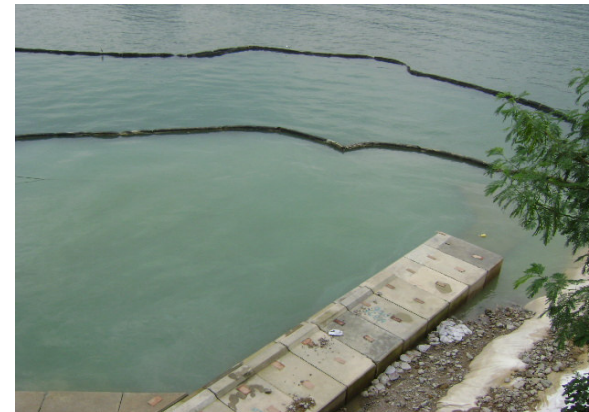
Site photo

**Photographic record for exceedance of Dissolved Oxygen (marine surface) recorded at O-1(ET) on 08-Oct-11**

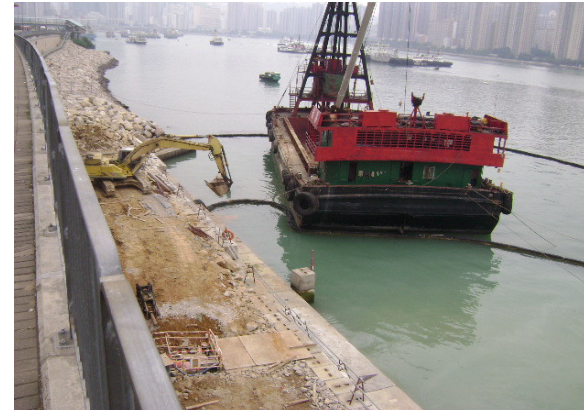
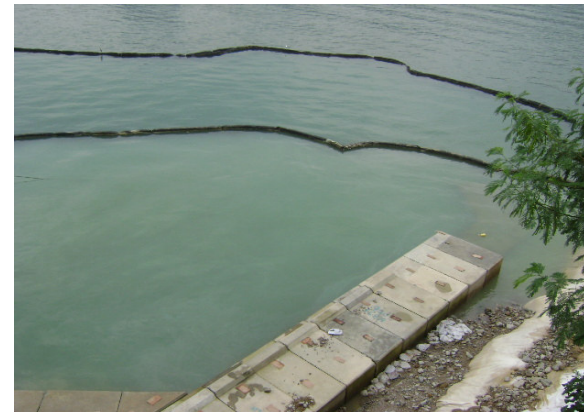
Site photo

**Photographic record for exceedance of Dissolved Oxygen (marine mid-depth) recorded at O-1(ET) on 08-Oct-11**

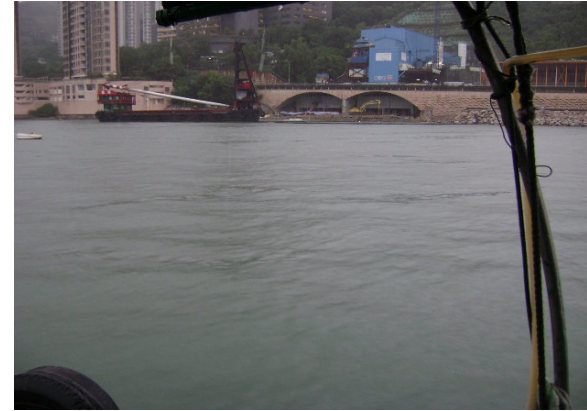
Site photo

**Photographic record for exceedance of Dissolved Oxygen (marine surface) recorded at O-1(FT) on 12-Oct-11**

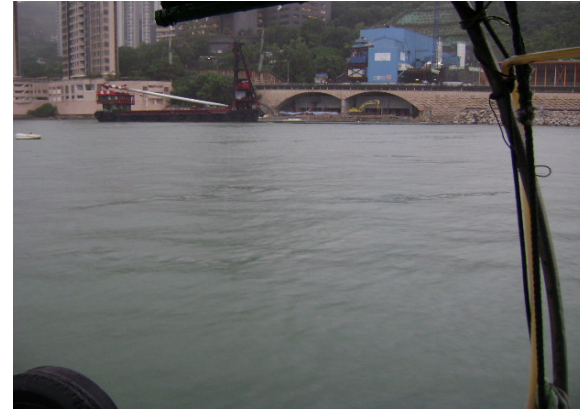
Site photo

**Photographic record for exceedance of Dissolved Oxygen (marine bottom) recorded at O-1(FT) on 12-Oct-11**

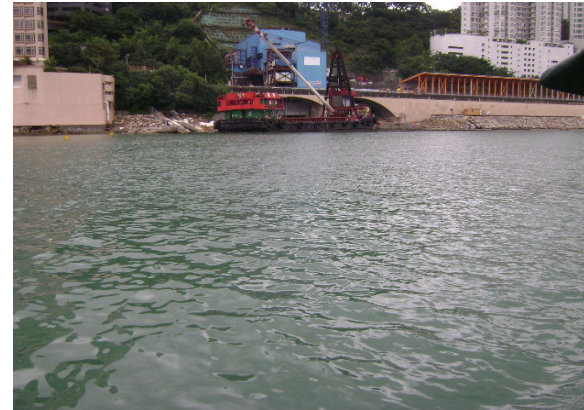
Site photo

**Photographic record for exceedance of Dissolved Oxygen (marine surface) recorded at O-1(ET) on 12-Oct-11**

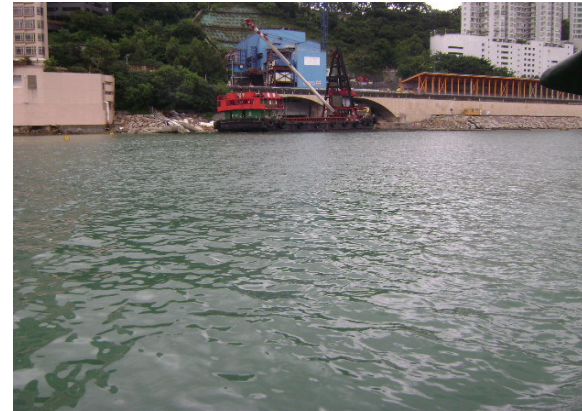
Site photo

**Photographic record for exceedance of Dissolved Oxygen (marine mid-depth) recorded at O-1(ET) on 12-Oct-11**

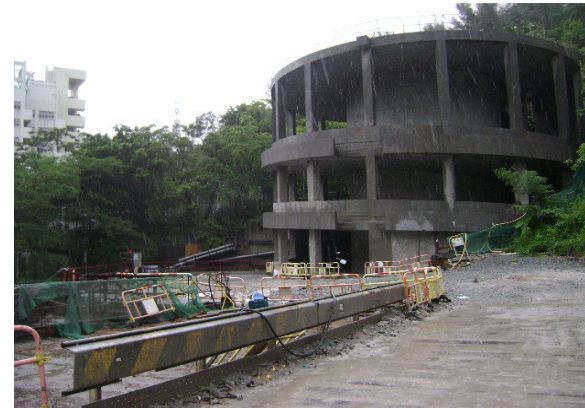
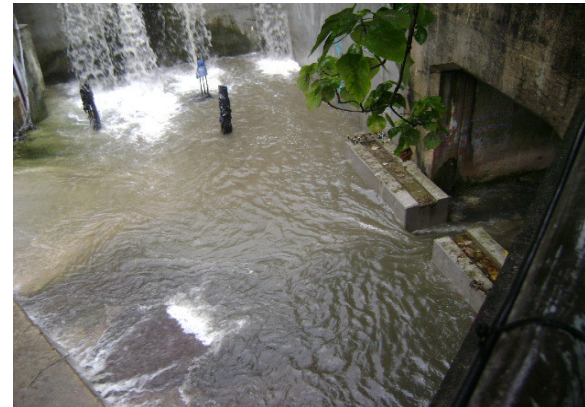
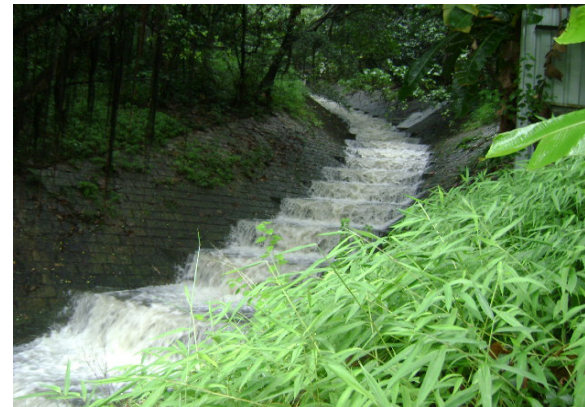
Photo taken at I-1

**Photographic record for exceedance of Turbidity recorded at Sik Sik Yuen Ho Fung College (I-1) on 12-Oct-11**

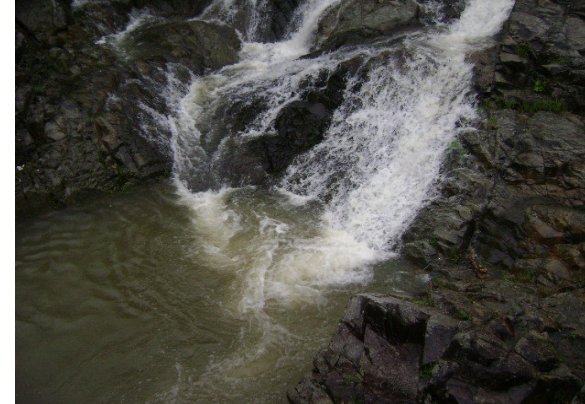
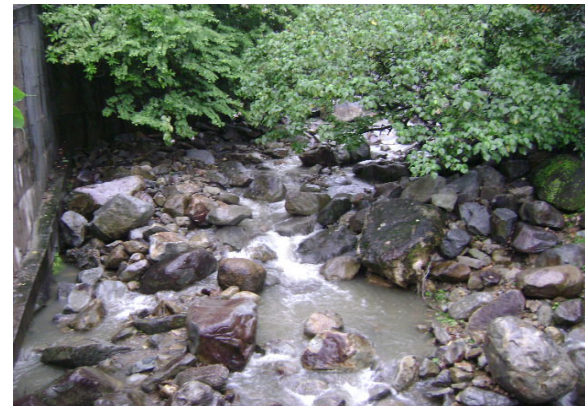
Photo taken at I-2

**Photographic record for exceedance of Turbidity recorded at Hong Hoi Chee Hong Temple (I-2) on 12-Oct-11**

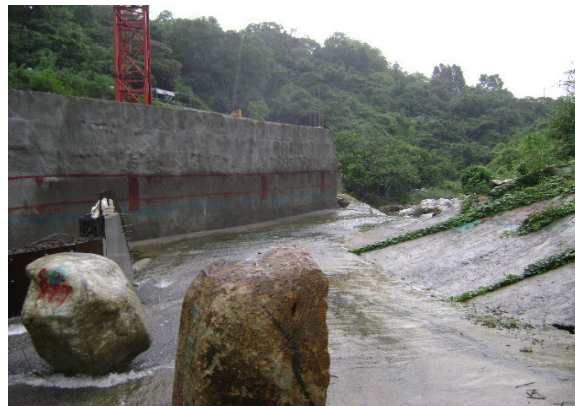
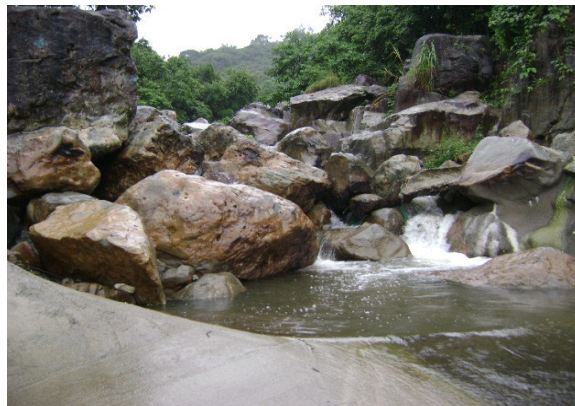
Photo taken at I-3

**Photographic record for exceedance of Turbidity recorded at Squatters (I-3) on 12-Oct-11**

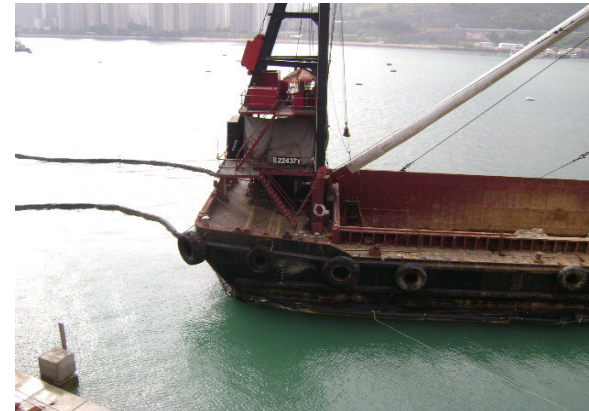
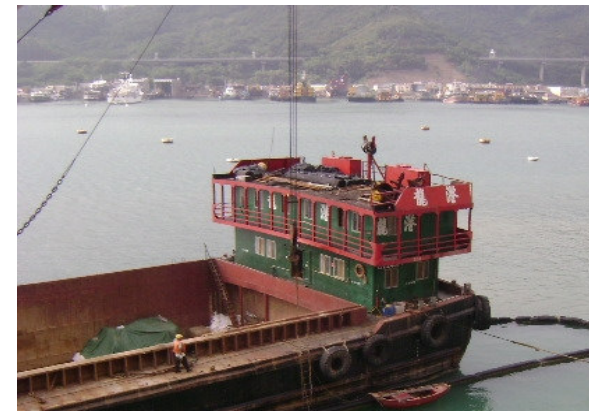
Site photo

**Photographic record for exceedance of Suspended Solids (SS) recorded at O-1(ET) on 06-Oct-11**

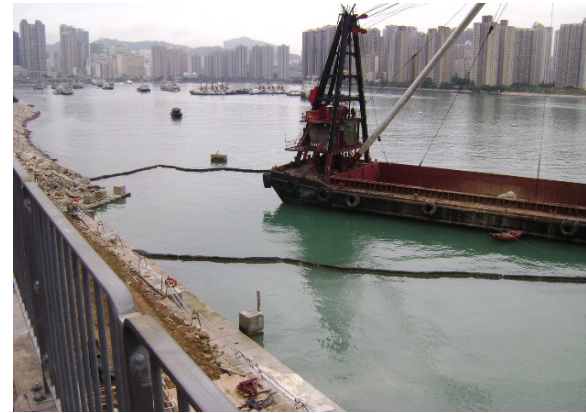
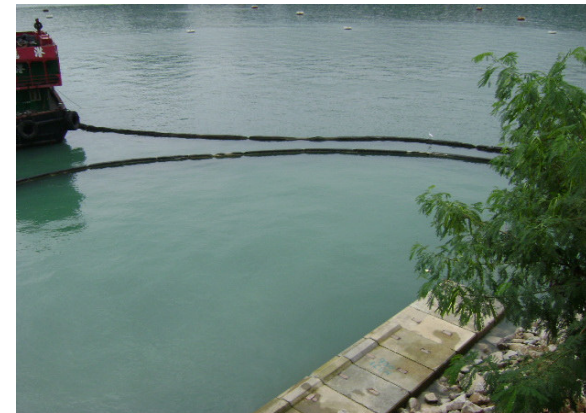
Site photo

**Photographic record for exceedance of Dissolved Oxygen (marine surface) recorded at O-1(FT) on 14-Oct-11**

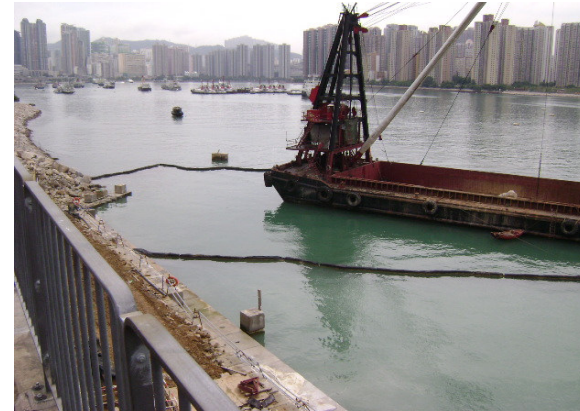
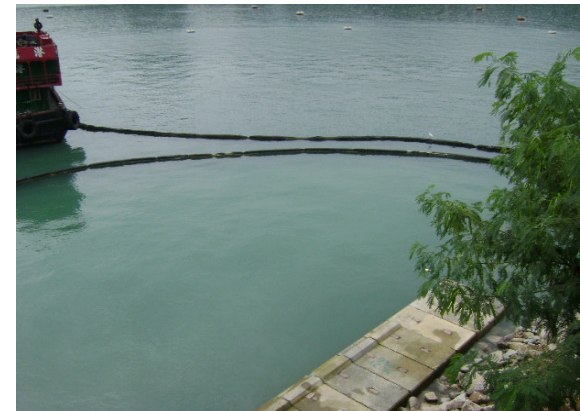
Site photo

**Photographic record for exceedance of Dissolved Oxygen (marine bottom) recorded at O-1(FT) on 14-Oct-11**

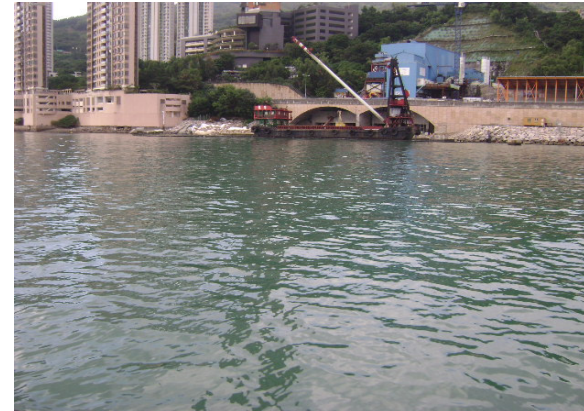
Site photo

**Photographic record for exceedance of Dissolved Oxygen (marine surface) recorded at O-1(ET) on 14-Oct-11**

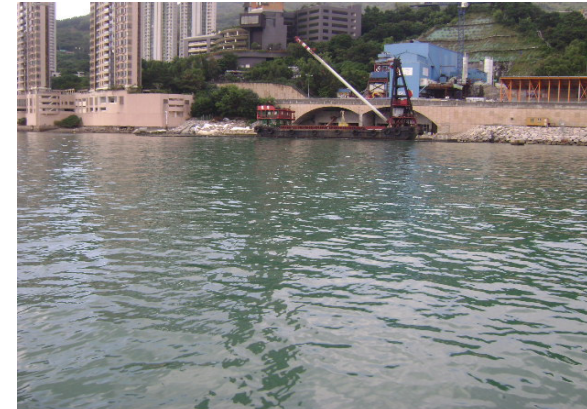
Site photo

**Photographic record for exceedance of Dissolved Oxygen (marine mid-depth) recorded at O-1(ET) on 14-Oct-11**

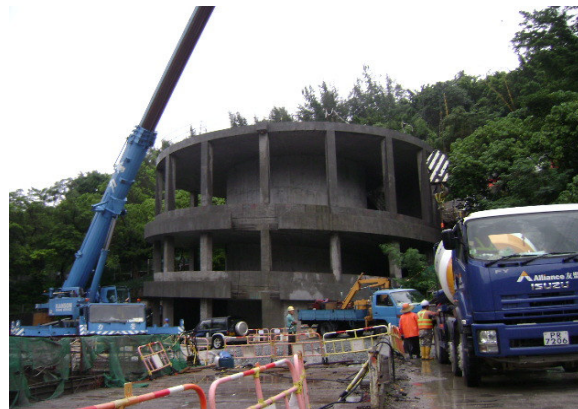
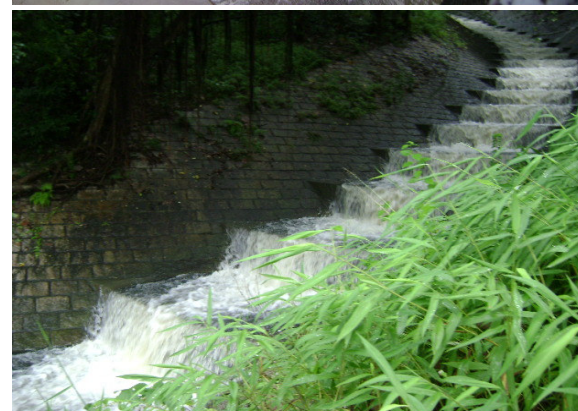
Photo taken at I-1-C

**Photographic record for exceedance of Turbidity recorded at Sik Sik Yuen Ho Fung College (I-1) on 14-Oct-11**

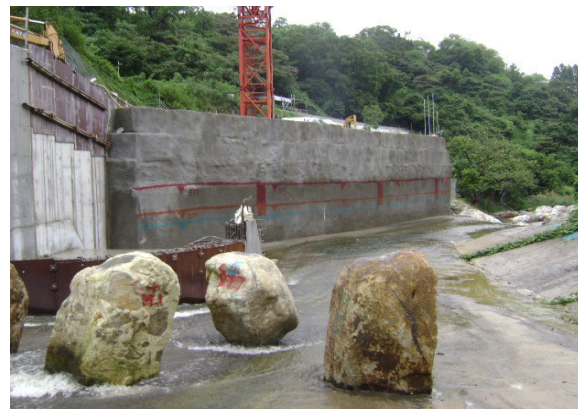
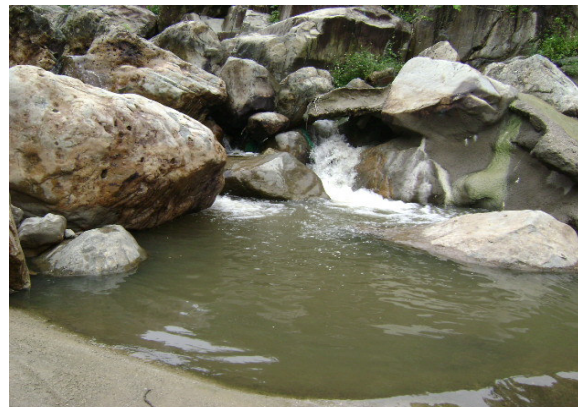
Photo taken at I-3

**Photographic record for exceedance of Turbidity recorded at Squatters (I-3) on 14-Oct-11**

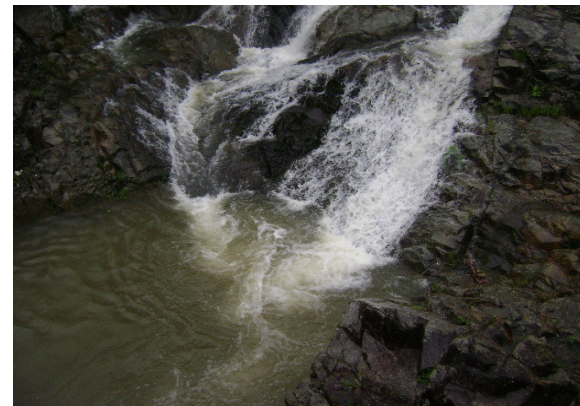
Photo taken at I-2

**Photographic record for exceedance of Suspended Solids (SS) recorded at Hong Hoi Chee Hong Temple (I-2) on 12-Oct-11**

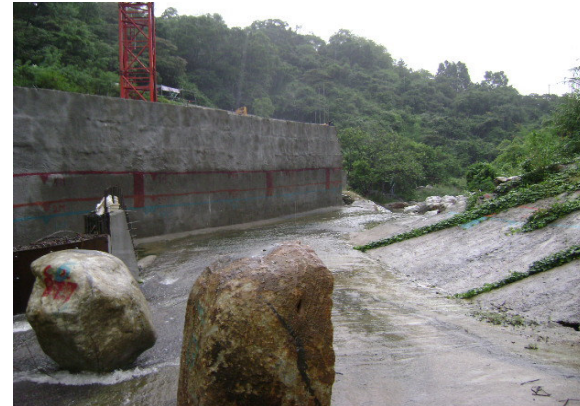
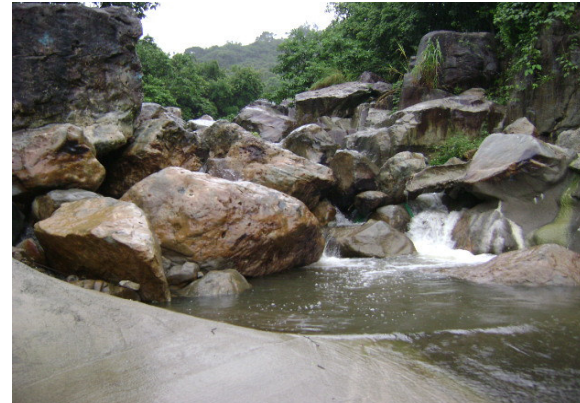
Photo taken at I-3

**Photographic record for exceedance of Suspended Solids (SS) recorded at Squatters (I-3) on 12-Oct-11**

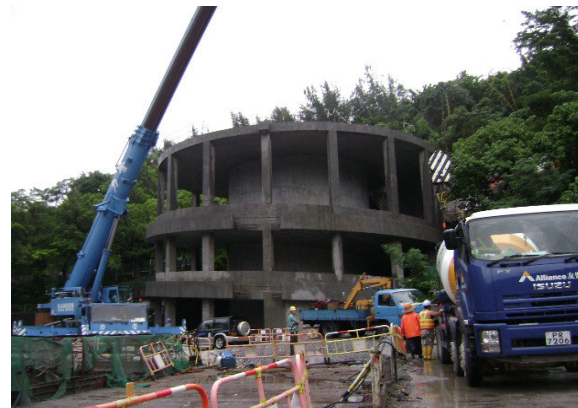
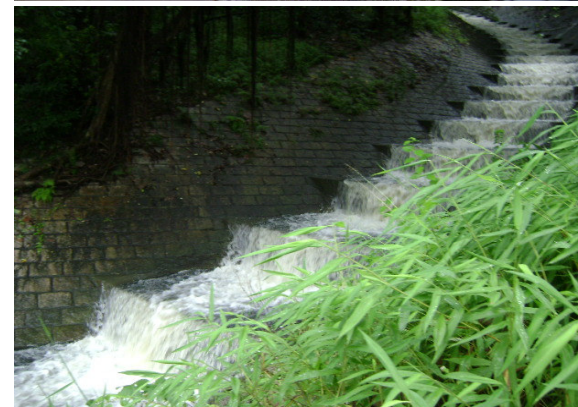
Photo taken at I-1-C

**Photographic record for exceedance of Suspended Solids (SS) recorded at Sik Sik Yuen Ho Fung College (I-1) on 14-Oct-11**

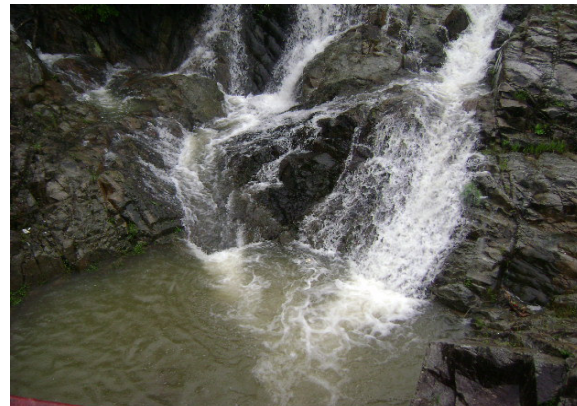
Photo taken at I-2

**Photographic record for exceedance of Suspended Solids (SS) recorded at Hong Hoi Chee Hong Temple (I-2) on 14-Oct-11**

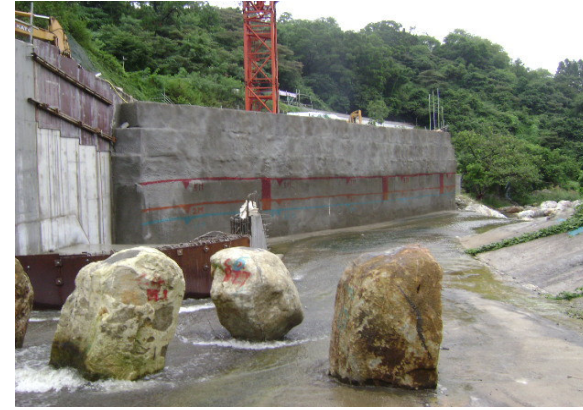
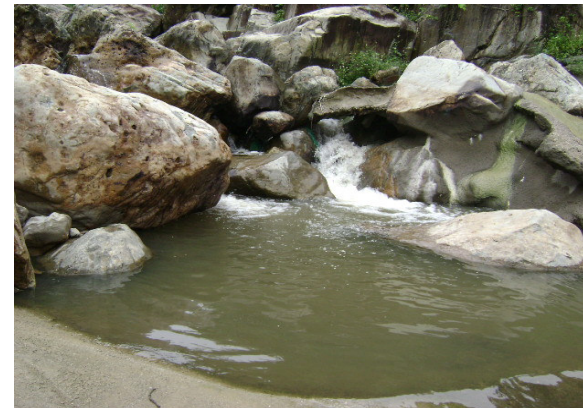
**Photographic record for exceedance of Suspended Solids (SS) recorded at Squatters (I-3) on 14-Oct-11**

Photo taken at I-3

Photo of I-3-C (Far View)

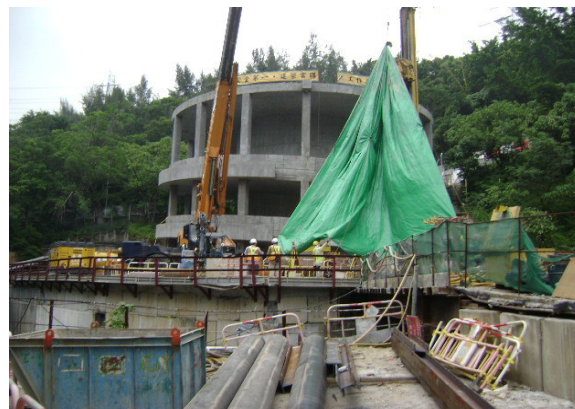
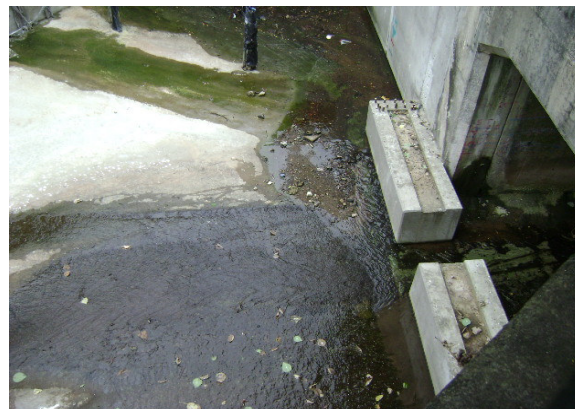
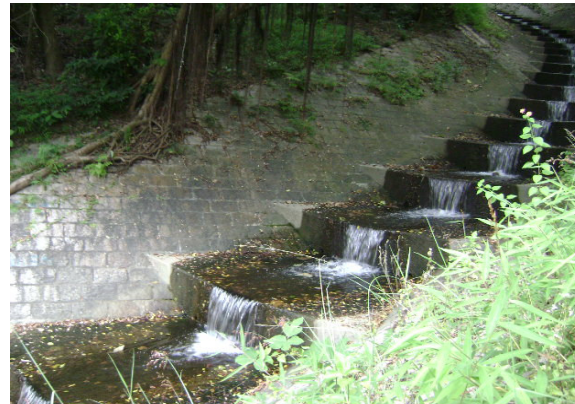
**Photographic record for exceedance of Suspended Solids (SS) recorded at Sik Sik Yuen Ho Fung College (I-1) on 26-Oct-11**

Site photo

Photo taken at I-1

Photo taken at I-1-C

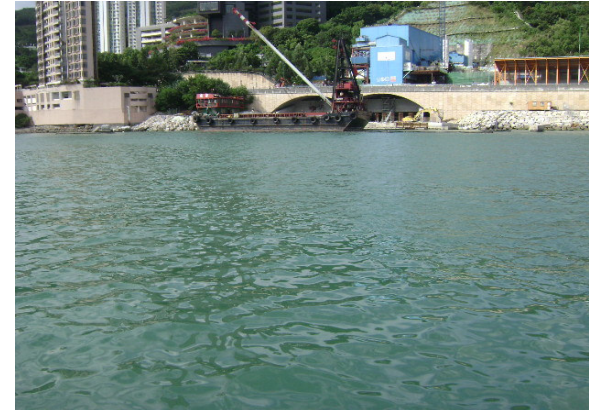
**Photographic record for exceedance of Dissolved Oxygen (marine surface) recorded at O-1(ET) on 04-Nov-11**

Site photo

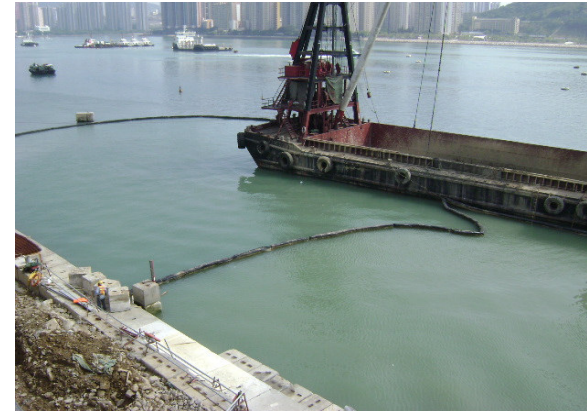
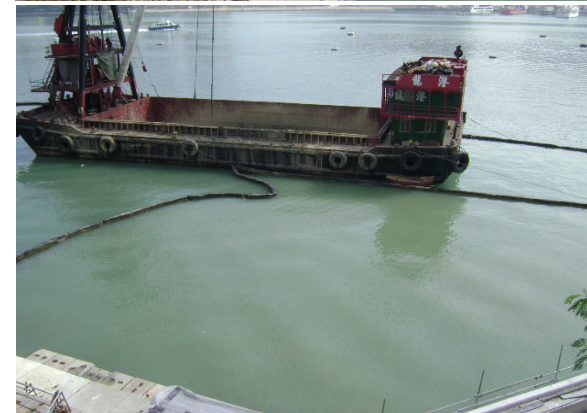
**Photographic record for exceedance of Suspended Solids (SS) recorded at O-1(ET) on 02-Nov-11**

Site photo

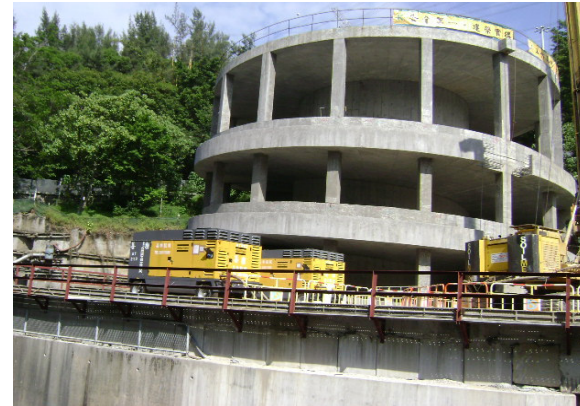
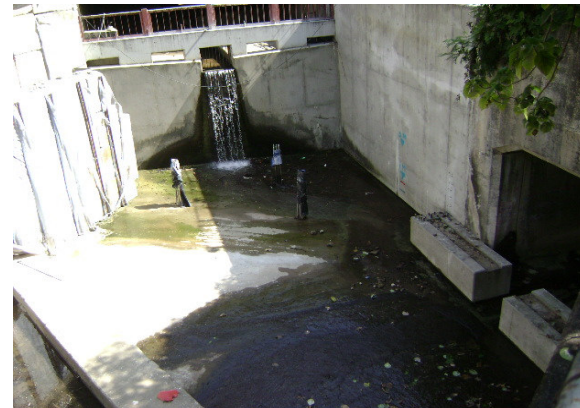
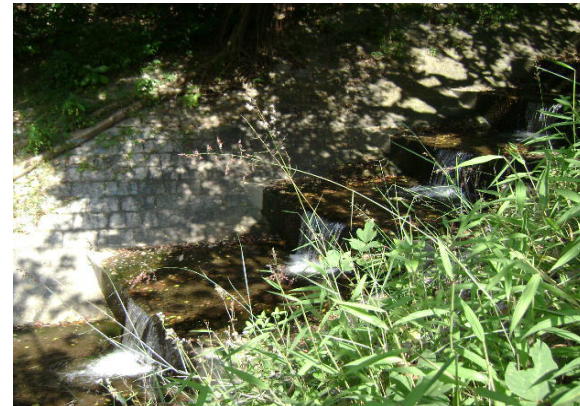
**Photographic record for exceedance of Suspended Solids (SS) recorded at Sik Sik Yuen Ho Fung College (I-1) on 02-Nov-11**

Site photo

Photo taken at I-1

Photo taken at I-1-C

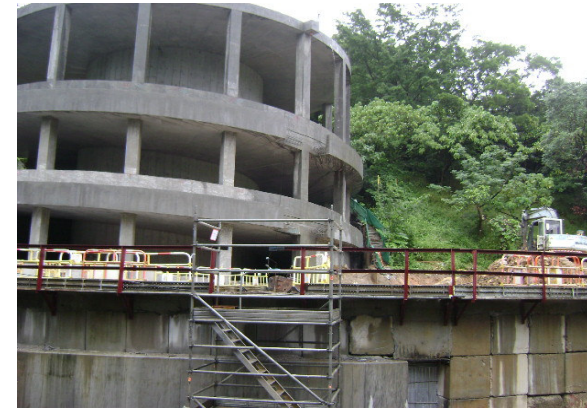
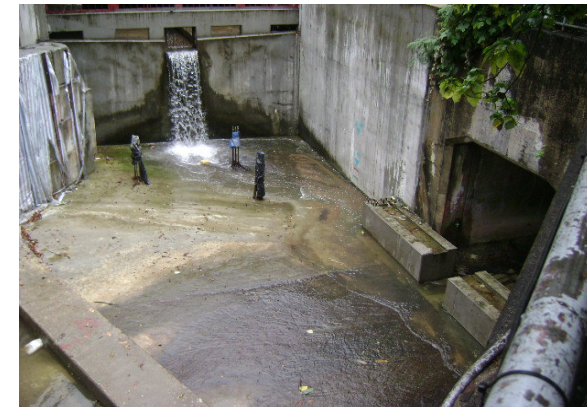
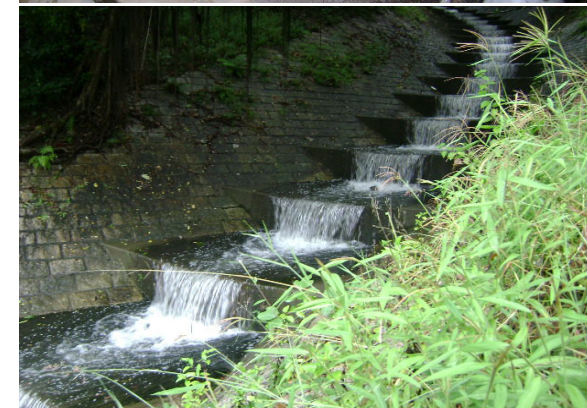
**Photographic record for exceedance of Turbidity recorded at Sik Sik Yuen Ho Fung College (I-1) on 09-Nov-11**

Site photo

Photo taken at I-1

Photo taken at I-1-C

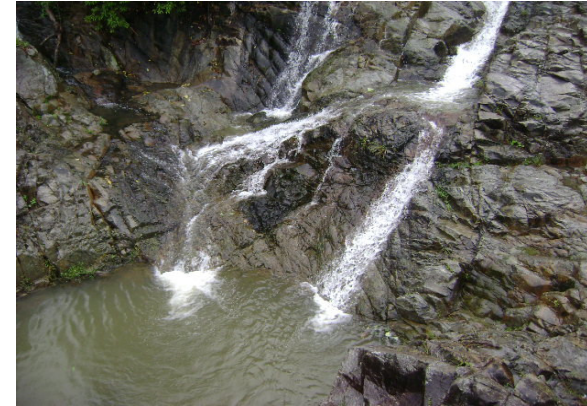
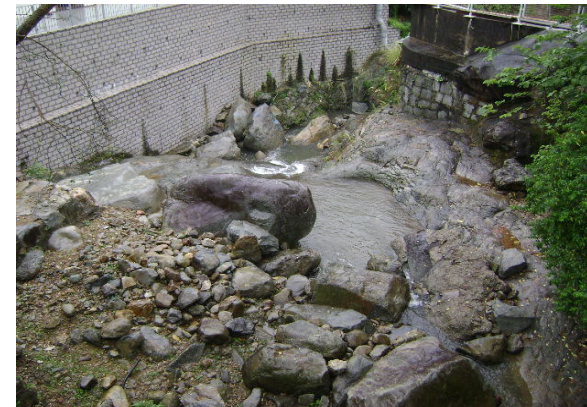
**Photographic record for exceedance of Turbidity recorded at Hong Hoi Chee Hong Temple (I-2) on 09-Nov-11**

Photo taken at I-2

Photo taken at I-2-C

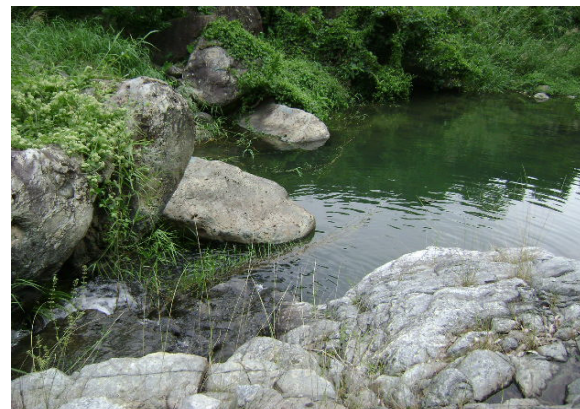
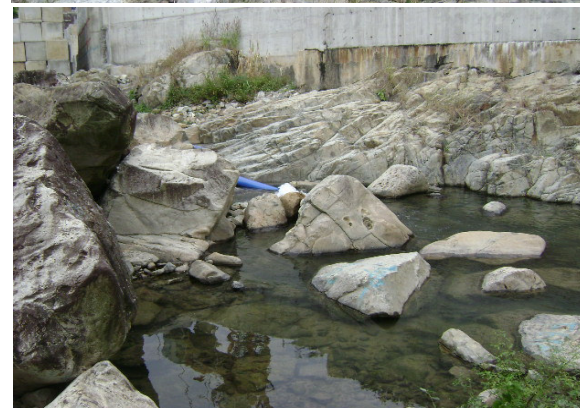
**Photographic record for exceedance of Turbidity recorded at Squatters (I-3) on 09-Nov-11**

Photo taken at I-3

Photo of I-3-C

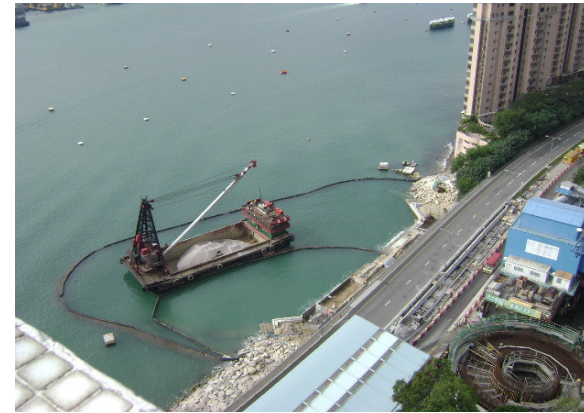
**Photographic record for exceedance of Suspended Solids (SS) recorded at O-1(FT) on 07-Nov-11**

Site photo

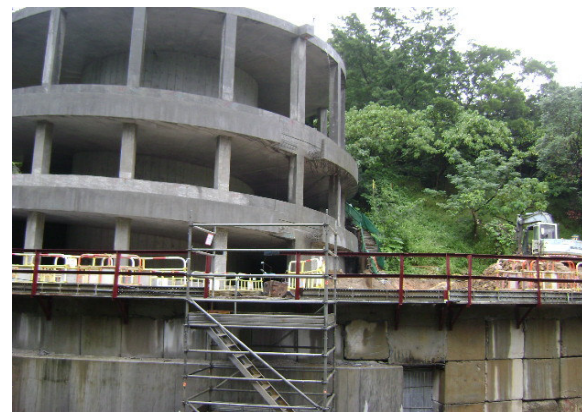
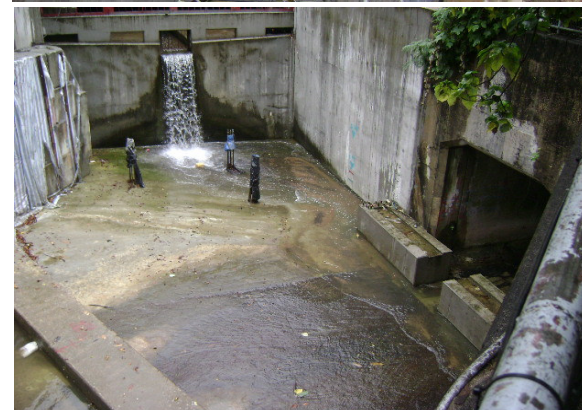
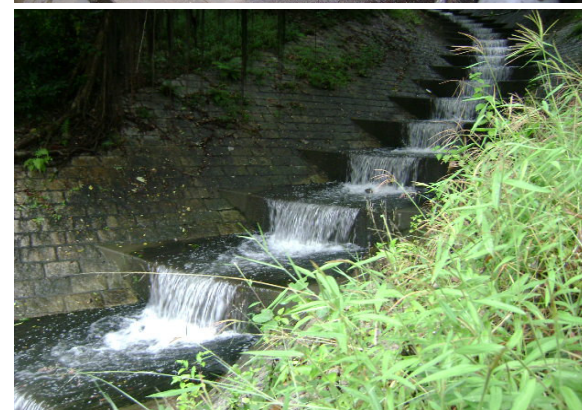
**Photographic record for exceedance of Suspended Solids (SS) recorded at Sik Sik Yuen Ho Fung College (I-1) on 09-Nov-11**

Site photo

Photo taken at I-1

Photo taken at I-1-C

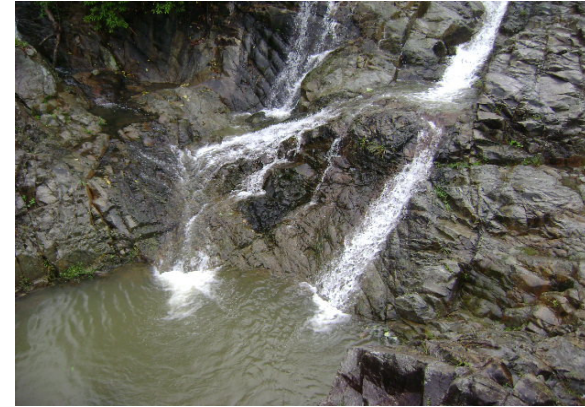
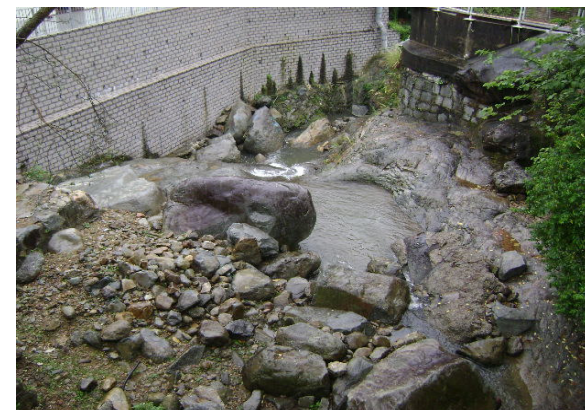
**Photographic record for exceedance of Suspended Solids (SS) recorded at Hong Hoi Chee Hong Temple (I-2) on 09-Nov-11**

Photo taken at I-2

Photo taken at I-2-C

Actions taken / to be taken	(1) Silt curtain was provided along the Portion E boundary line and extended from the seawater level to the bottom of seabed; (2) floating type silt curtain was employed at the inner side; (3) sufficient slack of silt curtain was allowed to cope with the wave and tidal action to ensure the curtains (outer and inner) were rested on seabed; and (4) condition of silt curtains was checked by the supervisor daily before undertaking any marine works.
Remarks	None

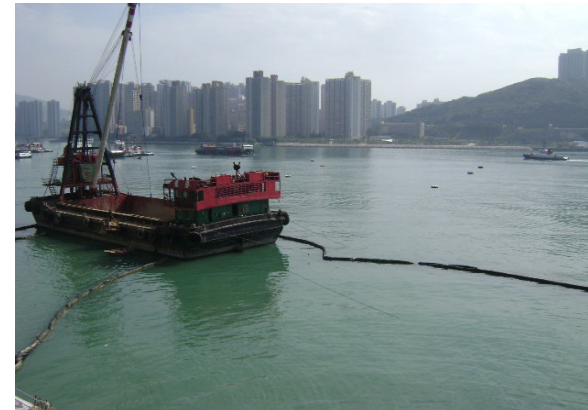
**Photographic record for exceedance of Suspended Solids (SS) recorded at O-1(FT) on 23-Nov-11**

Site photo

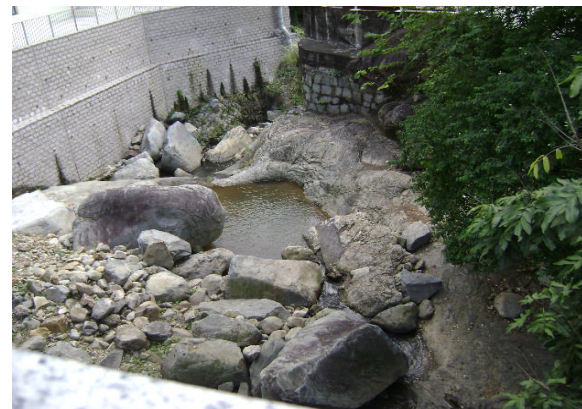
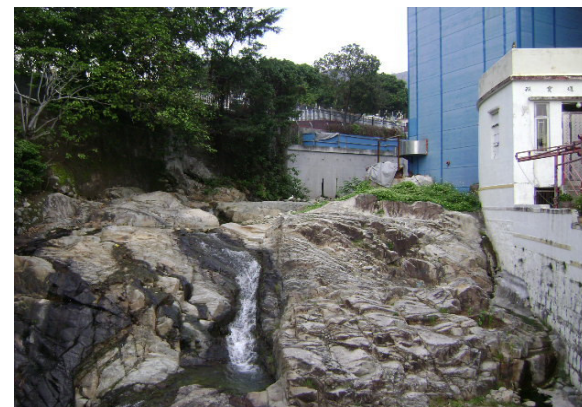
**Photographic record for exceedance of Suspended Solids (SS) recorded at Hong Hoi Chee Hong Temple (I-2) on 23-Nov-11**

Photo taken at I-2

Photo taken at I-2-C

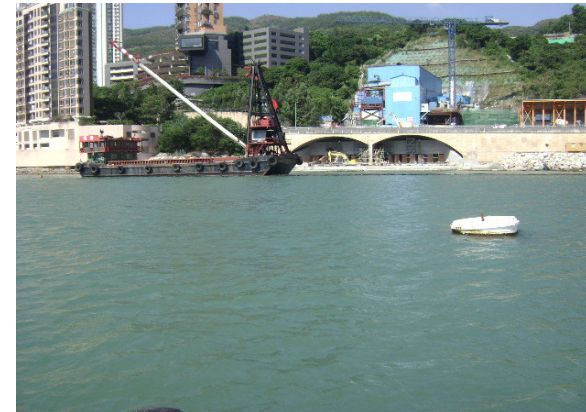
**Photographic record for exceedance of Suspended Solids (SS) recorded at O-1(FT) on 28-Nov-11**

Site photo

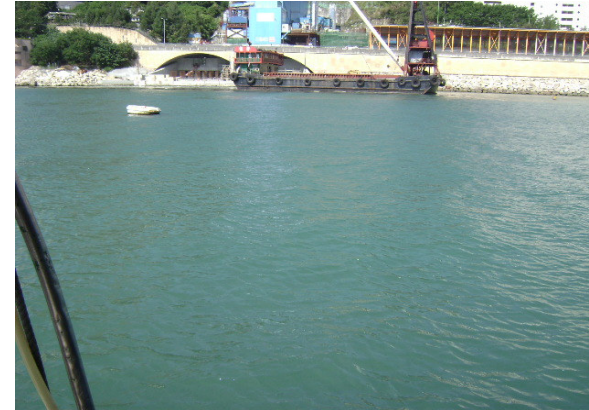
**Photographic record for exceedance of Dissolved Oxygen (marine surface) recorded at O-1(FT) on 02-Dec-11**

Site photo

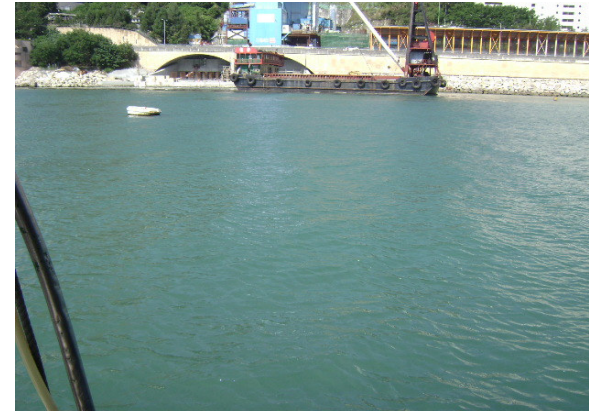
**Photographic record for exceedance of Dissolved Oxygen (marine mid-depth) recorded at O-1(FT) on 02-Dec-11**

Site photo

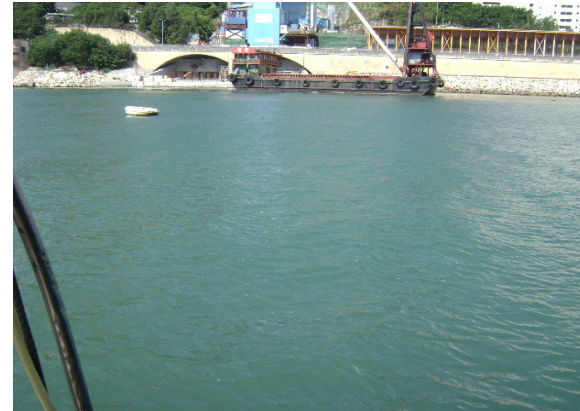
**Photographic record for exceedance of Dissolved Oxygen (marine bottom) recorded at O-1(FT) on 02-Dec-11**

Site photo

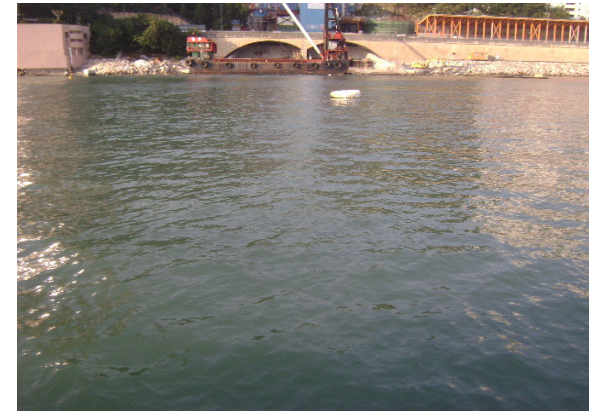
**Photographic record for exceedance of Dissolved Oxygen (marine surface) recorded at O-1(ET) on 02-Dec-11**

Site photo

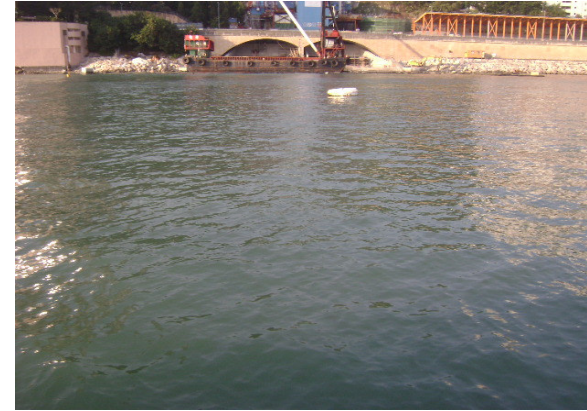
**Photographic record for exceedance of Dissolved Oxygen (marine mid-depth) recorded at O-1(ET) on 02-Dec-11**

Site photo

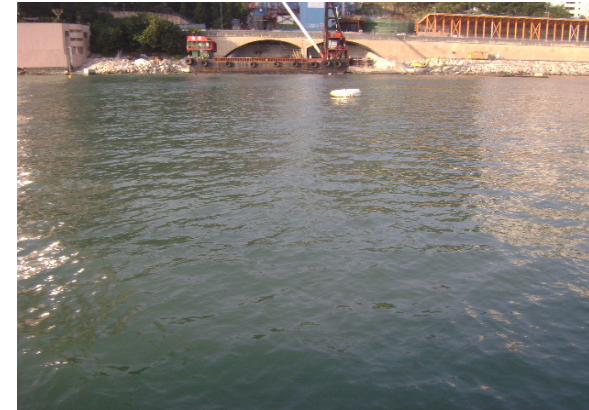
**Photographic record for exceedance of Dissolved Oxygen (marine bottom) recorded at O-1(ET) on 02-Dec-11**

Site photo

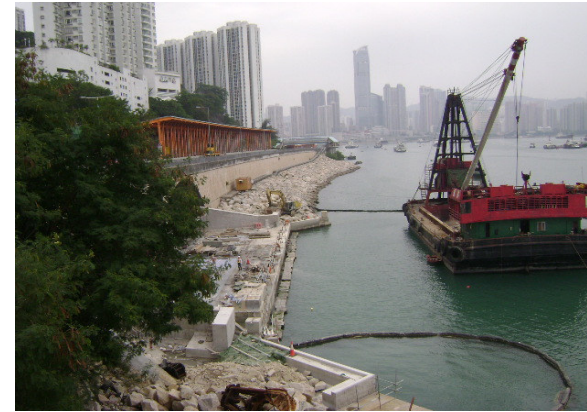
**Photographic record for exceedance of Dissolved Oxygen (marine surface) recorded at O-1(FT) on 05-Dec-11**

Site photo

Actions taken / to be taken	(1) Silt curtain was provided along the Portion E boundary line and extended from the seawater level to the bottom of seabed; (2) floating type silt curtain was employed at the inner side; (3) sufficient slack of silt curtain was allowed to cope with the wave and tidal action to ensure the curtains (outer and inner) were rested on seabed; and (4) condition of silt curtains was checked by the supervisor daily before undertaking any marine works.
Remarks	None

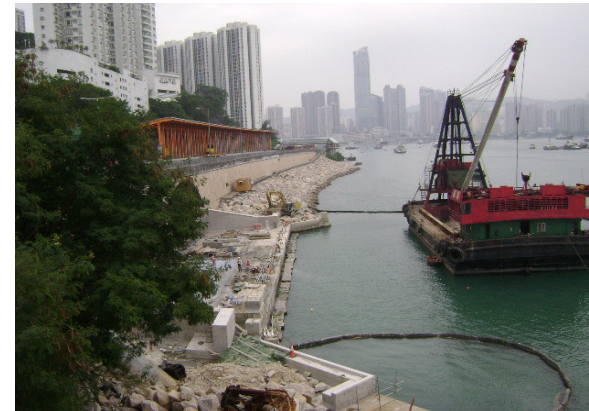
**Photographic record for exceedance of Dissolved Oxygen (marine mid-depth) recorded at O-1(FT) on 05-Dec-11**

Site photo

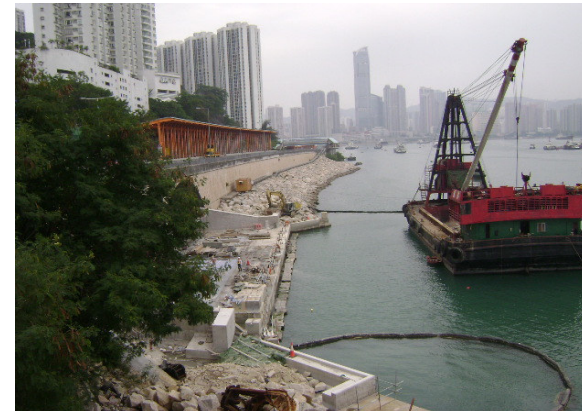
**Photographic record for exceedance of Dissolved Oxygen (marine bottom) recorded at O-1(FT) on 05-Dec-11**

Site photo

Actions taken / to be taken	(1) Silt curtain was provided along the Portion E boundary line and extended from the seawater level to the bottom of seabed; (2) floating type silt curtain was employed at the inner side; (3) sufficient slack of silt curtain was allowed to cope with the wave and tidal action to ensure the curtains (outer and inner) were rested on seabed; and (4) condition of silt curtains was checked by the supervisor daily before undertaking any marine works.
Remarks	None

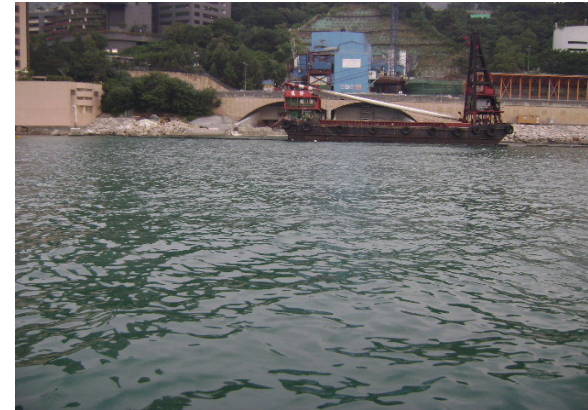
**Photographic record for exceedance of Dissolved Oxygen (marine surface) recorded at O-1(ET) on 05-Dec-11**

Site photo

Actions taken / to be taken	(1) Silt curtain was provided along the Portion E boundary line and extended from the seawater level to the bottom of seabed; (2) floating type silt curtain was employed at the inner side; (3) sufficient slack of silt curtain was allowed to cope with the wave and tidal action to ensure the curtains (outer and inner) were rested on seabed; and (4) condition of silt curtains was checked by the supervisor daily before undertaking any marine works.
Remarks	None
