Contract NO. DC/2007/12 - Design and  
Construction of Tsuen Wan Drainage Tunnel

Quarterly EM&A Report (October to December 2011)

**Report No** EB000364R0741

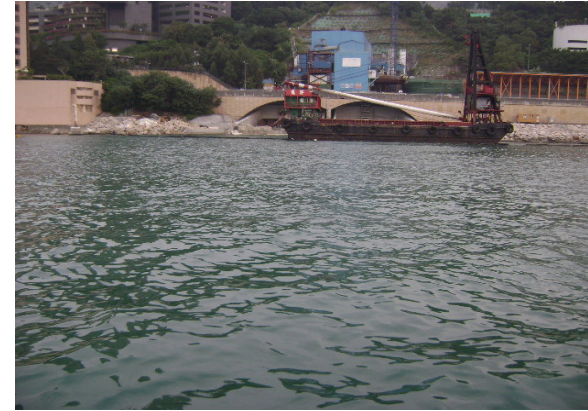
**Photographic record for exceedance of Dissolved Oxygen (marine mid-depth) recorded at O-1(ET) on 05-Dec-11**

Site photo

Actions taken / to be taken	(1) Silt curtain was provided along the Portion E boundary line and extended from the seawater level to the bottom of seabed; (2) floating type silt curtain was employed at the inner side; (3) sufficient slack of silt curtain was allowed to cope with the wave and tidal action to ensure the curtains (outer and inner) were rested on seabed; and (4) condition of silt curtains was checked by the supervisor daily before undertaking any marine works.
Remarks	None

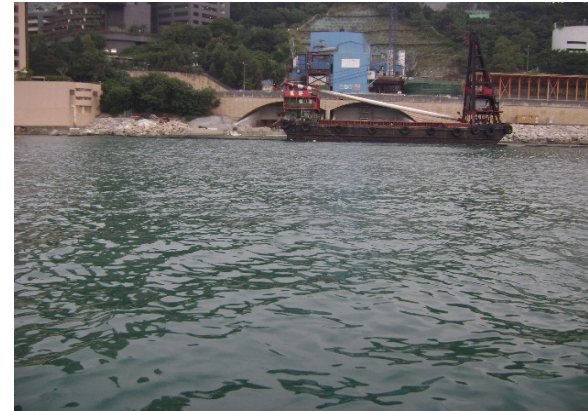
**Photographic record for exceedance of Dissolved Oxygen (marine bottom) recorded at O-1(ET) on 05-Dec-11**

Site photo

Actions taken / to be taken	(1) Silt curtain was provided along the Portion E boundary line and extended from the seawater level to the bottom of seabed; (2) floating type silt curtain was employed at the inner side; (3) sufficient slack of silt curtain was allowed to cope with the wave and tidal action to ensure the curtains (outer and inner) were rested on seabed; and (4) condition of silt curtains was checked by the supervisor daily before undertaking any marine works.
Remarks	None

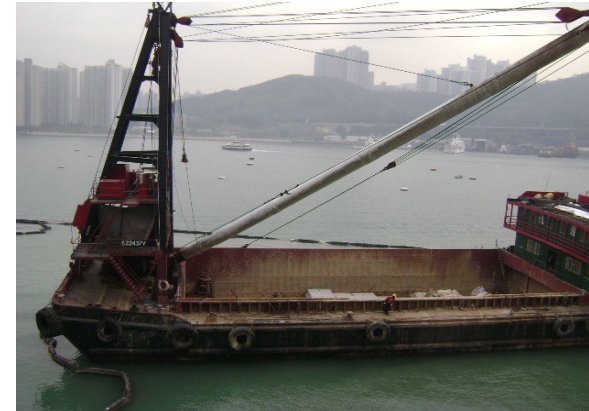
**Photographic record for exceedance of Dissolved Oxygen (marine surface) recorded at O-1(FT) on 07-Dec-11**

Site photo

Actions taken / to be taken	(1) Silt curtain was provided along the Portion E boundary line and extended from the seawater level to the bottom of seabed; (2) floating type silt curtain was employed at the inner side; (3) sufficient slack of silt curtain was allowed to cope with the wave and tidal action to ensure the curtains (outer and inner) were rested on seabed; and (4) condition of silt curtains was checked by the supervisor daily before undertaking any marine works.
Remarks	None

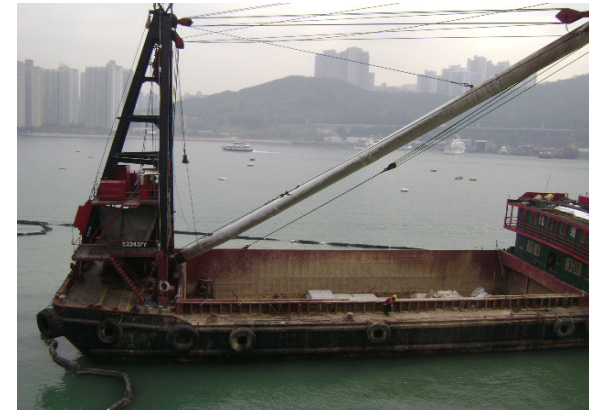
**Photographic record for exceedance of Dissolved Oxygen (marine mid-depth) recorded at O-1(FT) on 07-Dec-11**

Site photo

Actions taken / to be taken	(1) Silt curtain was provided along the Portion E boundary line and extended from the seawater level to the bottom of seabed; (2) floating type silt curtain was employed at the inner side; (3) sufficient slack of silt curtain was allowed to cope with the wave and tidal action to ensure the curtains (outer and inner) were rested on seabed; and (4) condition of silt curtains was checked by the supervisor daily before undertaking any marine works.
Remarks	None

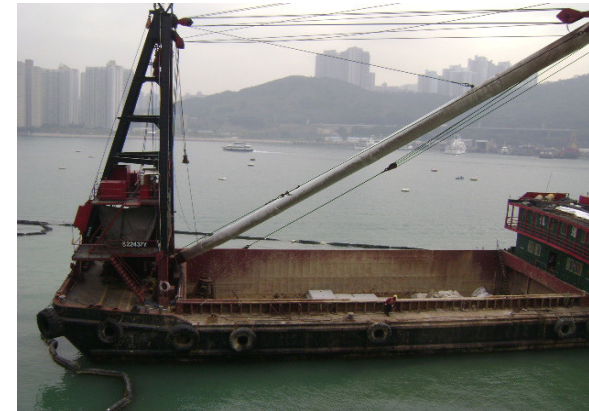
**Photographic record for exceedance of Dissolved Oxygen (marine bottom) recorded at O-1(FT) on 07-Dec-11**

Site photo

Actions taken / to be taken	(1) Silt curtain was provided along the Portion E boundary line and extended from the seawater level to the bottom of seabed; (2) floating type silt curtain was employed at the inner side; (3) sufficient slack of silt curtain was allowed to cope with the wave and tidal action to ensure the curtains (outer and inner) were rested on seabed; and (4) condition of silt curtains was checked by the supervisor daily before undertaking any marine works.
Remarks	None

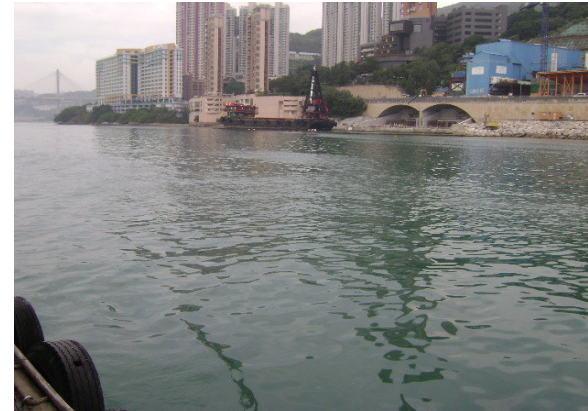
**Photographic record for exceedance of Dissolved Oxygen (marine surface) recorded at O-1(ET) on 07-Dec-11**

Site photo

Actions taken / to be taken	(1) Silt curtain was provided along the Portion E boundary line and extended from the seawater level to the bottom of seabed; (2) floating type silt curtain was employed at the inner side; (3) sufficient slack of silt curtain was allowed to cope with the wave and tidal action to ensure the curtains (outer and inner) were rested on seabed; and (4) condition of silt curtains was checked by the supervisor daily before undertaking any marine works.
Remarks	None

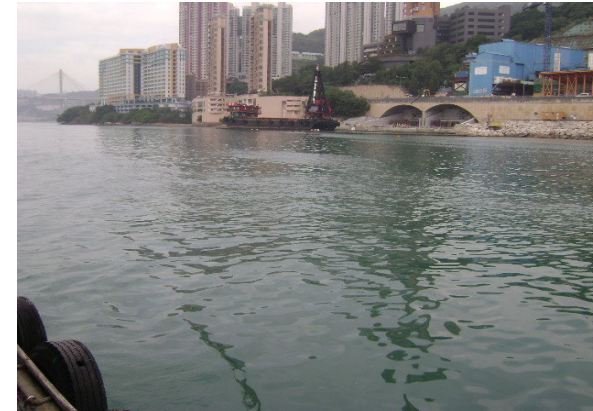
**Photographic record for exceedance of Dissolved Oxygen (marine mid-depth) recorded at O-1(ET) on 07-Dec-11**

Site photo

Actions taken / to be taken	(1) Silt curtain was provided along the Portion E boundary line and extended from the seawater level to the bottom of seabed; (2) floating type silt curtain was employed at the inner side; (3) sufficient slack of silt curtain was allowed to cope with the wave and tidal action to ensure the curtains (outer and inner) were rested on seabed; and (4) condition of silt curtains was checked by the supervisor daily before undertaking any marine works.
Remarks	None

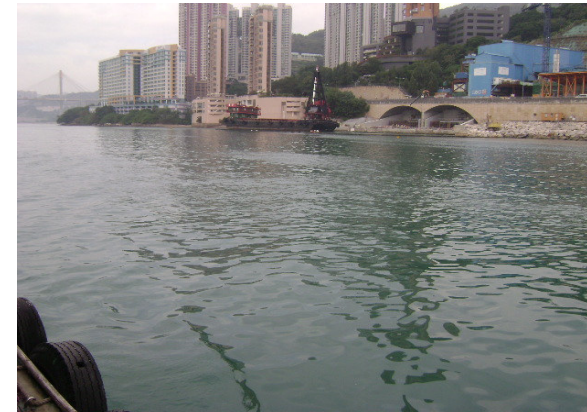
**Photographic record for exceedance of Dissolved Oxygen (marine bottom) recorded at O-1(ET) on 07-Dec-11**

Site photo

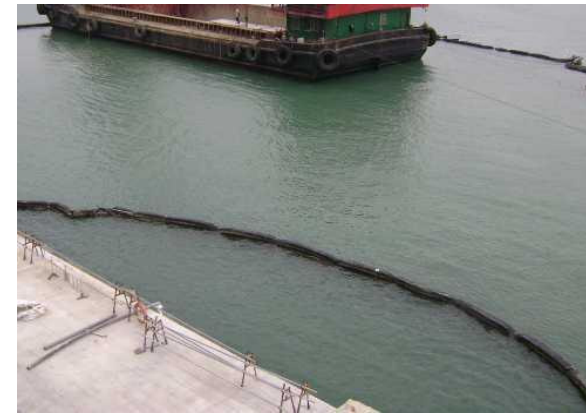
**Photographic record for exceedance of Dissolved Oxygen (marine surface) recorded at O-1(FT) on 09-Dec-11**

Site photo

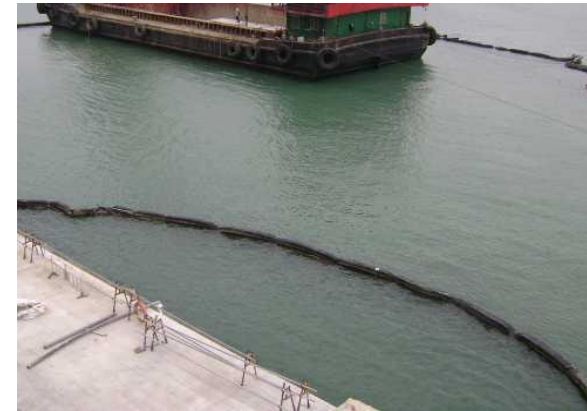
**Photographic record for exceedance of Dissolved Oxygen (marine mid-depth) recorded at O-1(FT) on 09-Dec-11**

Site photo

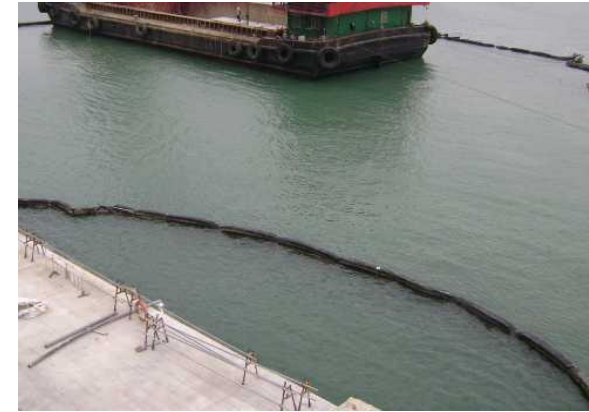
**Photographic record for exceedance of Dissolved Oxygen (marine bottom) recorded at O-1(FT) on 09-Dec-11**

Site photo

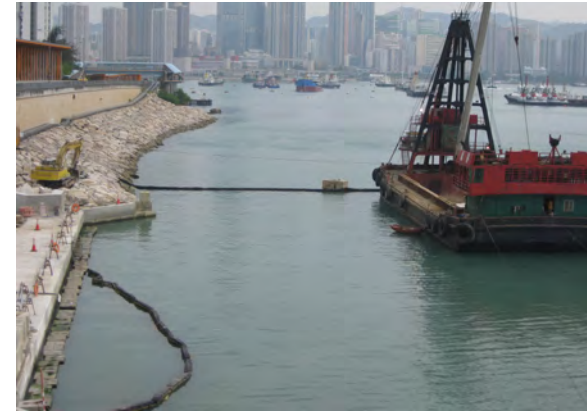
**Photographic record for exceedance of Dissolved Oxygen (marine surface) recorded at O-1(ET) on 09-Dec-11**

Site photo

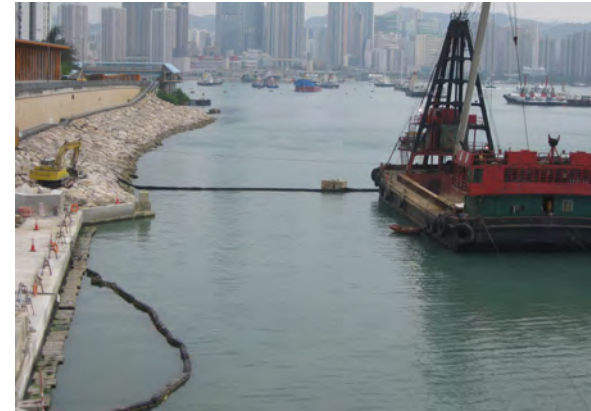
**Photographic record for exceedance of Dissolved Oxygen (marine mid-depth) recorded at O-1(ET) on 09-Dec-11**

Site photo

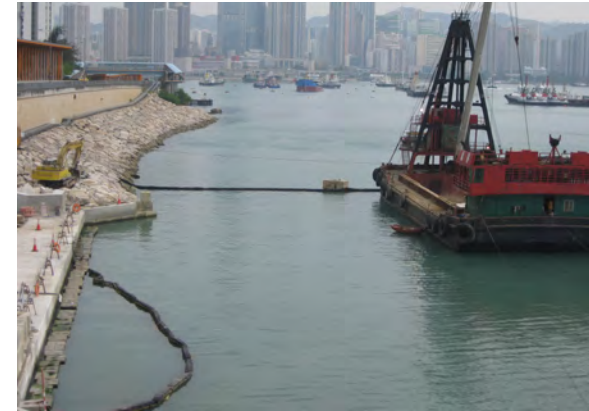
**Photographic record for exceedance of Dissolved Oxygen (marine bottom) recorded at O-1(ET) on 09-Dec-11**

Site photo

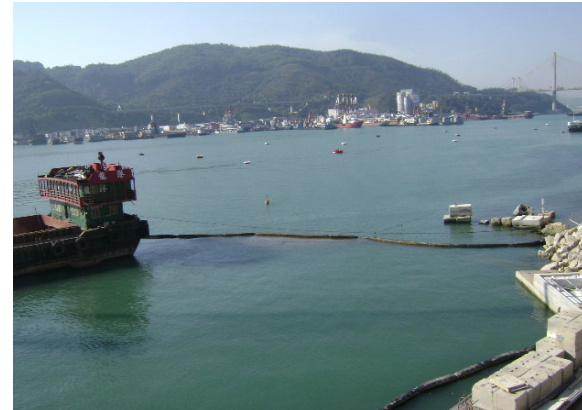
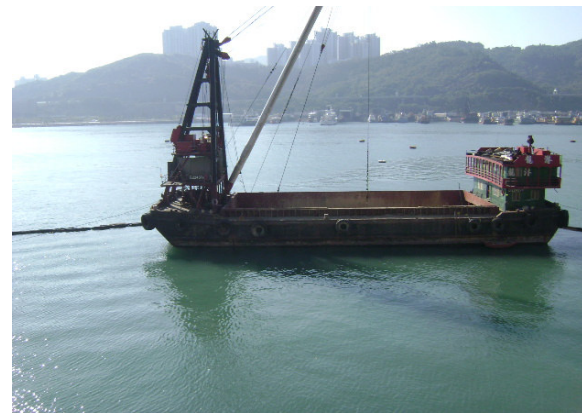
**Photographic record for exceedance of Dissolved Oxygen (marine surface) recorded at O-1(FT) on 12-Dec-11**

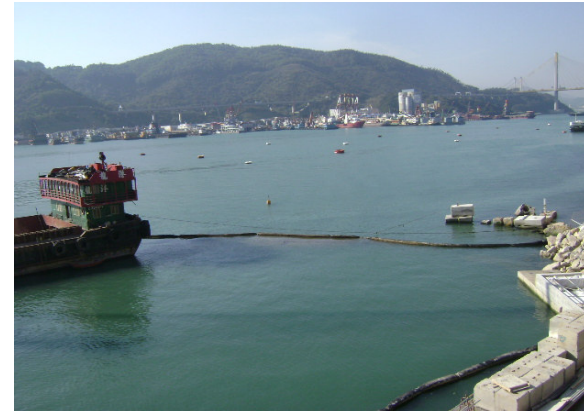
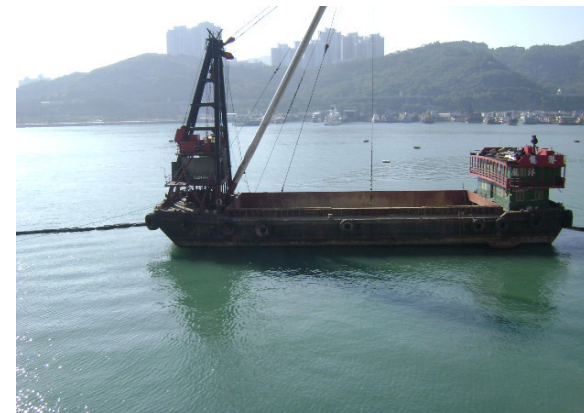
**Photographic record for exceedance of Dissolved Oxygen (marine mid-depth) recorded at O-1(FT) on 12-Dec-11**

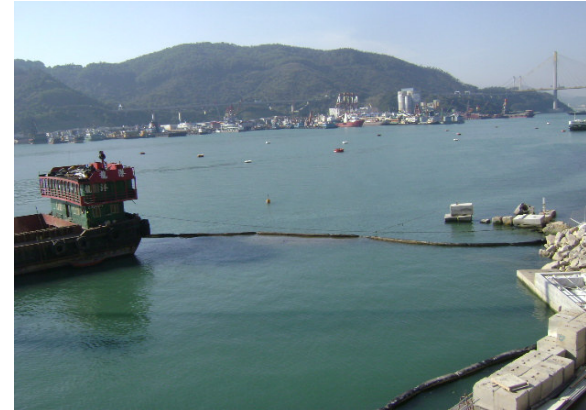
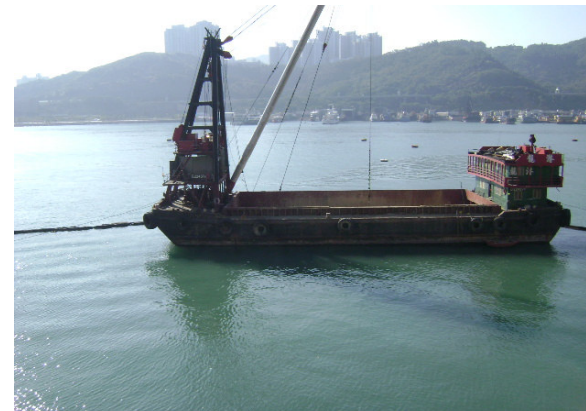
**Photographic record for exceedance of Dissolved Oxygen (marine bottom) recorded at O-1(FT) on 12-Dec-11**

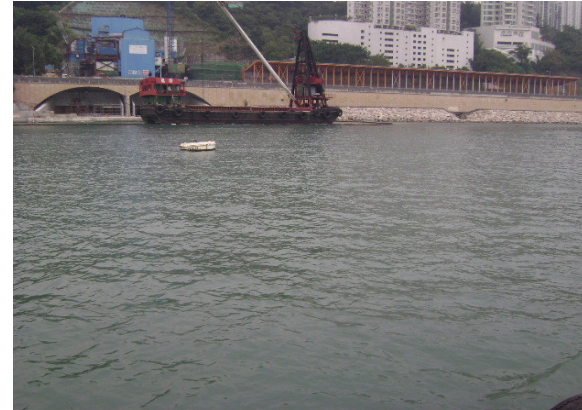
**Photographic record for exceedance of Dissolved Oxygen (marine surface) recorded at O-1(FT) on 14-Dec-11**

Site photo

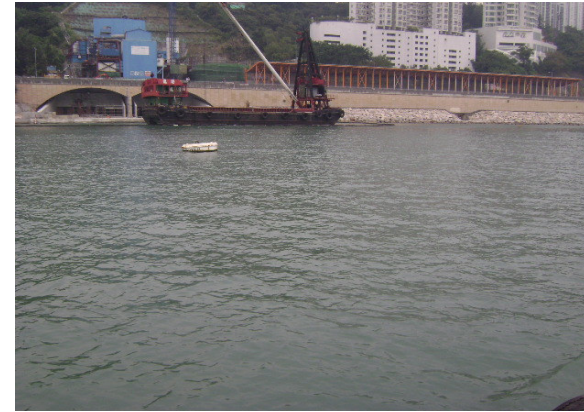
**Photographic record for exceedance of Dissolved Oxygen (marine mid-depth) recorded at O-1(FT) on 14-Dec-11**

Site photo

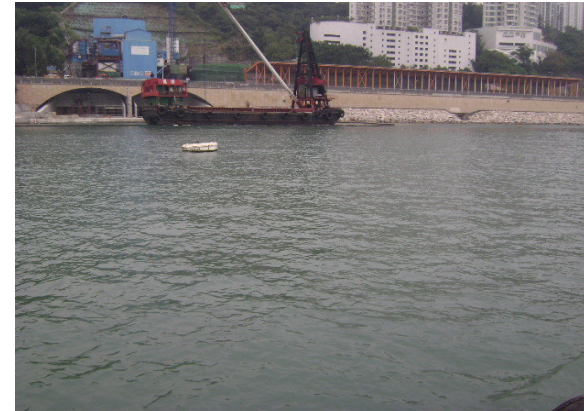
**Photographic record for exceedance of Dissolved Oxygen (marine bottom) recorded at O-1(FT) on 14-Dec-11**

Site photo

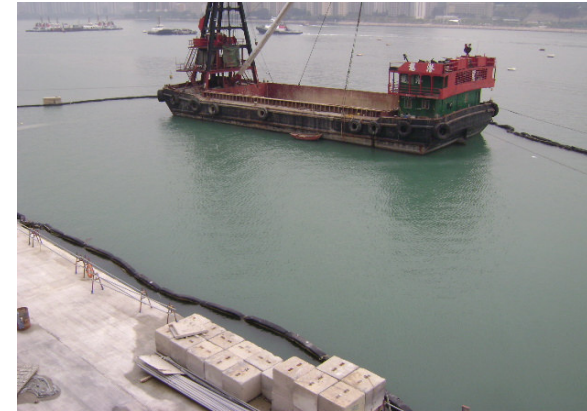
**Photographic record for exceedance of Dissolved Oxygen (marine surface) recorded at O-1(ET) on 14-Dec-11**

Site photo

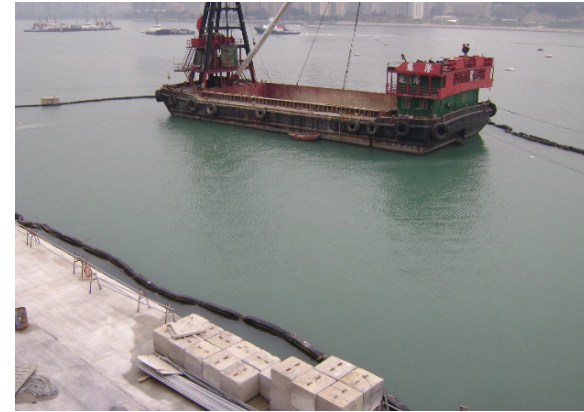
**Photographic record for exceedance of Dissolved Oxygen (marine mid-depth) recorded at O-1(ET) on 14-Dec-11**

Site photo

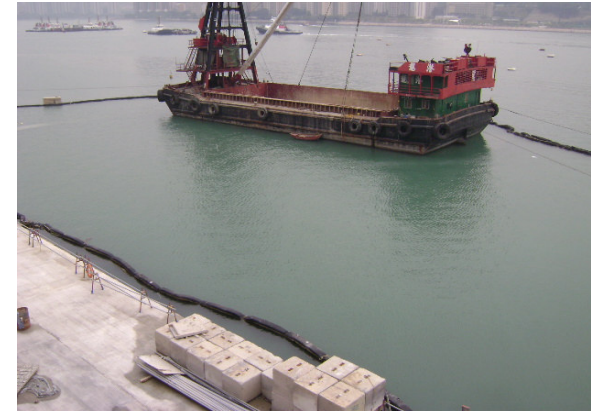
**Photographic record for exceedance of Dissolved Oxygen (marine bottom) recorded at O-1(ET) on 14-Dec-11**

Site photo

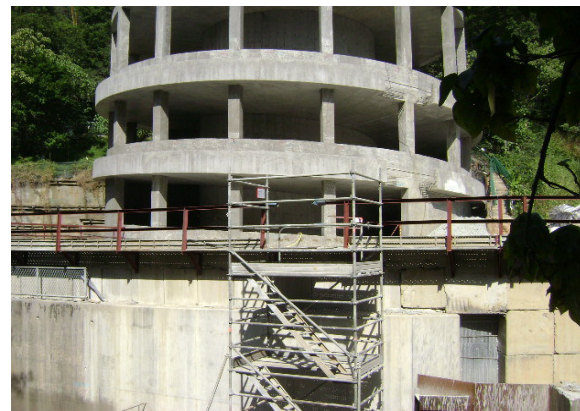
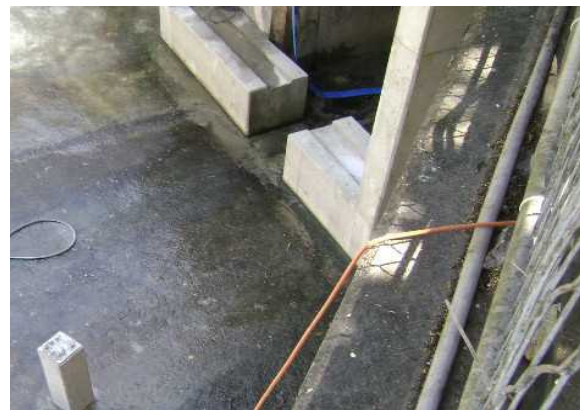
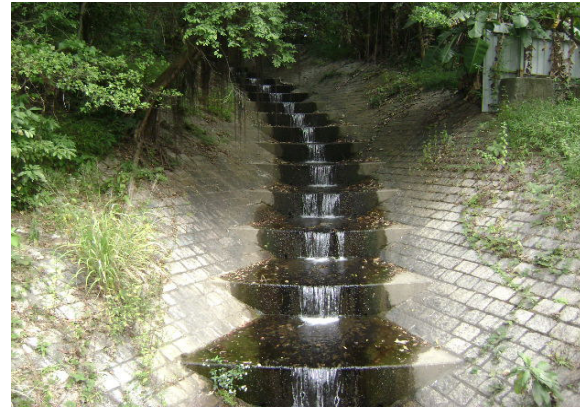
**Photographic record for exceedance of Suspended Solids (SS) recorded at Sik Sik Yuen Ho Fung College (I-1) on 12-Dec-11**

Actions taken / to be taken	(1) Silt curtain was provided along the Portion E boundary line (outer silt curtain) and extended from the seawater level to the bottom of seabed; (2) floating type silt curtain was employed at the inner side; (3) sufficient slack of silt curtain was allowed to cope with the wave and tidal action to ensure the curtains (outer and inner) were rested on seabed; and (4) condition of silt curtains was checked by the supervisor daily before undertaking any marine works.
Remarks	None

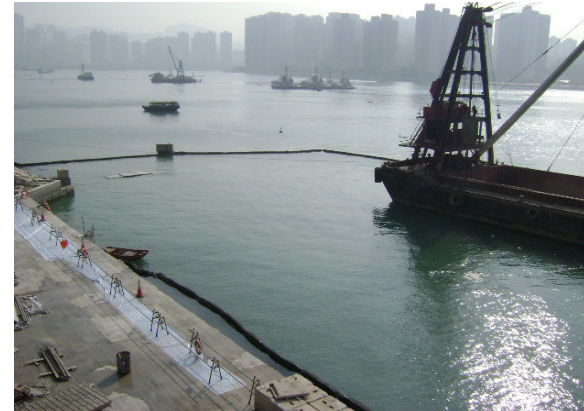
**Photographic record for exceedance of Dissolved Oxygen (marine surface) recorded at O-1(FT) on 16-Dec-11**

Site photo

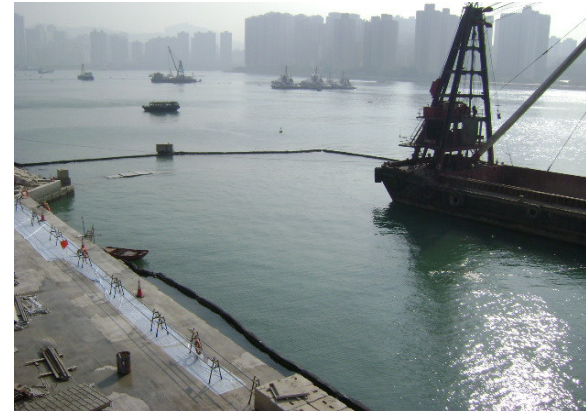
**Photographic record for exceedance of Dissolved Oxygen (marine bottom) recorded at O-1(FT) on 16-Dec-11**

Site photo

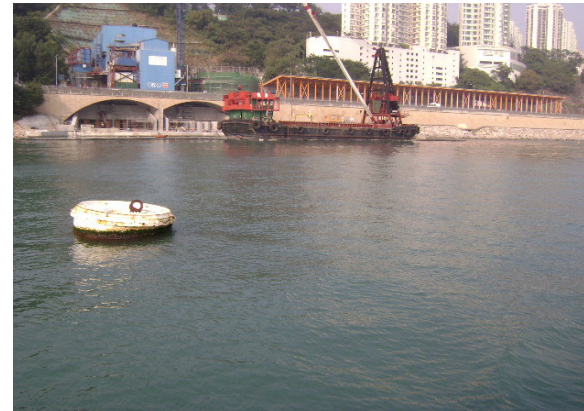
**Photographic record for exceedance of Dissolved Oxygen (marine surface) recorded at O-1(ET) on 16-Dec-11**

Site photo

Actions taken / to be taken	(1) Silt curtain was provided along the Portion E boundary line (outer silt curtain) and extended from the seawater level to the bottom of seabed; (2) floating type silt curtain was employed at the inner side; (3) sufficient slack of silt curtain was allowed to cope with the wave and tidal action to ensure the curtains (outer and inner) were rested on seabed; and (4) condition of silt curtains was checked by the supervisor daily before undertaking any marine works.
Remarks	None

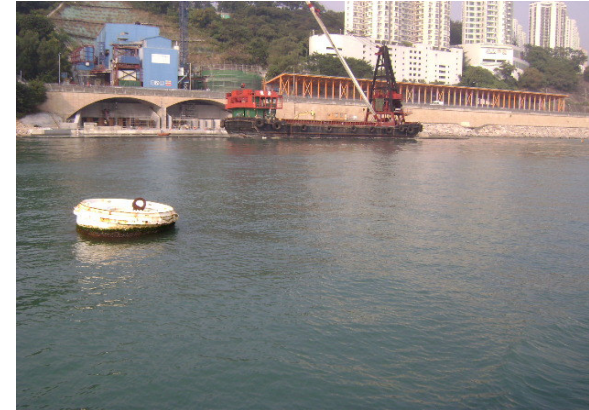
**Photographic record for exceedance of Dissolved Oxygen (marine mid-depth) recorded at O-1(ET) on 16-Dec-11**

Site photo

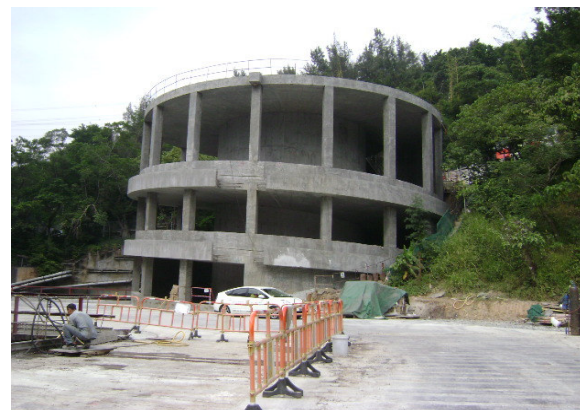
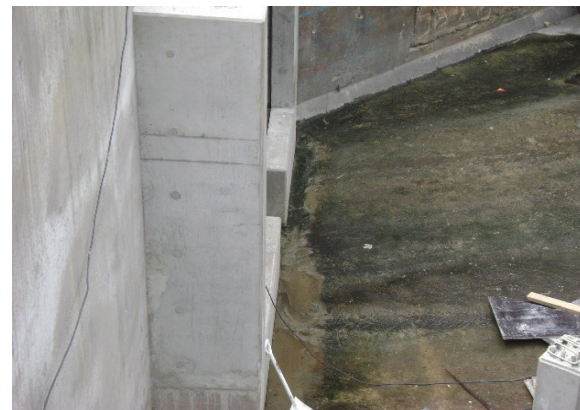
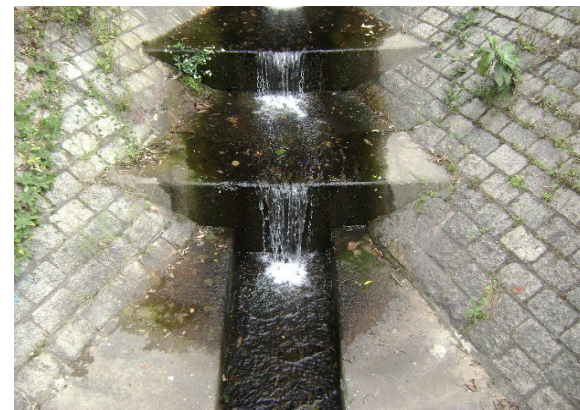
**Photographic record for exceedance of Suspended Solids (SS) recorded at Sik Sik Yuen Ho Fung College (I-1) on 14-Dec-11**

Actions taken / to be taken	(1) Silt curtain was provided along the Portion E boundary line (outer silt curtain) and extended from the seawater level to the bottom of seabed; (2) floating type silt curtain was employed at the inner side; (3) sufficient slack of silt curtain was allowed to cope with the wave and tidal action to ensure the curtains (outer and inner) were rested on seabed; and (4) condition of silt curtains was checked by the supervisor daily before undertaking any marine works.
Remarks	None

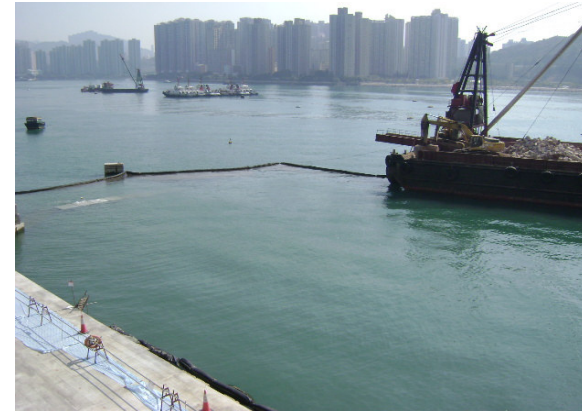
**Photographic record for exceedance of Dissolved Oxygen (marine surface) recorded at O-1(FT) on 19-Dec-11**

Site photo

Actions taken / to be taken	(1) Silt curtain was provided along the Portion E boundary line (outer silt curtain) and extended from the seawater level to the bottom of seabed; (2) floating type silt curtain was employed at the inner side; (3) sufficient slack of silt curtain was allowed to cope with the wave and tidal action to ensure the curtains (outer and inner) were rested on seabed; and (4) condition of silt curtains was checked by the supervisor daily before undertaking any marine works.
Remarks	None

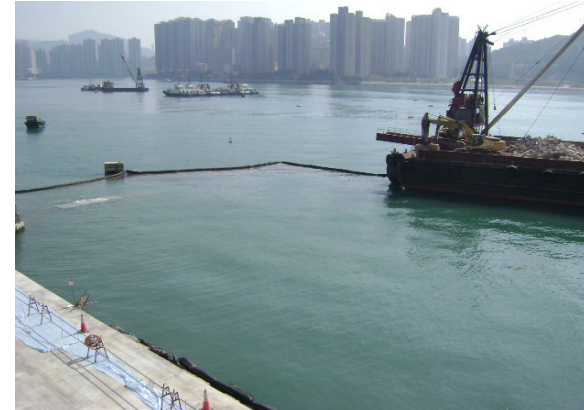
**Photographic record for exceedance of Dissolved Oxygen (marine mid-depth) recorded at O-1(FT) on 19-Dec-11**

Site photo

Actions taken / to be taken	(1) Silt curtain was provided along the Portion E boundary line (outer silt curtain) and extended from the seawater level to the bottom of seabed; (2) floating type silt curtain was employed at the inner side; (3) sufficient slack of silt curtain was allowed to cope with the wave and tidal action to ensure the curtains (outer and inner) were rested on seabed; and (4) condition of silt curtains was checked by the supervisor daily before undertaking any marine works.
Remarks	None

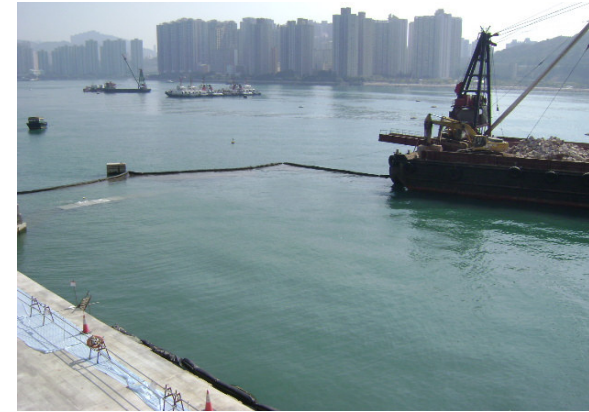
**Photographic record for exceedance of Dissolved Oxygen (marine bottom) recorded at O-1(FT) on 19-Dec-11**

Site photo

Actions taken / to be taken	(1) Silt curtain was provided along the Portion E boundary line (outer silt curtain) and extended from the seawater level to the bottom of seabed; (2) floating type silt curtain was employed at the inner side; (3) sufficient slack of silt curtain was allowed to cope with the wave and tidal action to ensure the curtains (outer and inner) were rested on seabed; and (4) condition of silt curtains was checked by the supervisor daily before undertaking any marine works.
Remarks	None

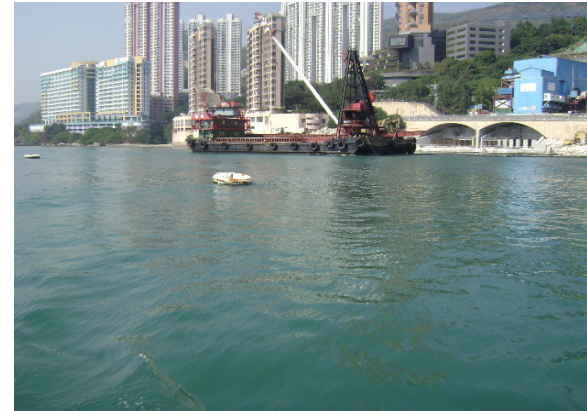
**Photographic record for exceedance of Dissolved Oxygen (marine surface) recorded at O-1(ET) on 19-Dec-11**

Site photo

Actions taken / to be taken	(1) Silt curtain was provided along the Portion E boundary line (outer silt curtain) and extended from the seawater level to the bottom of seabed; (2) floating type silt curtain was employed at the inner side; (3) sufficient slack of silt curtain was allowed to cope with the wave and tidal action to ensure the curtains (outer and inner) were rested on seabed; and (4) condition of silt curtains was checked by the supervisor daily before undertaking any marine works.
Remarks	None

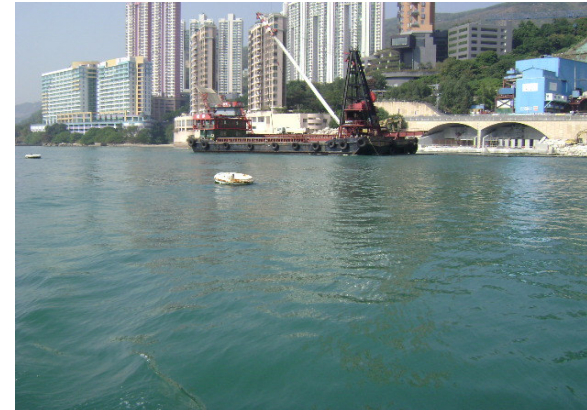
**Photographic record for exceedance of Dissolved Oxygen (marine mid-depth) recorded at O-1(ET) on 19-Dec-11**

Site photo

Actions taken / to be taken	(1) Silt curtain was provided along the Portion E boundary line (outer silt curtain) and extended from the seawater level to the bottom of seabed; (2) floating type silt curtain was employed at the inner side; (3) sufficient slack of silt curtain was allowed to cope with the wave and tidal action to ensure the curtains (outer and inner) were rested on seabed; and (4) condition of silt curtains was checked by the supervisor daily before undertaking any marine works.
Remarks	None

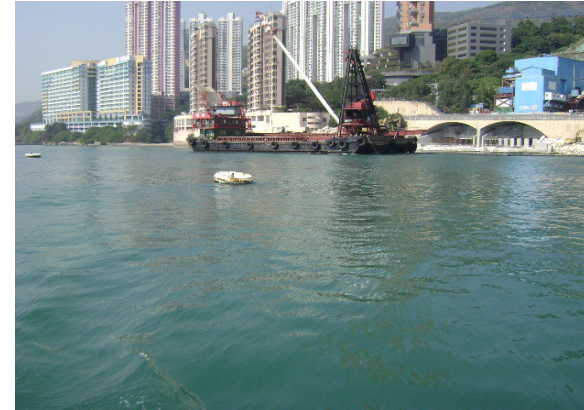
Site photo

**Photographic record for exceedance of Dissolved Oxygen (marine bottom) recorded at O-1(ET) on 19-Dec-11**

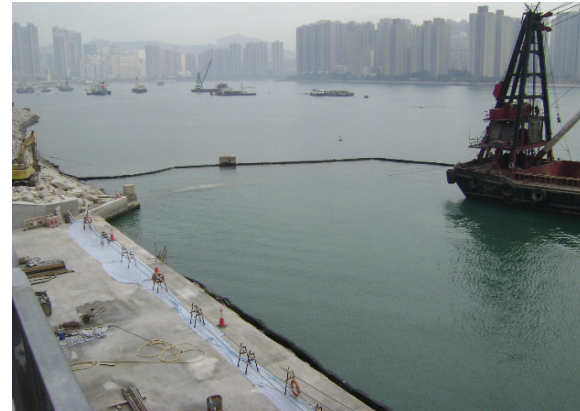
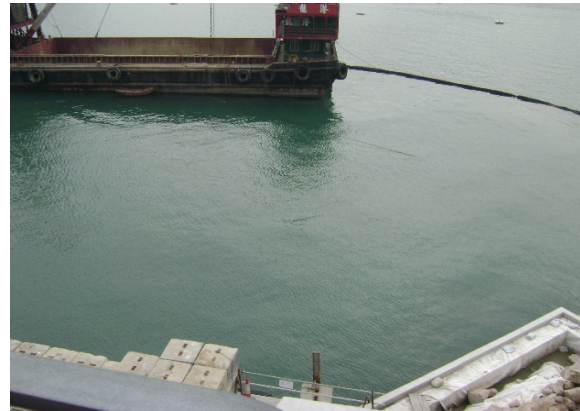
Site photo

**Photographic record for exceedance of Dissolved Oxygen (marine surface) recorded at O-1(FT) on 21-Dec-11**

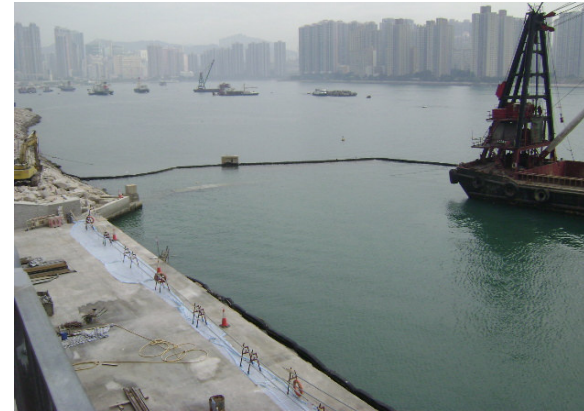
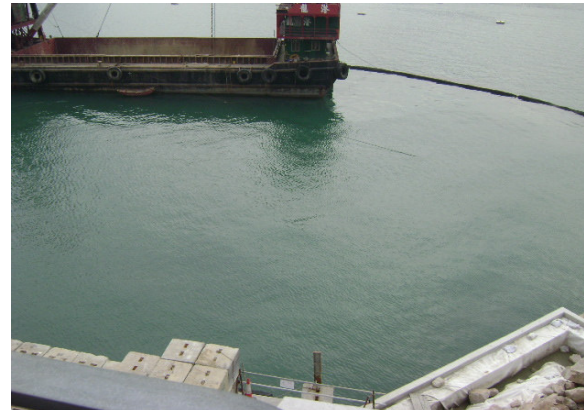
Site photo

**Photographic record for exceedance of Dissolved Oxygen (marine mid-depth) recorded at O-1(FT) on 21-Dec-11**

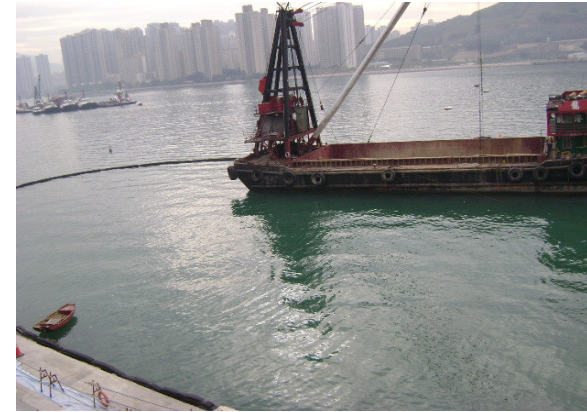
Site photo

**Photographic record for exceedance of Dissolved Oxygen (marine surface) recorded at O-1(ET) on 21-Dec-11**

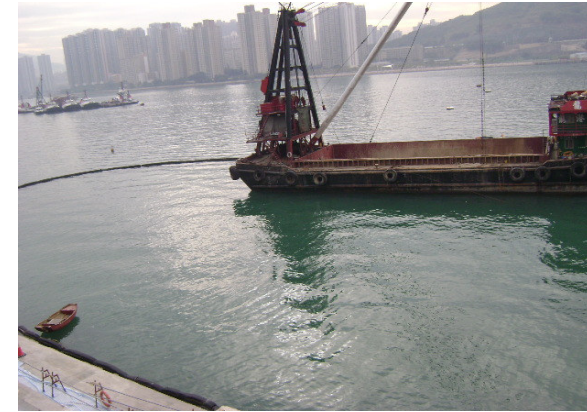
Site photo

**Photographic record for exceedance of Dissolved Oxygen (marine mid-depth) recorded at O-1(ET) on 21-Dec-11**

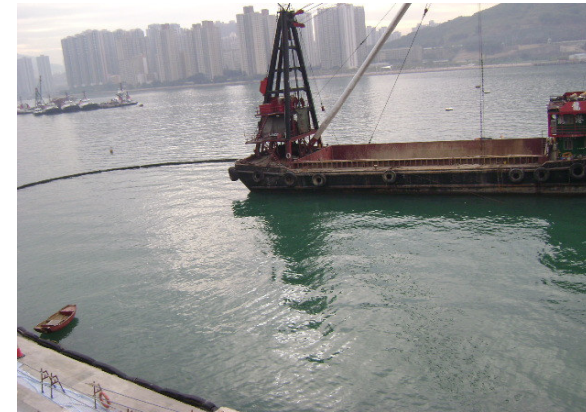
Site photo

**Photographic record for exceedance of Dissolved Oxygen (marine bottom) recorded at O-1(ET) on 21-Dec-11**

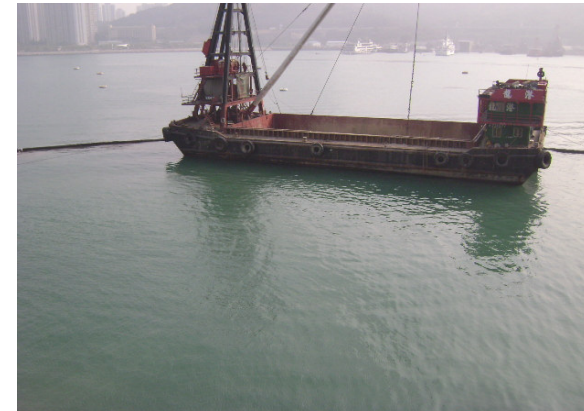
Site photo

**Photographic record for exceedance of Dissolved Oxygen (marine surface) recorded at O-1(FT) on 23-Dec-11**

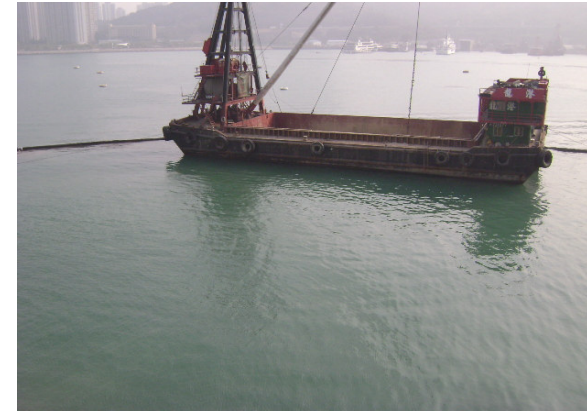
Site photo

**Photographic record for exceedance of Dissolved Oxygen (marine mid-depth) recorded at O-1(FT) on 23-Dec-11**

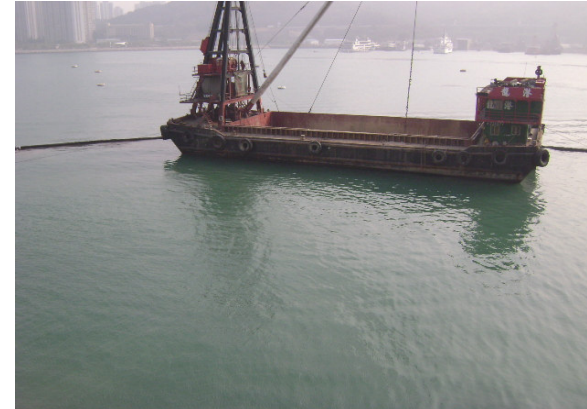
Site photo

**Photographic record for exceedance of Dissolved Oxygen (marine bottom) recorded at O-1(FT) on 23-Dec-11**

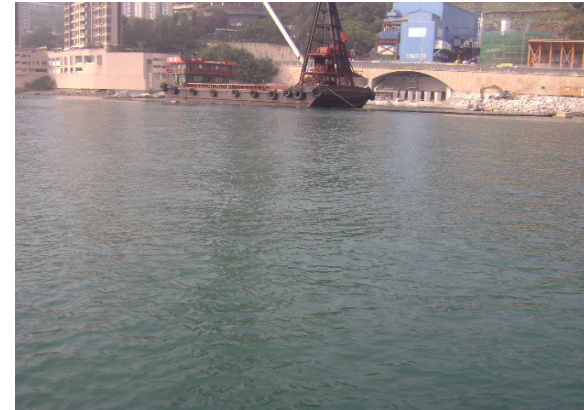
Site photo

**Photographic record for exceedance of Dissolved Oxygen (marine surface) recorded at O-1(ET) on 23-Dec-11**

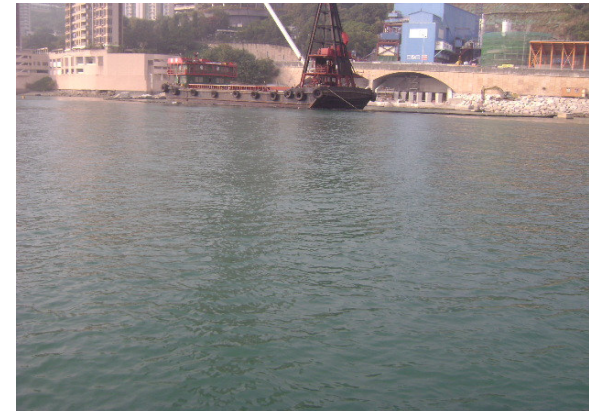
Site photo

**Photographic record for exceedance of Dissolved Oxygen (marine mid-depth) recorded at O-1(ET) on 23-Dec-11**

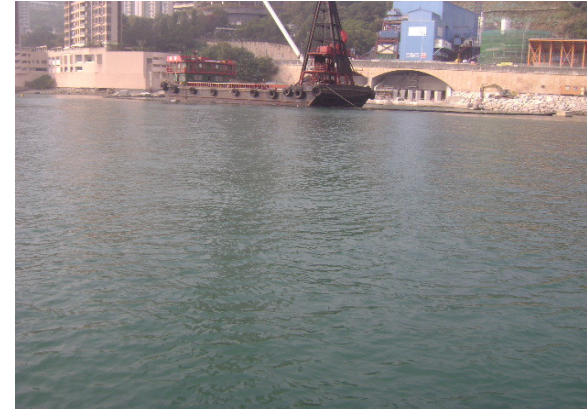
Site photo

**Photographic record for exceedance of Dissolved Oxygen (marine bottom) recorded at O-1(ET) on 23-Dec-11**

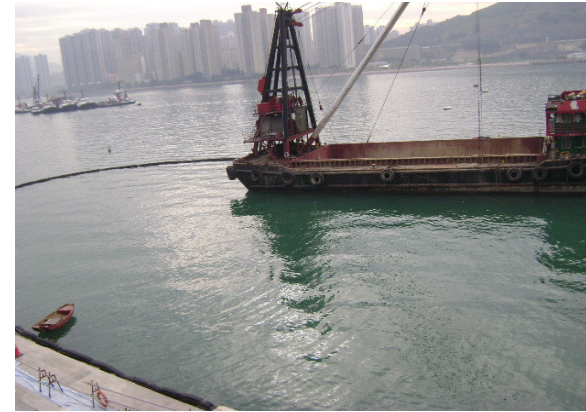
Site photo

**Photographic record for exceedance of Suspended Solids (SS) recorded at O-1(ET) on 21-Dec-11**

Actions taken / to be taken	(1) Silt curtain was provided along the Portion E boundary line and extended from the seawater level to the bottom of seabed; (2) sufficient slack of silt curtain was allowed to cope with the wave and tidal action to ensure the curtain was rested on seabed; and (3) condition of silt curtains was checked by the supervisor daily before undertaking any marine works.
Remarks	None

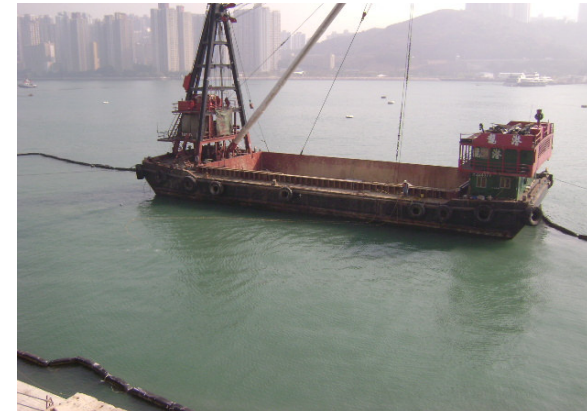
Site photo

**Photographic record for exceedance of Dissolved Oxygen (marine surface) recorded at O-1(ET) on 28-Dec-11**

Actions taken / to be taken	(1) Silt curtain was provided along the Portion E boundary line and extended from the seawater level to the bottom of seabed; (2) sufficient slack of silt curtain was allowed to cope with the wave and tidal action to ensure the curtain was rested on seabed; and (3) condition of silt curtains was checked by the supervisor daily before undertaking any marine works.
Remarks	None

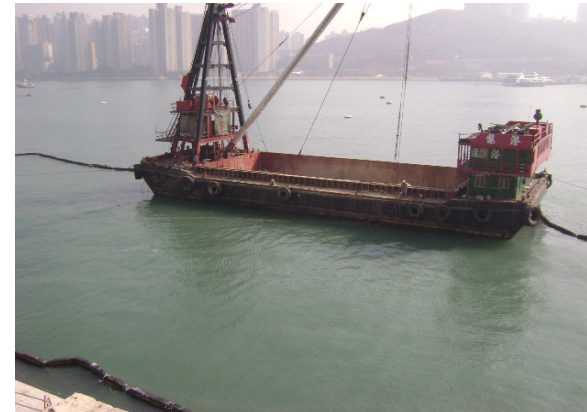
Site photo

**Photographic record for exceedance of Dissolved Oxygen (marine mid-depth) recorded at O-1(ET) on 28-Dec-11**

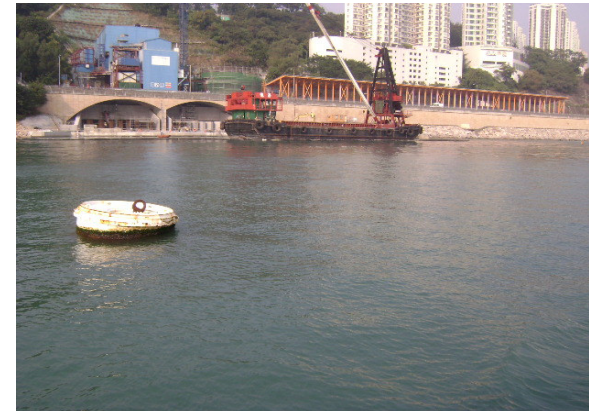
Site photo

**Photographic record for exceedance of Suspended Solids (SS) recorded at O-1(ET) on 16-Dec-11**

Actions taken / to be taken	(1) Silt curtain was provided along the Portion E boundary line (outer silt curtain) and extended from the seawater level to the bottom of seabed; (2) floating type silt curtain was employed at the inner side; (3) sufficient slack of silt curtain was allowed to cope with the wave and tidal action to ensure the curtains (outer and inner) were rested on seabed; and (4) condition of silt curtains was checked by the supervisor daily before undertaking any marine works.
Remarks	None

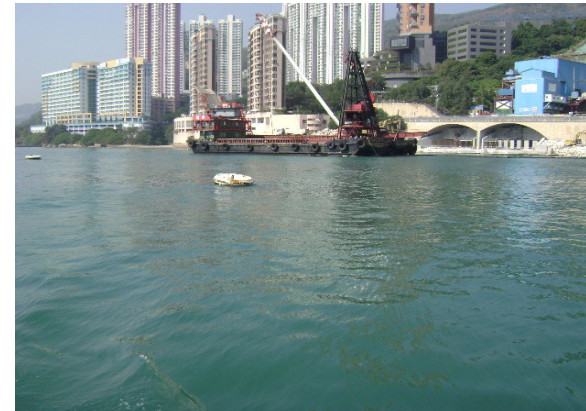
Site photo

**Photographic record for exceedance of Suspended Solids (SS) recorded at O-1(ET) on 19-Dec-11**

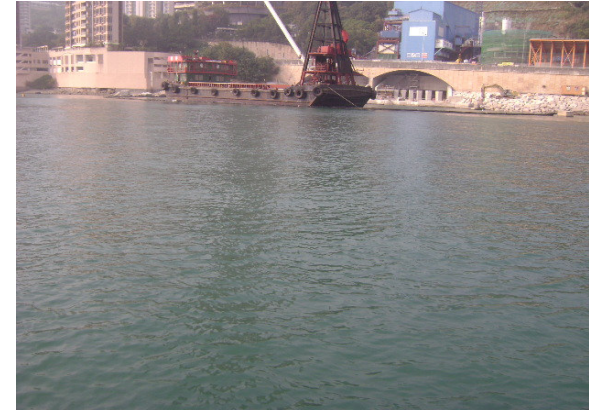
Site photo

**Photographic record for exceedance of Suspended Solids (SS) recorded at O-1(ET) on 23-Dec-11**

Actions taken / to be taken	(1) Silt curtain was provided along the Portion E boundary line and extended from the seawater level to the bottom of seabed; (2) sufficient slack of silt curtain was allowed to cope with the wave and tidal action to ensure the curtain was rested on seabed; and (3) condition of silt curtain was checked by the supervisor daily before undertaking any marine works.
Remarks	None
