Contract SCL1123 – Exhibition Station & Western Approach Tunnel

Monthly EM&A Report No. 22

Works Contract 1123 -CEDD Entrusted Work for Road P2 & other roads and Slip Road 3

Monthly EM&A Report for October 2022

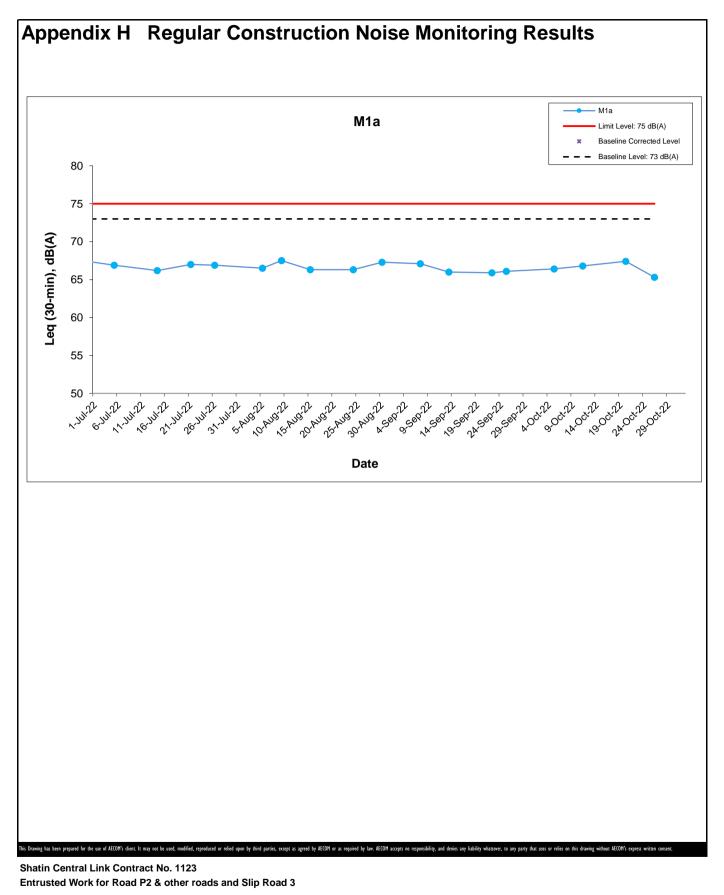
Graphical Presentation of Impact Noise Monitoring Results **APPENDIX I**

Daytime Noise Monitoring Results at Station M1a (Footbridge for Ex-Harbour Road Sport Centre)

⁺ - Façade measurement
