**Contract SCL1123 –
Exhibition Station & Western Approach
Tunnel**

Monthly EM&A Report No. 24

[Period from 1 to 31 December 2022]

Leighton – China State J.V.**Shatin to Central Link -
Hung Hom to Admiralty Section****Works Contract 1123 -
CEDD Entrusted Work for Road P2 & other roads and Slip Road 3****Monthly EM&A Report for
December 2022**

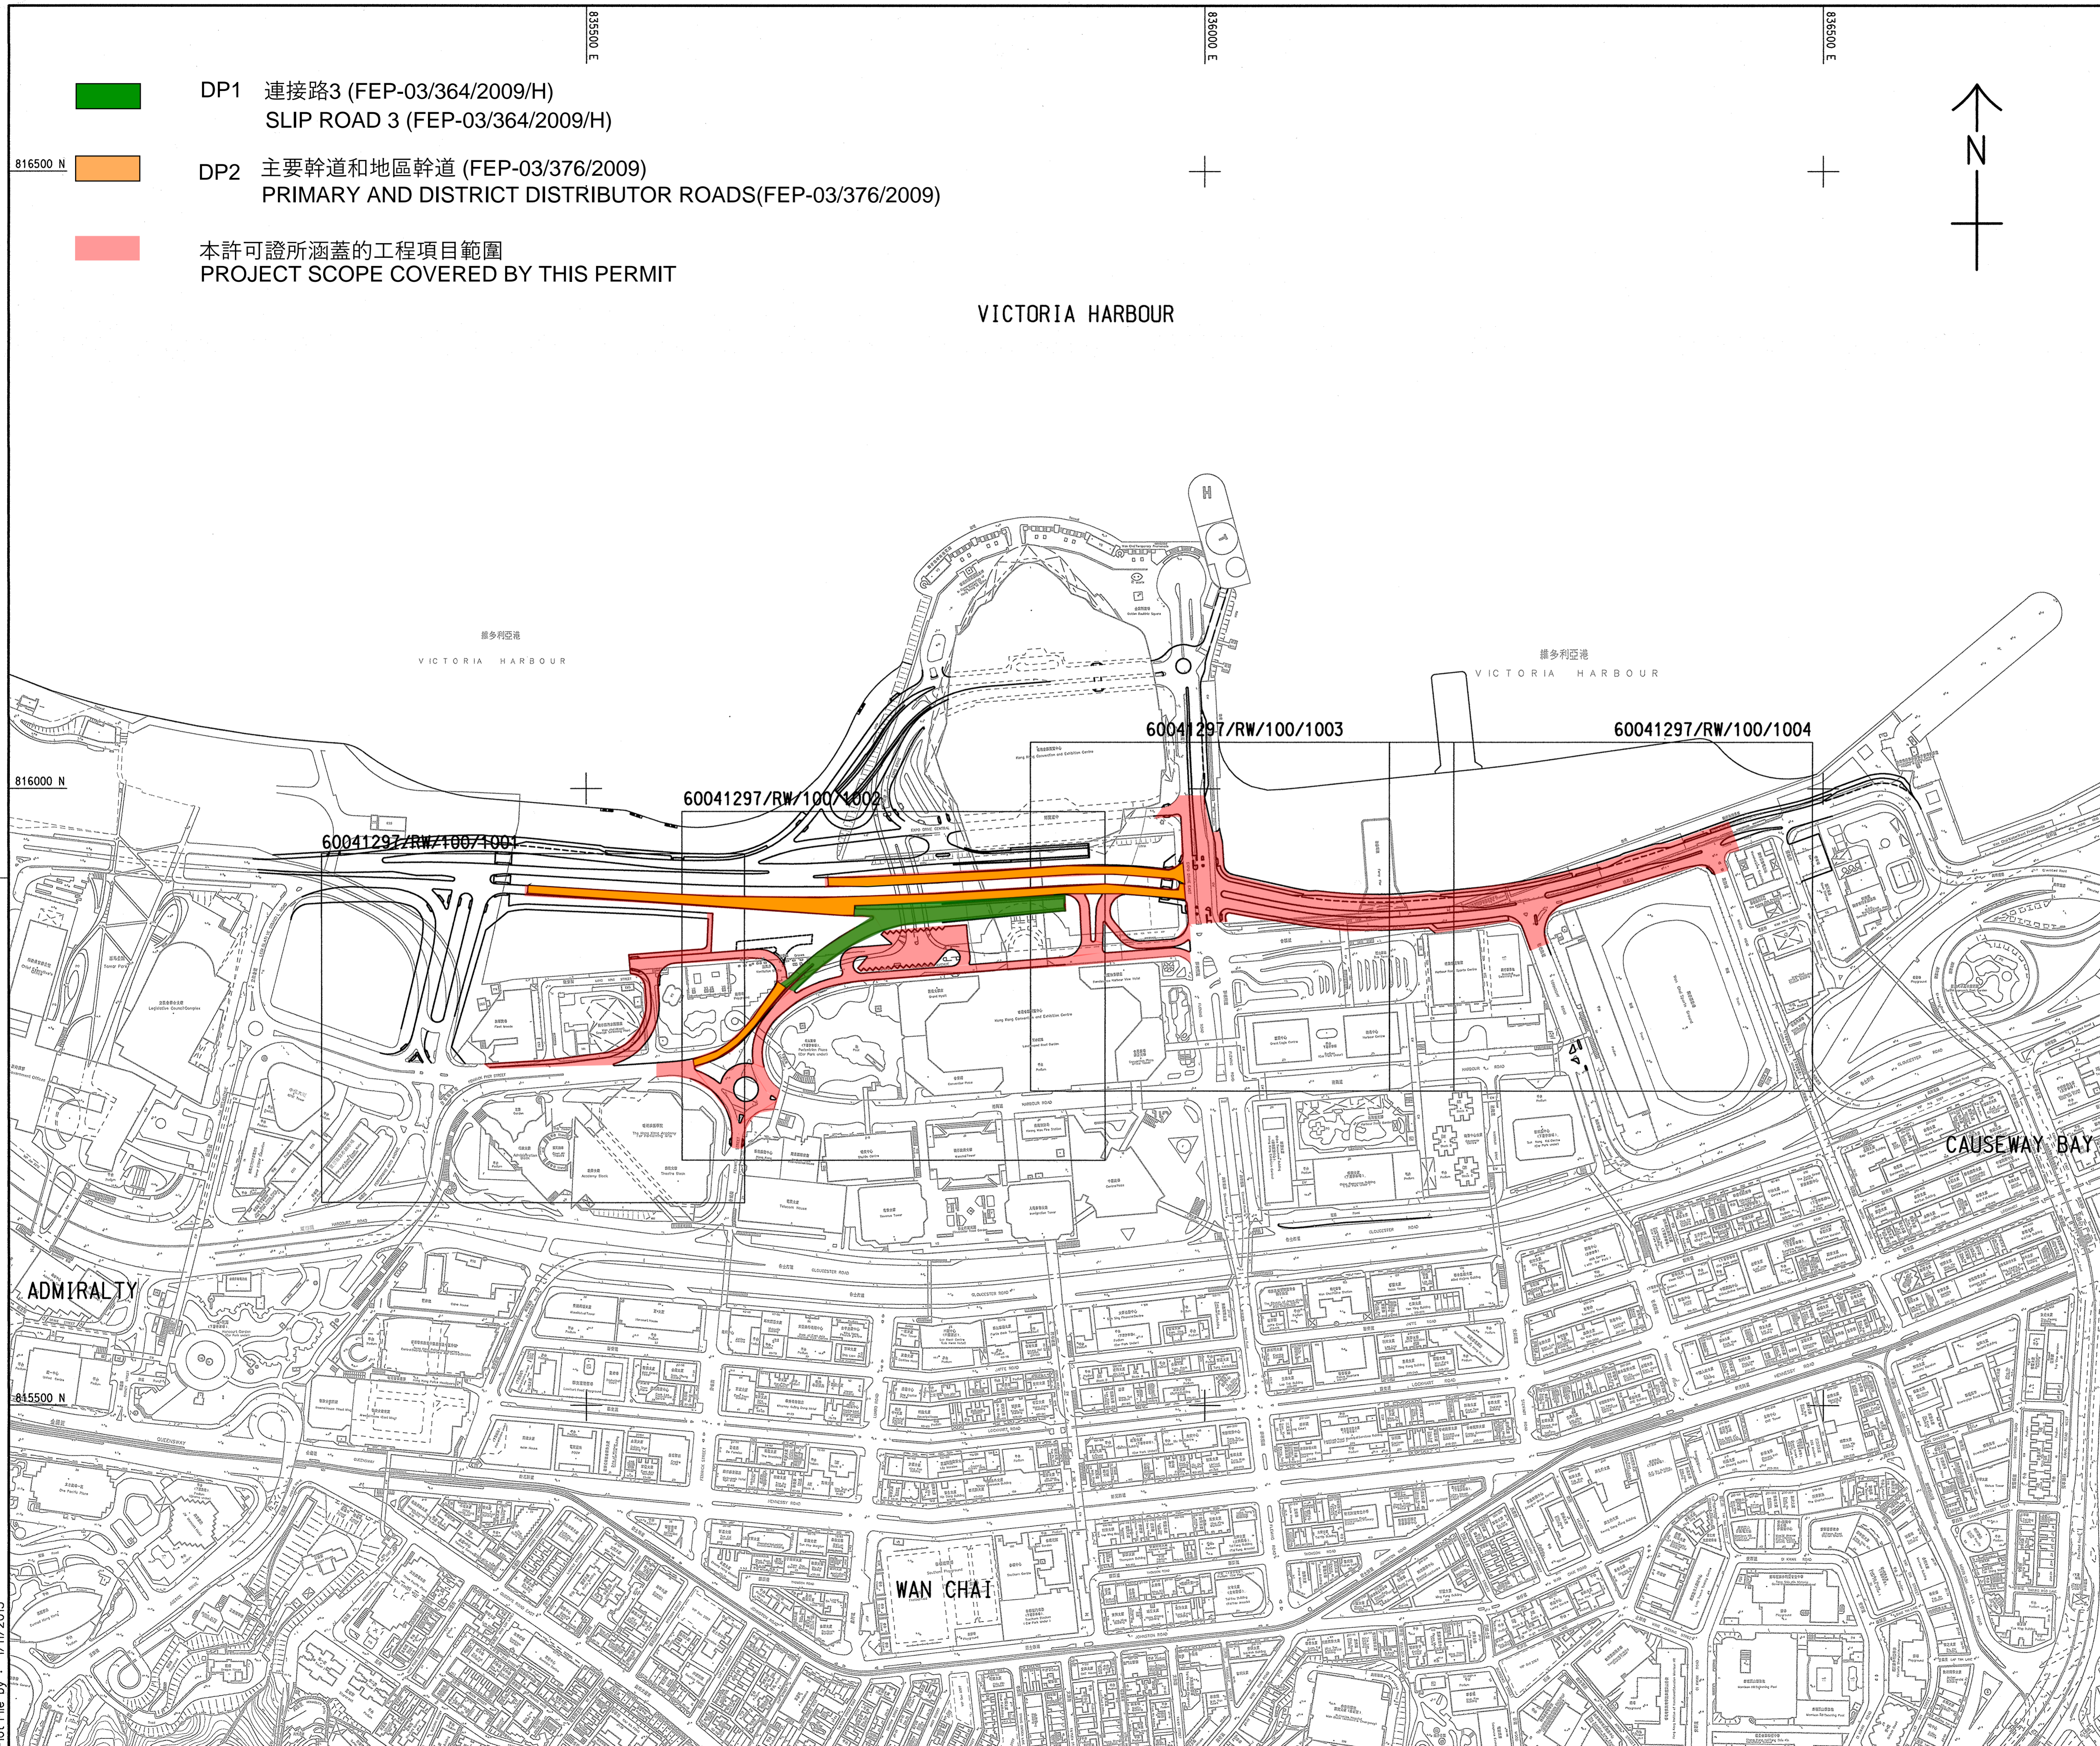
- DP1 連接路3 (FEP-03/364/2009/H)
SLIP ROAD 3 (FEP-03/364/2009/H)
- DP2 主要幹道和地區幹道 (FEP-03/376/2009)
PRIMARY AND DISTRICT DISTRIBUTOR ROADS(FEP-03/376/2009)
- 本許可證所涵蓋的工程項目範圍
PROJECT SCOPE COVERED BY THIS PERMIT

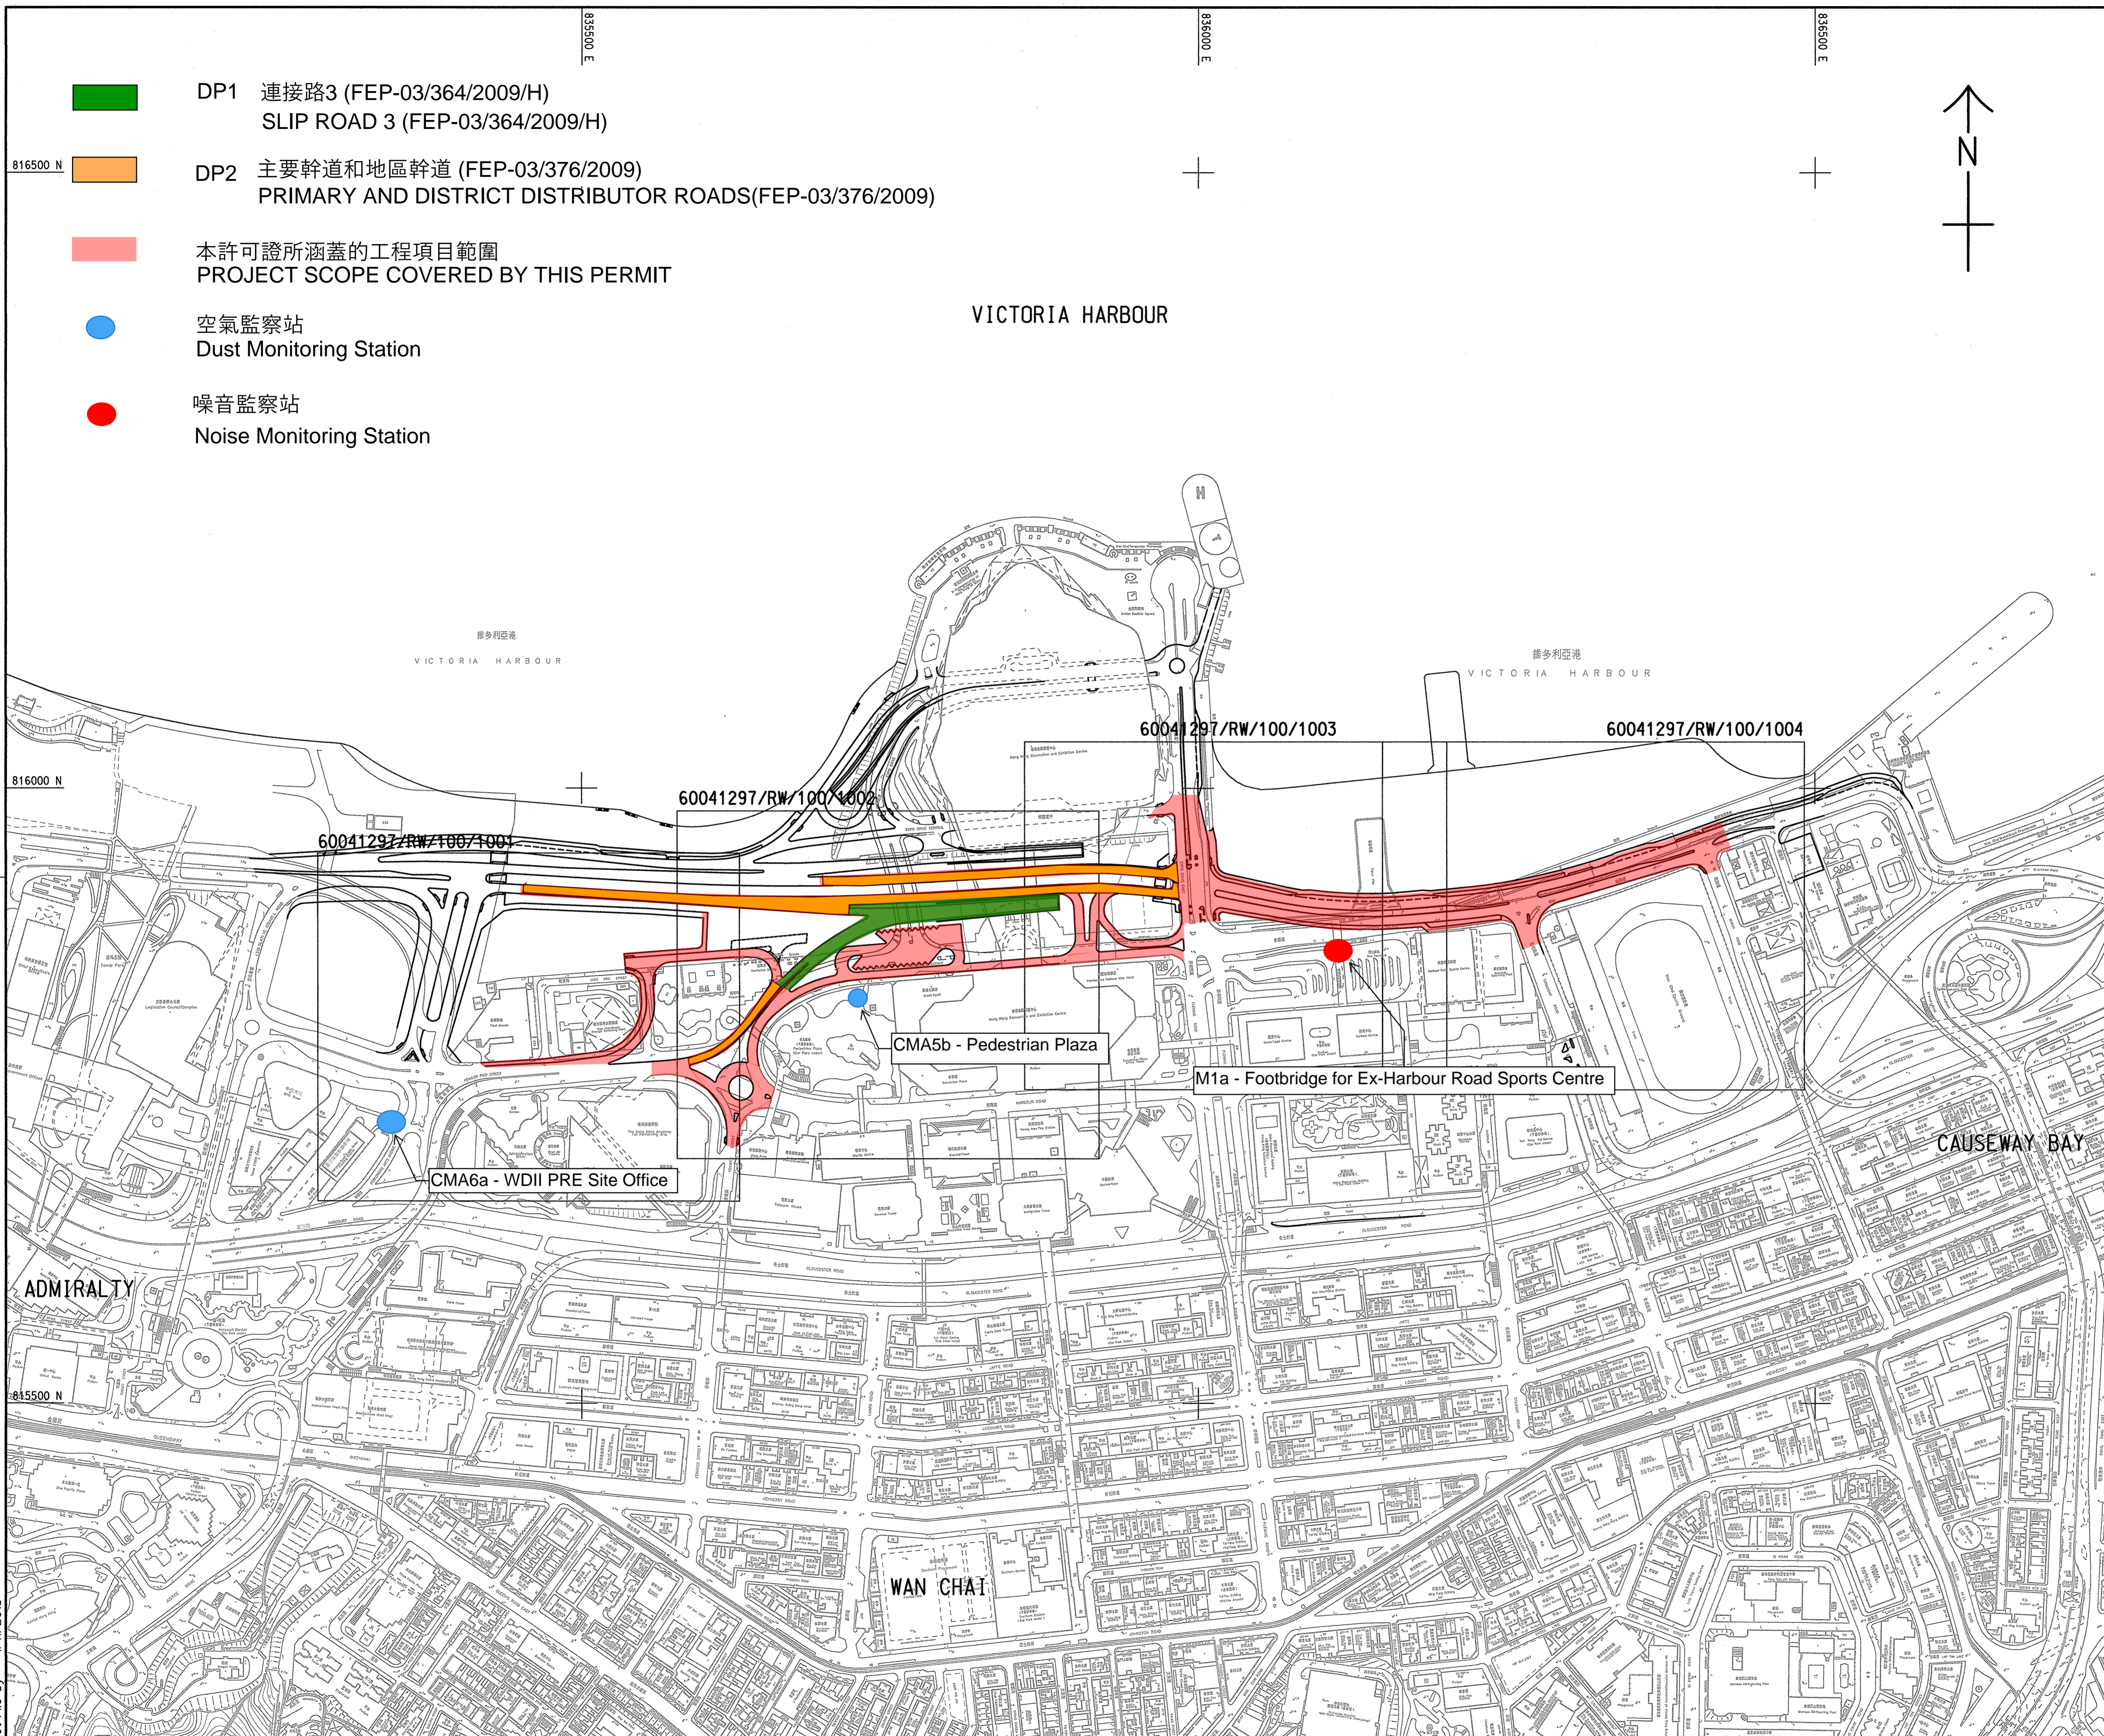
- DP1 連接路3 (FEP-03/364/2009/H)
SLIP ROAD 3 (FEP-03/364/2009/H)
- DP2 主要幹道和地區幹道 (FEP-03/376/2009)
PRIMARY AND DISTRICT DISTRIBUTOR ROADS(FEP-03/376/2009)
- 本許可證所涵蓋的工程項目範圍
PROJECT SCOPE COVERED BY THIS PERMIT
- 空氣監察站
Dust Monitoring Station
- 噪音監察站
Noise Monitoring Station

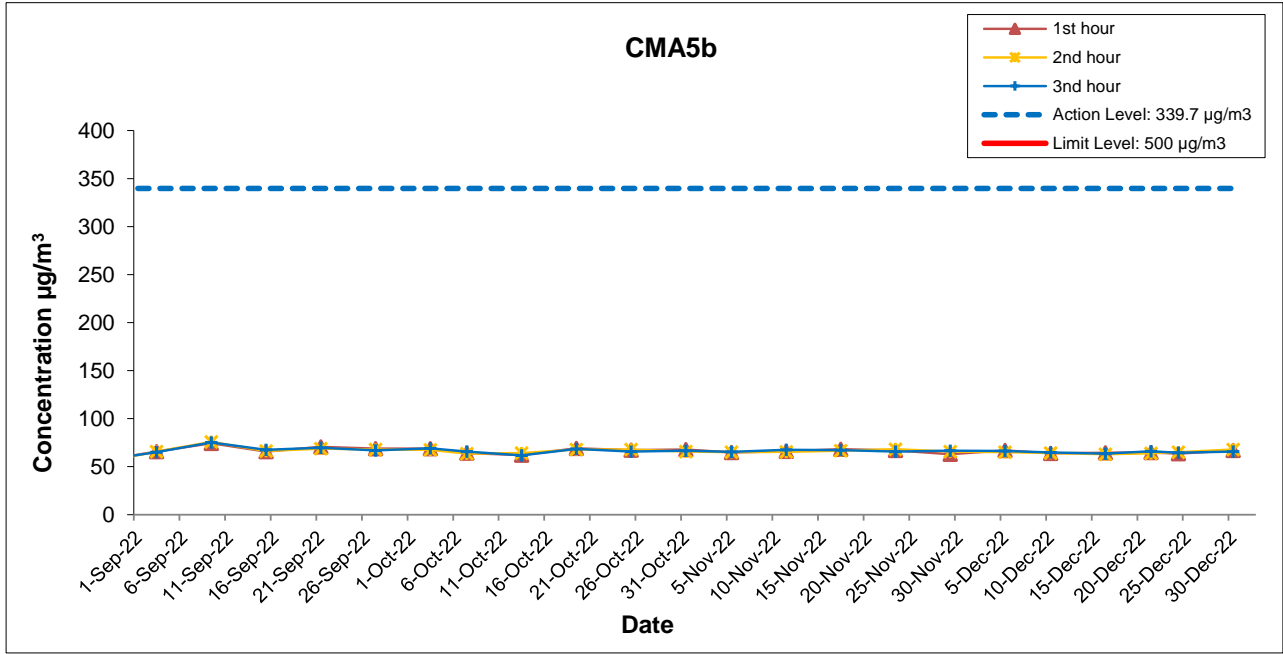
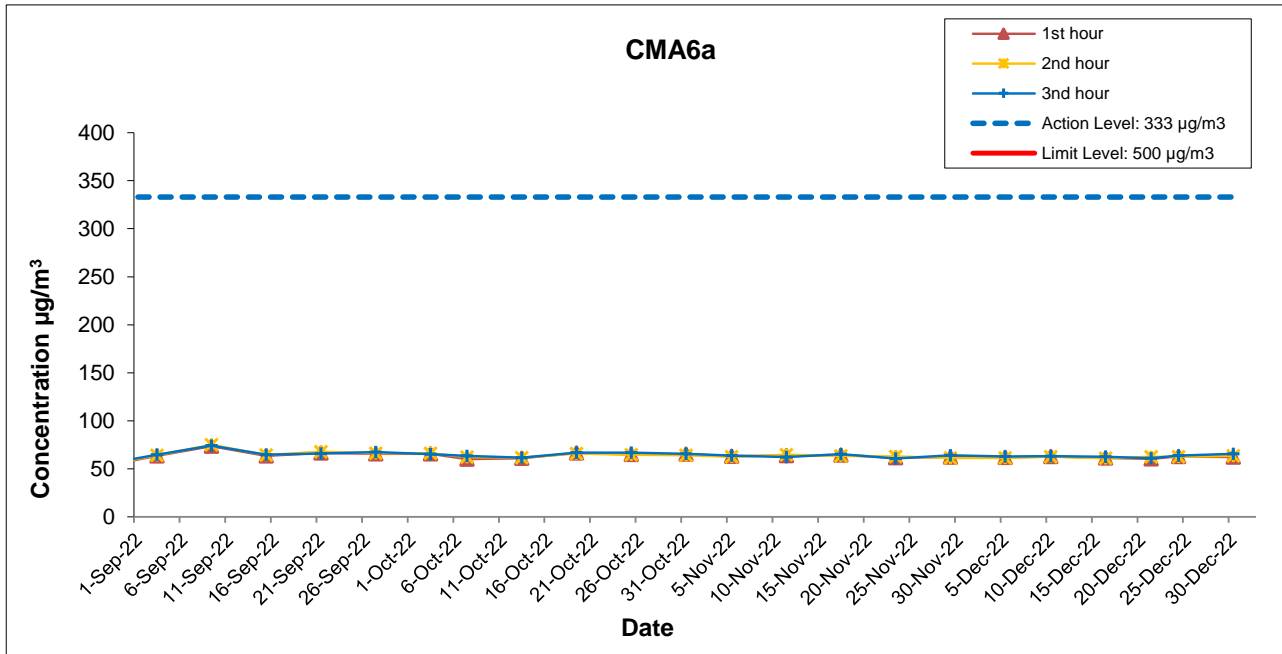
1-hour TSP Monitoring Results at Station CMA6a (WDII PRE Site Office)

Date	Start Time (hh:mm)	Weather Condition	1st Hour	2nd Hour	3rd Hour
			Conc. ($\mu\text{g}/\text{m}^3$)	Conc. ($\mu\text{g}/\text{m}^3$)	Conc. ($\mu\text{g}/\text{m}^3$)
05-Dec-22	13:05	Sunny	62.1	61.3	62.8
10-Dec-22	14:20	Fine	62.9	62.7	63.3
16-Dec-22	13:05	Cloudy	61.4	61.1	62.7
21-Dec-22	13:10	Sunny	60.4	62.6	61.0
24-Dec-22	13:45	Sunny	62.9	62.7	63.8
30-Dec-22	13:15	Sunny	62.2	63.4	65.7
Average					62.5
Min					60.4
Max					65.7

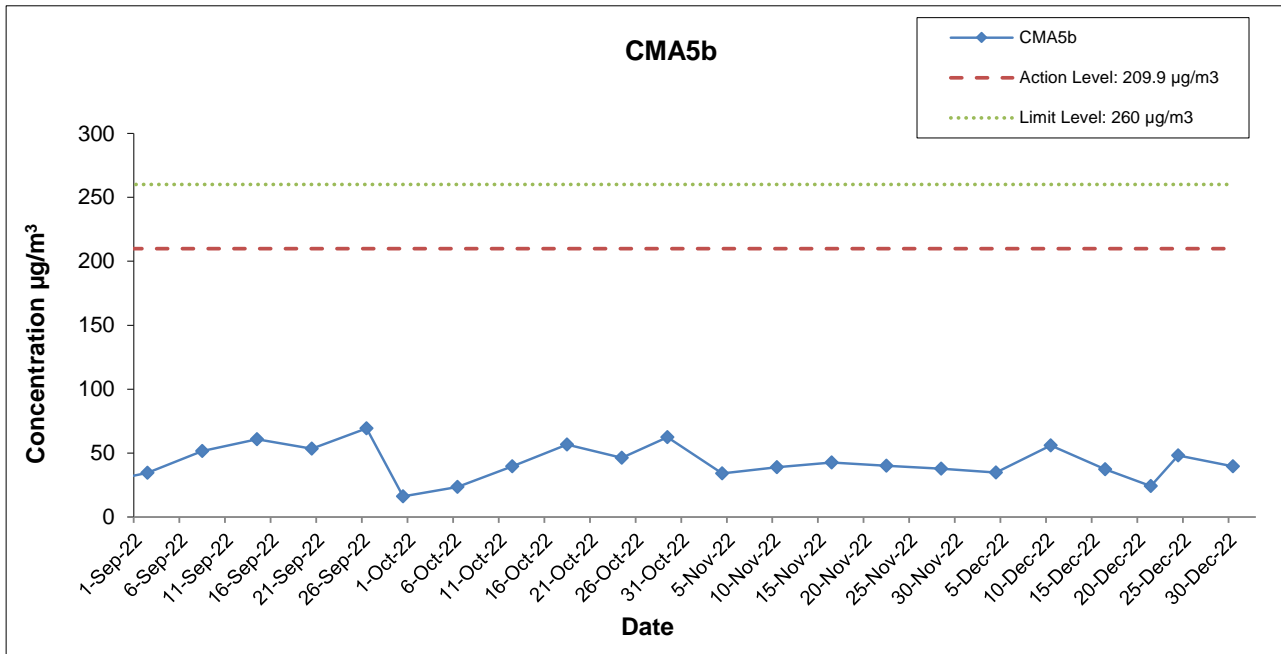
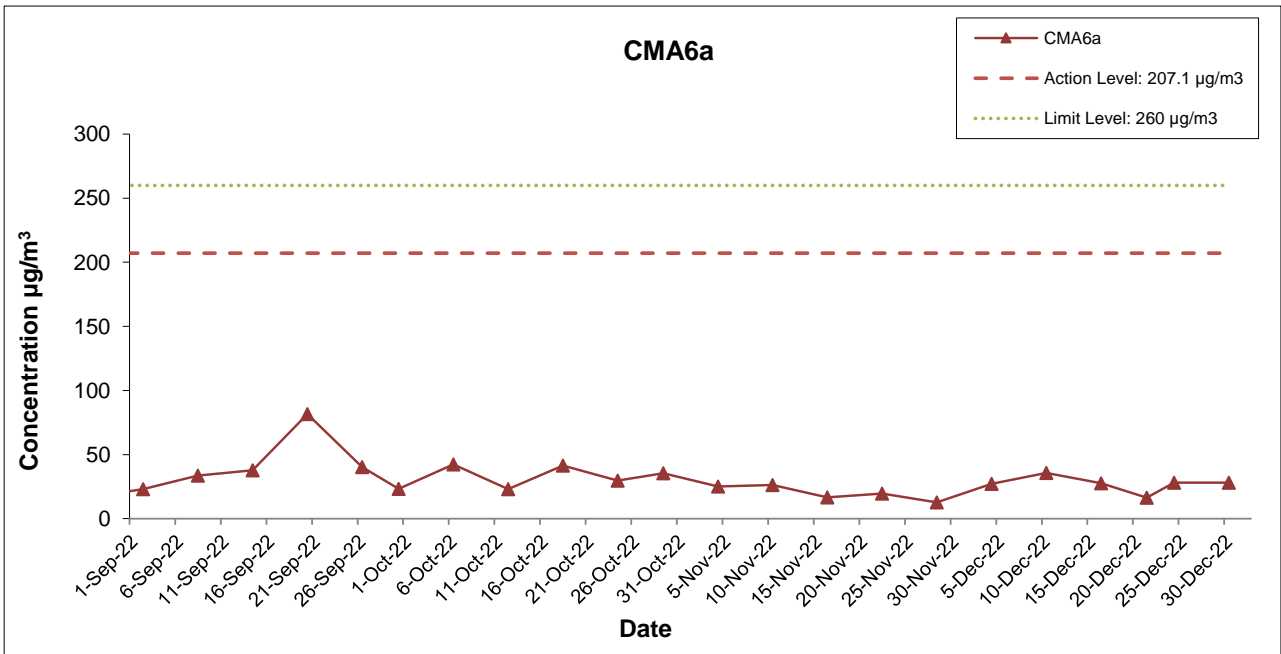
Start		End		Weather Condition	Air Temp. (°C)	Atmospheric Pressure (hPa)	Flow Rate (m ³ /min.)		Av. flow (m ³ /min)	Total vol. (m ³)	Filter Weight (g)		Particulate weight(g)	Elapse Time		Sampling Time(hrs.)	Conc. (µg/m ³)
Date	Time	Date	Time				Initial	Final			Initial	Final		Initial	Final		
3-Dec-22	0:00	4-Dec-22	0:00	Sunny	19.2	1017.1	1.33	1.33	1.33	1916.6	2.7818	2.8338	0.0520	11904.57	11928.57	24.00	27.1
9-Dec-22	0:00	10-Dec-22	0:00	Fine	19.6	1015.8	1.33	1.33	1.33	1916.6	2.7809	2.8495	0.0686	11928.57	11952.57	24.00	35.8
15-Dec-22	0:00	16-Dec-22	0:00	Cloudy	14.6	1017.9	1.33	1.33	1.33	1916.6	2.7752	2.8284	0.0532	11952.57	11976.57	24.00	27.8
20-Dec-22	0:00	21-Dec-22	0:00	Sunny	16.8	1018.3	1.33	1.33	1.33	1916.6	2.8145	2.8460	0.0315	11976.57	12000.57	24.00	16.4
23-Dec-22	0:00	24-Dec-22	0:00	Sunny	17.1	1019.0	1.33	1.33	1.33	1916.6	2.7882	2.8421	0.0539	12000.57	12024.57	24.00	28.1
29-Dec-22	0:00	30-Dec-22	0:00	Sunny	16.8	1024.2	1.33	1.33	1.33	1916.6	2.7724	2.8263	0.0539	12024.57	12048.57	24.00	28.1

Average																27.2	
Minimum																16.4	
Maximum																35.8

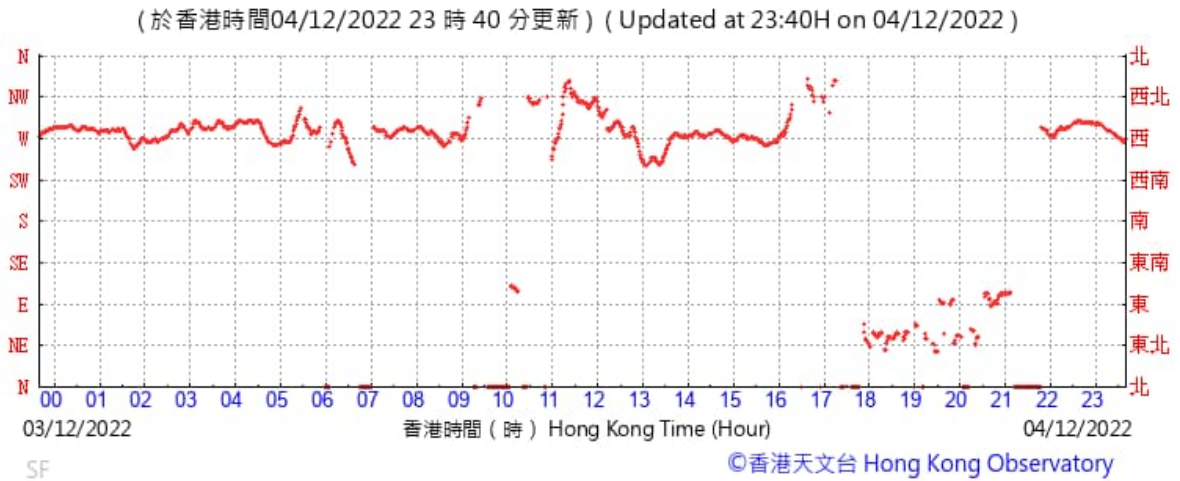
Wind Direction:

Appendix G – Extract of Meteorological Observations for Star Ferry Automatic Weather Station
November 2022

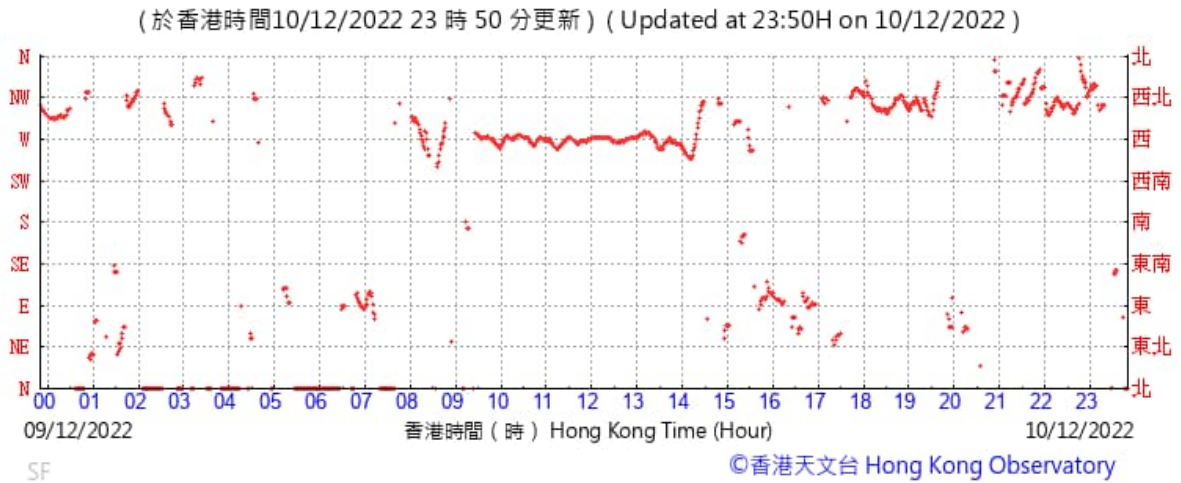
Wind Direction:

Appendix G – Extract of Meteorological Observations for Star Ferry Automatic Weather Station
November 2022

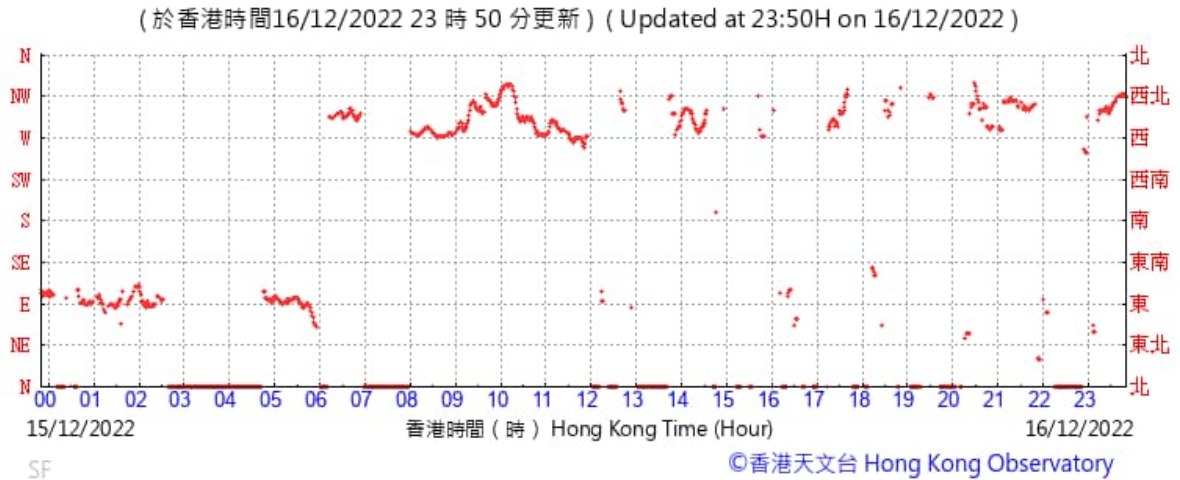
Wind Direction:

Appendix G – Extract of Meteorological Observations for Star Ferry Automatic Weather Station
November 2022

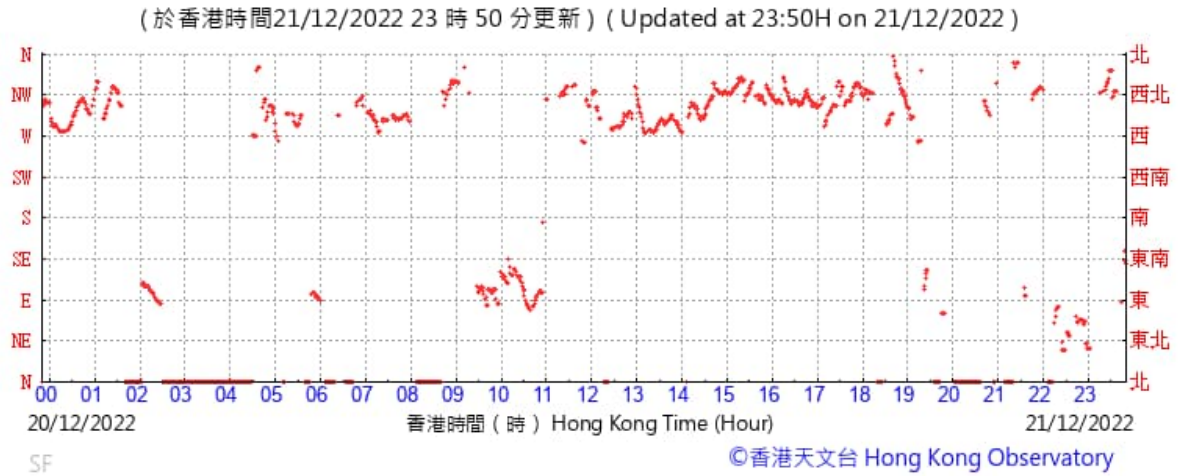
Wind Direction:

Appendix G – Extract of Meteorological Observations for Star Ferry Automatic Weather Station
November 2022

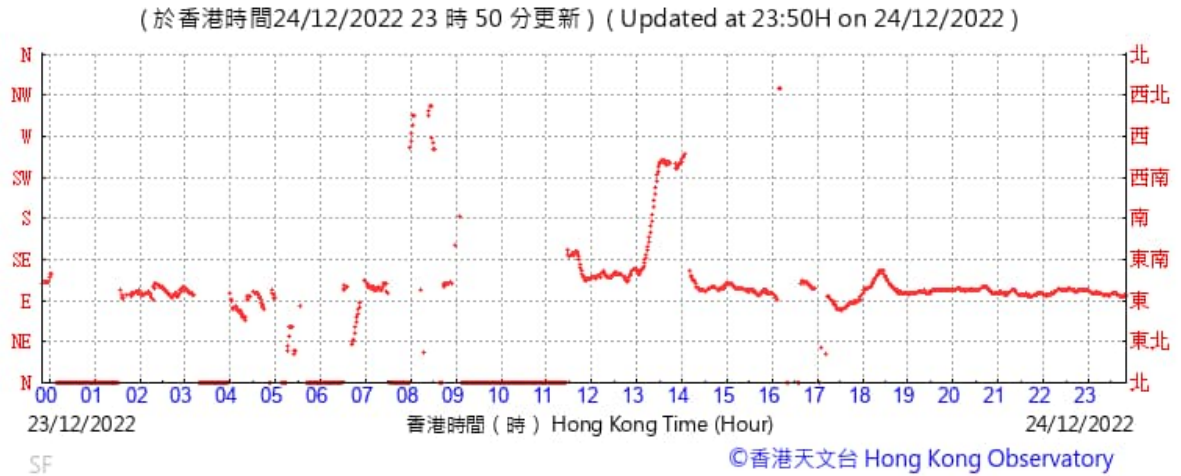
Wind Direction:

Appendix G – Extract of Meteorological Observations for Star Ferry Automatic Weather Station
November 2022

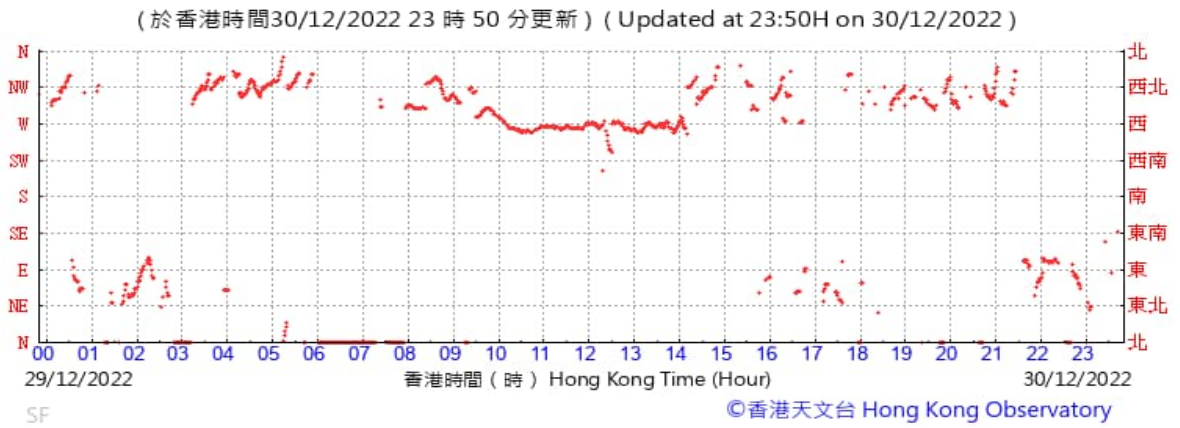
Wind Direction:

Appendix G – Extract of Meteorological Observations for Star Ferry Automatic Weather Station
November 2022

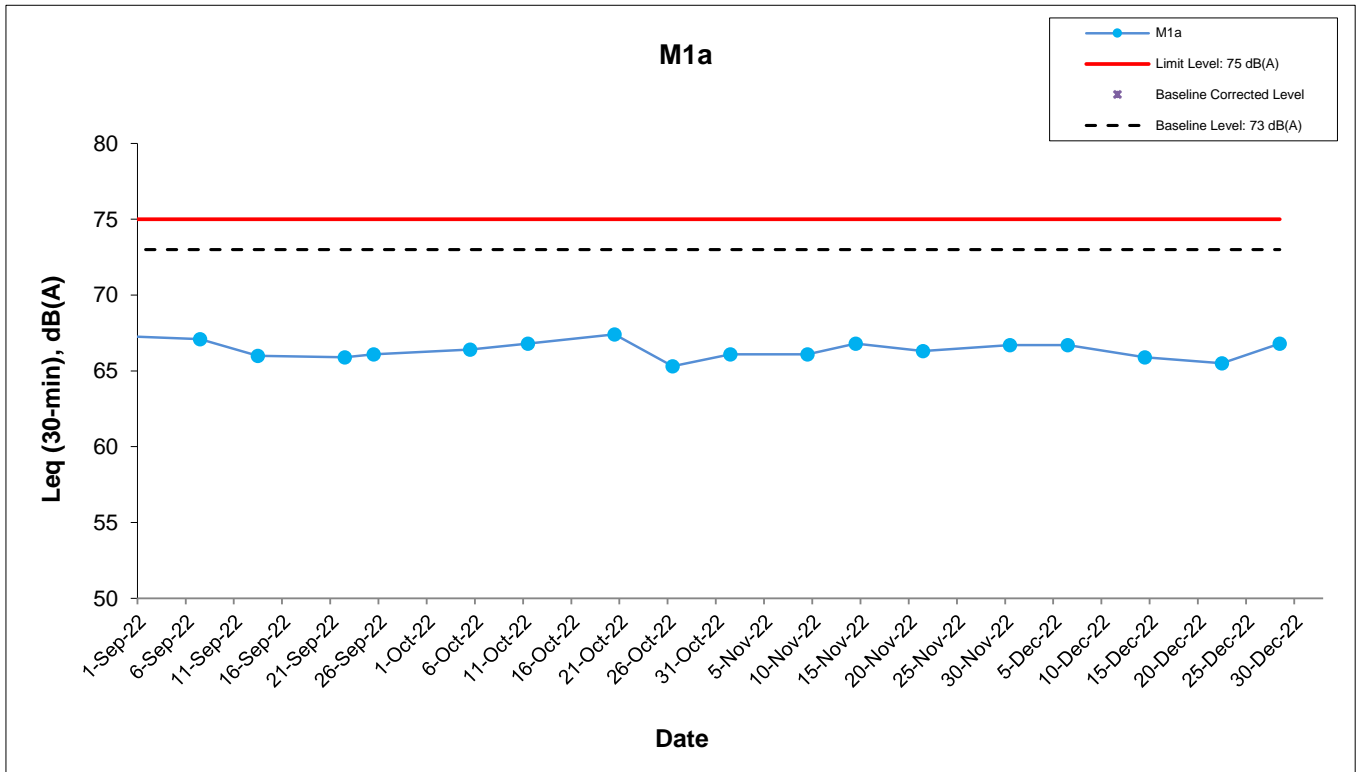
Appendix H Regular Construction Noise Monitoring Results

Date	Weather Condition	Noise Level for 30-min, dB(A) ⁺				Baseline Corrected Level, dB(A)	Baseline Noise Level, dB(A)	Limit Level, dB(A)	Exceedance (Y/N)
		Time	L90	L10	Leq				
6-Dec-22	Sunny	13:50	64.1	68.0	66.7	<Baseline	73.0	75	N
14-Dec-22	Cloud	14:00	64.7	67.1	65.9	<Baseline	73.0	75	N
22-Dec-22	Sunny	11:25	64.0	66.4	65.5	<Baseline	73.0	75	N
28-Dec-22	Sunny	14:20	64.2	67.5	66.8	<Baseline	73.0	75	N

⁺ - Façade measurement
