**Contract SCL1123 –
Exhibition Station & Western Approach
Tunnel**

Monthly EM&A Report No. 3

[Period from 1 to 31 March 2021]

Leighton – China State J.V.**Shatin to Central Link -
Hung Hom to Admiralty Section****Works Contract 1123 -
CEDD Entrusted Work for Road P2 & other roads and Slip Road 3****Monthly EM&A Report for
March 2021**

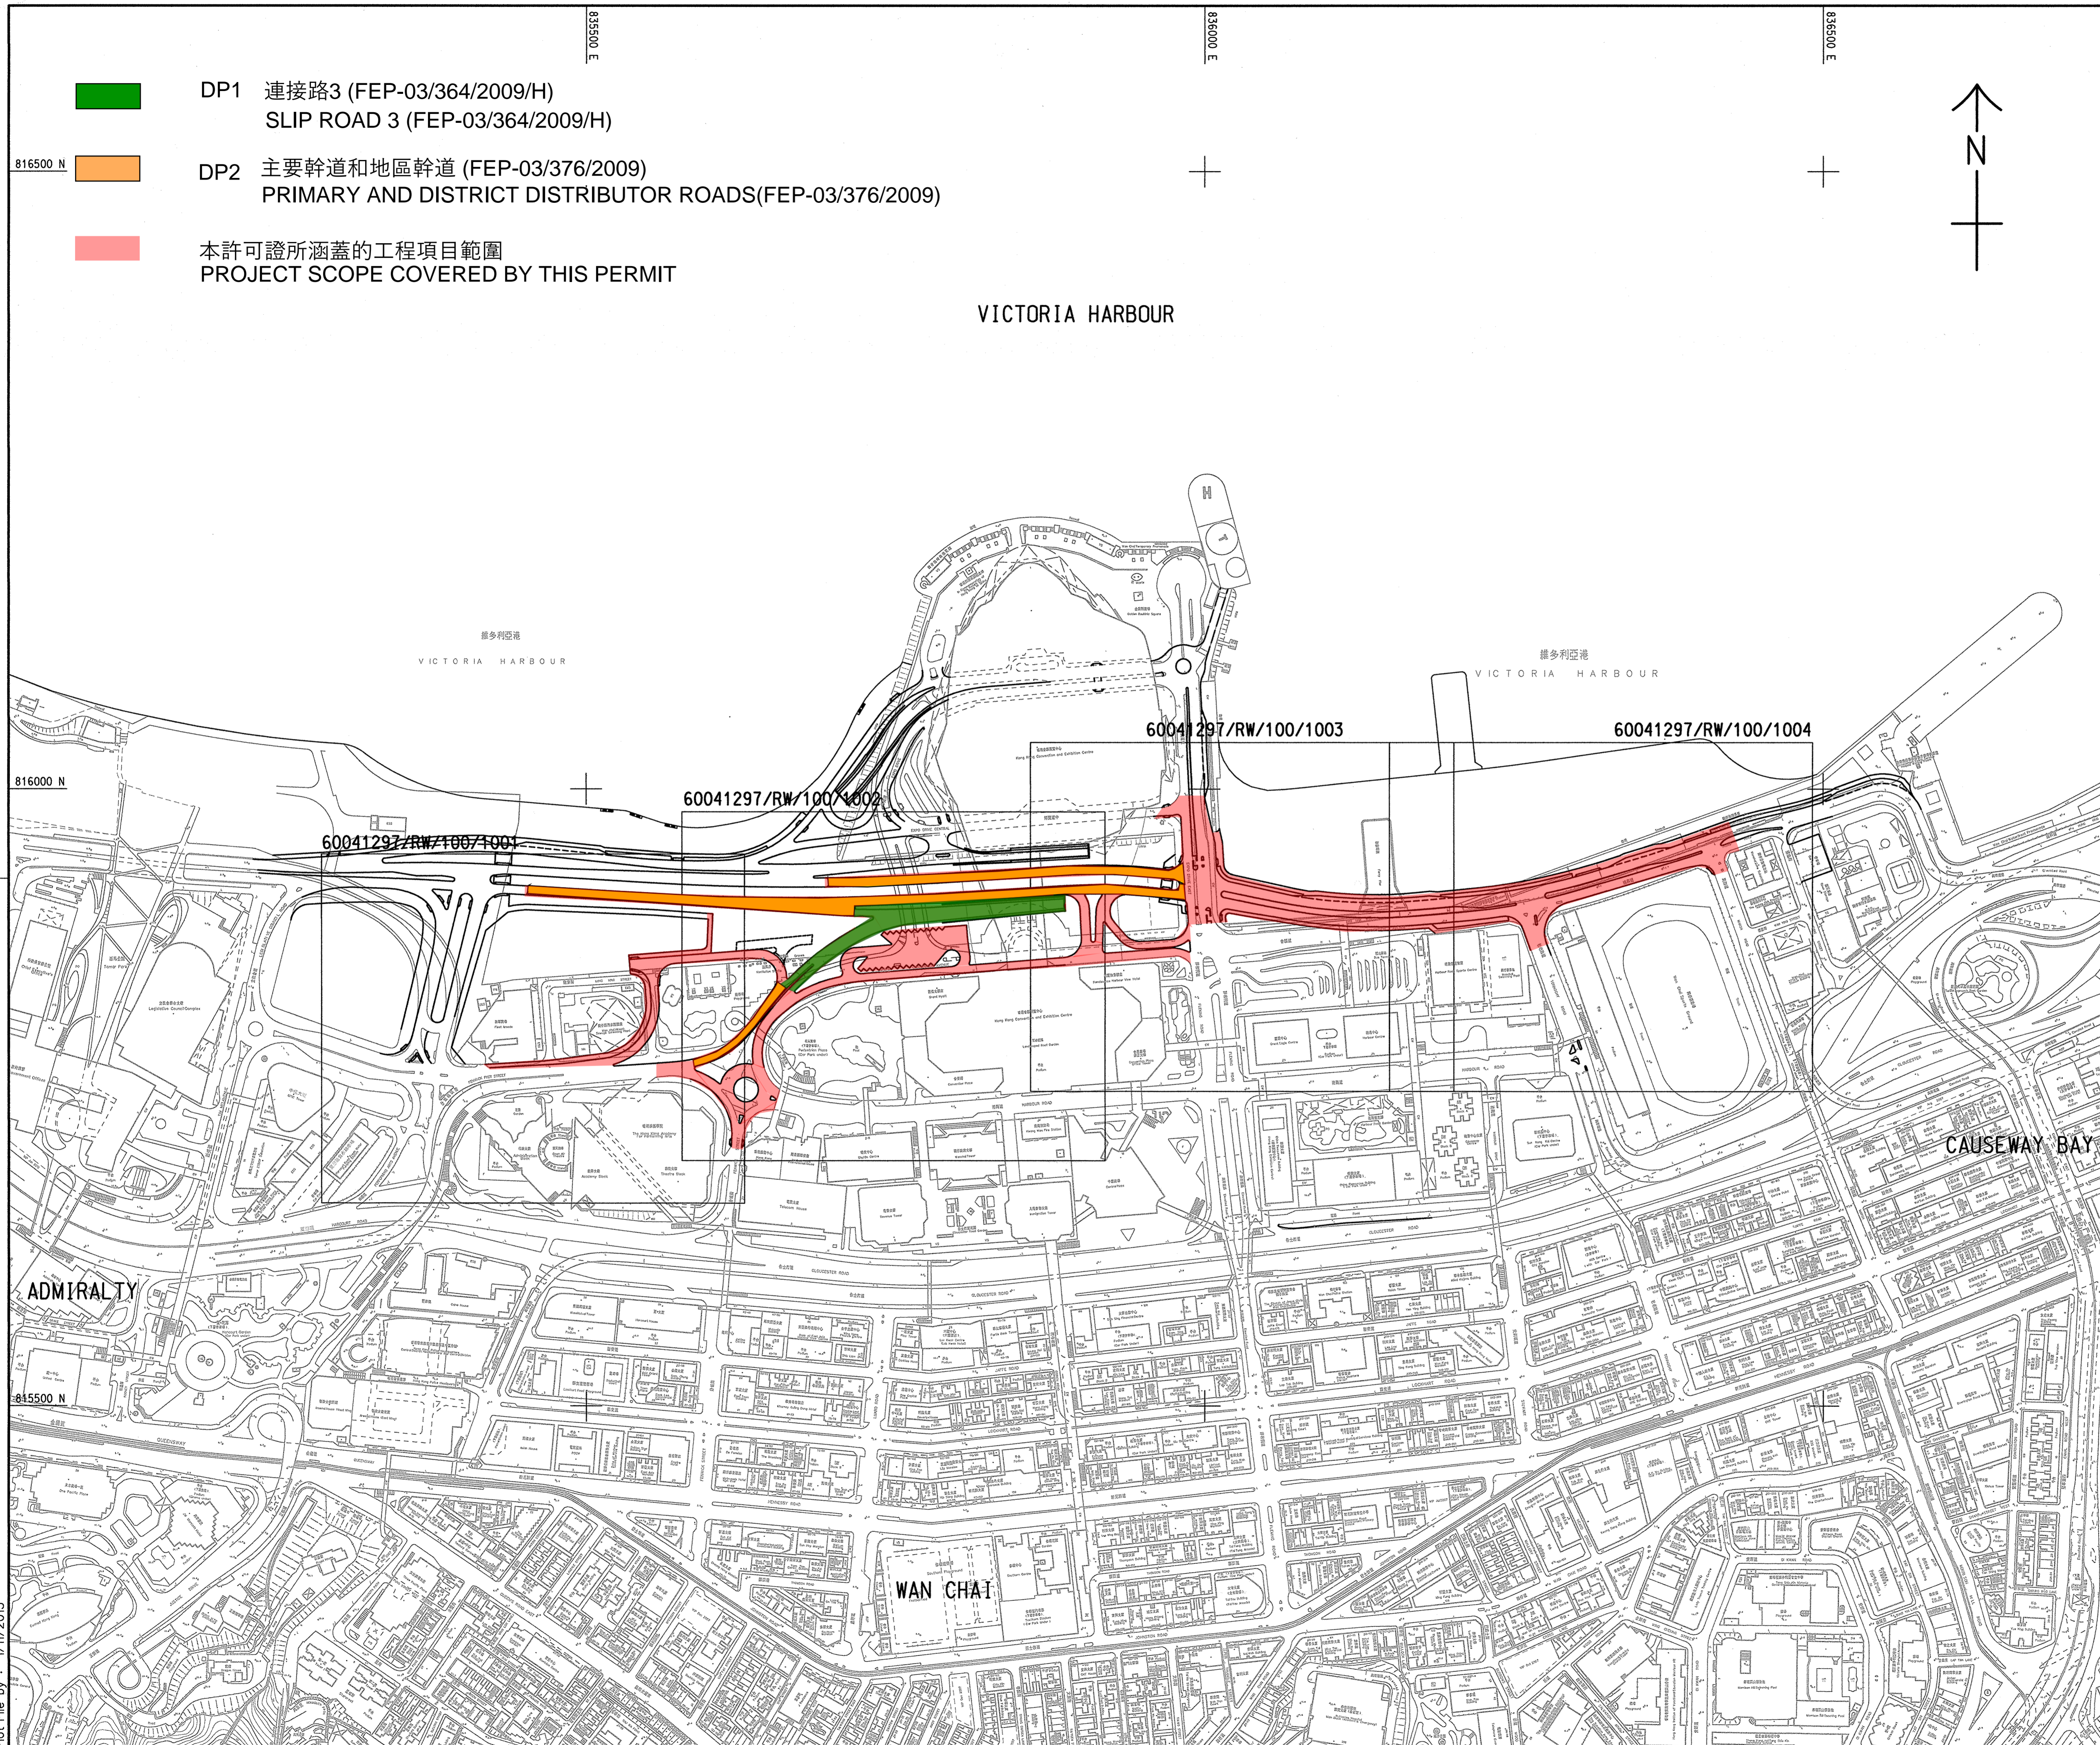
| Figure 1.1 | Site Layout Plan of CEDD Entrusted Works under Contract 1123 |

- DP1 連接路3 (FEP-03/364/2009/H)
SLIP ROAD 3 (FEP-03/364/2009/H)
- DP2 主要幹道和地區幹道 (FEP-03/376/2009)
PRIMARY AND DISTRICT DISTRIBUTOR ROADS(FEP-03/376/2009)
- 本許可證所涵蓋的工程項目範圍
PROJECT SCOPE COVERED BY THIS PERMIT

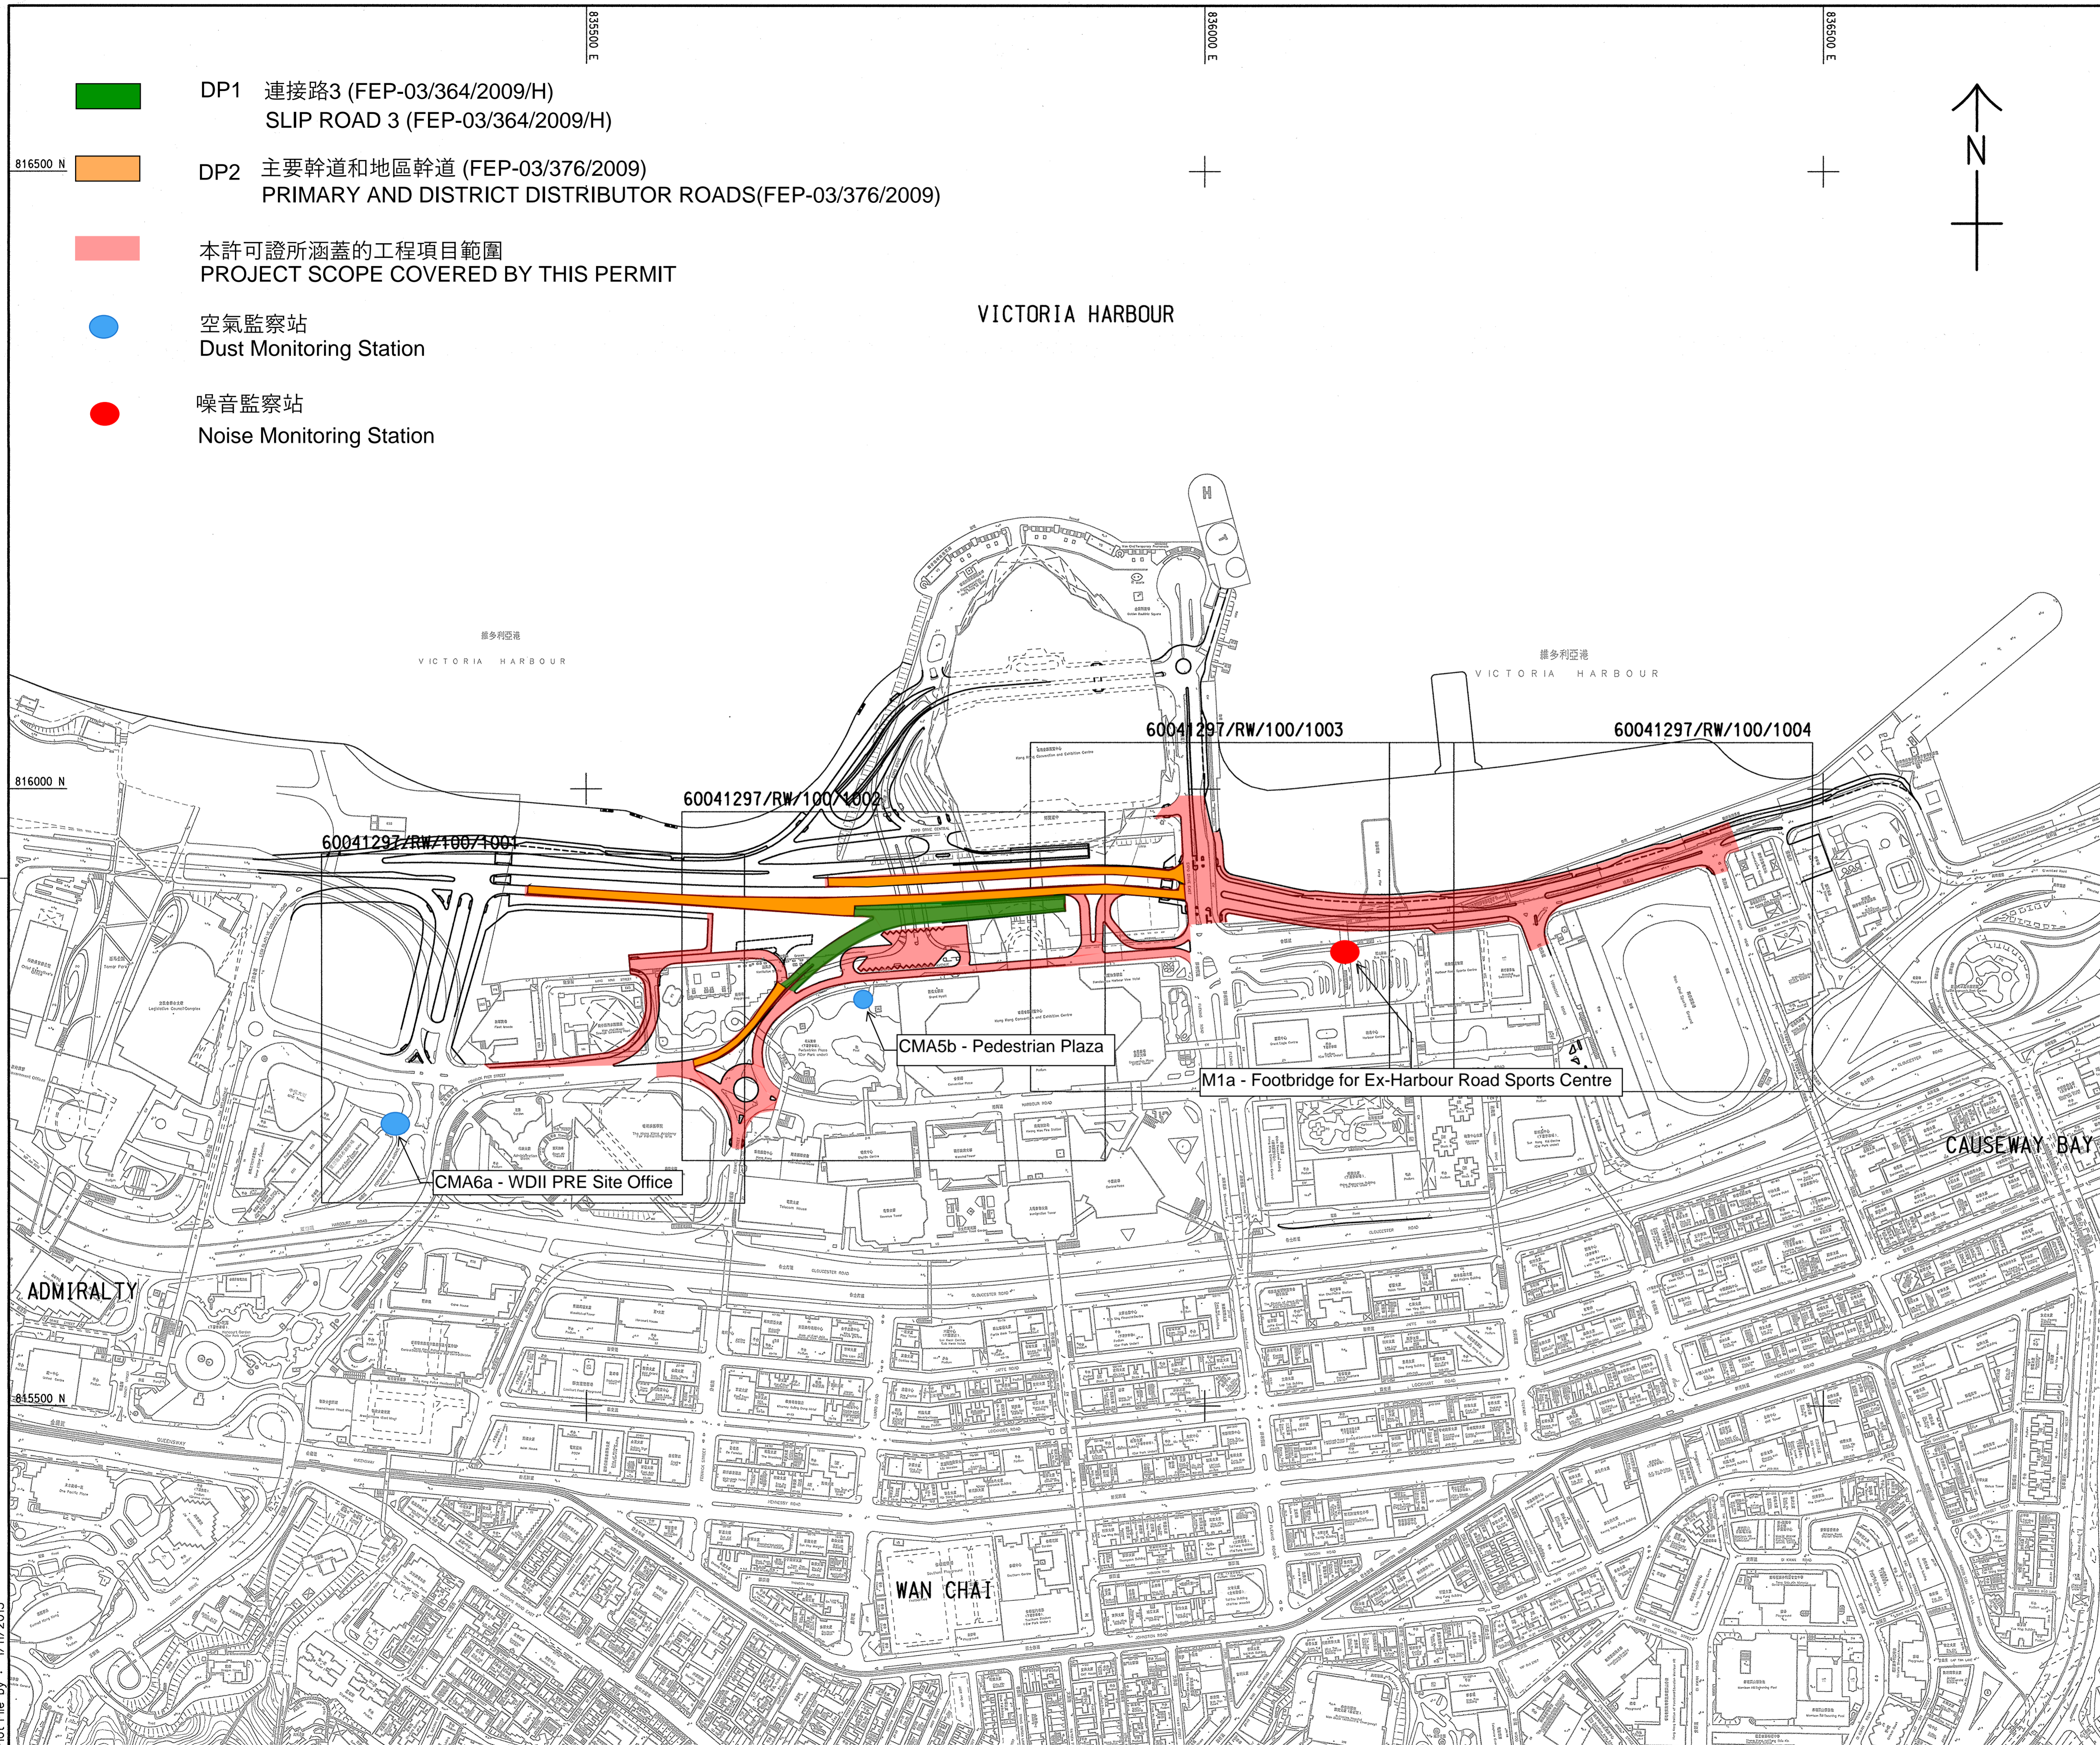
| Figure 3.1 | Air Quality and Noise Monitoring Locations for CEDD Entrusted Works |

- DP1 連接路3 (FEP-03/364/2009/H)
SLIP ROAD 3 (FEP-03/364/2009/H)
- DP2 主要幹道和地區幹道 (FEP-03/376/2009)
PRIMARY AND DISTRICT DISTRIBUTOR ROADS(FEP-03/376/2009)
- 本許可證所涵蓋的工程項目範圍
PROJECT SCOPE COVERED BY THIS PERMIT
- 空氣監察站
Dust Monitoring Station
- 噪音監察站
Noise Monitoring Station

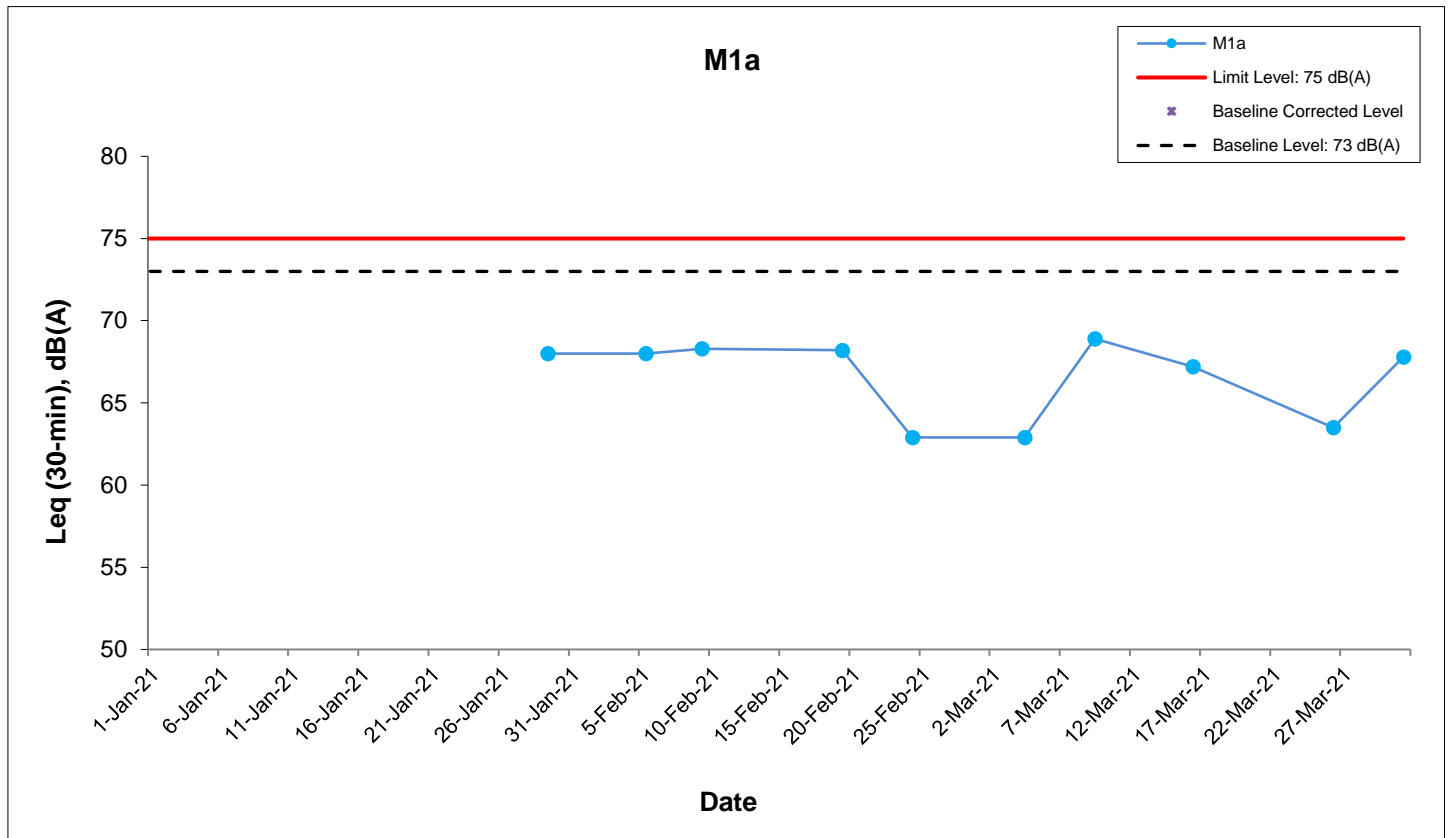
Appendix H Regular Construction Noise Monitoring Results

| Date | Weather Condition | Noise Level for 30-min, dB(A) ⁺ | | | | Baseline Corrected Level, dB(A) | Baseline Noise Level, dB(A) | Limit Level, dB(A) | Exceedance (Y/N) |
