Gammon Skanska Limited

Contract No. CV/2002/04

Penny's Bay Reclamation Stage 2

Monthly EM&A Report for August 2003

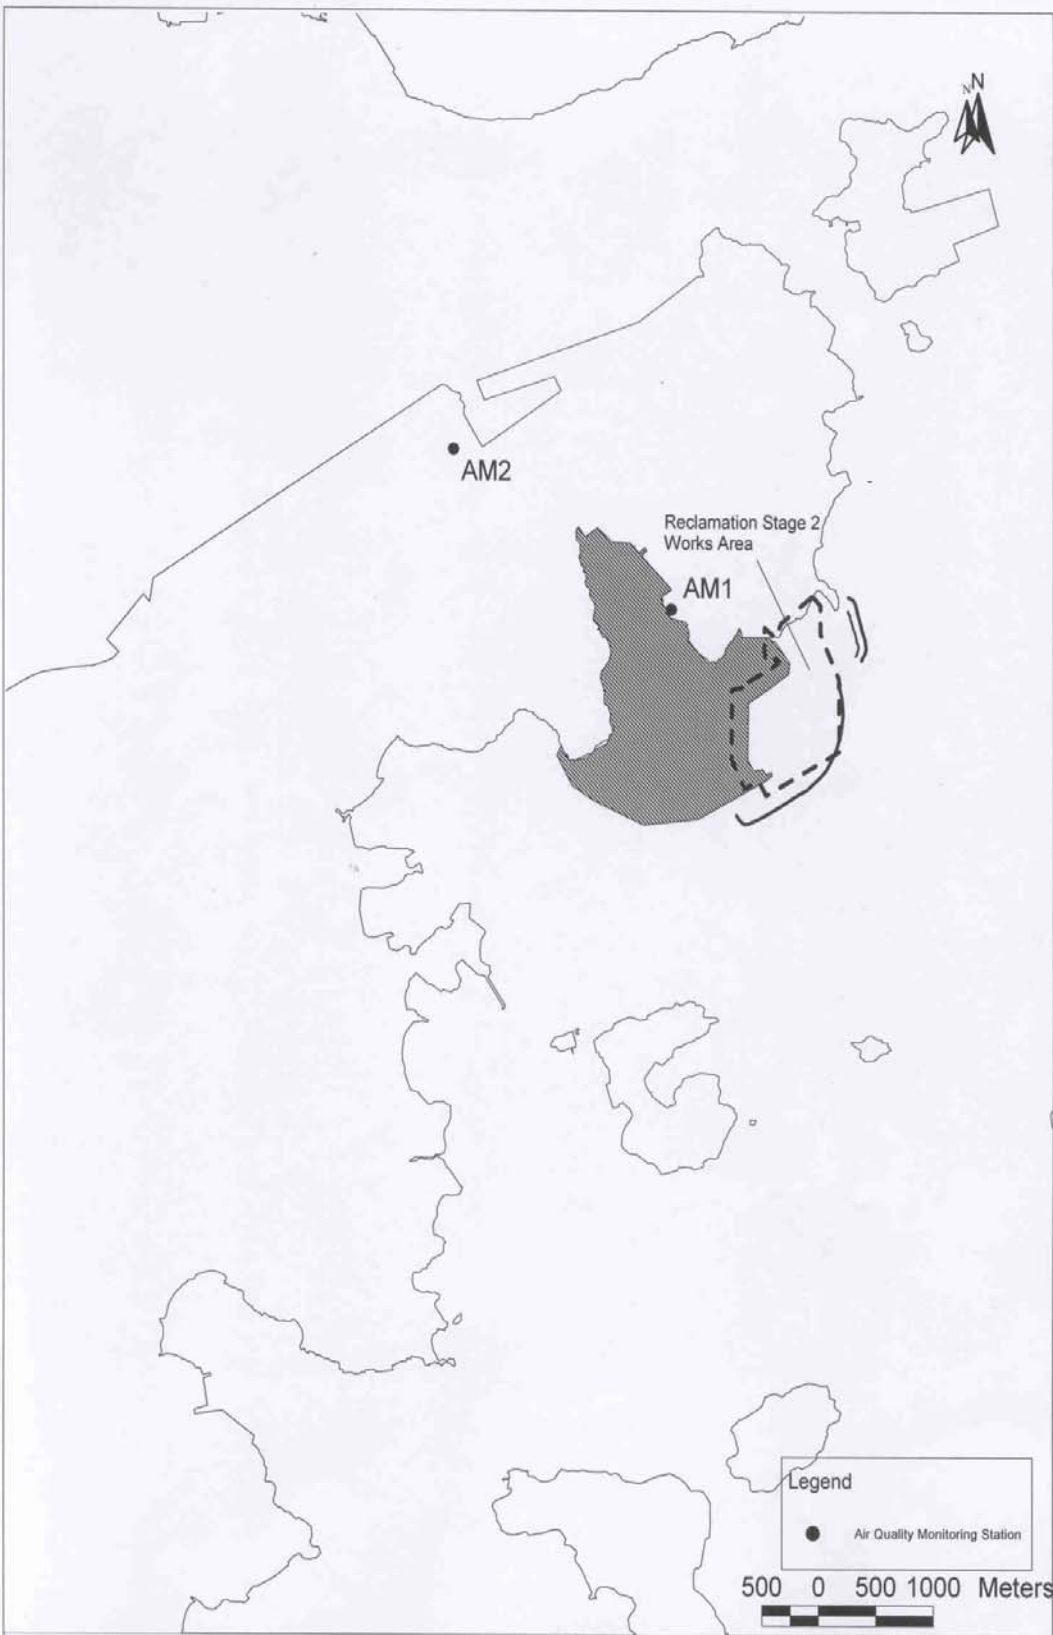
Title Penny's Bay Reclamation Stage 2 Location of Air Quality Monitoring Stations	Scale As Shown	Project No. S02803

- 2.4 In accordance with the EM&A Manual, two air quality monitoring stations, as shown in Figure 2.1, were selected for 24-hour TSP sampling. Table 2.3 describes the location of the air quality monitoring stations.

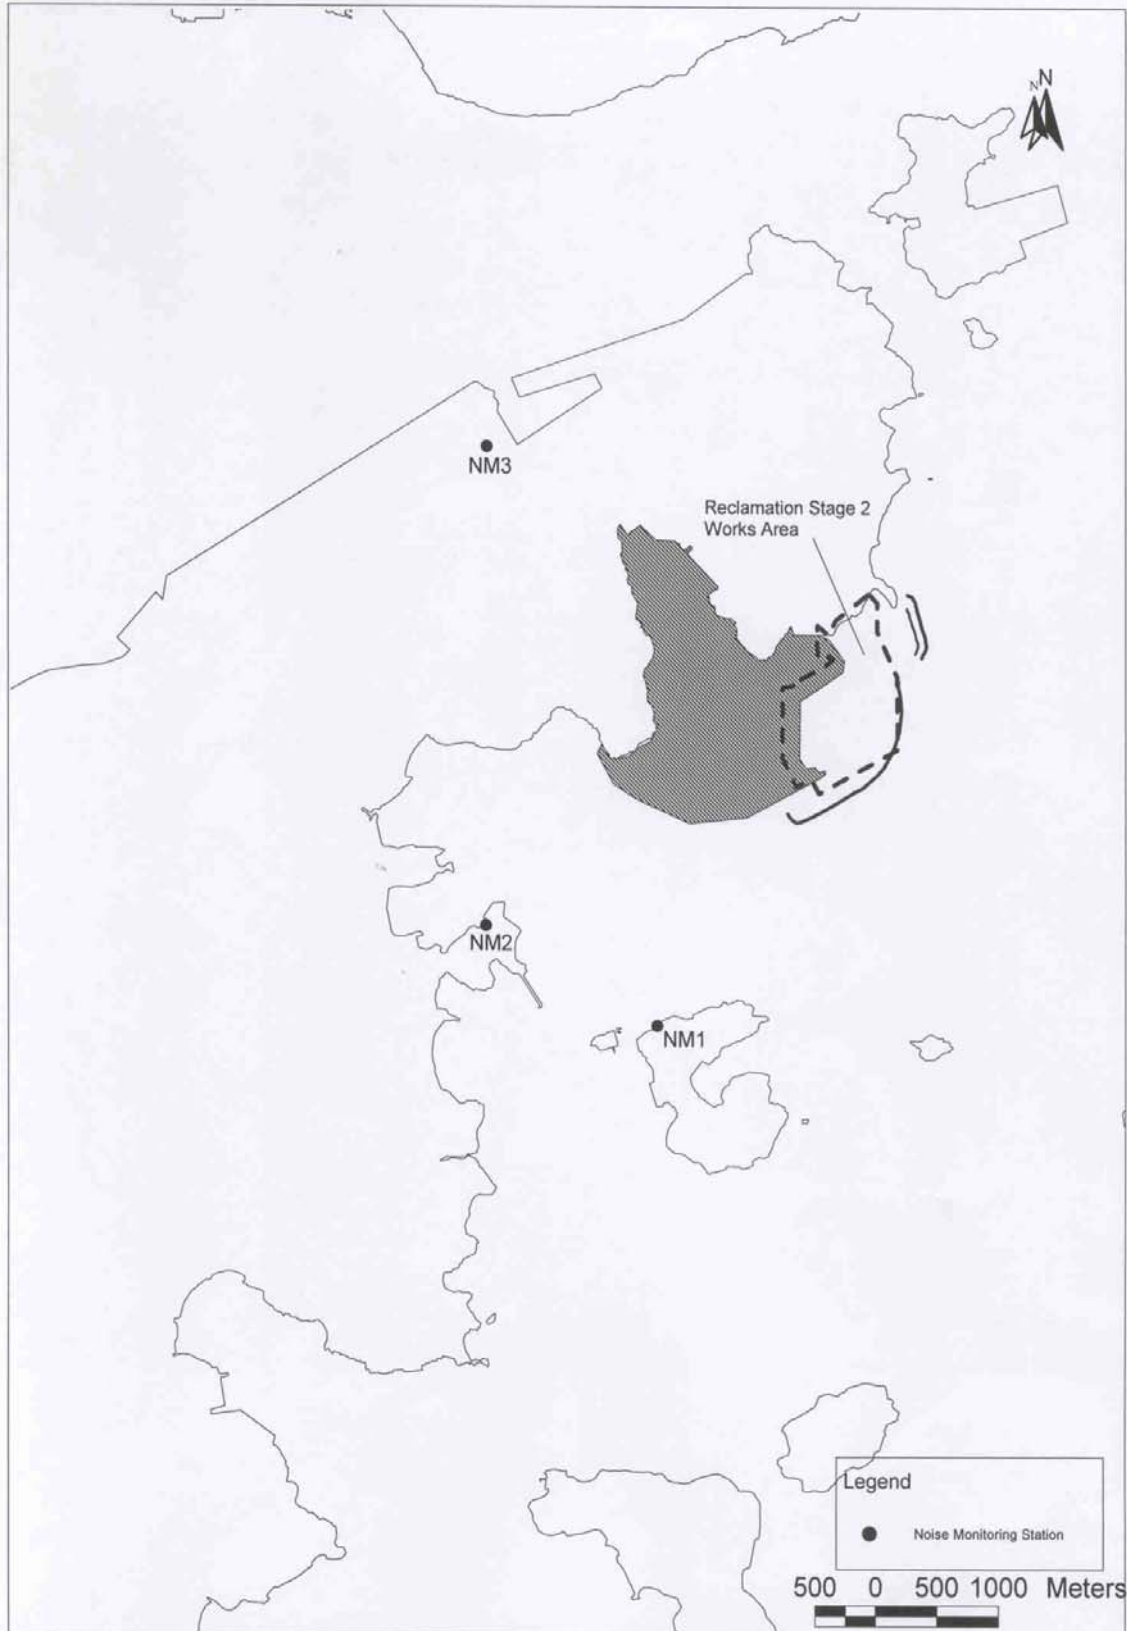
Title Penny's Bay Reclamation Stage 2 Location of Noise Monitoring Stations	Scale As Shown	Project No. S02803	
	Date 2003	Figure No. 3.1

- 3.4 In accordance with the EM&A Manual, noise monitoring was conducted at three designated monitoring stations as shown in Figure 3.1. Table 3.3 describes the locations of these monitoring stations.

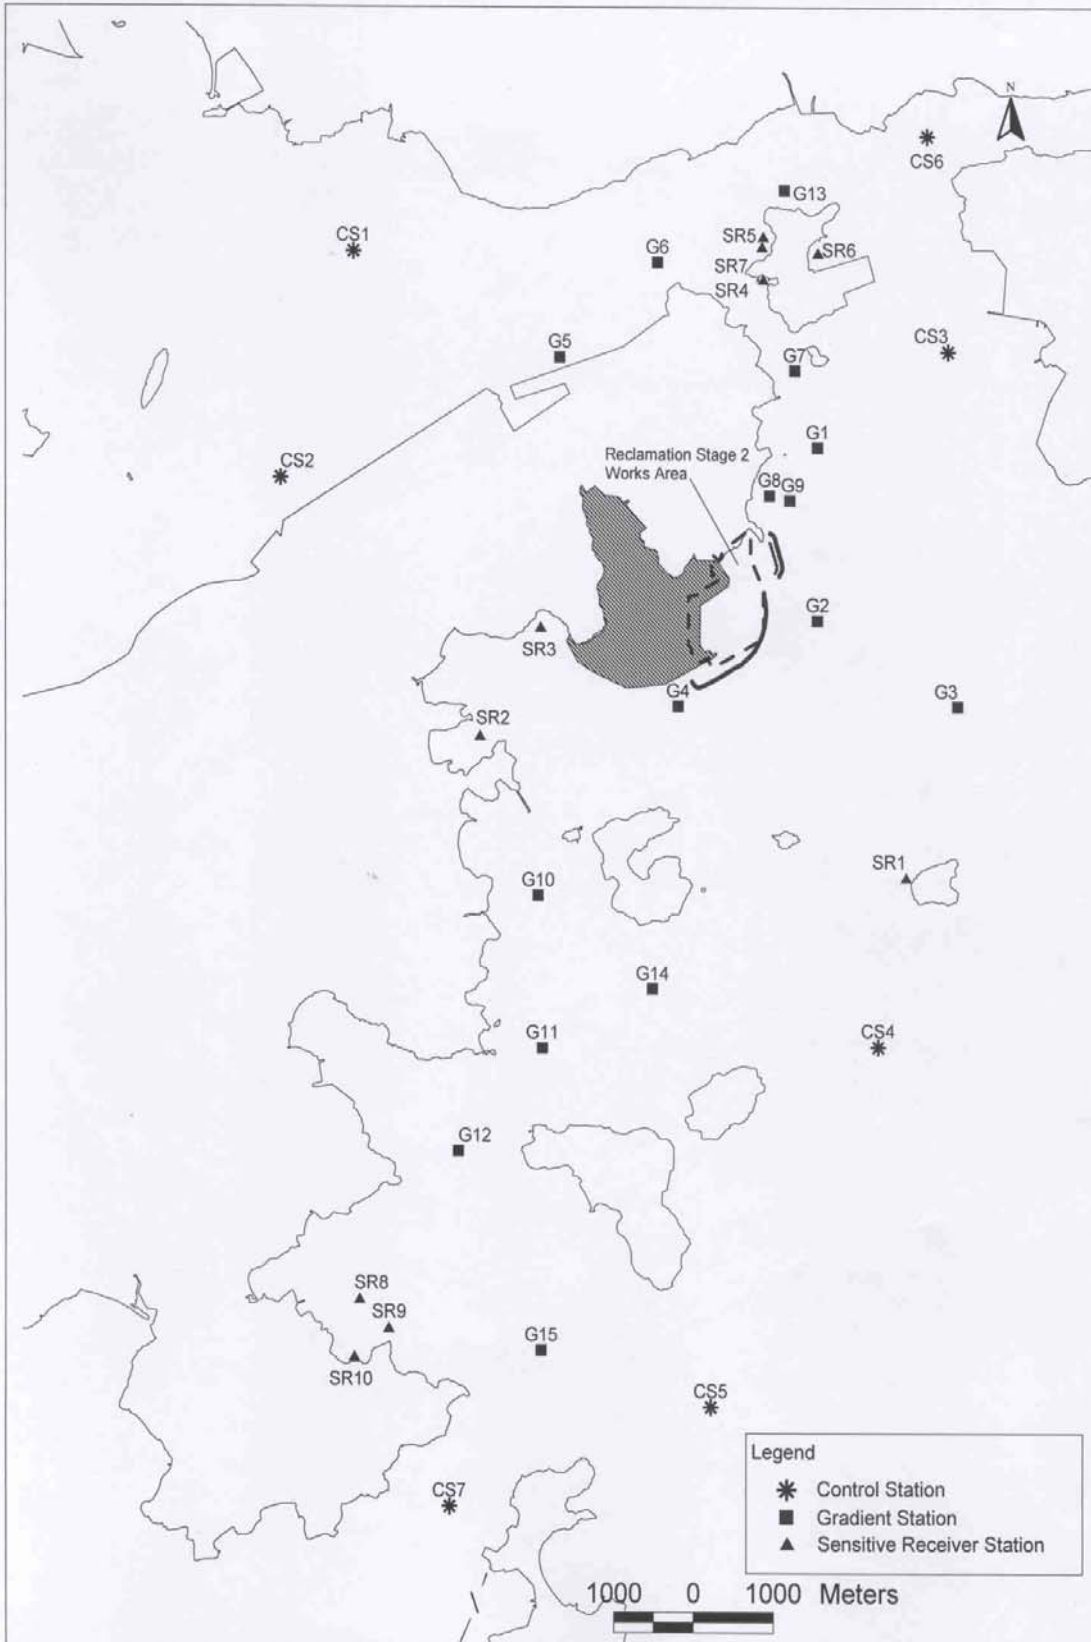
Title Penny's Bay Reclamation Stage 2 Location of Water Quality Monitoring Stations	Scale As Shown	Project No. S02803	
	Date 2003	Figure No. 4.1

- 4.4 In accordance with the EM&A Manual, thirty-two stations (10 Sensitive Receiver Stations, 7 Control Stations and 15 Gradient Stations) were designated for discrete marine water quality monitoring. The ten Sensitive Receiver (SR) Stations were chosen on the basis of their proximity to the reclamation and thus the greatest potential for water quality impacts, the seven Control Stations (CS) were chosen to facilitate comparison of the water quality of the SR stations with ambient water quality conditions and, the fifteen Gradient Stations (G) were chosen to assist in the identification of the source of any impact. The locations of these monitoring stations are summarized in Table 4.3 and depicted in Figure 4.1.

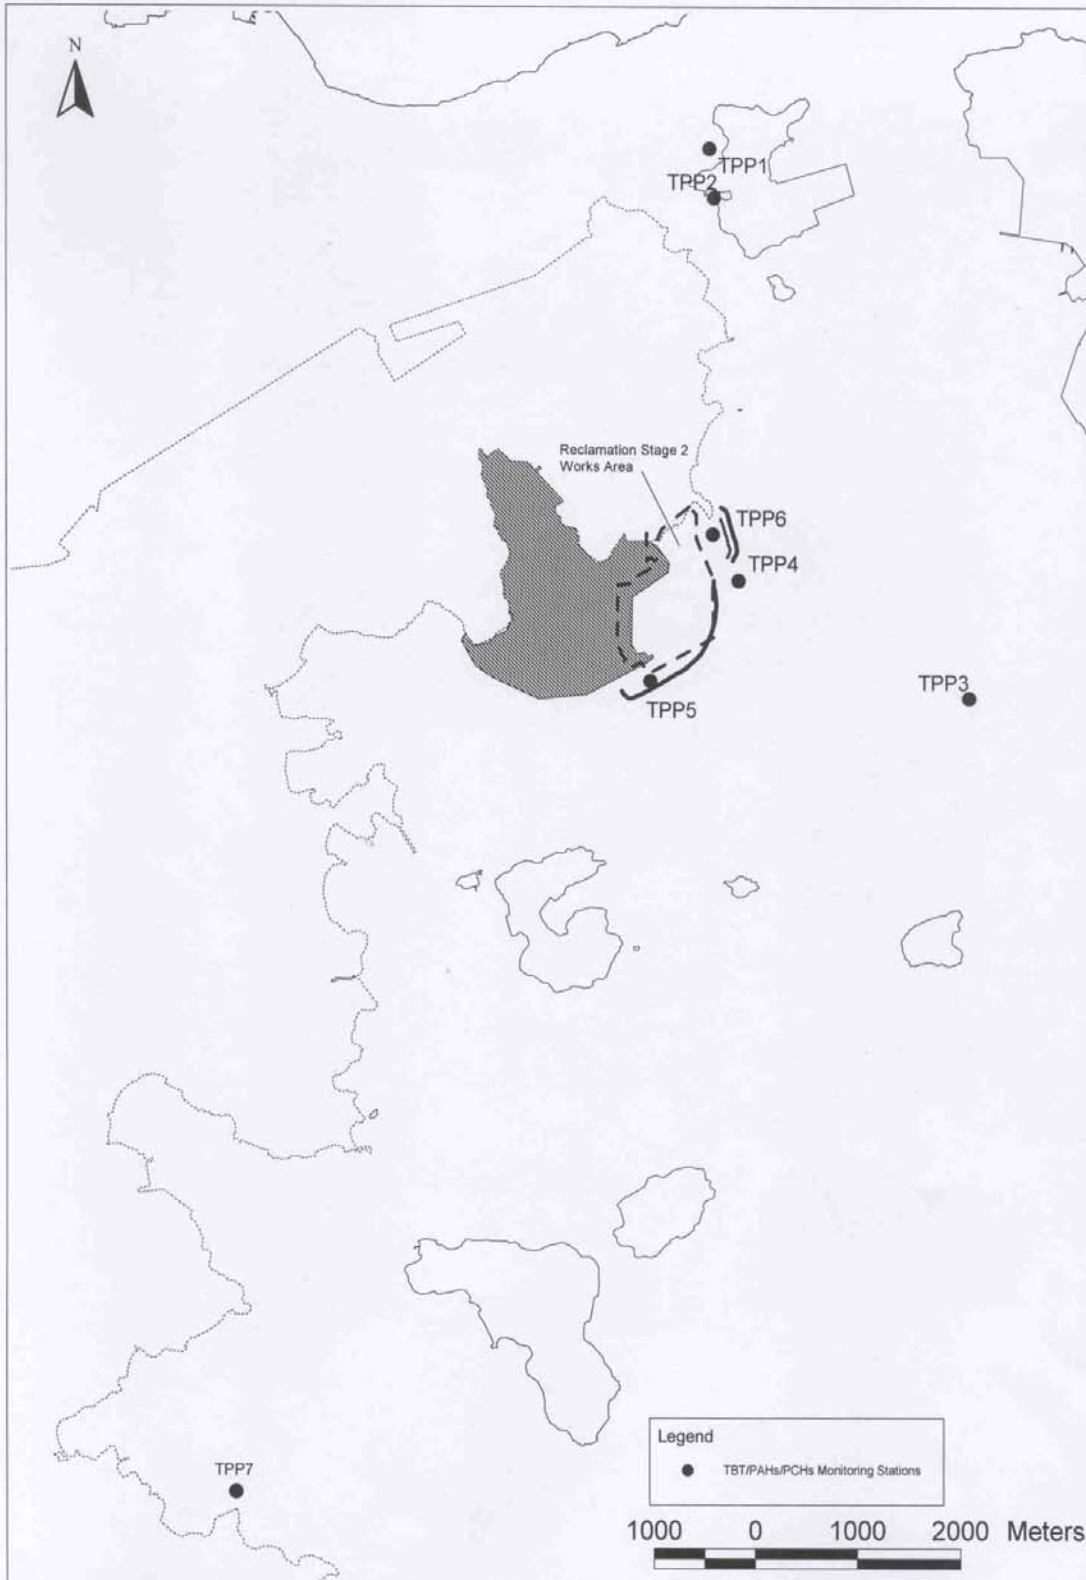
Title Penny's Bay Reclamation Stage 2 Locations for TBT/PAHs/PCBs Monitoring Stations	Scale 1 : 50000	Project No. S02803	
	Date 2003	Figure No. 4.2

- 4.26 In accordance with the EM&A Manual, seven stations were designated for TBT, PAHs and PCBs monitoring. The locations of these monitoring stations are summarized in Table 4.7 and depicted in Figure 4.2.

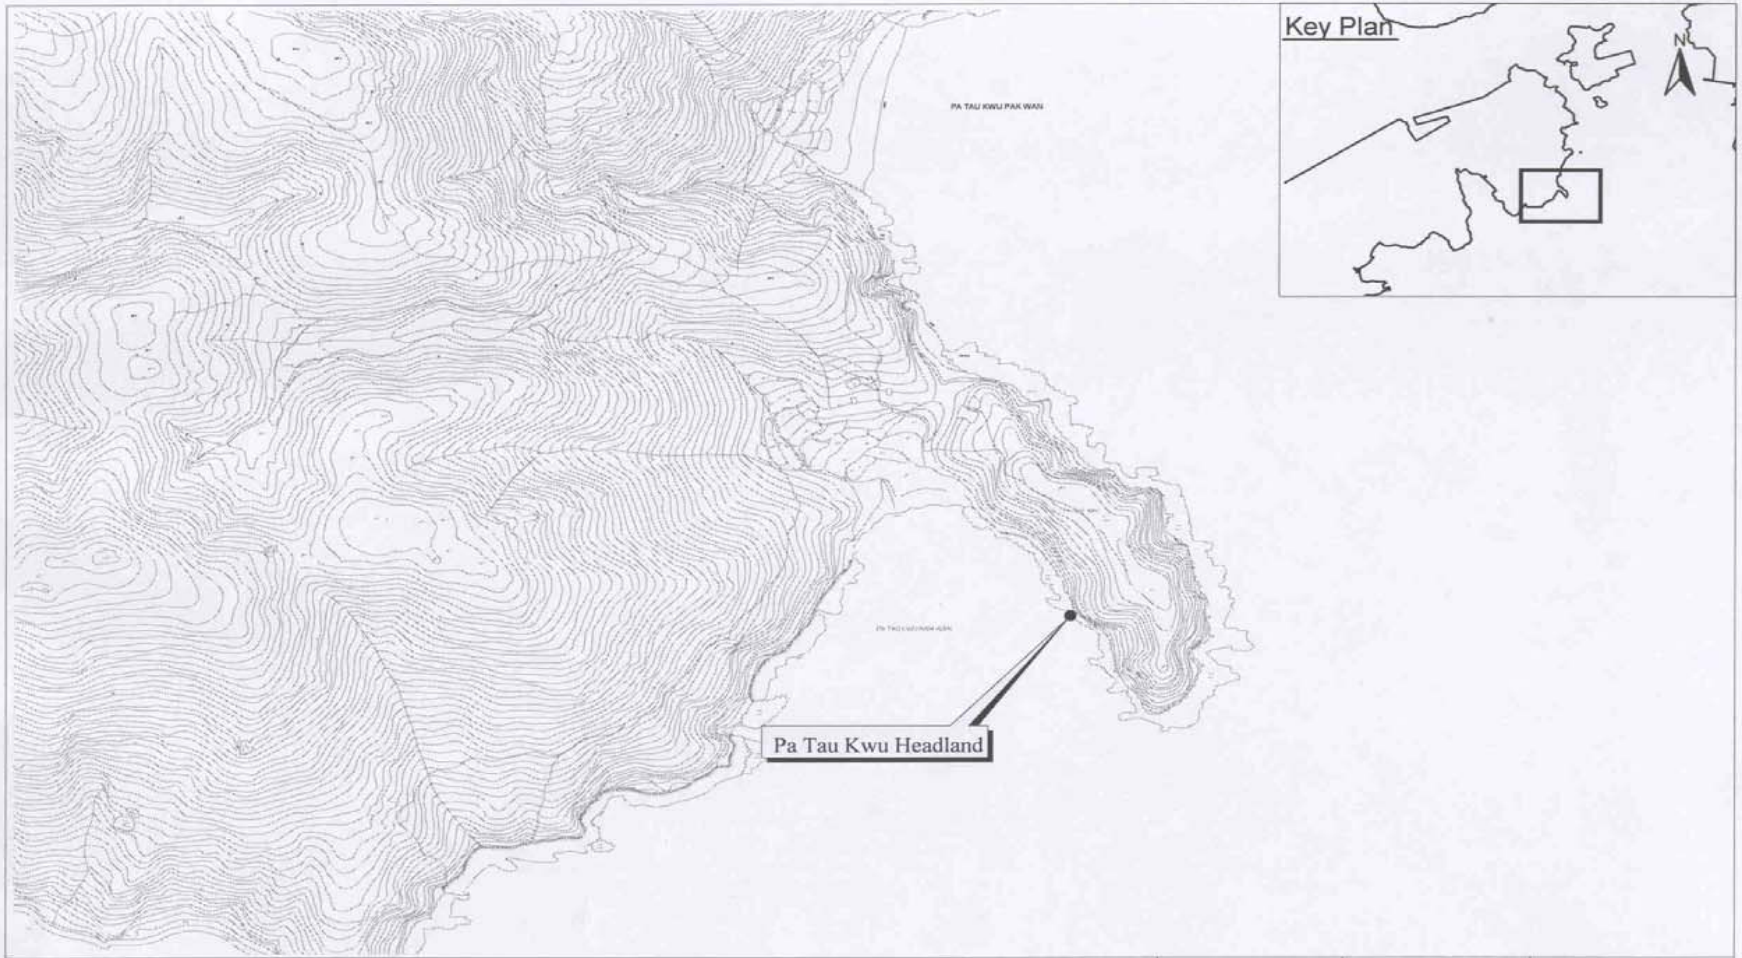
Title	Penny' s Bay Reclamation Stage 2	Scale	1 : 4 000	Project	S02803	Maunsell <small>MAUNSELL ENVIRONMENTAL MANAGEMENT CONSULTANTS LTD</small>
	Location of White-bellied Sea Eagles Monitoring	Date	2003	Figure	5.1

- 5.4 In accordance with the EM&A Manual, monitoring of the White-bellied Sea Eagles was conducted at Pa Tau Kwu. The monitoring location is shown at Figure 5.1.

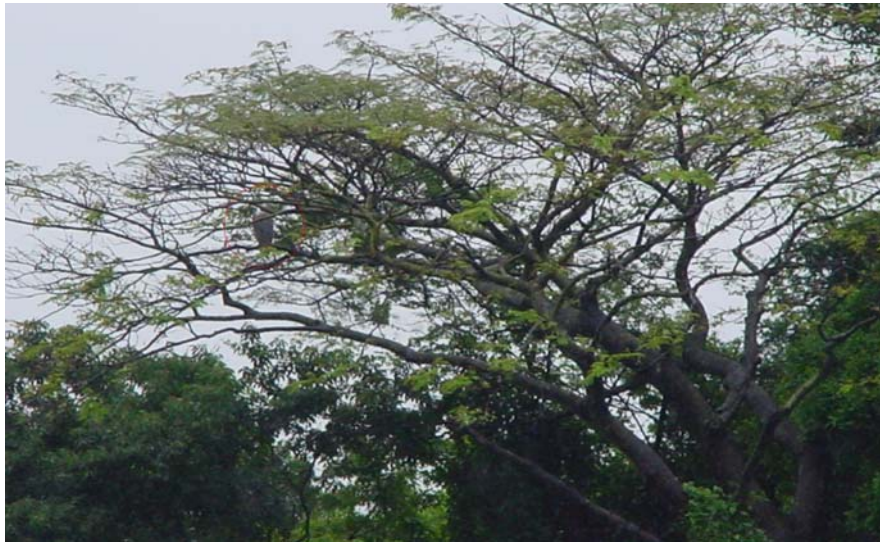
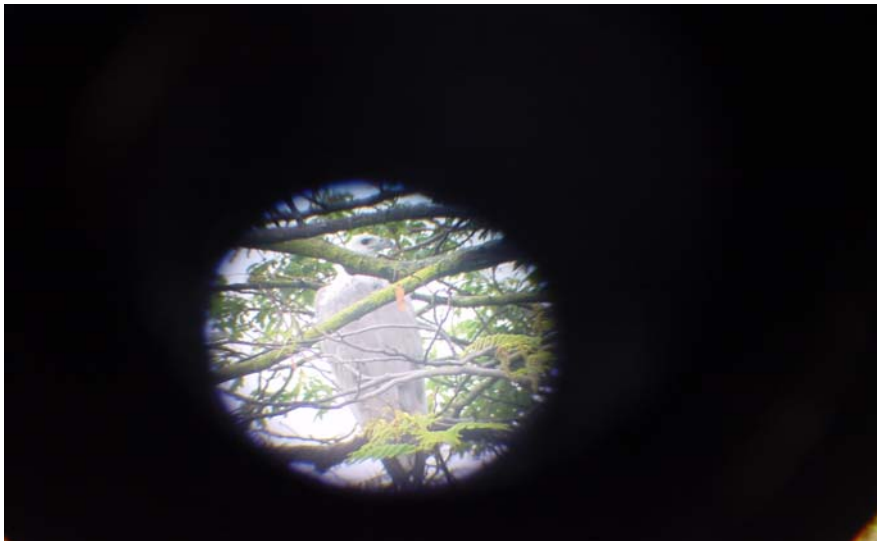
Photographic records of the White-bellied Sea Eagle	Project No. S02803	Figure No. 5.2

- 5.7 In the reporting month, field survey was conducted on 16 August between 8:45am and 5:45pm. The monitoring results are summarised and presented in Table 5.1
- 5.8 Photographic records of the White-bellied Sea Eagle were presented in Figure 5.2.

Photo 1. The White-bellied Sea Eagle stayed on Albizia tree at the monitoring site.

Photo 2. The close shot of the White-bellied Sea Eagle taken by digital camera through telescope.

- 10.8 A single White-bellied Sea Eagle, considered to be the male, was observed at the monitoring site during the survey in August. There was no evidence to indicate that the works of Reclamation Stage 2 have disturbed the White-bellied Sea Eagles.

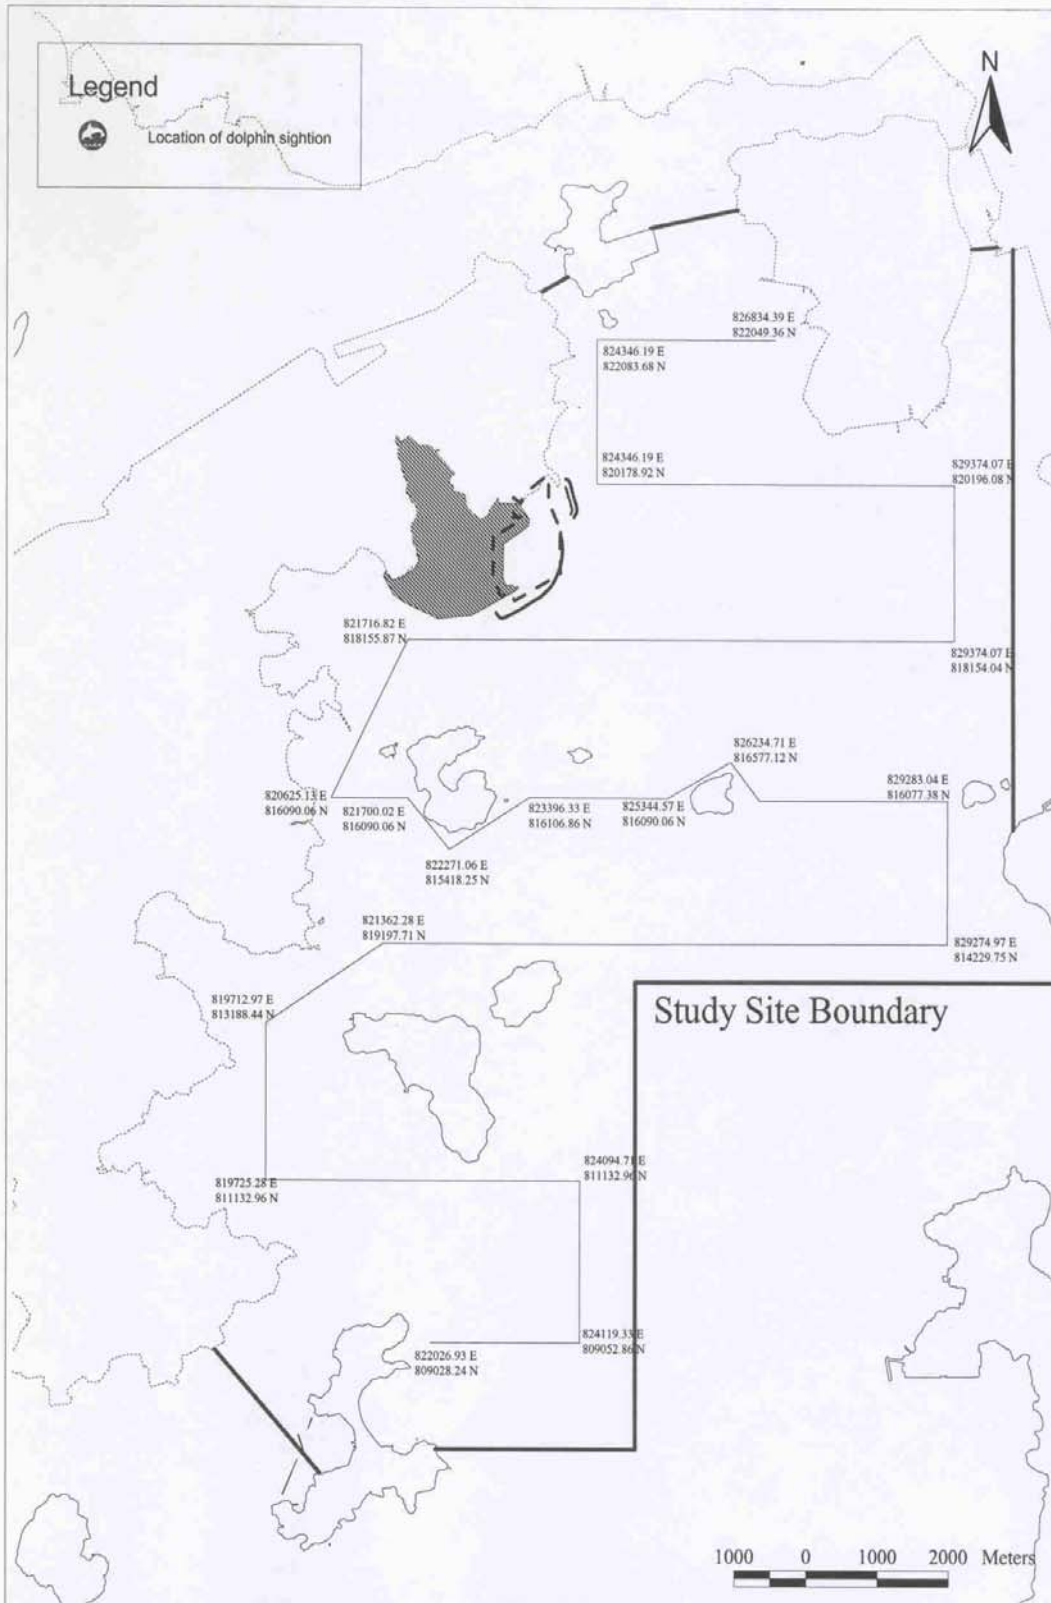
Title Penny's Bay Reclamation Stage 2 Locations of Marine Mammal Monitoring	Scale 1 : 80 000	Project No. S02803	 <small>MAUNSELL ENVIRONMENTAL MANAGEMENT CONSULTANTS LTD</small>
	Date 2003	Figure No. 6.1

- 6.4 The marine mammal monitoring was conducted at East Lantau. The detailed monitoring location with transect lines are shown in Figure 6.1.

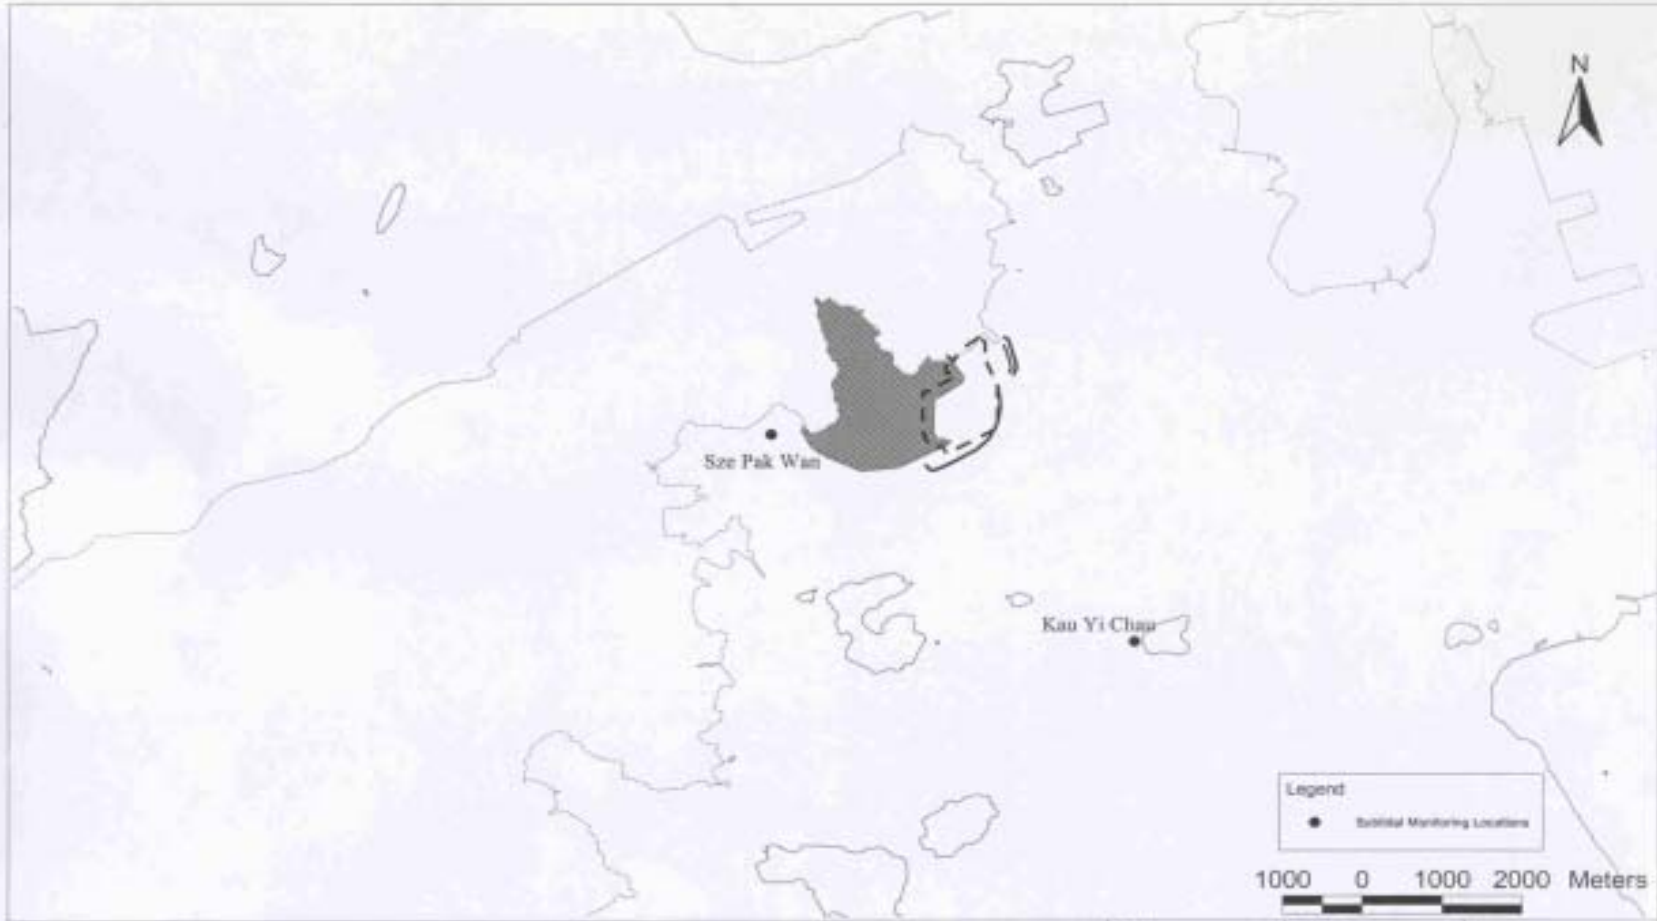
Project 502803
Figure 7.1

- 7.3 In accordance with the EM&A Manual, subtidal monitoring is conducted at Kau Yi Chau and Sze Pak Wan. The monitoring locations are shown in Figure 7.1. Monitoring procedures are detailed below. The survey methods and locations of transects are to be the same on each survey due to fixed transect monitoring.

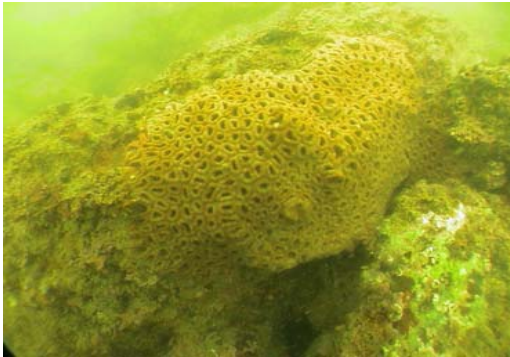
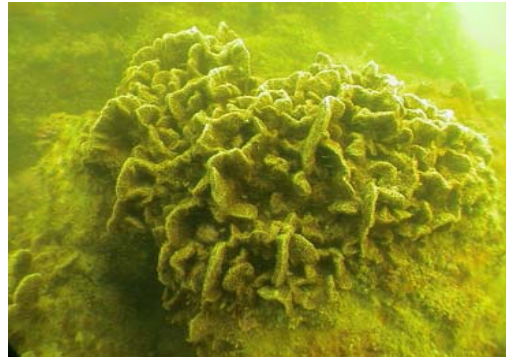
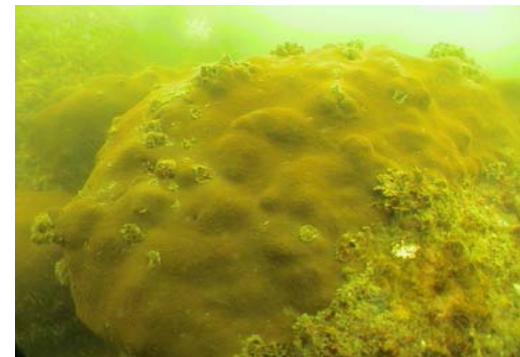
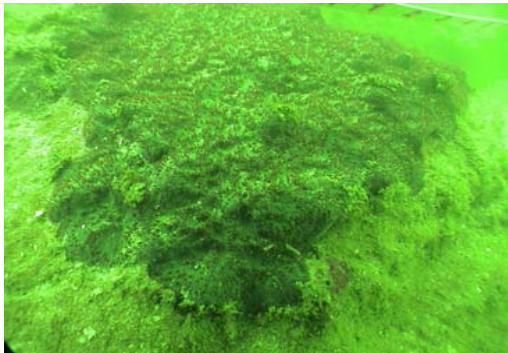
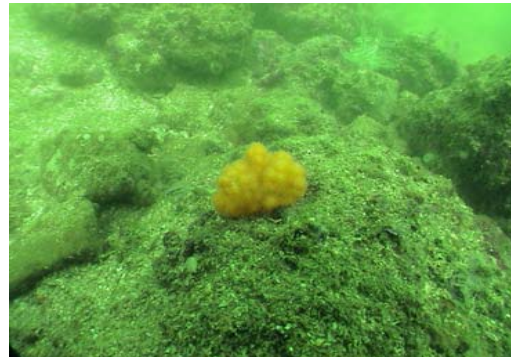
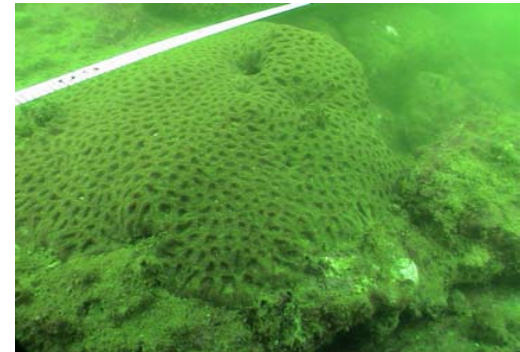
Title	Penny's Bay Reclamation Stage 2		Scale	N.T.S.	Project No.	S02803	
	Photographic Records of Corals at Kau Yi Chau		Date	2003	Figure No.	7.3

Favia Sp. at Kau Yi Chau (Transect 1)

Pavona Sp. at Kau Yi Chau (Transect 1)

Psammocora Sp. at Kau Yi Chau (Transect 1)

Conscinaraea Sp. at Kau Yi Chau (Transect 2)

Dendronephthya Sp. at Kau Yi Chau (Transect 2)

Goniastrea Sp. at Kau Yi Chau (Transect 2)

- 7.16 Results are summarised in Table 7.2. The raw data are provided in Appendix P and representative photographs of corals at Kau Yi Chau are provided in Figure 7.3.
