**OPERATION OF FILL BANK AT  
TSEUNG KWAN O AREA 137 AND  
BARGING FACILITIES AT HONG  
KONG ISLAND AND MUI WO  
(CONTRACT NO.: CV/2005/05)**

**TSEUNG KWAN O AREA 137**

**MONTHLY EM&A REPORT  
(SEPTEMBER 2005)**

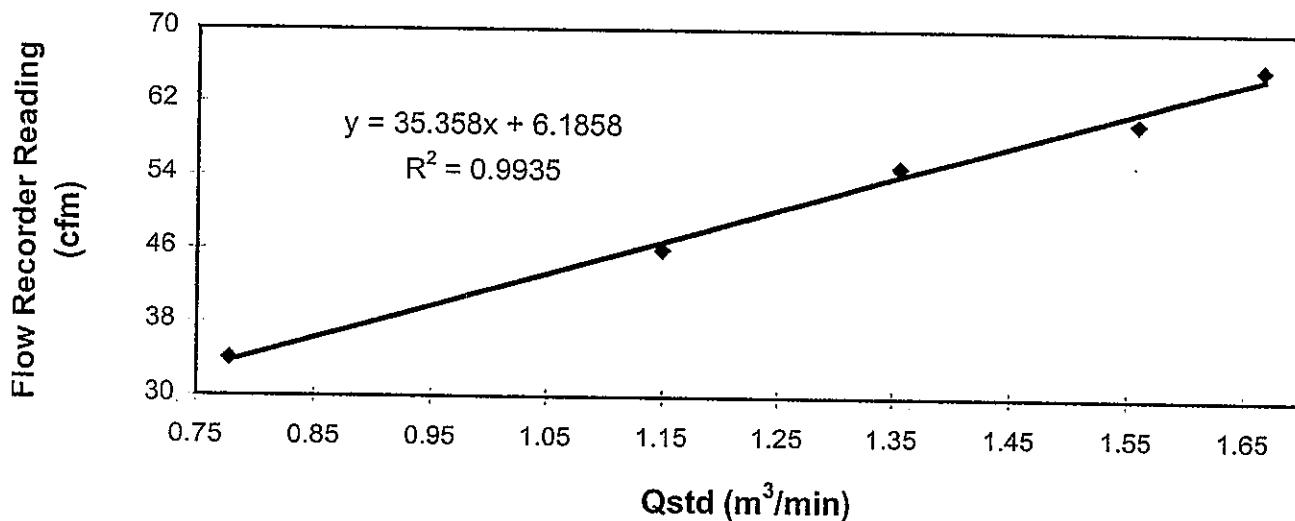
**Air Sampler 10347 Calibration Curve**  
Site:Tseung Kwan O (AA1)  
Date of Calibration: 16 July 2005

Acceptance Criteria : Correlation coefficient (*r*) of the calibration curve greater than 0.990 after a 5 point calibration

The high volume sampler complies \* / ~~does not comply~~ \* with the specified requirements and is deemed acceptable \*/ ~~unacceptable~~ \* for use.

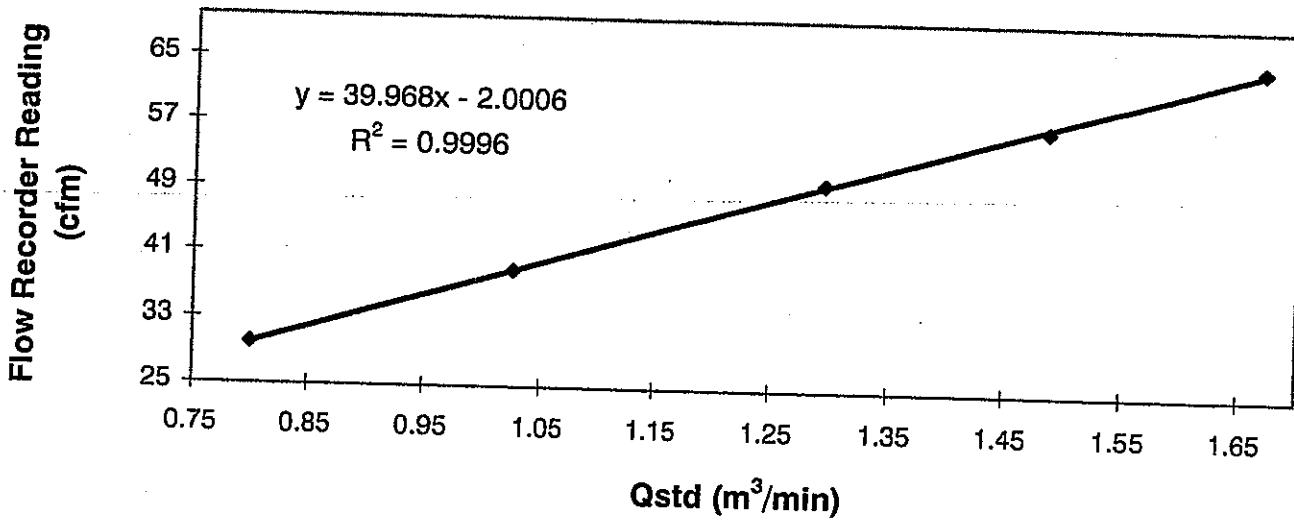
Air Sampler 10347 Calibration Curve  
Site:Tseung Kwan O (AA1)  
Date of Calibration: 14 September 2005

Acceptance Criteria : Correlation coefficient (*r*) of the calibration curve greater than 0.990 after a 5 point calibration

The high volume sampler complies \* / does not comply \* with the specified requirements and is deemed acceptable \* / unacceptable \* for use.

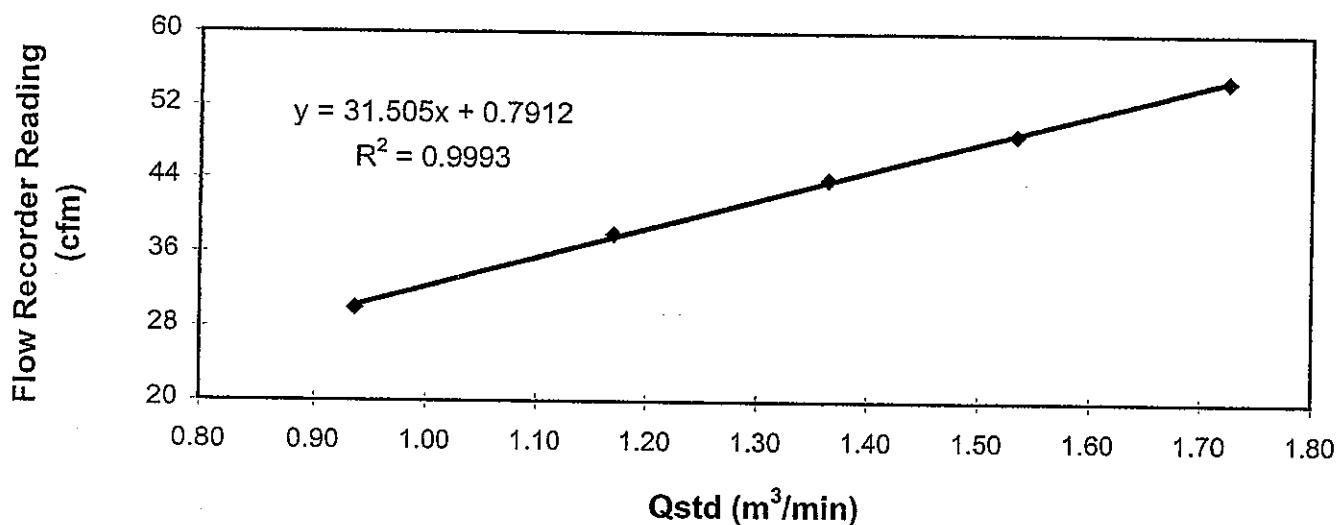
**Air Sampler 1176 Calibration Curve**  
**Site: Tseung Kwan O (AA2)**  
**Date of Calibration: 16 July 2005**

Acceptance Criteria : Correlation coefficient ( $r$ ) of the calibration curve greater than 0.990 after a 5 point calibration

The high volume sampler complies \* / does not comply \* with the specified requirements and is deemed acceptable \*/ unacceptable \* for use.

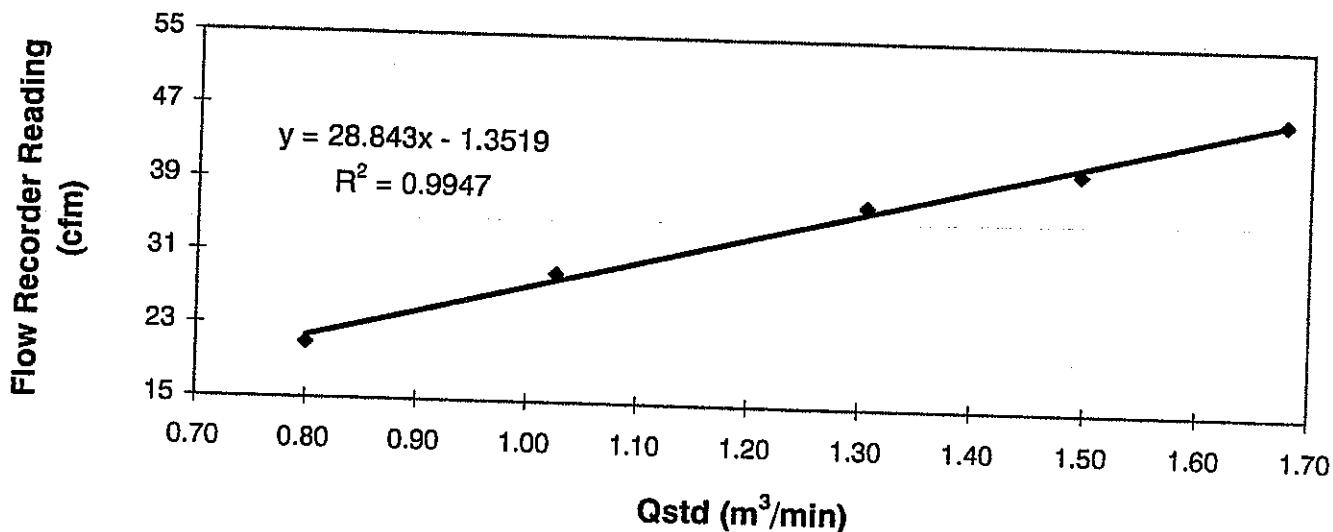
**Air Sampler 1176 Calibration Curve**  
**Site: Tseung Kwan O (AA2)**  
**Date of Calibration: 14 September 2005**

Acceptance Criteria : Correlation coefficient (*r*) of the calibration curve greater than 0.990 after a 5 point calibration

The high volume sampler complies \* / ~~does not comply~~ \* with the specified requirements and is deemed acceptable \*/ ~~unacceptable~~ \* for use.

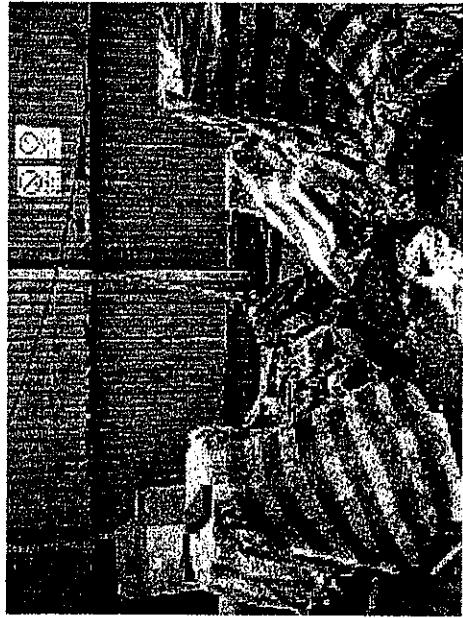
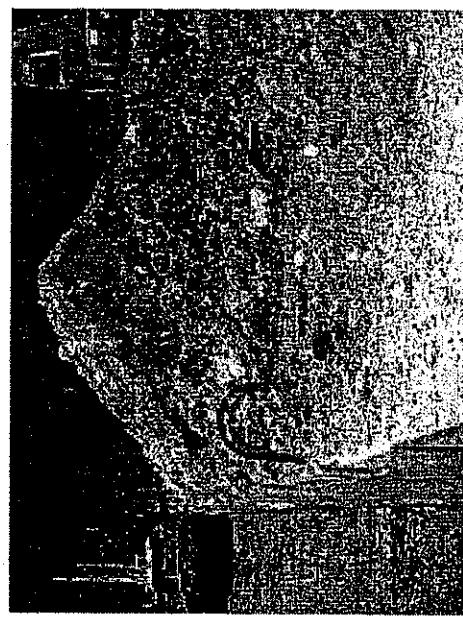
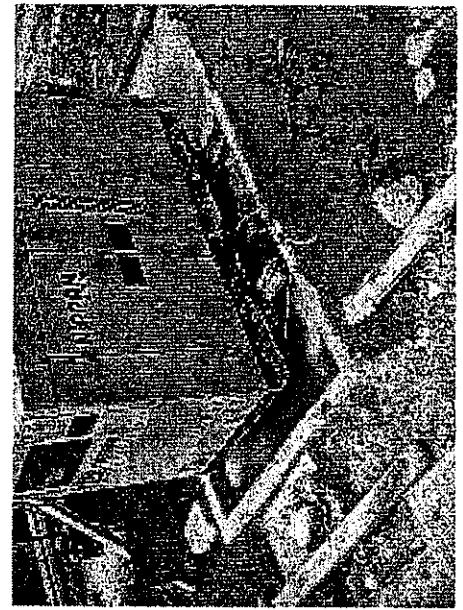
Photo 050907_001
	Photo 050907_002
	Photo 050907_003
	Photo 050907_004
	Photo 050907_005
	Photo 050907_006
	Photo 050907_007

Date	Key Findings	Action
7 Sep 2005	<ul style="list-style-type: none"> <li>PDC A still remains to be cleaned of the mud (from the adjacent PBR2 site). Some soil and dead vegetation noted in the far upstream section of the eastern trapezoidal channel (outside of the water bowser filling station) as well as just immediately upstream of the baffle system (of the same trapezoidal channel).</li> <li>The surface channel upstream of DP4 needs to be regularly cleared of the overgrowth (of vegetation).</li> <li>The six empty oil containers (1000L each) located behind a shed by the water bowser filling station should be removed from site if no longer in use.</li> <li>Rain water has collected in the drip trays underneath the generators located at the water bowser filling station and the maintenance workshop.</li> <li>Leakage of lubricating oil from machine maintenance activities (at the maintenance workshop area) was observed at time of inspection. However, it was observed that the Contractor's site staff quickly used clean sand to soak away the liquid.</li> <li>A number of open top plastic buckets filled with waste oil was observed in the chemical waste storage shed together with eight 250L drums.</li> <li>C&amp;D material noted along the concrete walkway of the BHA.</li> </ul>	<ul style="list-style-type: none"> <li>Contractor has been reminded to maintain tight liaison with the PBR2 Contractor to establish the arrangements for cleaning PDC A and the upstream channel. The eastern trapezoidal channel should also be cleaned regularly.</li> <li>Contractor's Representative was advised of this.</li> <li>Contractor's Representative was advised of this.</li> <li>Contractor's Representative noted this and stated they would take action to clear the drip trays.</li> <li>Contractor's Representative reminded to treat the sand as contaminated material and to dispose of as chemical waste.</li> <li>Contractor's Representative was advised to dispose of the collected chemical waste to avoid over storage of these materials on site.</li> <li>Contractor's Representative reminded to regularly clear the walkway of C&amp;D material to avoid any of it falling into the marine waters in the BHA.</li> </ul>

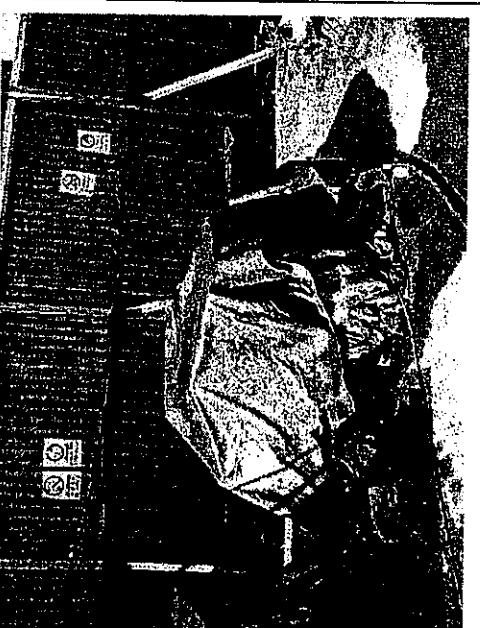
Date	Key Findings	Action
14 Sep 2005	<ul style="list-style-type: none"> <li>Debris (dead vegetation) observed at Permanent Desilting Chambers (PDC) B and C in last audit had been removed. However, a thin silt layer was observed on the channel bottom of Chamber B.</li> </ul>	<ul style="list-style-type: none"> <li>The Contractor advised the channel beds would be cleaned on 17-Sep-2005.</li> </ul>
	<ul style="list-style-type: none"> <li>Floating rubbish observed on the water surface in the last audit had been collected and no floating rubbish was observed in this audit</li> </ul>	<ul style="list-style-type: none"> <li>The Contractor was reminded to collect the floating rubbish regularly.</li> </ul>
	<ul style="list-style-type: none"> <li>The situation of the last hydroseeded panel in Portion I was improved.</li> </ul>	<ul style="list-style-type: none"> <li>The Contractor advised addition of seedlings would be conducted in the afternoon.</li> </ul>

<ul style="list-style-type: none"> <li>One drum containing lubricant oil was not capped or covered.</li> </ul>	<ul style="list-style-type: none"> <li>Contractor was reminded to cap all the containers and ensure no chemical waste leakage.</li> </ul>
	<ul style="list-style-type: none"> <li>Chemical wastes were collected and stored in the Chemical Waste Storage Area but many of the stored drums were not labeled.</li> </ul>	<ul style="list-style-type: none"> <li>Contractor was reminded to properly manage the storage of chemical waste on site (i.e. proper storage with appropriate labels etc.)</li> </ul>
	<ul style="list-style-type: none"> <li>C&amp;D material stockpiles were observed too close to the waterfront of the Barge Handling Area (BHA).</li> </ul>	<ul style="list-style-type: none"> <li>The Contractor was reminded the stockpiles should be formed behind the concrete walkway and any spilled material (onto the walkway) should be cleaned regularly.</li> </ul>
