**PENTA-OCEAN CONSTRUCTION CO. LTD.**

**OPERATION OF FILL BANK AT  
TSEUNG KWAN O AREA 137 AND  
BARGING FACILITIES AT HONG  
KONG ISLAND AND MUI WO  
(CONTRACT NO.: CV/2005/05)**

**MONTHLY EM&A REPORT  
(NOVEMBER 2005)**

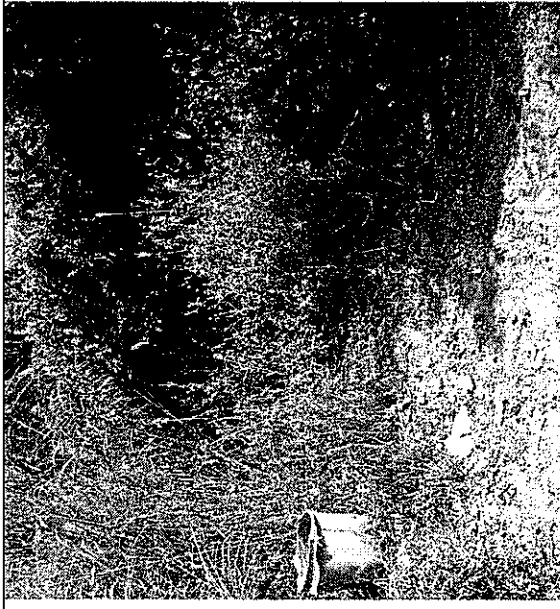
121105\_01

Item	Details of defective works or observations	Response	Date of Action taken	Photo Ref.
1	Follow up action to previous comment item #6 (24/10/05), rubbish was observed behind the water tank at Water Truck Filling Station. The Contractor was reminded to clean up the rubbish and provide rubbish bins at Water Truck Filling Station.	The area around the Water Filling Station has been cleaned up and a rubbish bin has been provided there on 12 November 2005.	12 Nov 2005	121105_01
2	Follow up action to previous comment item #5 (24/10/05), the License of "The Registration of Waste Producer" posted of the previous contract was still posted at Chemical Waste Storage Shed. The Contractor was reminded to displace the valid license.	The valid license of "The Registration of Waste Producer" for this Works Contract has been displaced at the Chemical Waste Storage Shed.	12 Nov 2005	121105_02
3	Follow up action to previous comment item #2 (24/10/05), the generator at Portion D4 was still without drip tray. The Contractor was reminded to provide drip trays for all generators.	The generator has been removed away in associated with the handover of Portion D4 to other contractor on 12 November 2005.	12 Nov 2005	-

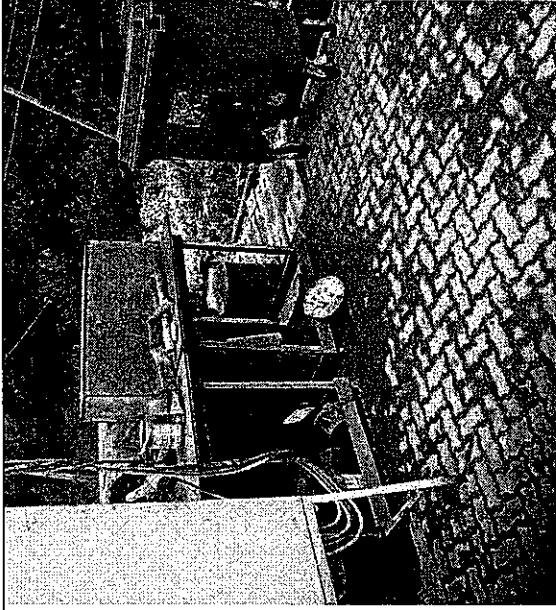
111105\_02

5	Follow up action to previous comment item #2 (24/10/05) and item #4 (03/11/05), the generator at Portion D4 was still without drip tray. The Contractor was reminded to provide drip trays for all generators.	The whole area of Portion D4 had been formally handed over to other contractor on 12 November 2005 and thus the area concerned is not managed by us thereafter.	-	-
6	Two 200L metal waste oil container and one 20L plastic container without labels and drip tray were placed on the ground at DB3 (near the wheel washing facilities). The Contractor was reminded to provide labels and drip tray for all containers.	The metal waste oil containers and plastic container were all removed away and stored inside the Chemical Waste Storage Shed on 11 November 2005.	11 Nov 2005	111105_02

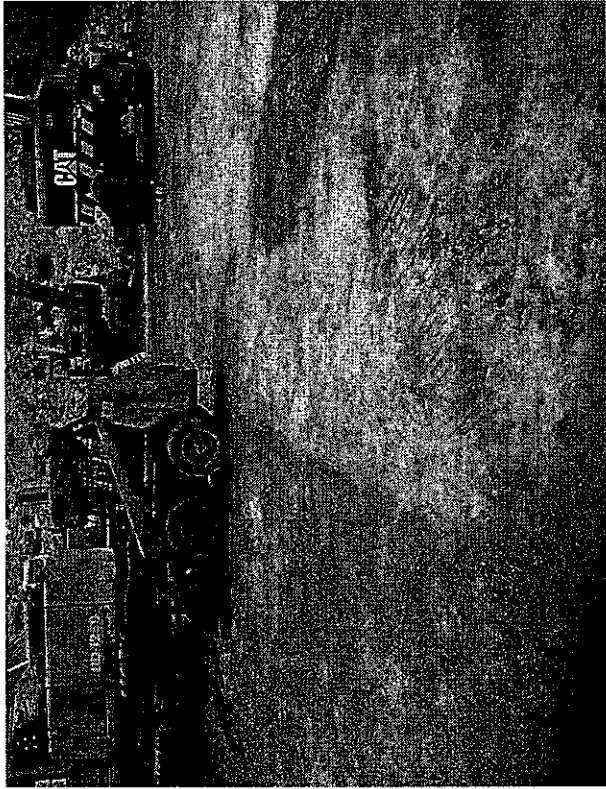
221105\_01

Item	Details of defective works or observations	Response	Date of Action taken	Photo Ref.
1	<p>Follow up action to previous comments item #4 (11/11/05) and item #2 (15/11/05), oil spillage from the maintenance work of the excavator was still observed on the bare ground at Workshop. The Contractor should clean up the contaminated soil and treat as chemical wastes immediately after the maintenance work. Besides, the Contractor was also reminded to provide impermeable sheet on the ground before repairing and maintenance works.</p>	<p><i>The oil spillage had been cleaned up after completion of maintenance of the plant concerned.</i></p>	<p>22 Nov 2005</p>	<p>221105_01</p>
