**OPERATION OF FILL BANK AT  
TSEUNG KWAN O AREA 137 AND  
BARGING FACILITIES AT HONG  
KONG ISLAND AND MUI WO  
(CONTRACT NO.: CV/2005/05)**

**TSEUNG KWAN O AREA 137**

**MONTHLY EM&A REPORT  
(DECEMBER 2005)**

Report No.: ENA50760

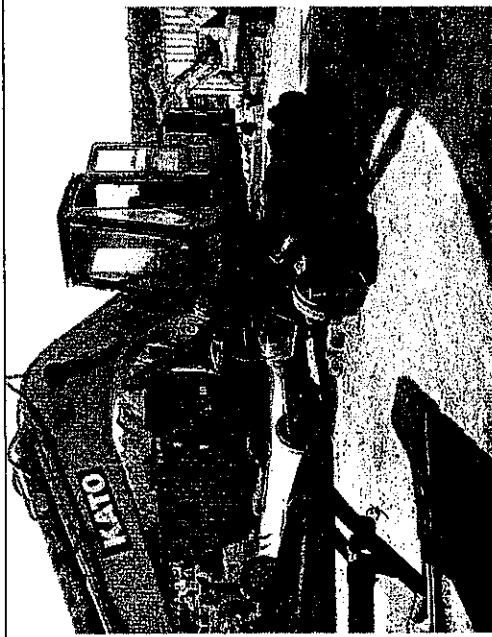
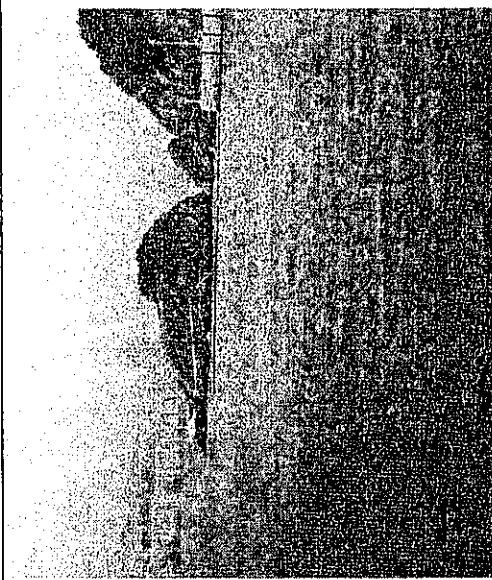
4	Haul road at Barging Handling Area was dry and potential fugitive dust emission was observed. The frequency of watering the haul road and exposed area should be increased especially during dry season in order to prevent the generation of dust.	The daily frequency of watering of the haul roads by water lorries has been increased.	20 Dec 2005	20122005_04
5	Two stockpiles of C&D materials next to the U-channel at DP4 were found without cover. The stockpiles should be covered with tarpaulin sheets.	The C&D material stockpiles have been removed away.	20 Dec 2005	20122005_05
6	Rubbish such as plastic bags was observed at the water truck filling station. The Contractor was reminded to clean up the rubbish and keep the site are tidy.	The rubbish observed at the water truck filling station has been cleaned up.	20 Dec 2005	20122005_06
