**OPERATION OF PUBLIC FILL  
RECEPTION FACILITIES AT  
TSEUNG KWAN O AREA 137,  
QUARRY BAY AND MUI WO  
(CONTRACT NO.: CV/2005/12)**

**TSEUNG KWAN O AREA 137**

**MONTHLY EM&A REPORT  
(MAY 2006)**

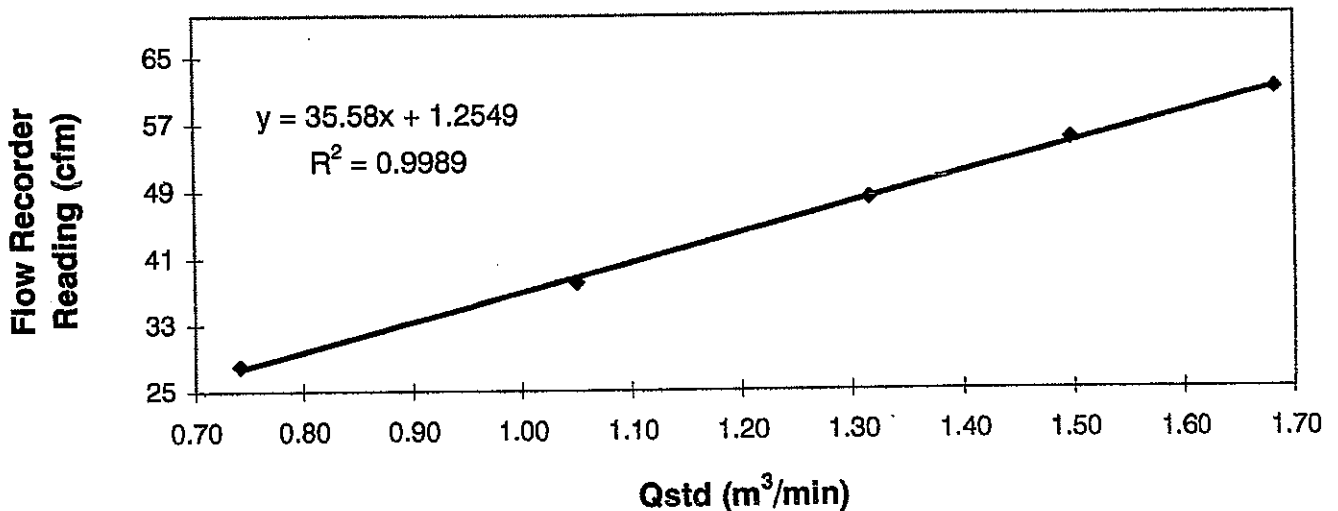
**Air Sampler 10347 Calibration Curve**  
**Site:Tseung Kwan O (AA1)**  
**Date of Calibration: 20 March 2006**

**Acceptance Criteria :** Correlation coefficient (r) of the calibration curve greater than 0.990 after a 5 point calibration

The high volume sampler complies \* / ~~does not comply~~ \* with the specified requirements and is deemed acceptable \* / unacceptable \* for use.

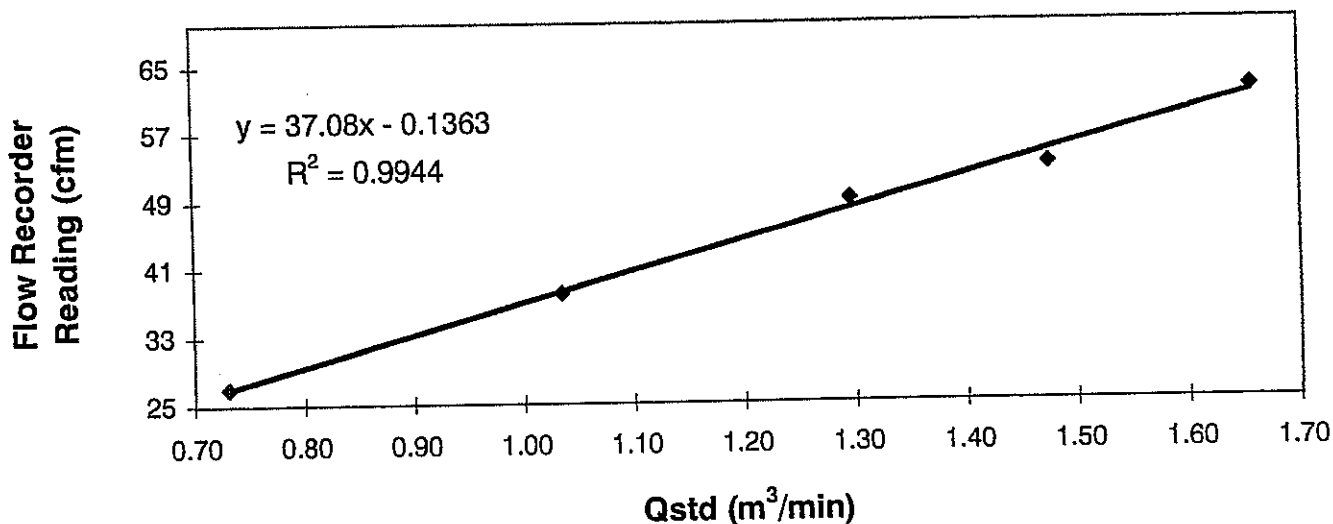
**Air Sampler 10347 Calibration Curve**  
Site:Tseung Kwan O (AA1)  
Date of Calibration: 22 May 2006

Acceptance Criteria : Correlation coefficient (r) of the calibration curve greater than 0.990 after a 5 point calibration

The high volume sampler complies \* / ~~does not comply~~ \* with the specified requirements and is deemed acceptable \* / ~~unacceptable~~ \* for use.

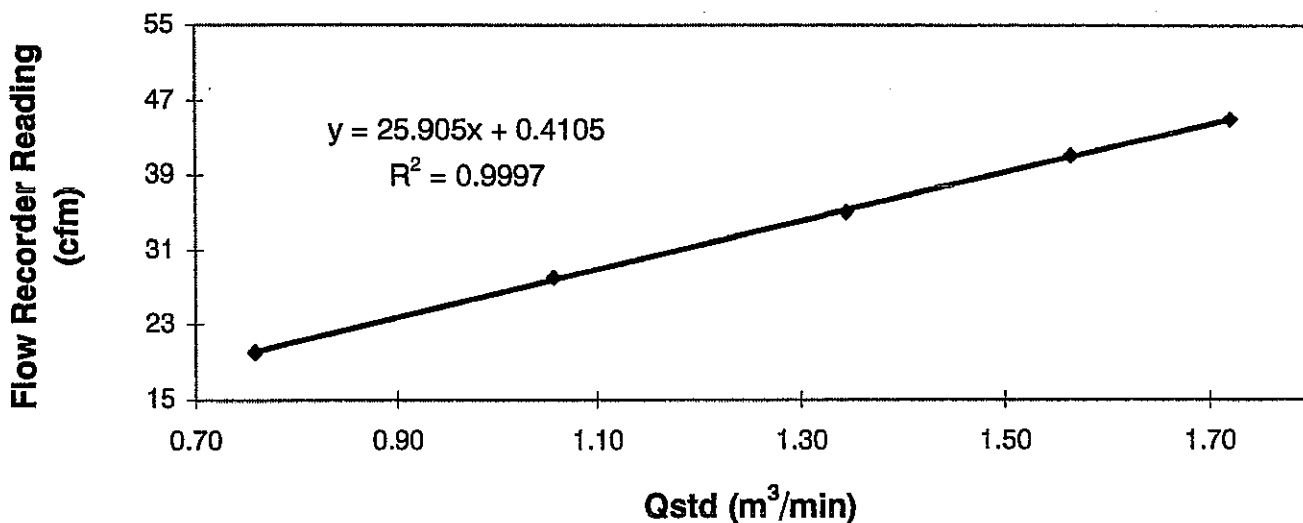
**Air Sampler 1176 Calibration Curve  
Site: Tseung Kwan O (AA2)  
Date of Calibration: 20 March 2006**

Acceptance Criteria : Correlation coefficient (r) of the calibration curve greater than 0.990 after a 5 point calibration

The high volume sampler complies \* / ~~does not comply~~ \* with the specified requirements and is deemed acceptable \* / ~~unacceptable~~ \* for use.

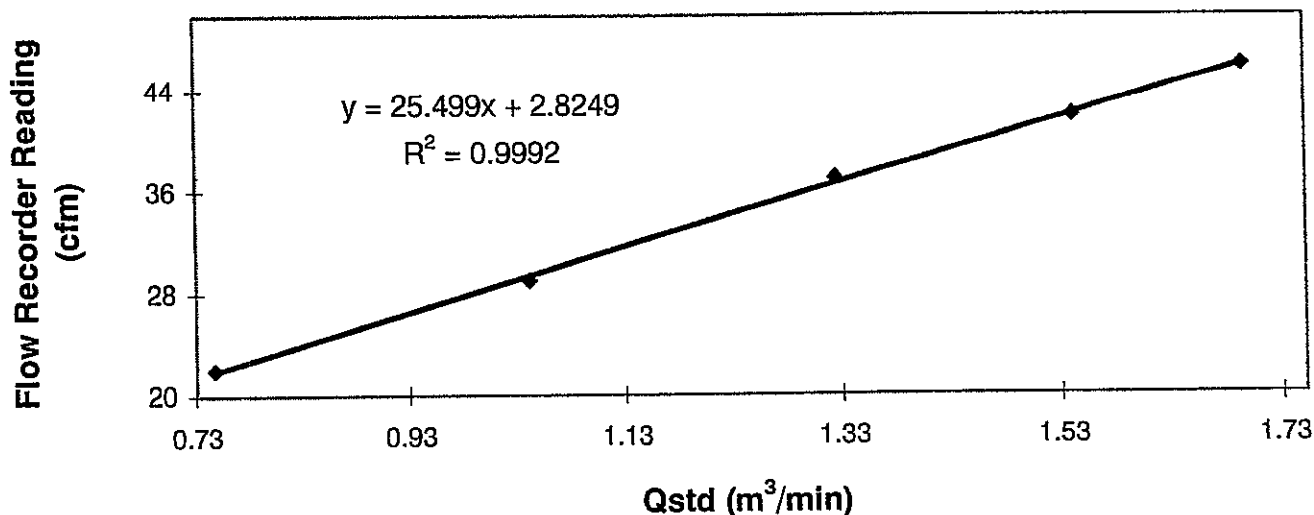
**Air Sampler 1176 Calibration Curve**  
**Site: Tseung Kwan O (AA2)**  
**Date of Calibration: 22 May 2006**

Acceptance Criteria : Correlation coefficient (r) of the calibration curve greater than 0.990 after a 5 point calibration

The high volume sampler complies \* / ~~does not comply~~ \* with the specified requirements and is deemed acceptable \* / ~~unacceptable~~ \* for use.

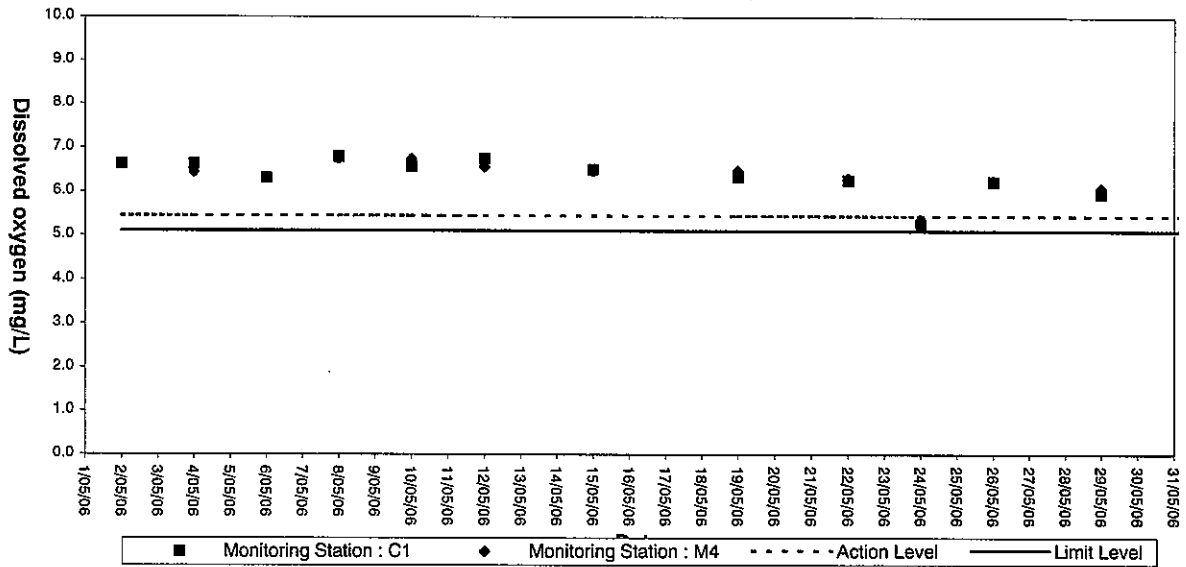
### Dissolved Oxygen (Surface & Middle) at Mid-Flood Tide

According to the summary of marine water monitoring results, two exceedances of Action Level on Dissolved Oxygen at Monitoring Stations C1 and M4 were recorded on 24 May 2006 (mid-flood). According to the monitoring results, it was found that dissolved oxygen content of the impact station C1 (5.25mg/L) was found closed to that of reference station M4 (5.37mg/L). At the same time, no abnormal site activities was observed at the Fill Bank. Therefore, the exceedances might be due to natural fluctuation of dissolved oxygen content in the water body around the area and considered not due to the Fill Bank operation. Since the exceedances were not due to the operation of Fill Bank, no further actions were required.
