**OPERATION OF PUBLIC FILL
RECEPTION FACILITES AT
TSEUNG KWAN O AREA 137,
QUARRY BAY AND MUI WO
(CONTRACT NO.: CV/2005/12)**

TSEUNG KWAN O AREA 137

**MONTHLY EM&A REPORT
(AUGUST 2006)**

Report No.: ENA60627

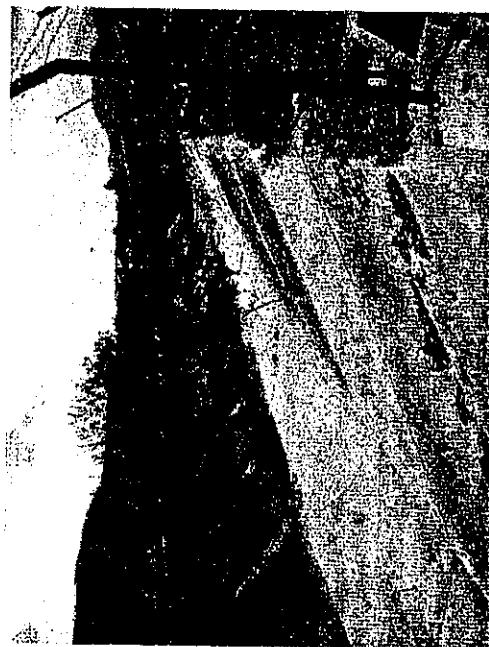
Photo of Follow-up Action

Item	Details of defective works or observations	Response	Date of Action taken	Photo Ref.
1	Follow up action to previous comments on 02/06/06 (item 4), 08/06/06 (item 4), 14/06/06 (item 3), 20/06/06 (item 3), 26/06/06 (item 4), 06/07/06 (item 2), 12/07/06 (item 4), 18/07/06 (item 3) and 24/07/06 (item 1), silt curtain at marine barging area was still found damaged. The Contractor should repair the damaged part of the silt curtain immediately.	The Contractor had repaired well the whole pair of silt curtain.	29 Aug 2006	20060804a
2	Follow up action to the previous comments on 20/06/06 (item 2), 26/06/06 (item 2), 06/07/06 (item 1), 12/07/06 (item 2), 18/07/06 (item 1) and 24/07/06 (item 2), mud and debris were still observed to be accumulated in the drainage channel at Chamber A. The Contractor was reminded to remove the mud and debris accumulated regularly.		30 Aug 2006	20060804b
