**OPERATION OF PUBLIC FILL RECEPTION  
FACILITIES AT TUEN MUN AREA 38,  
TSEUNG KWAN O AREA 137, QUARRY BAY  
AND MUI WO**

**(CONTRACT NO.: CV/2006/02)**

**TSEUNG KWAN O AREA 137**

**MONTHLY EM&A REPORT  
(SEPTEMBER 2006)**

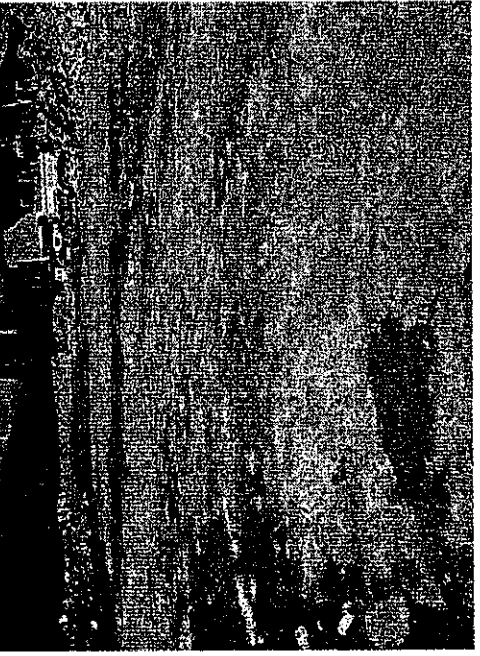
<p>20060908c</p>	
--	---	--	--

3	Mud and debris were observed to be accumulated in the drainage channel at Chamber A. The Contractor was reminded to remove the mud and debris accumulated regularly.	The Contractor had removed the mud and debris accumulated in the drainage channel at Chamber A.	5 Oct 2006	-
4	The generator at CCTV station was found without drip tray. The Contractor should provide drip trays for all generators.	The Contractor had removed away the generator concerned and cleaned the original ground properly.	9 Sep 2006	20060908c
