**TEST REPORT**

**DELIVERY OF RECLAMATION MATERIAL TO  
MAINLAND –  
ENVIRONMENTAL MONITORING AND AUDIT  
(CONTRACT NO.: CV/2005/01)**

**TSEUNG KWAN O AREA 137 FILL BANK  
QUARTERLY EM&A SUMMARY REPORT NO.5  
(FROM DECEMBER 2007 TO FEBRUARY 2008)**

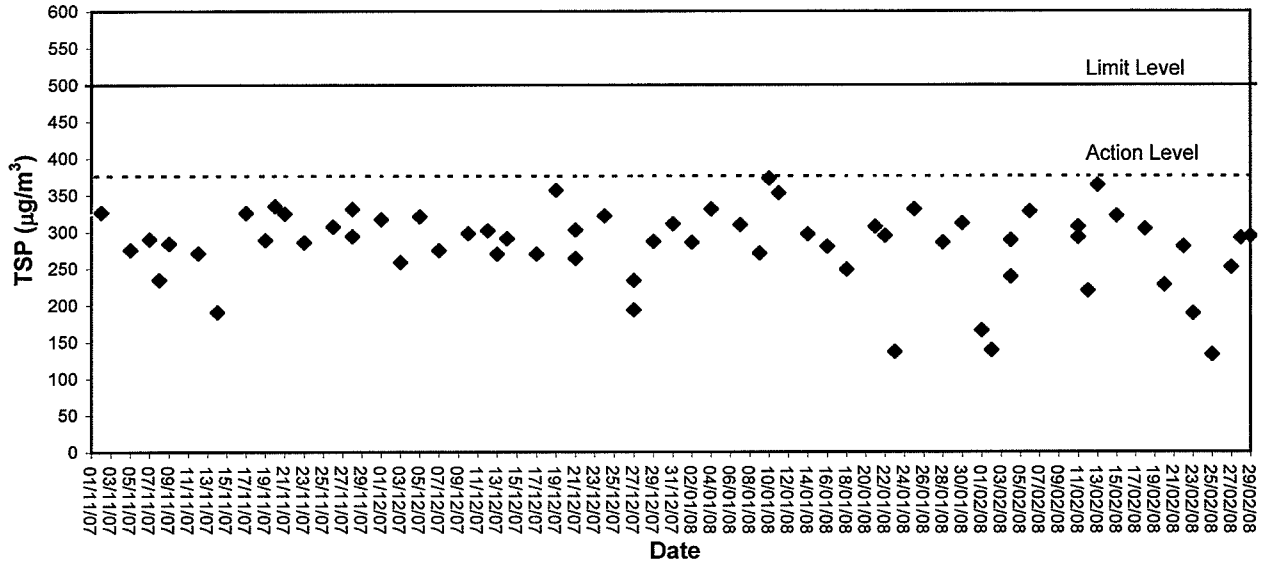
1-hour TSP level at TKO-A1 (Outside CEDD Site Office)

In accordance with the EM&A Manual, 1-hr and 24-hr TSP air quality monitoring were conducted three times and once per six days correspondingly. In the reporting quarter, all the 1-hr and 24-hr TSP monitoring results complied with the AL Levels. The trend of air quality during the reporting quarter is present in Appendices B.

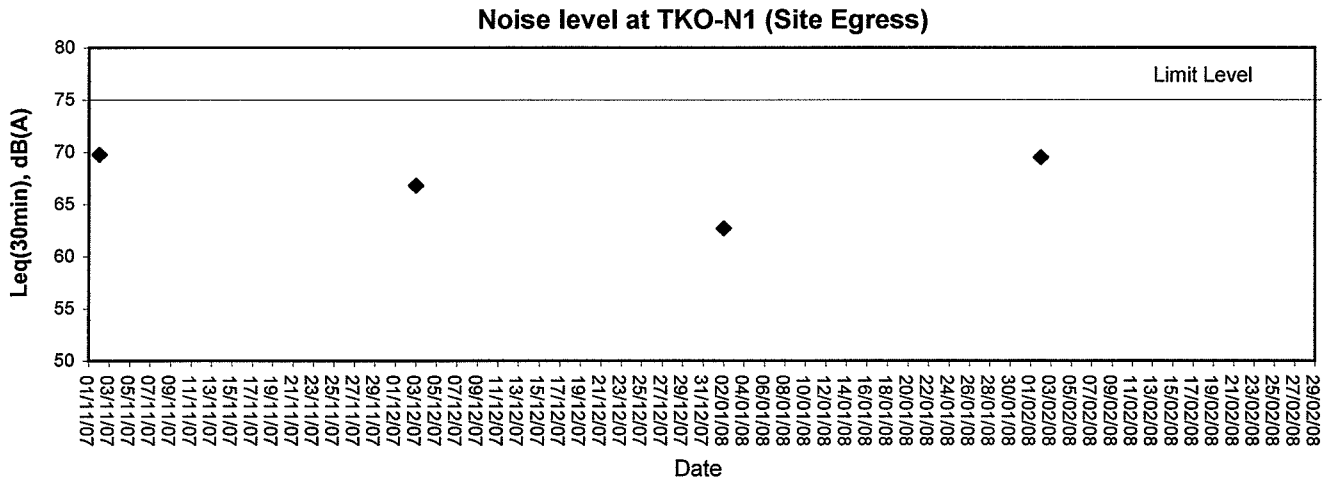
## Noise Monitoring (Day-time)

Noise monitoring was required to be conducted at least once per month. Only daytime noise was monitored in the reporting quarter. All recorded noise levels complied with the AL Levels. The registered noise levels in the past three months are plotted in Appendices C.

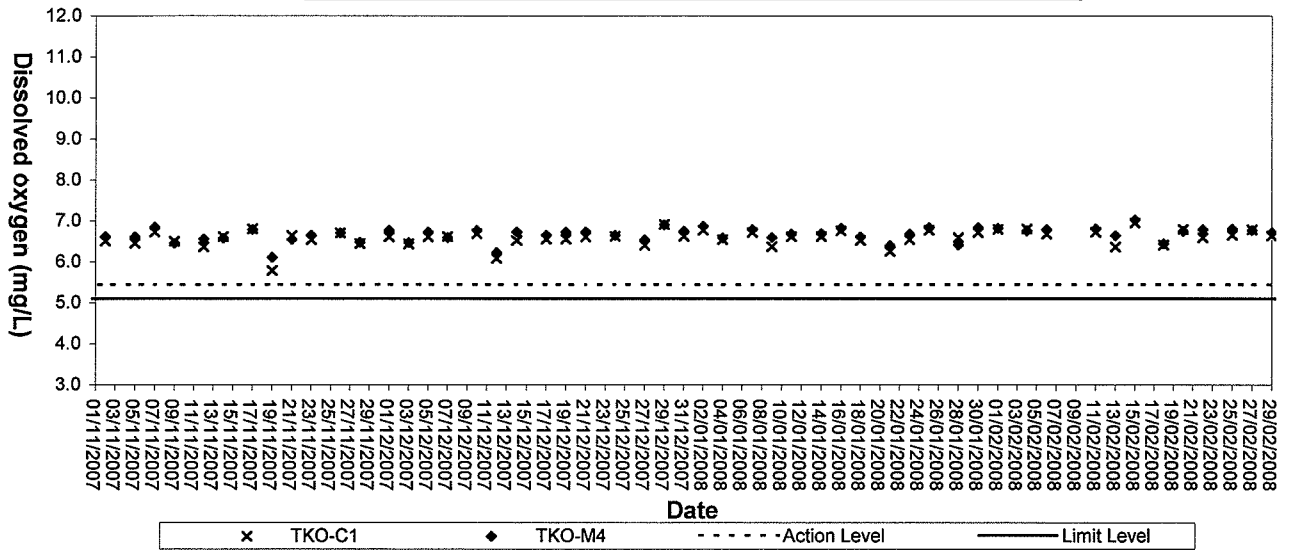
### Dissolved Oxygen (Surface & Middle) at Mid-Flood Tide

Table 4.4 presents the total number of marine water quality exceedances in the reporting quarter. The trend of marine water quality in the past three months is depicted in Appendix D.

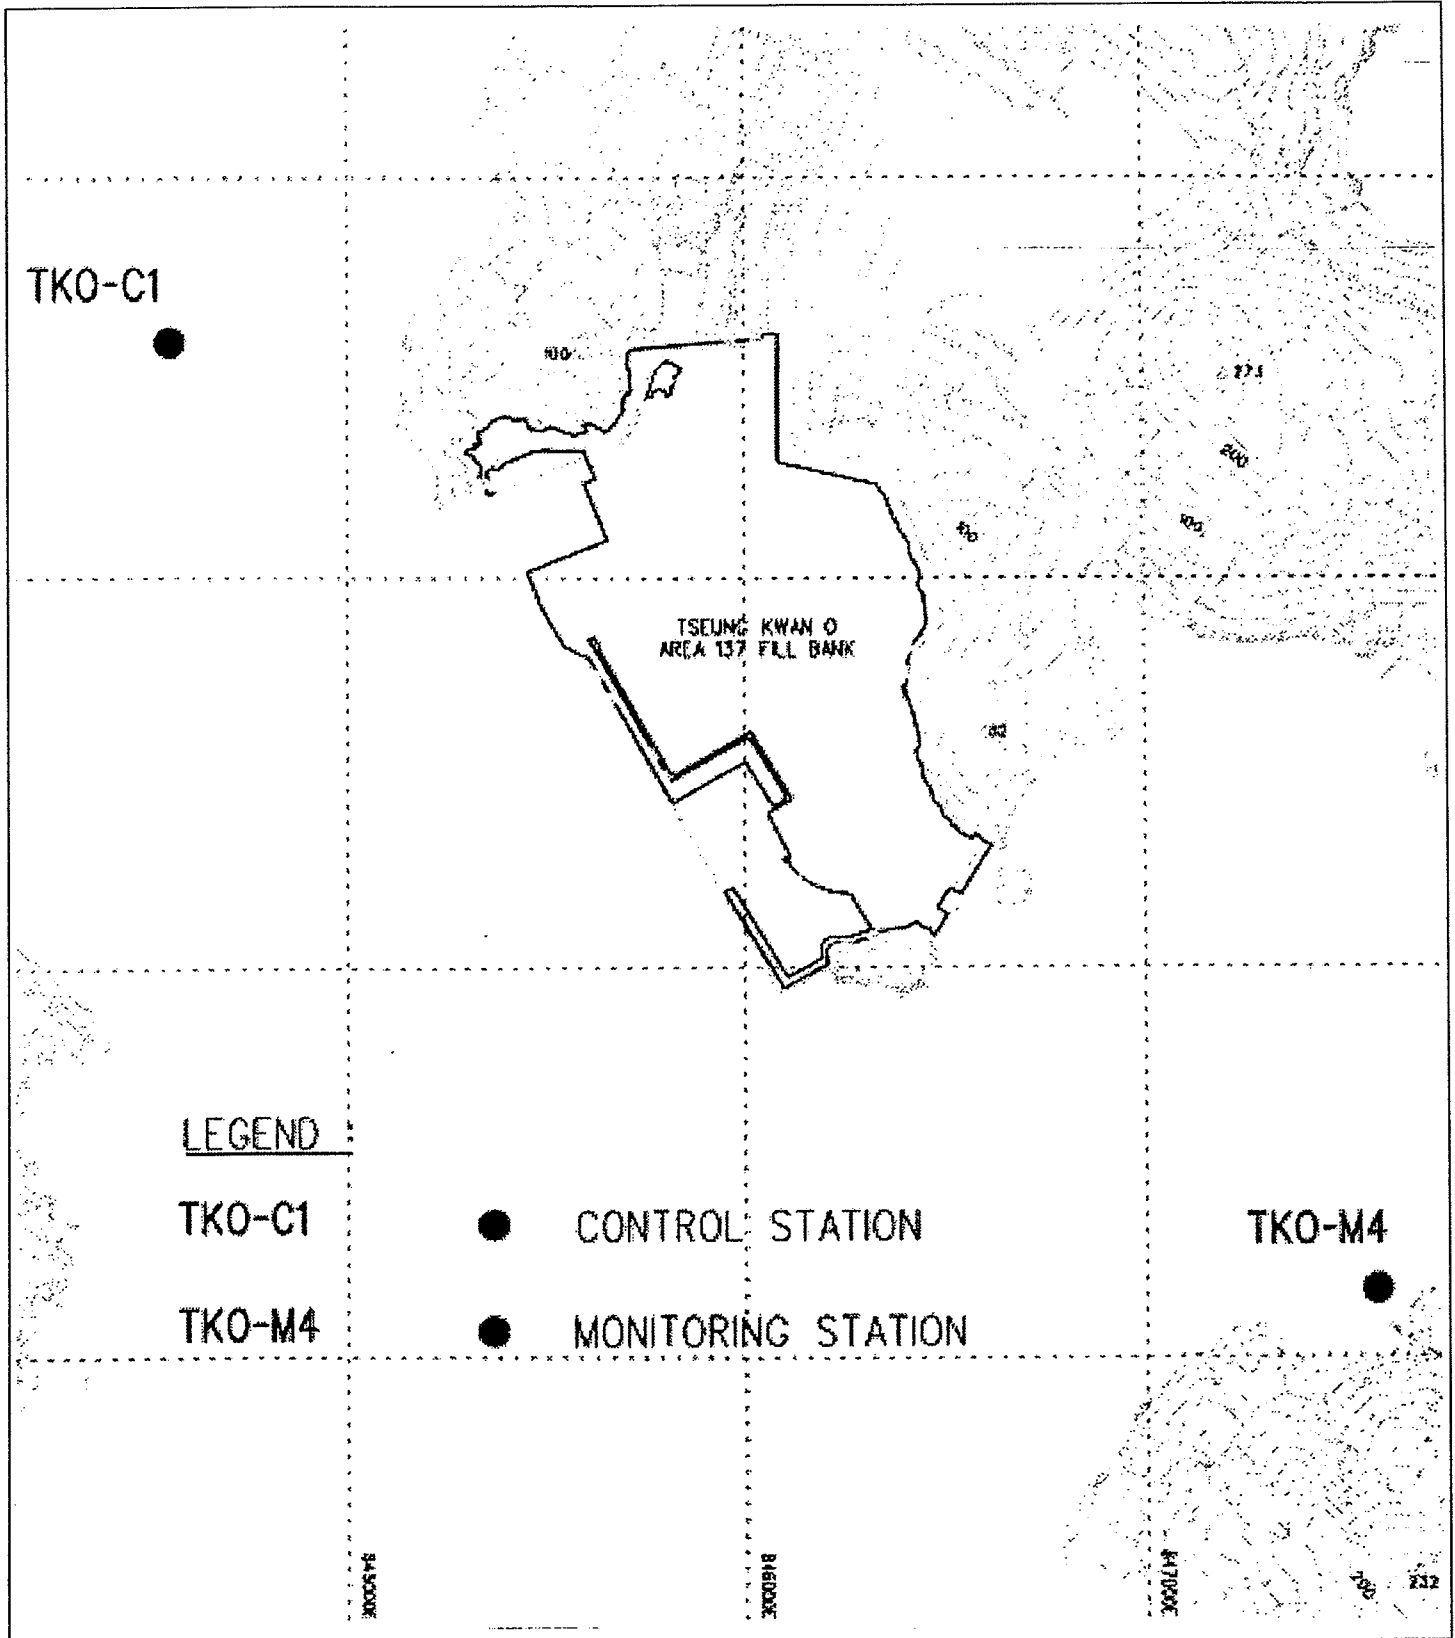
Figure 1  
 Locations of Water Quality Monitoring Stations –  
 Tseung Kwan O Area 137 Fill Bank

In accordance with the EM&A Manual, the marine water quality monitoring was conducted at the monitoring station (M4) and the control station (C1) in the reporting quarter.

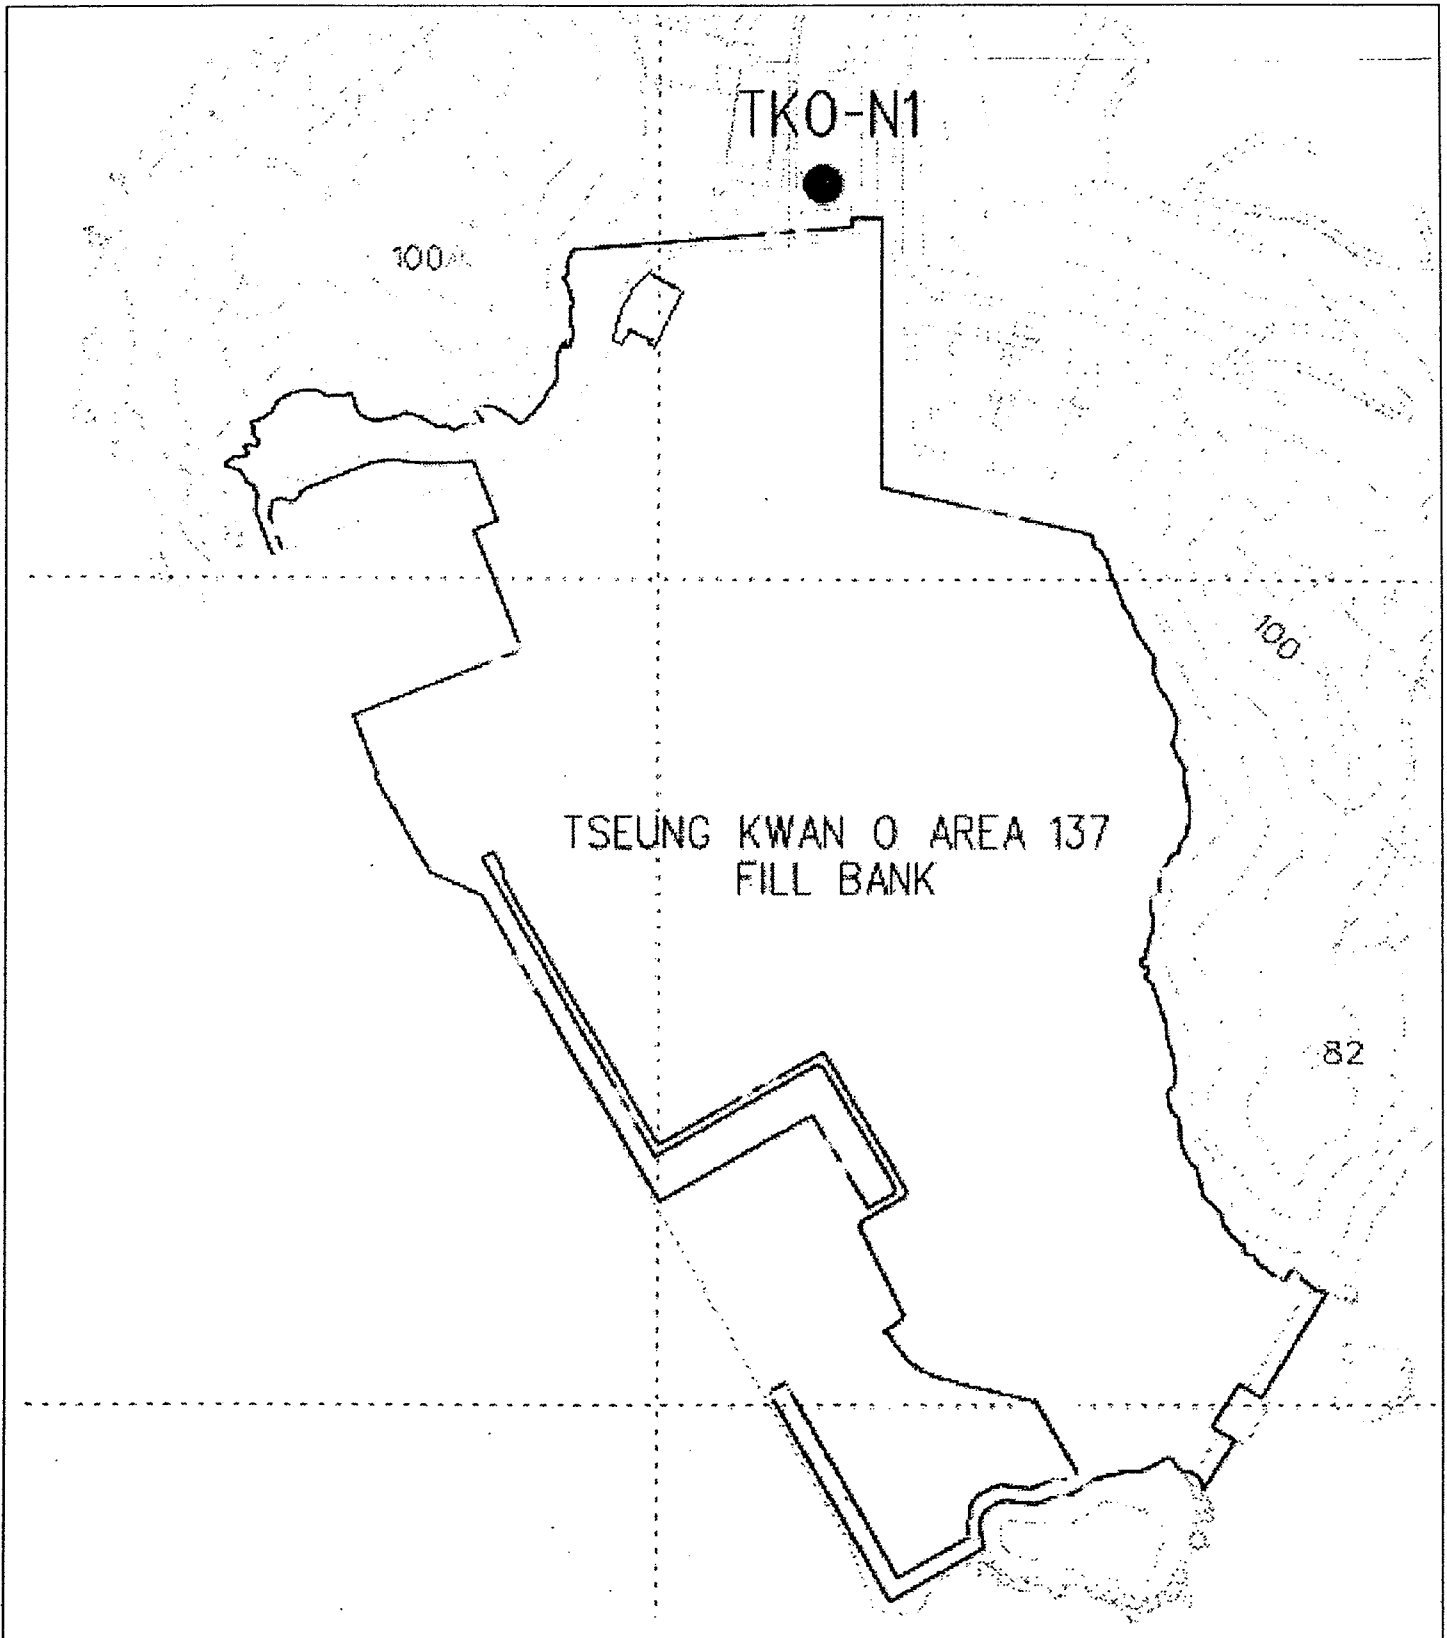
Figure 2  
 Locations of Noise Monitoring Station –  
 Tseung Kwan O Area 137 Fill Bank

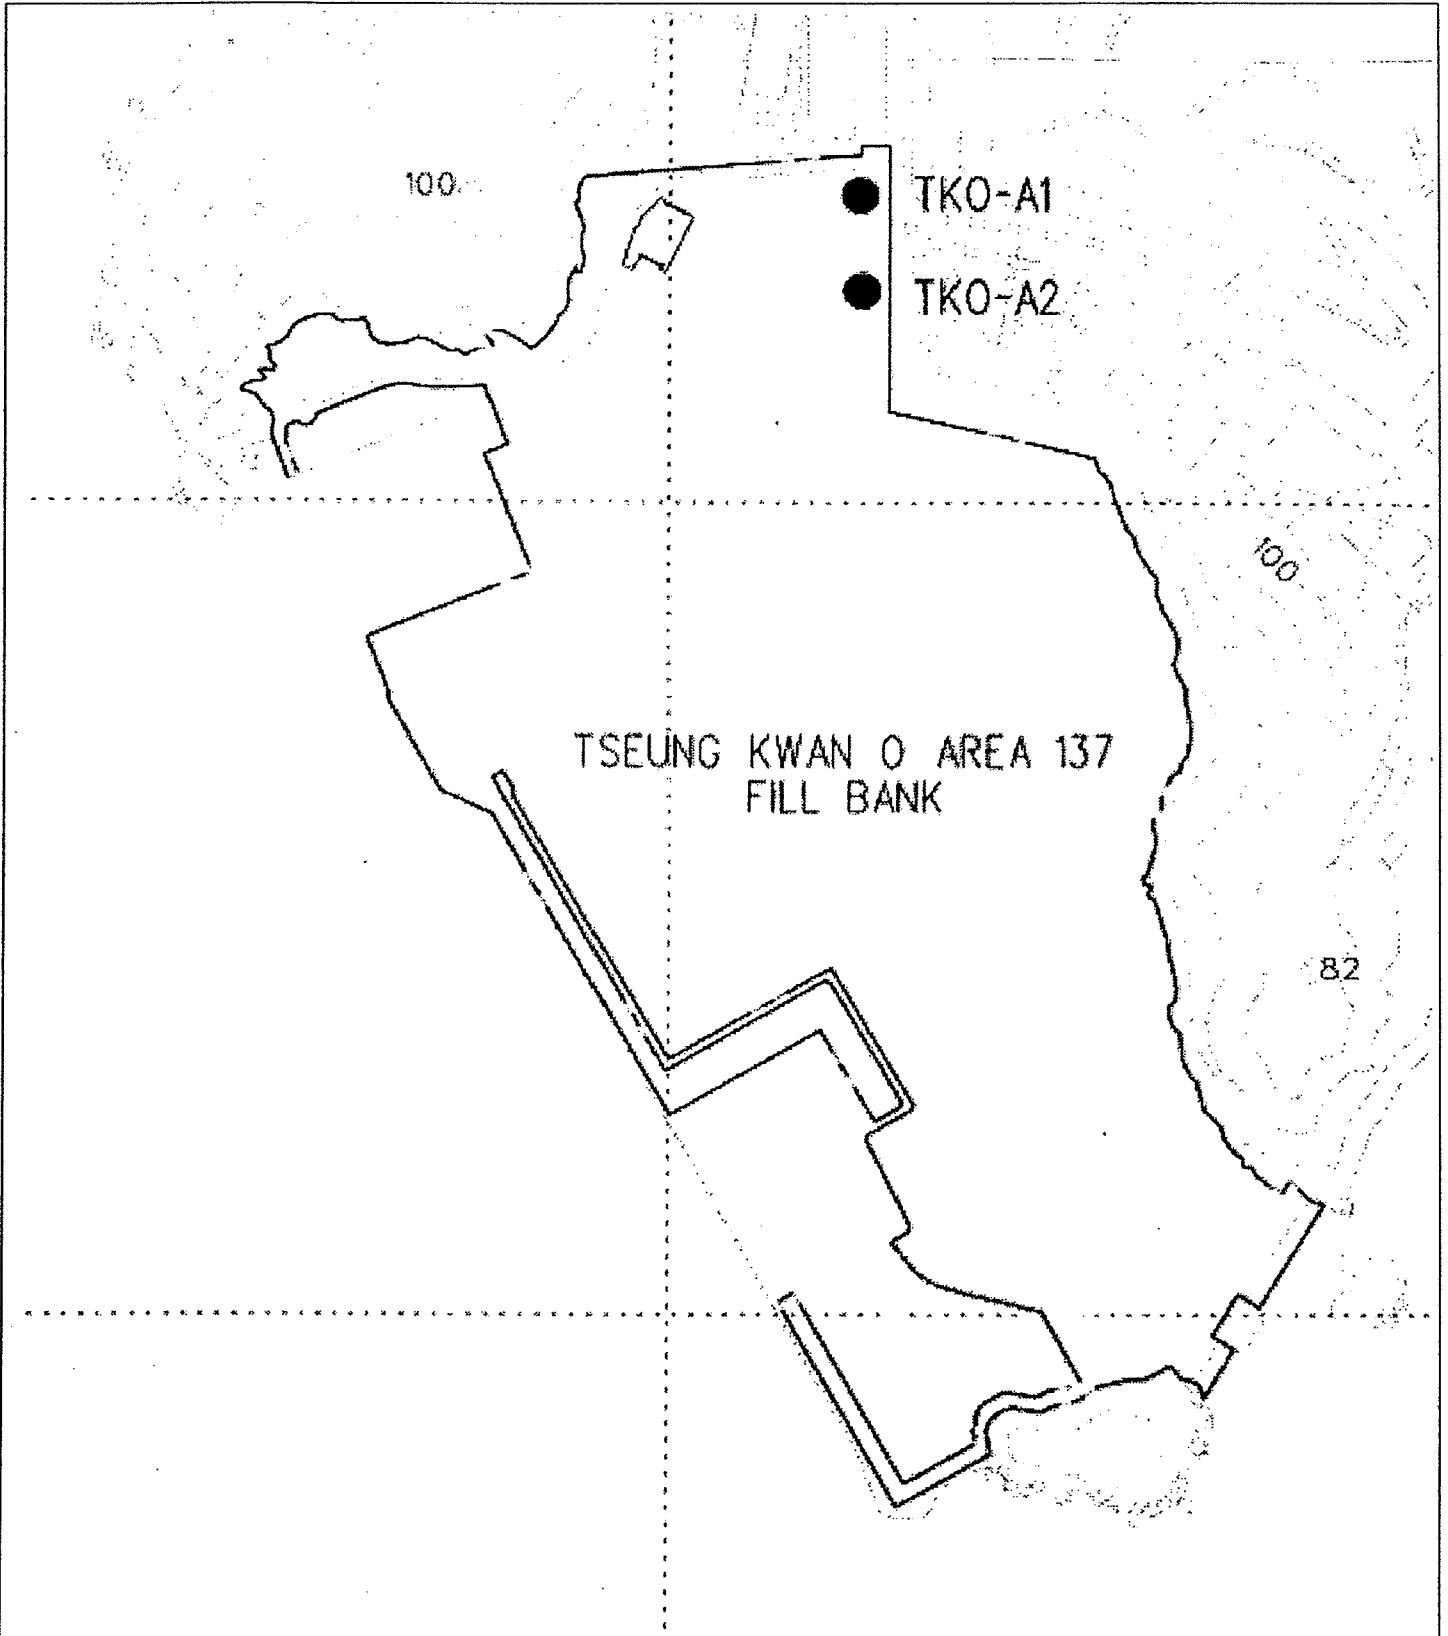
Figure 3  
 Locations of Air Quality Monitoring Stations –  
 Tseung Kwan O Area 137 Fill Bank
