**DELIVERY OF RECLAMATION MATERIAL  
TO MAINLAND –  
ENVIRONMENTAL MONITORING AND AUDIT  
(CONTRACT NO.: CV/2005/01)**

**TSEUNG KWAN O AREA 137 FILL BANK**

**MONTHLY EM&A REPORT**

**(APRIL 2008)**

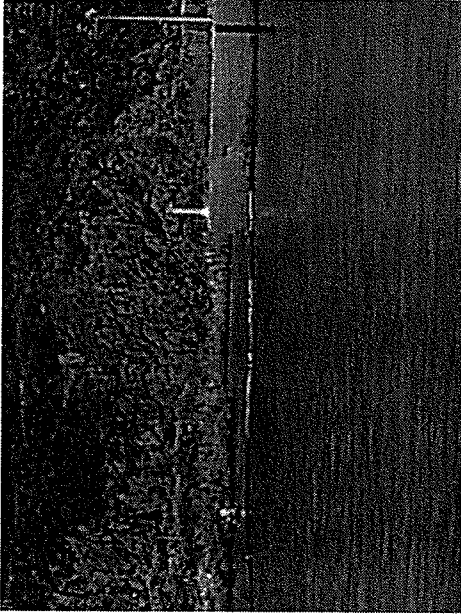
Photo 080407\_001

- During the weekly site inspection on 07 April 2008 oily water was leaked from the drip tray at workshop. The Contractor was reminded to repair the damaged drip tray, collect the oily water and treat it as chemical waste. Besides, the Contractor was also reminded to clean up the rainy water accumulated in the drip tray immediately after the rain in order to avoid mosquito breeding. No oily water was leaked from and noted inside drip tray at workshop during the subsequent weekly site inspection on 18 April 2008.

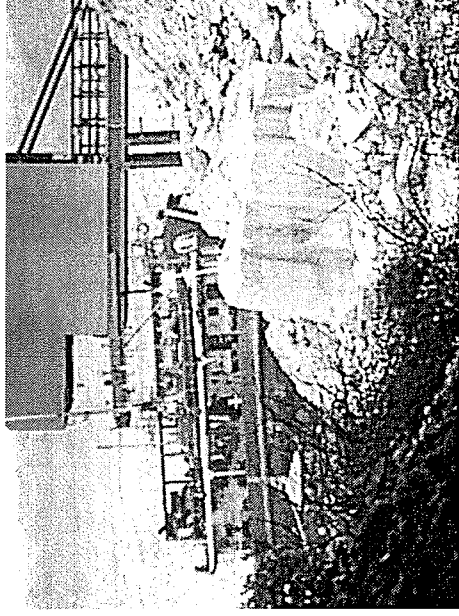
Photo 080418\_003

Item	Details of defective works or observations	Photo Ref.	Further Action Required (Yes/No)
1	Follow up action to the previous site inspections item 2 on 07/04/08, no oily water was leaked from and noted inside drip tray at workshop	080418_001	No
2	Follow up action to the previous site inspections item 3 on 11/03/08, item 2 on 17/03/08, item 3 on 26/03/08 and item 3 on 01/04/08 and item 2 on 07/04/08, the right side of the silt curtain at BHA was still found partly damaged. The Contractor was reminded to repair the damaged part of the silt curtain as soon as possible.	080418_002	Yes
3	Fill materials were accumulated on the concrete embankment at the BHA. The Contractor was reminded to clean up the fill materials as soon as each unloading activity completed to avoid the fill materials from being washed into the sea.	080418_003	Yes
