**DELIVERY OF RECLAMATION MATERIAL
TO MAINLAND –
ENVIRONMENTAL MONITORING AND AUDIT
(CONTRACT NO.: CV/2005/01)**

TSEUNG KWAN O AREA 137 FILL BANK

MONTHLY EM&A REPORT

(JULY 2008)

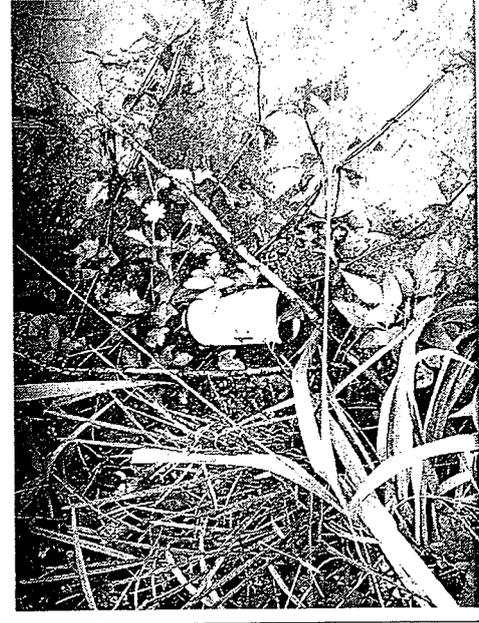
Photos

Date	Key Findings	Action Taken recommended by IEC
11 July 2008	• Silt curtain near tipping hall No.1 was sited improperly.	• To relocate the silt curtain as soon as possible.
	• Oil contaminated soil was found under the excavator (C7).	• To remove the contaminated soil and dispose as chemical waste.
23 July 2008	• Oil contaminated soil was found under the excavator (C7). (Rectified)	• To remove the contaminated soil and dispose as chemical waste.

- During the weekly site inspection on 11 July 2008, oil leakage was noted from a repairing excavator at workshop although drip tray and tarpaulin sheet were provided. The Contractor was reminded to cleanup and treat the contaminated soils as chemical waste, and provide appropriate impermeable sheets or bigger drip tray during the repairing and maintenance works. During the weekly site inspection on 23 July 2008, impermeable sheet was placed on the ground at workshop during the repairing and maintenance works in order to avoid spill oil contaminating the surrounding environment.

The Contractor should provide sufficient preventive measures during equipment maintenance works so as to avoid oil leakage on the ground. In the event of any oil leakage, the Contractor should clean up the polluted soil and handle all the materials used for this cleaning works as chemical waste.
